**Proposed Development**

**157-163 Cleveland St**  
**Redfern**

**Arboricultural Assessment**

November 2011

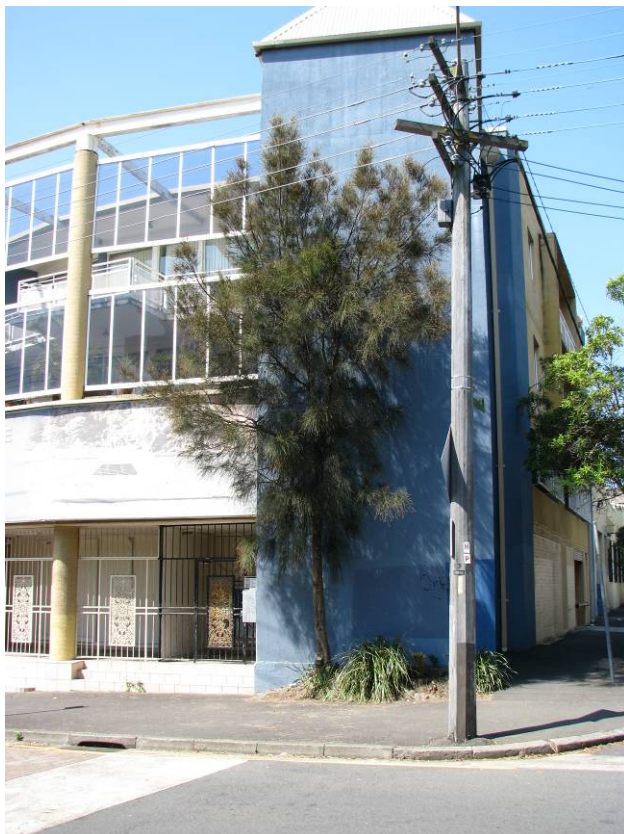
*Figure 1: Tree 7 viewed from west showing its relatively small size and narrow form at this stage.*

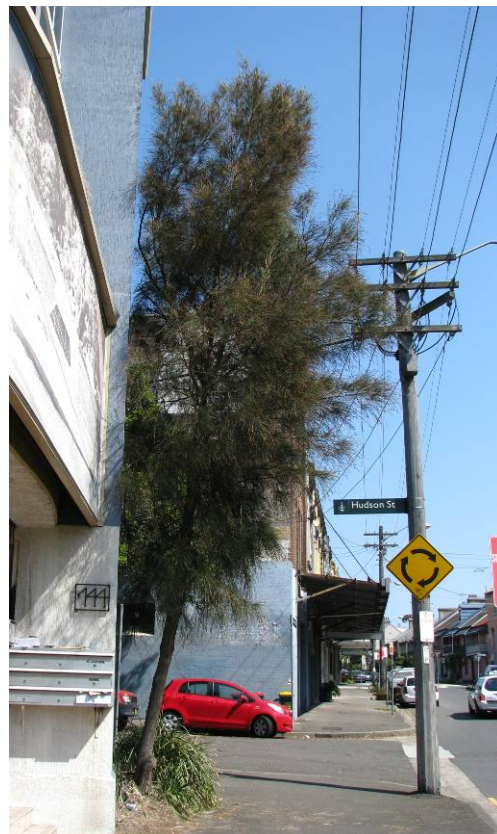
In the case of Tree 7, its location will be in conflict with the proposed location for the Fire Booster Assembly and access to the water and gas meters.

*Figure 2: Tree 7 viewed from north showing its proximity to the existing building. Its proximity to the overhead lines will*

*also lead to repeated lopping in the near future.*

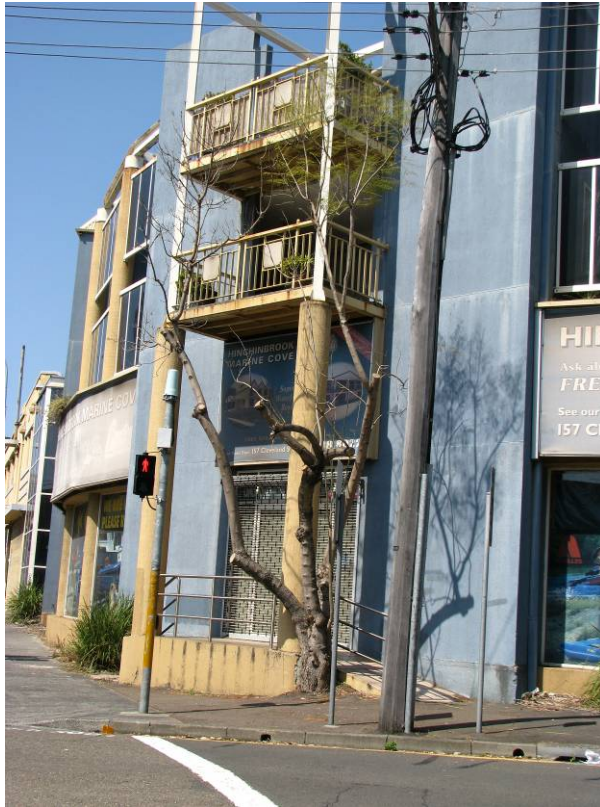
Figure 3: Tree 8 viewed from west showing its relatively small size and few remaining branches following lopping for powerline clearance..

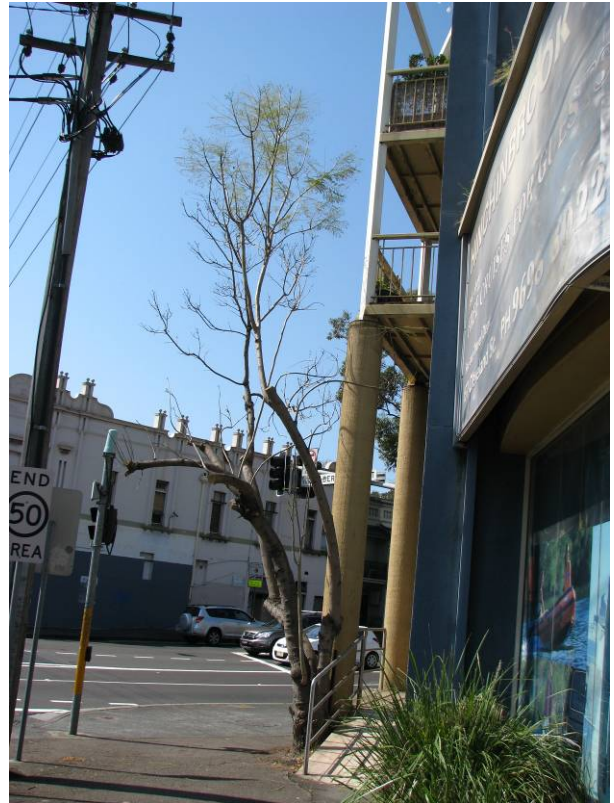
Figure 4: Tree 8 viewed from south west showing its proximity to the existing building and poor form.

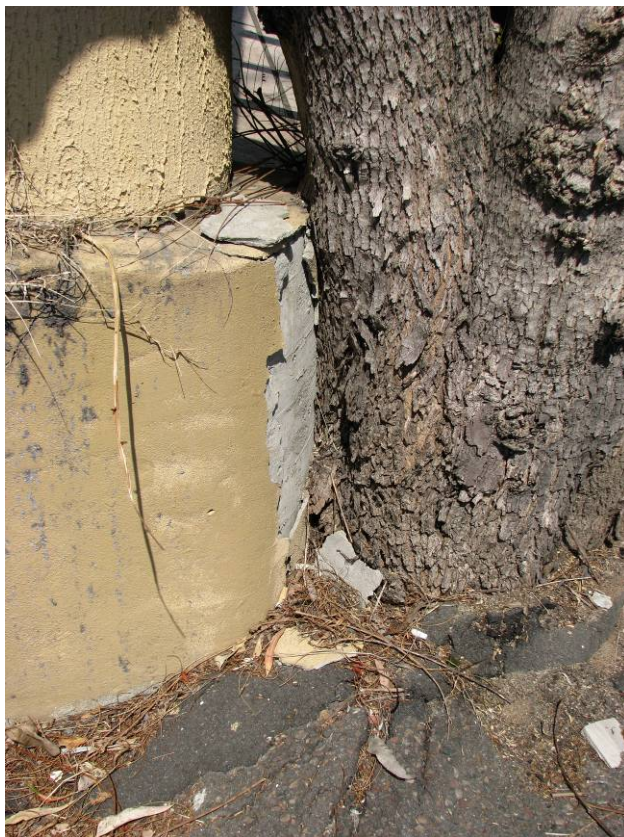
Figure 5: Tree 8 showing how the trunk is compressed against the pier of the existing building.

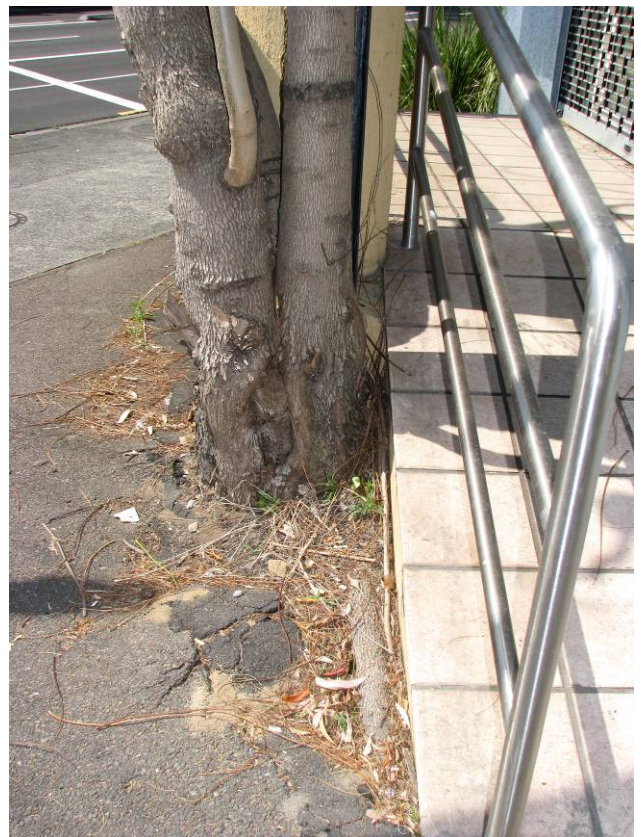
Figure 6: Tree 8 viewed from south showing one of the deep bark inclusions between trunks and roots restricted by the existing ramp.

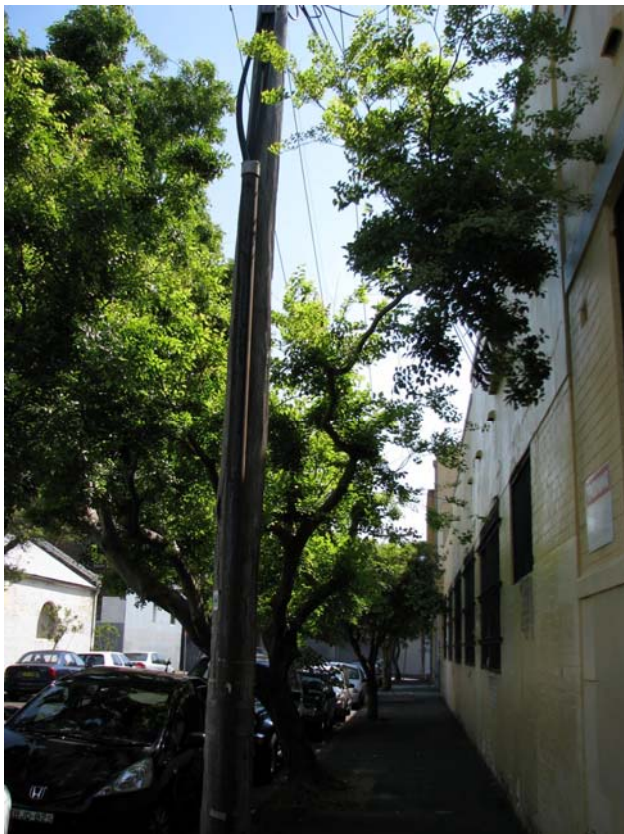
| Tree No. | Botanical Name | Common Name | HEIGHT <sup>1</sup><br>SPREAD <sup>2</sup><br>DBH <sup>3</sup> (mm) | | | Health | Hort. Viability | Structural Condition | Rank for Retention | Age Class | Tree Surgery <sup>4</sup> | Notes |
|---|---|---|---|---|---|---|---|---|---|---|---|---|
| 3 | <i>Celtis sinensis</i> | Chinese Nettle-tree | 9 | 8.0<br>12.5 | | Good | Good | Fair | 3 | Mature | 11 | Generally reasonable specimen although it has been repeatedly lopped for powerline clearance. Tree has numerous wounds to branches from truck damage. Its age appears to be 15-20 years and is growing at the base of a stump of a former street tree. Given its age and location it is likely that this is a self sown If retained, it will require further line clearance pruning and some directional pruning to remove poorly attached branches. Lopping has resulted in a spreading crown that will conflict with the installation of hoarding, requiring extensive pruning. The potential size of the tree also means that it will increasingly be in conflict with the adjacent building, requiring ongoing maintenance. Removal is recommended. |

*Figure 7: Tree 3 showing its distorted form and conflict with the existing building.*

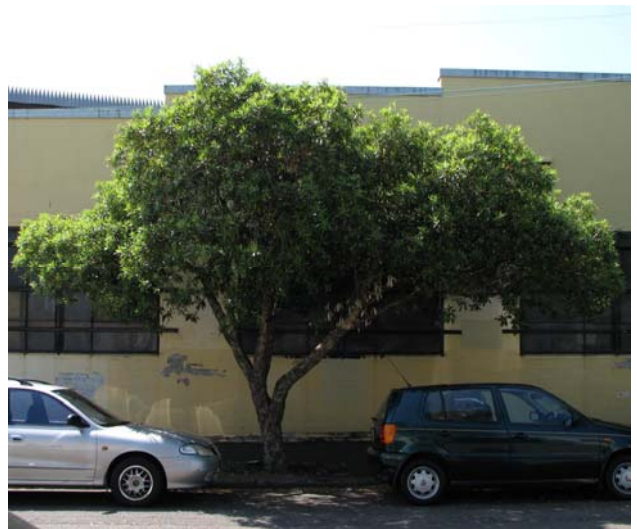
| Tree No. | Botanical Name | Common Name | HEIGHT <sup>1</sup><br>SPREAD <sup>2</sup><br>DBH <sup>3</sup> (mm) | | | Health | Hort. Viability | Structural Condition | Rank for Retention | Age Class | Tree Surgery <sup>4</sup> | Notes |
|---|---|---|---|---|---|---|---|---|---|---|---|---|
| 5 | <i>Tristaniopsis laurina</i> | Water Gum | 4.5 | 3.0<br>5.0 | 210 | Fair to good | Fair to good | Good | 1 | Mature | 12 | Generally reasonable specimen. Age appears to be 20-30 years although it is smaller than the Watergums on the southern side of Hudson St due to repeated lopping. The lopping has resulted in a low, flat-topped form with dense branching in the upper crown. No significant defects other than minor decay at the lopped branch tips. Its short and wide crown size means that it may conflict with the installation of hoarding. Some pruning may required at that stage. |

*Figure 8: The low broad crown of Tree 5 may create some difficulties for the erection of appropriate hoarding.*
