# **CVC Biodiversity Monitoring 2022**

## **Chain Valley Colliery**

E221082 RP1

February 2023

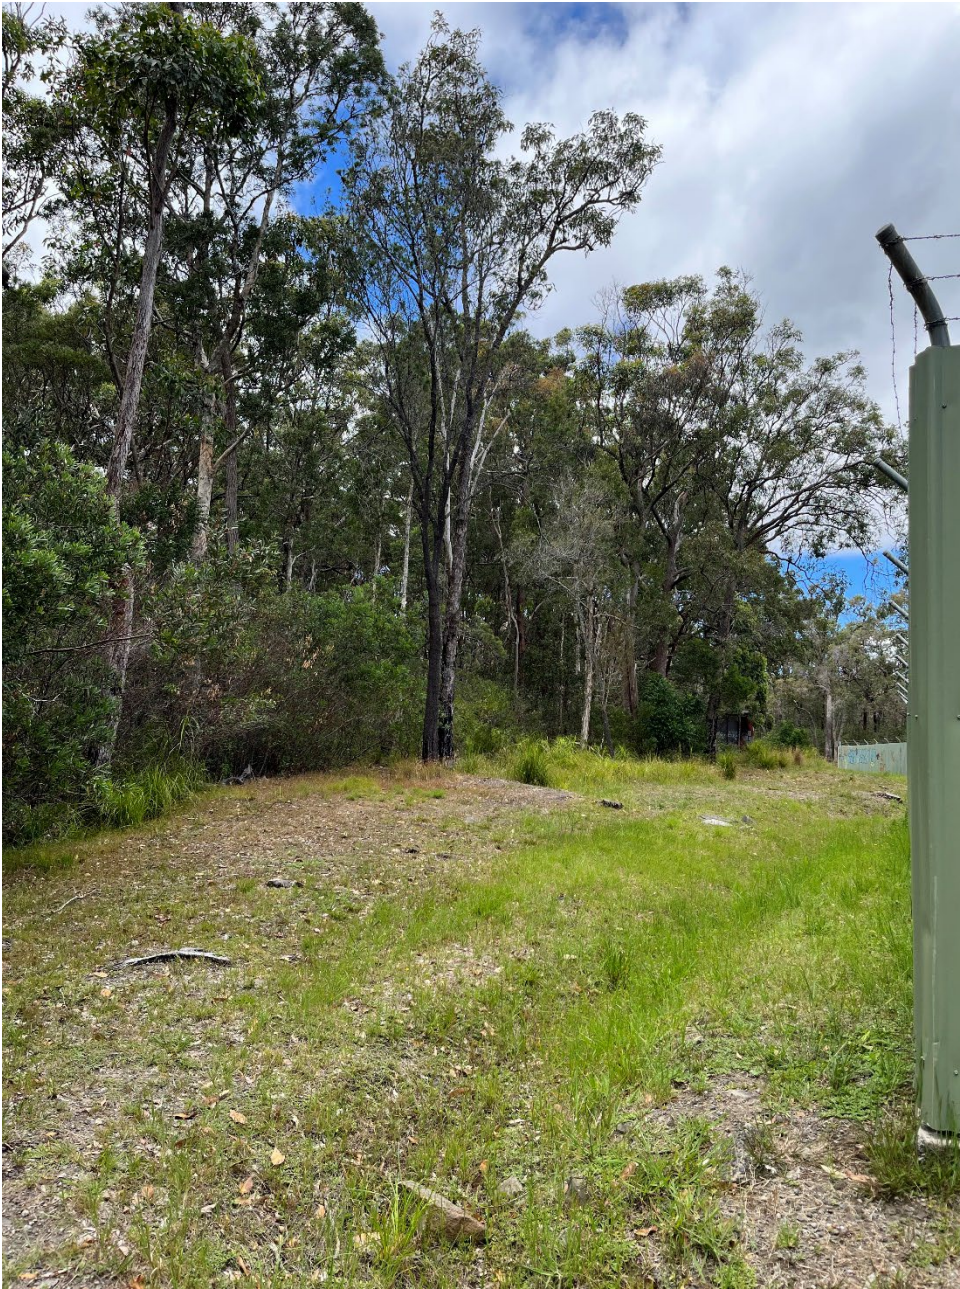
Photograph B.1      Photo point 1

| Monitoring point | 2022 monitoring observation |
|---|---|
| 1 | Vegetation appears healthy with persistent growth of canopy and midstorey species. No significant change observed |

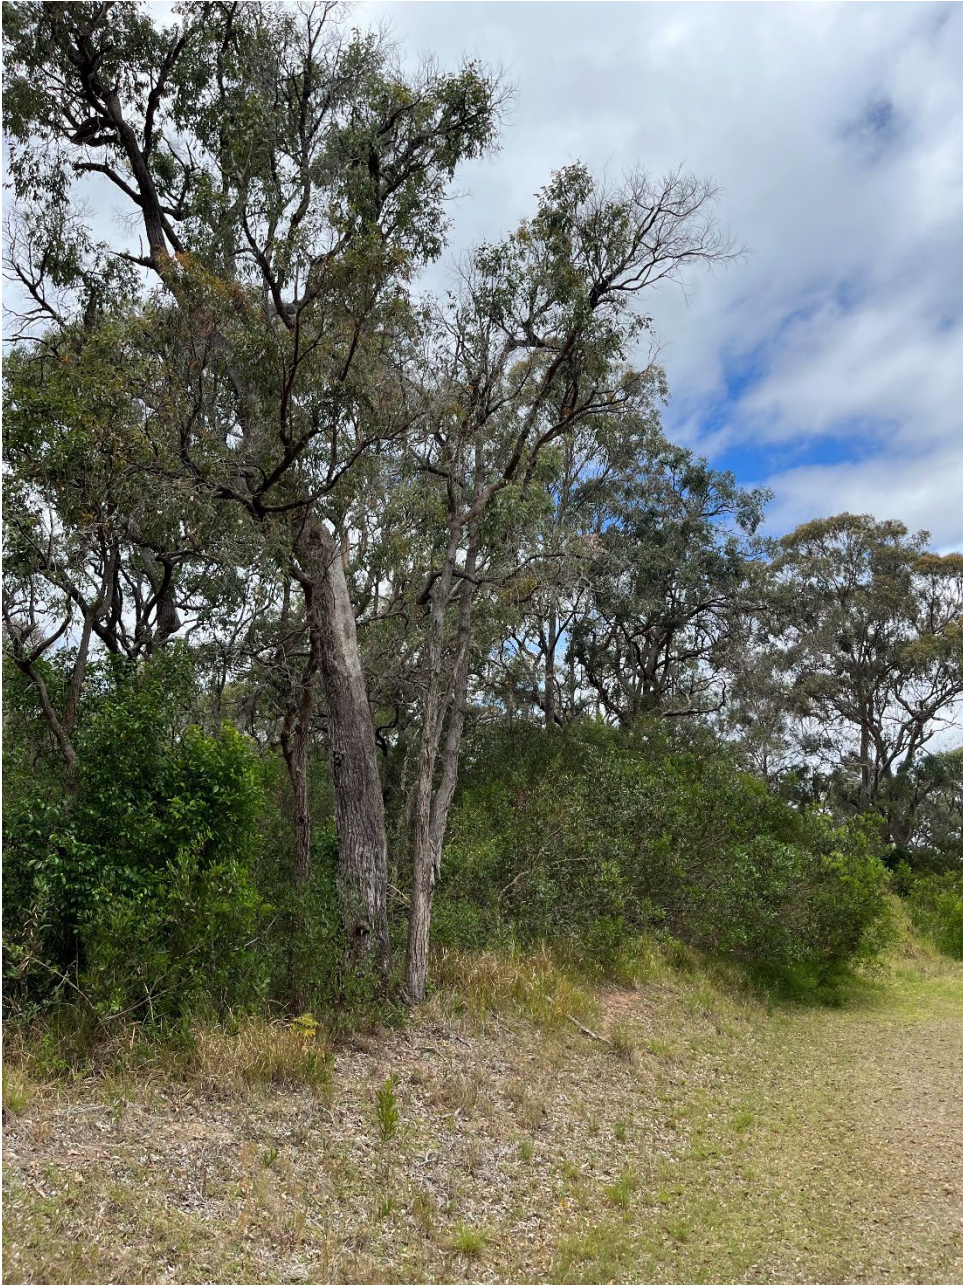
**Photograph B.2**      **Photo point 2**

| Monitoring point | 2022 monitoring observation |
|---|---|
| 2 | Some dieback is occurring to the canopy (see Tree 2 below). Encroachment of <i>Lantana</i> has increased from 2021 (EMM 2022). |

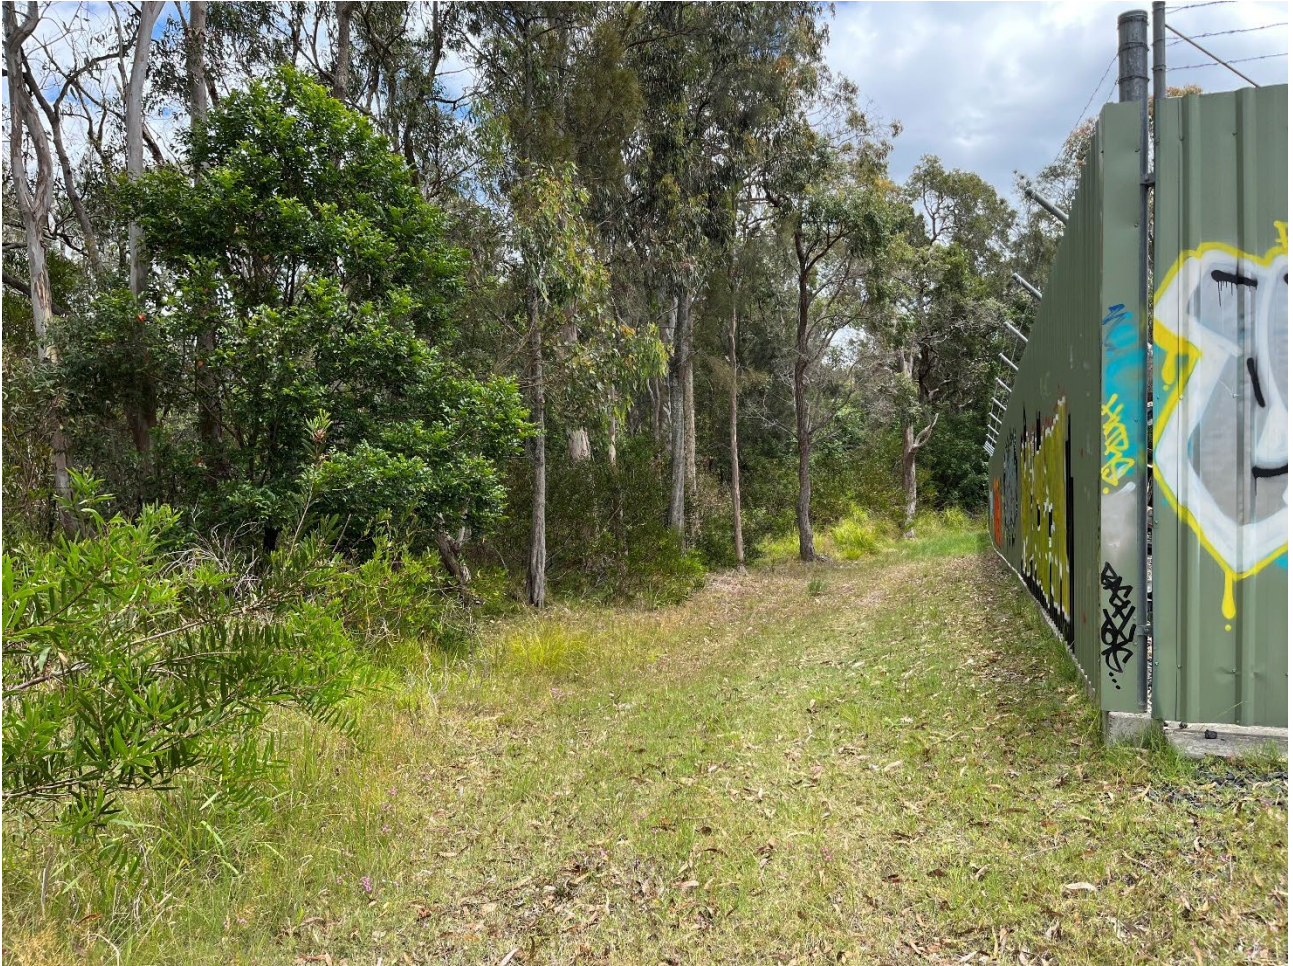
Photograph B.3      Photo point 3

| Monitoring point | 2022 monitoring observation |
|---|---|
| 3 | No observable change has occurred to canopy and midstorey vegetation. Patches of dense Rhodes Grass occur on the edges of the adjacent treed area. |

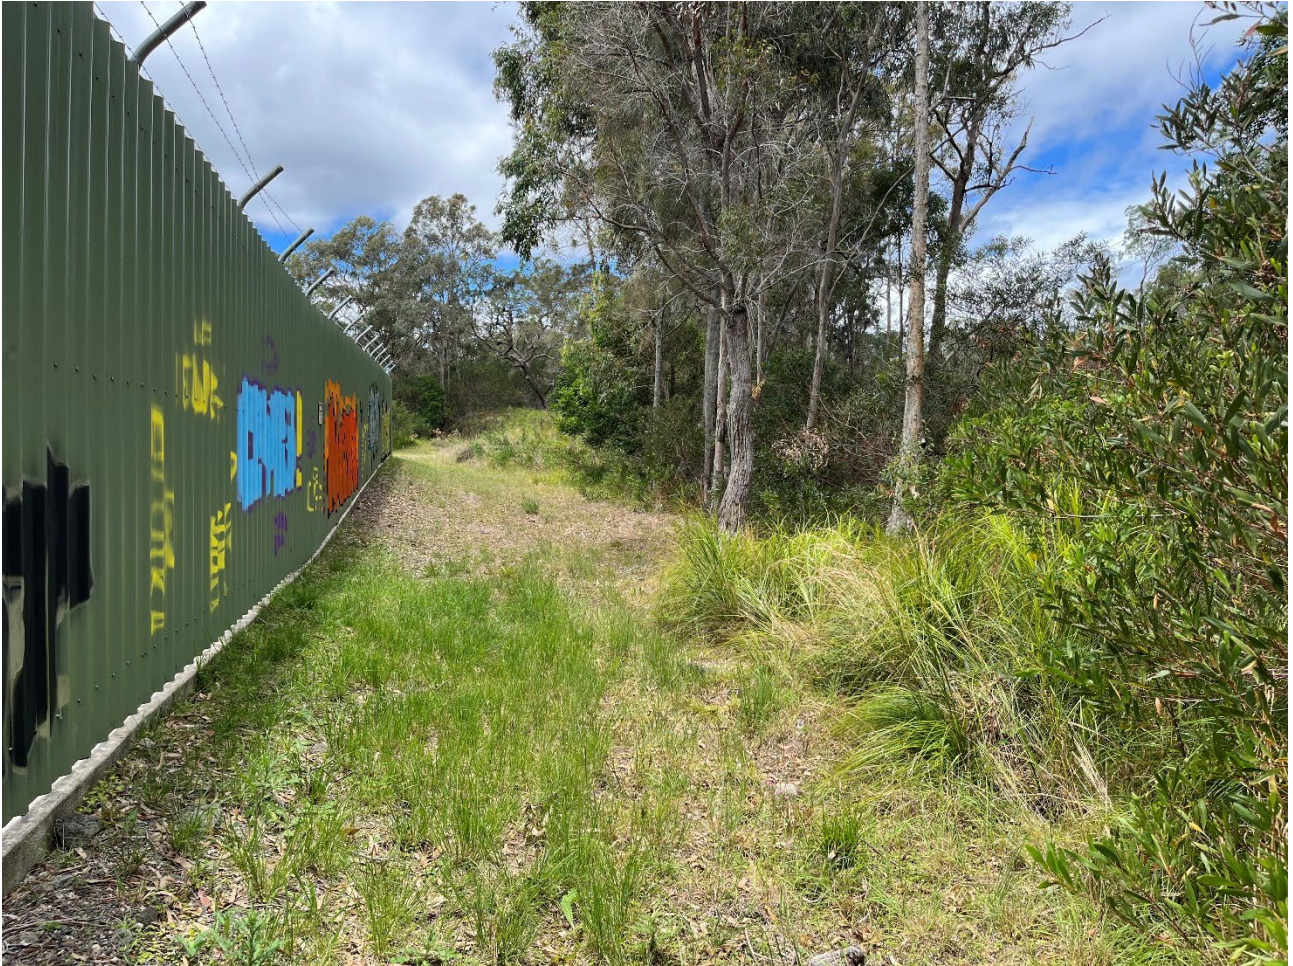
Photograph B.4      Photo point 4

| Monitoring point | 2022 monitoring observation |
|---|---|
| 4 | Vegetation appears healthy with no observable change in canopy or midstorey growth. Ground cover density appears to have increased from 2021 (EMM 2022), particularly <i>Gahnia clarkei</i> adjacent to the APZ. |

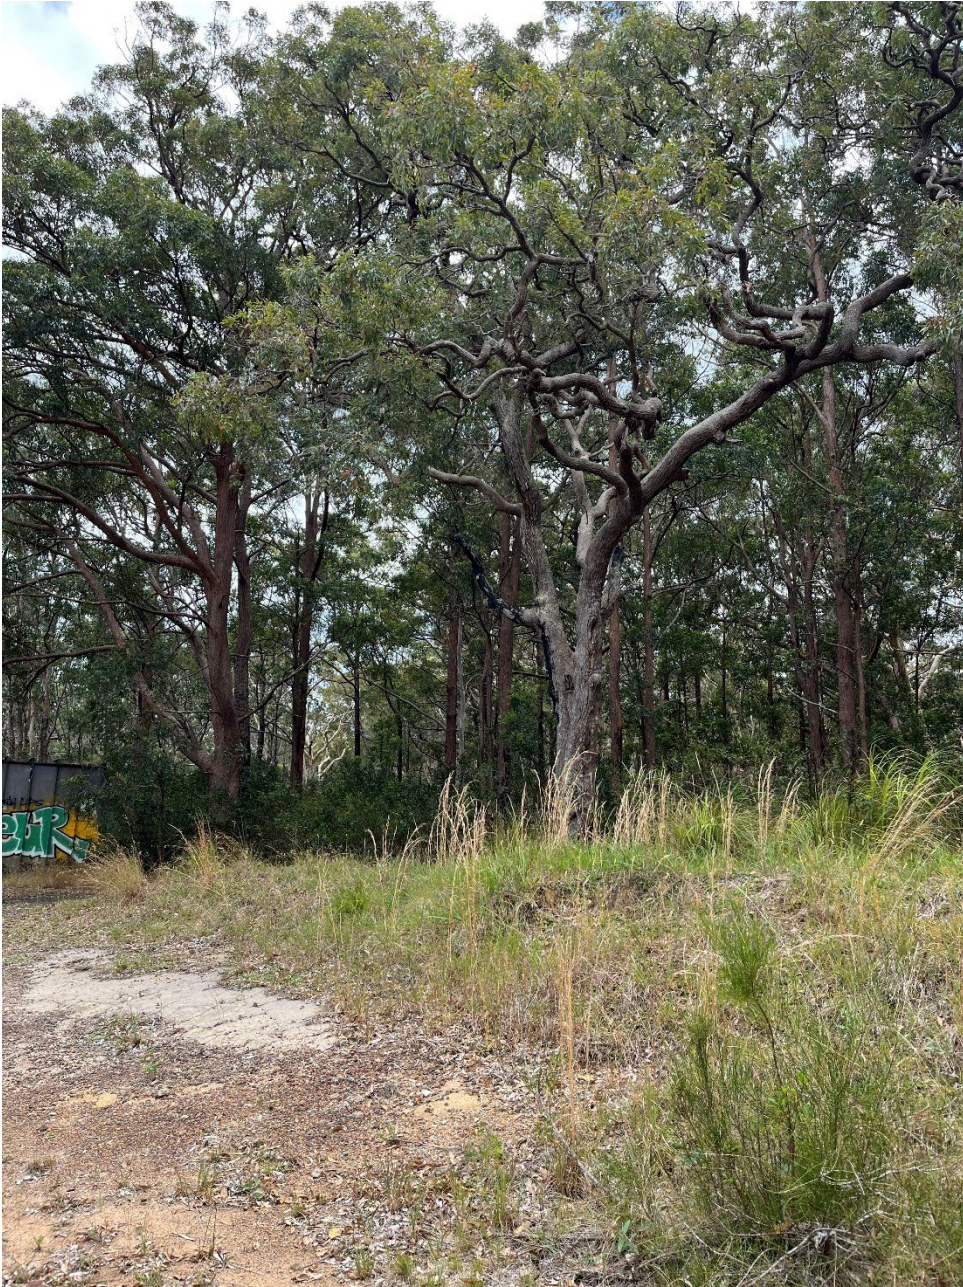
**Photograph B.5**      **Tree monitoring point 1**

| Monitoring point | 2022 monitoring observation |
|---|---|
| Tree 1 | Tree appears healthy with established growth observed, dense foliage within the crown and no dieback observed. |

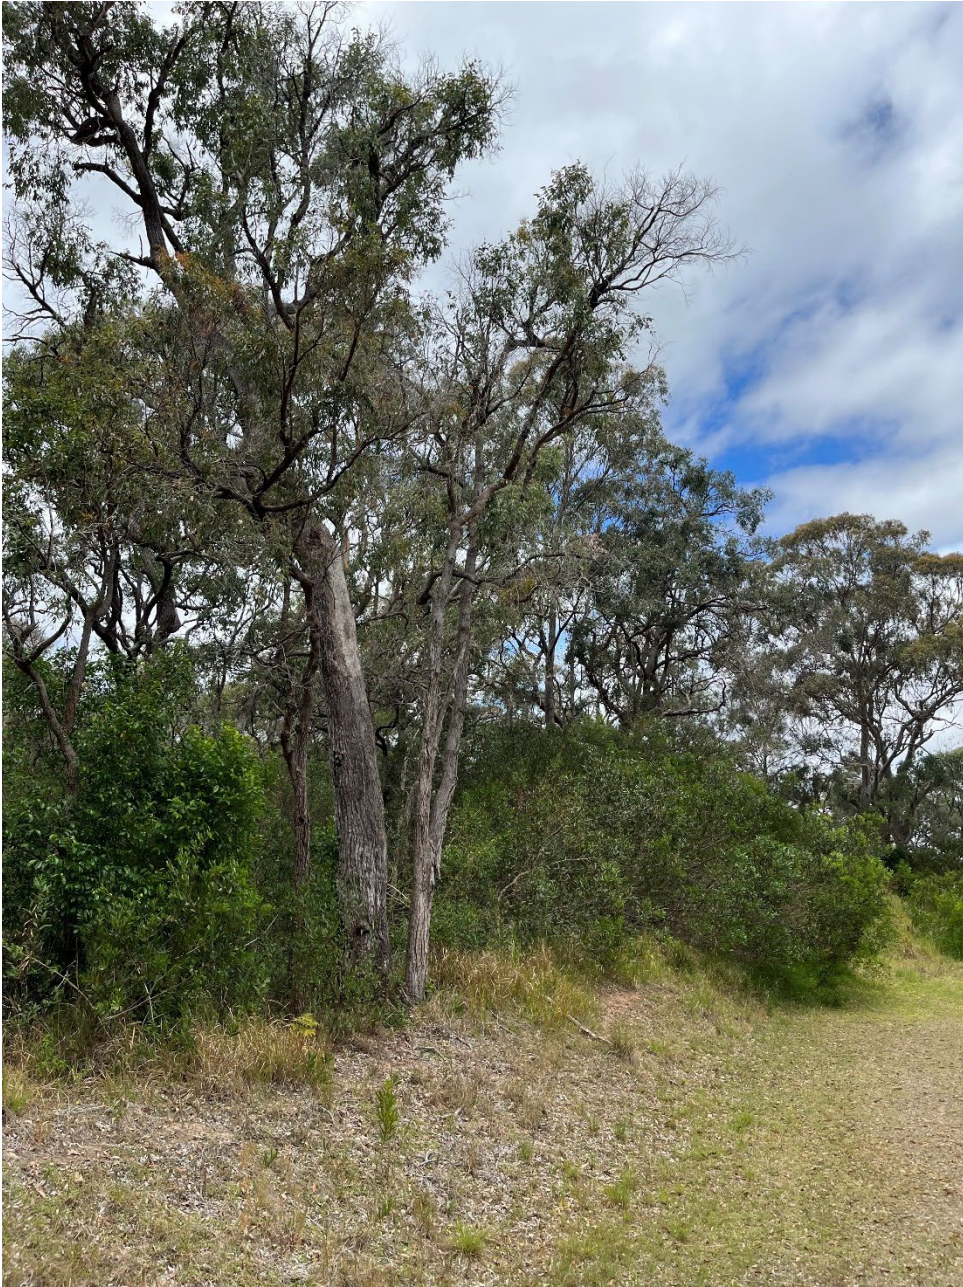
**Photograph B.6**      **Tree monitoring point 2**

When clearance for the APZ is taken into account, vegetation condition was broadly similar to previous years. Tree point 2 appeared to have dieback, with a decrease in canopy cover compared to previous monitoring years. No evidence was observed as to the cause of the dieback. The dieback was not concentrated on any one side of the crown, rather being consistent throughout. Surrounding vegetation did not appear to be affected by dieback. Climatic conditions have been favourable for plant growth (BOM 2023). Dieback observed during 2019 (EMM 2020) was following two years of less than average rainfall.

| Monitoring point | 2022 monitoring observation |
|---|---|
| Tree 2 | Tree appears to have some dieback. Crown coverage appears to have decreased since the 2021 monitoring survey (EMM 2022). The tree appears to have a percentage foliage cover similar to that of 2019 (EMM 2020). |

Observations and photo monitoring at the vent shaft area demonstrated sustained growth of native vegetation, whilst some weed species appear to be increasing in cover and abundance. The cause of potential tree dieback at tree point 2 at the vent shaft area is unknown, as weather conditions remain favourable for growth. There is no direct evidence that the vent shaft is causing the dieback due to the consistent dieback throughout the crown, and may be a systemic issue, perhaps disease. It is recommended that the tree is reviewed at the next monitoring event (2023).
