ARBORICULTURAL IMPACT ASSESSMENT

**PROPOSED RESIDENTIAL UNITS,
5 RETAIL SUITES AND CHILDCARE
DEVELOPMENT APPLICATION**

**30 AND 46 AUBURN ROAD
REGENTS PARK, NSW**

27th October 2023 – Version 5

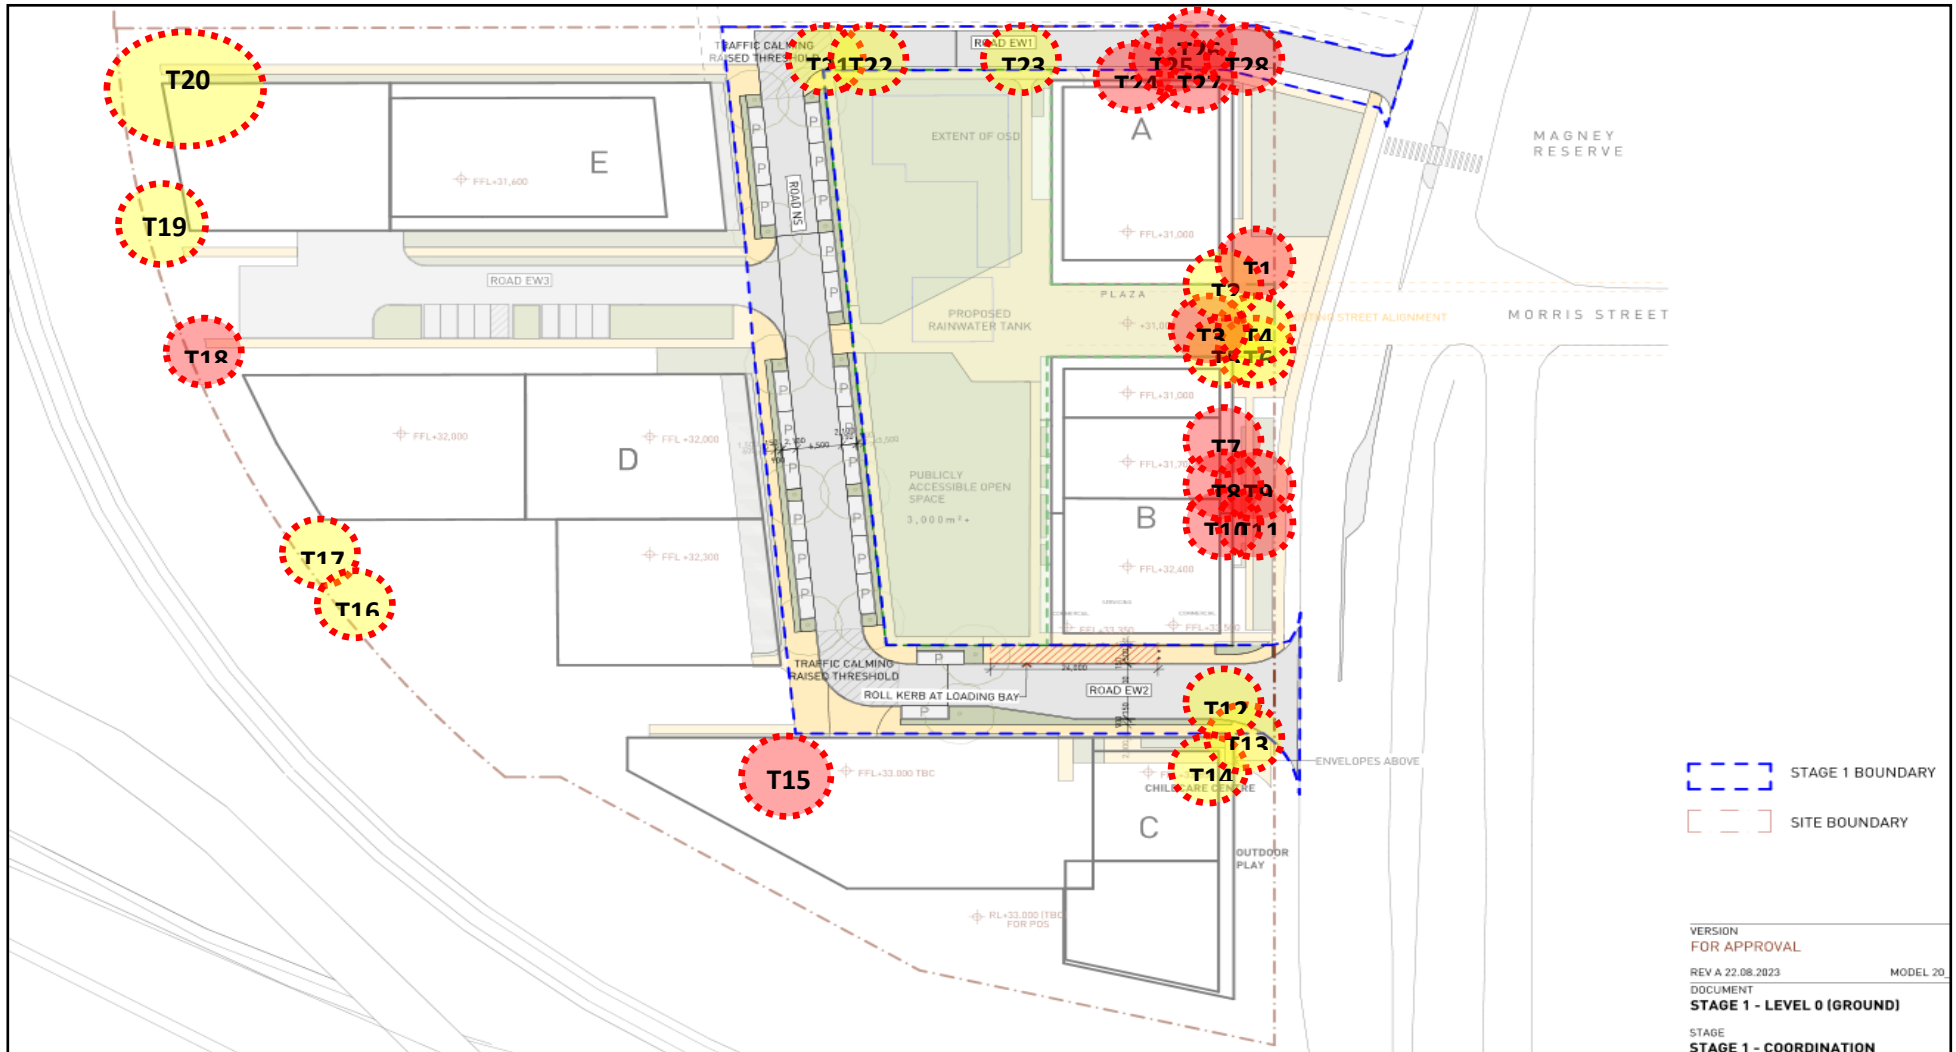
Figure 4 Shows Trees in RED and TPO Exempt in YELLOW to be removed based on the proposed development layout.

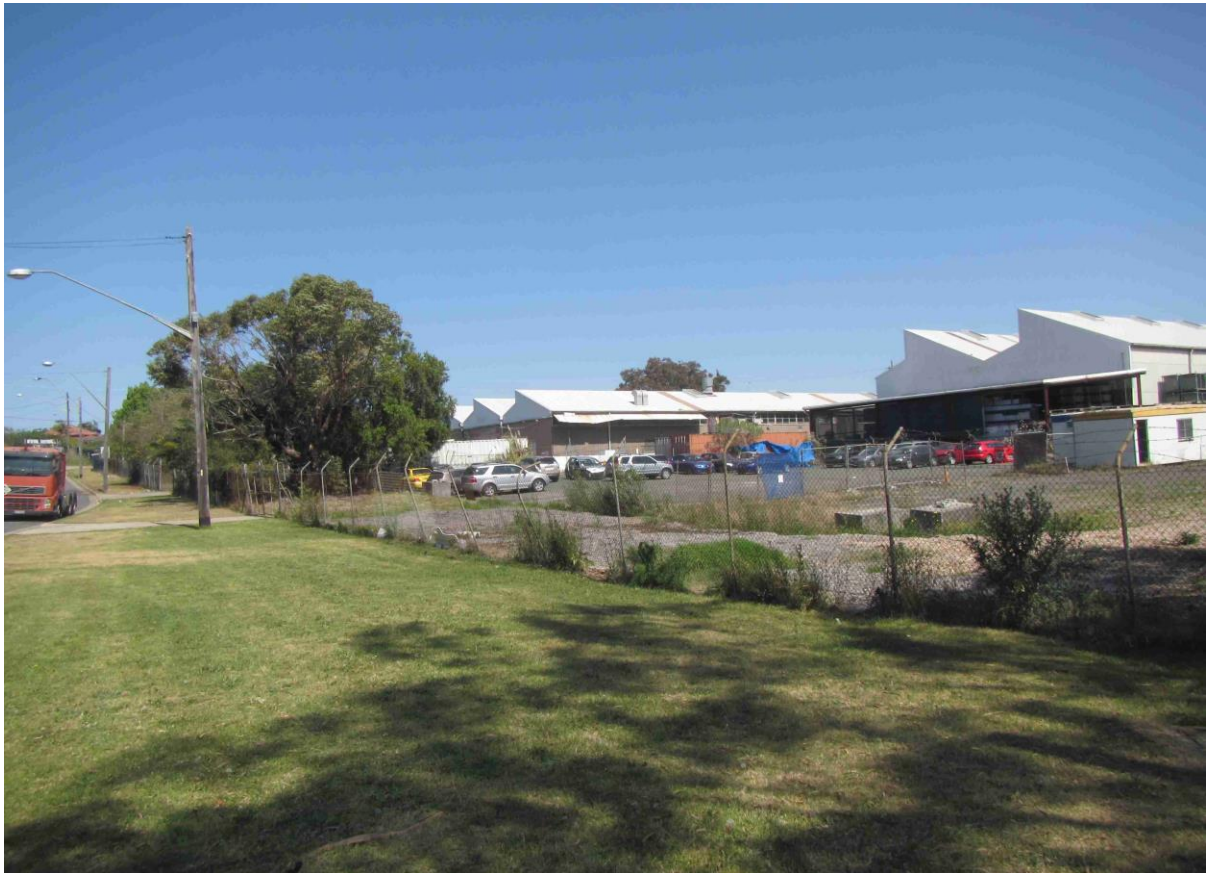
Figure 5 Shows looking along Auburn Road front boundary and Trees 1 to 6.

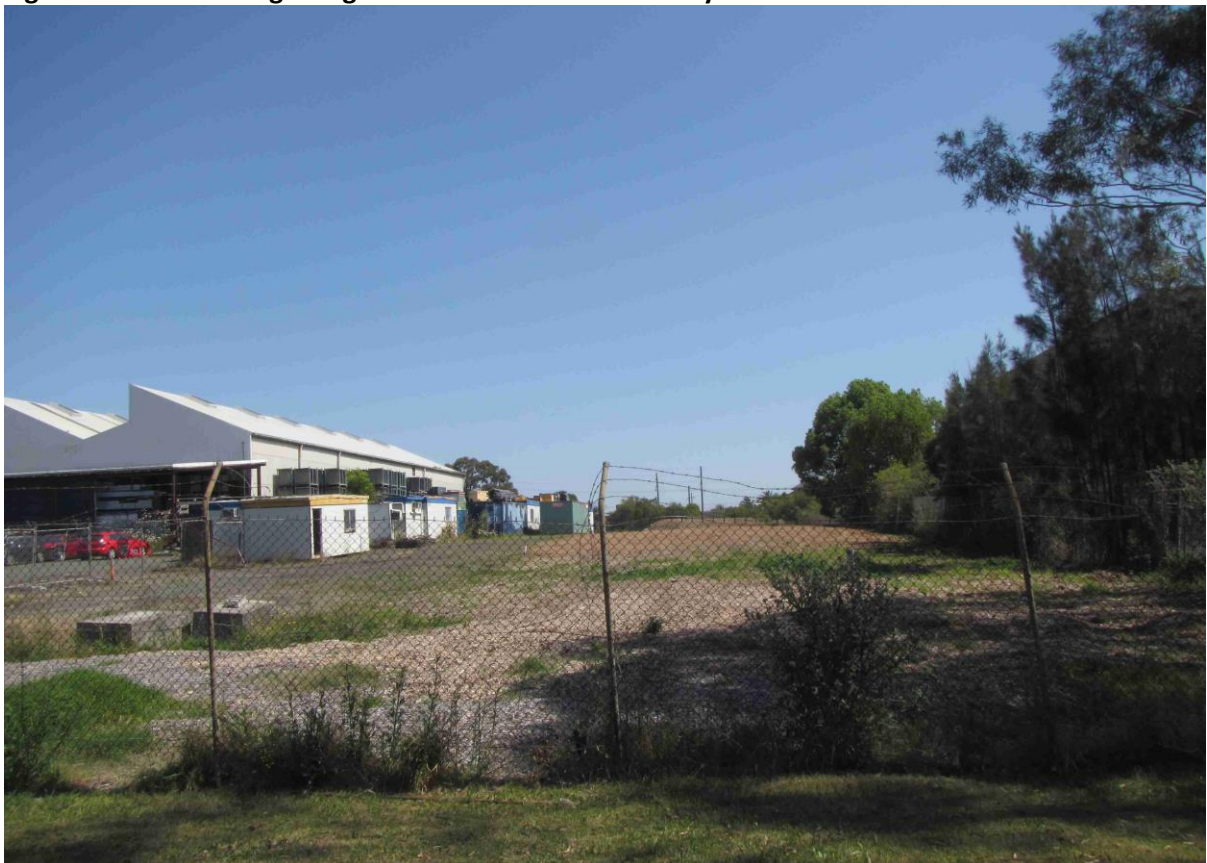
Figure 6 Shows looking down along the Northern boundary with minor trees along the side boundary to be removed.

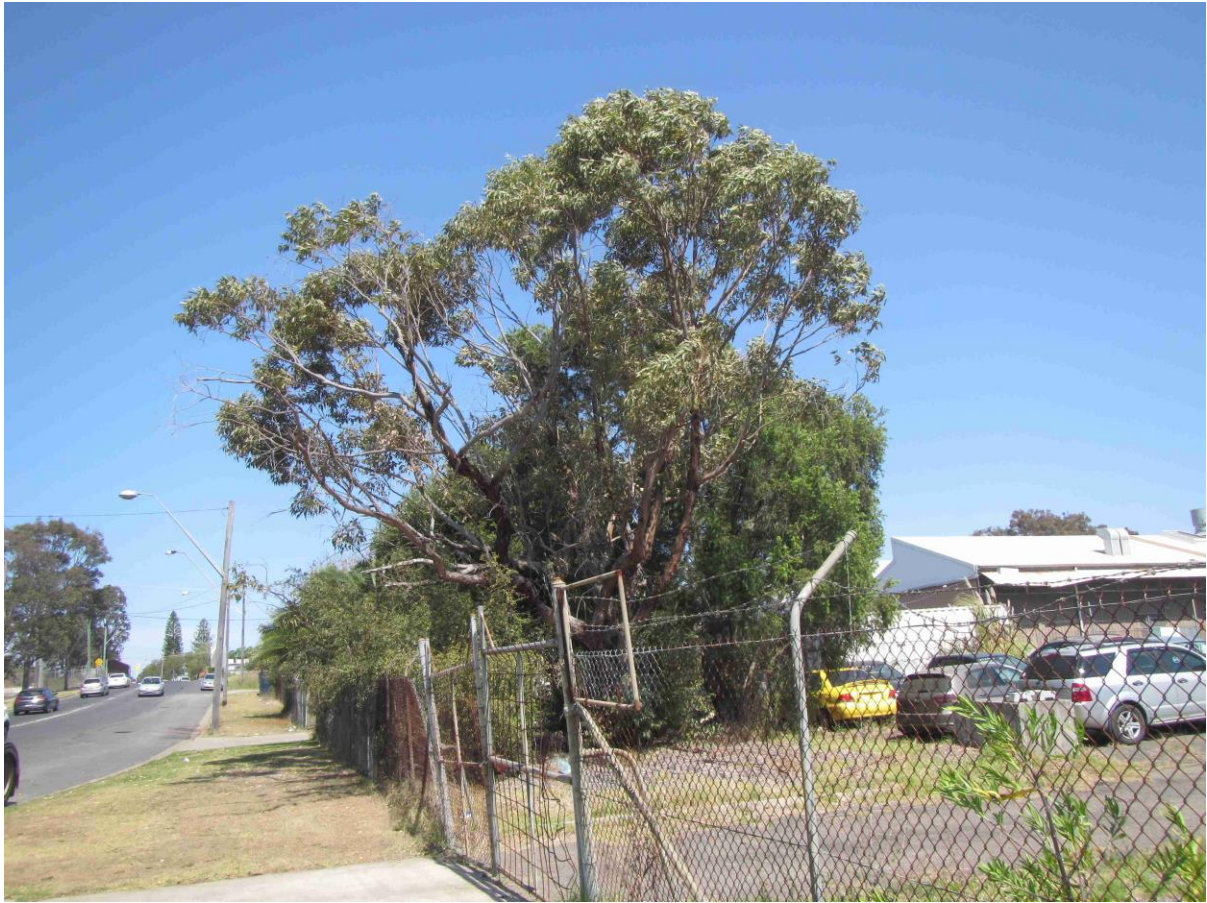
Figure 7 Shows Tree 1 and minor shrubs adjoining trees/shrubs.

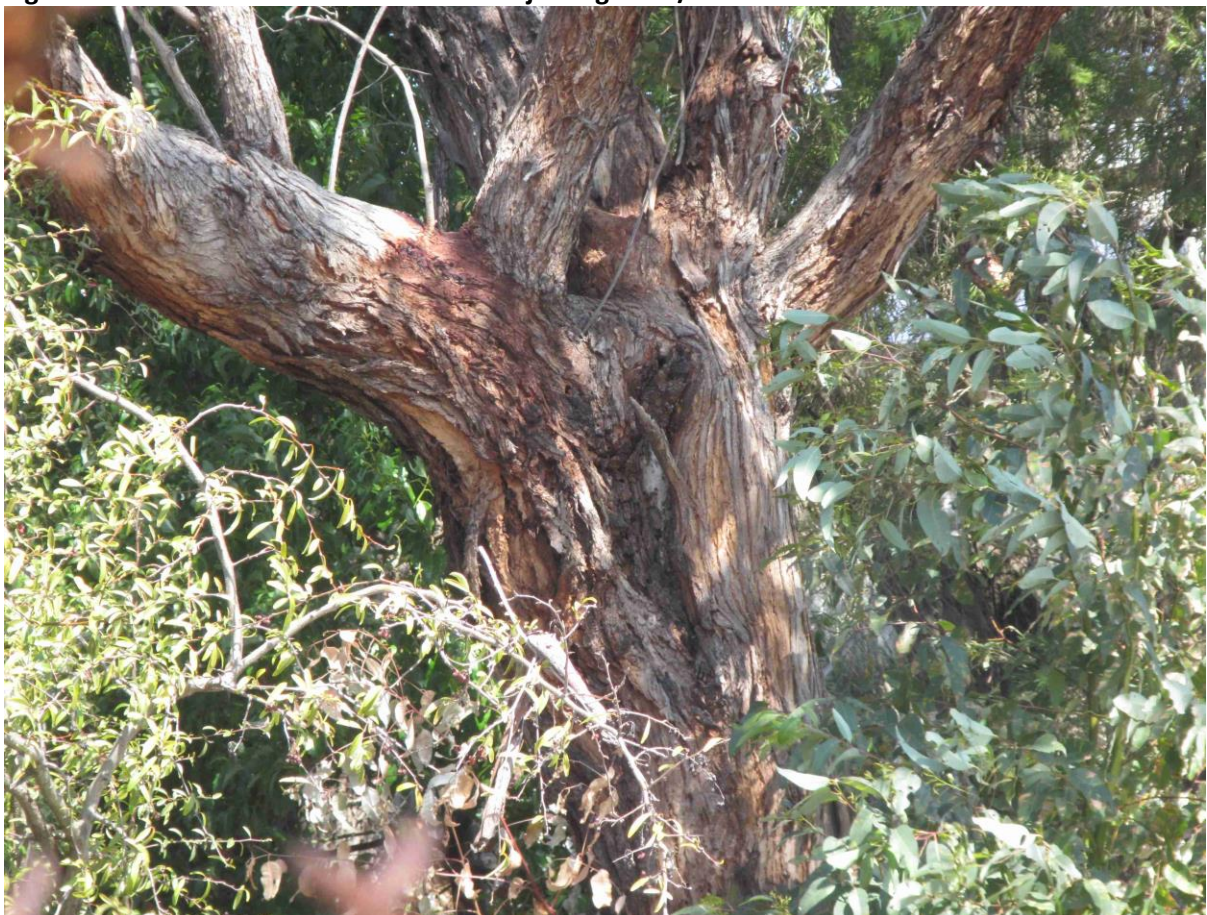
Figure 8 Shows an open wound with rot and bracket fungi damage on Tree 1 trunk.

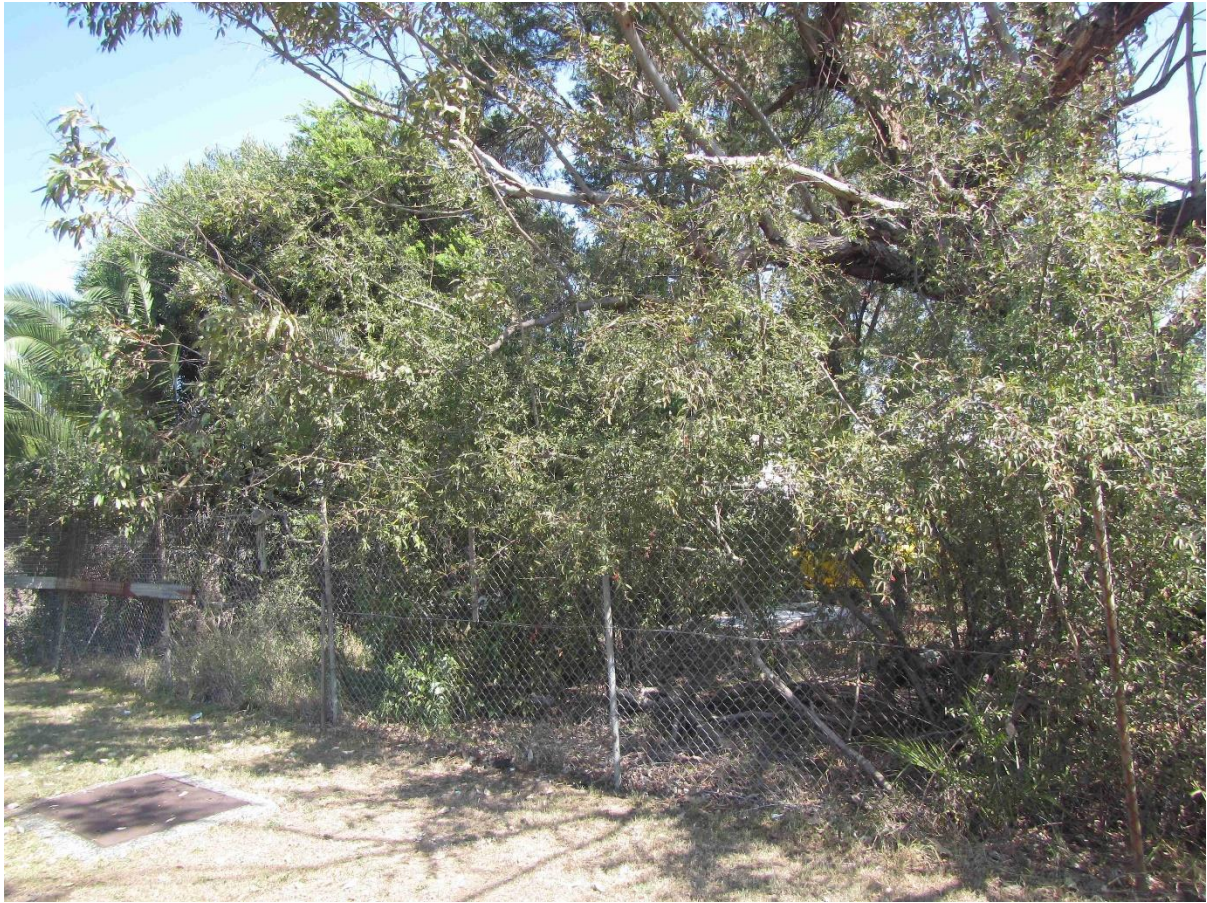
Figure 9 Shows minor self-seeded Cotoneaster and Olive to be removed.

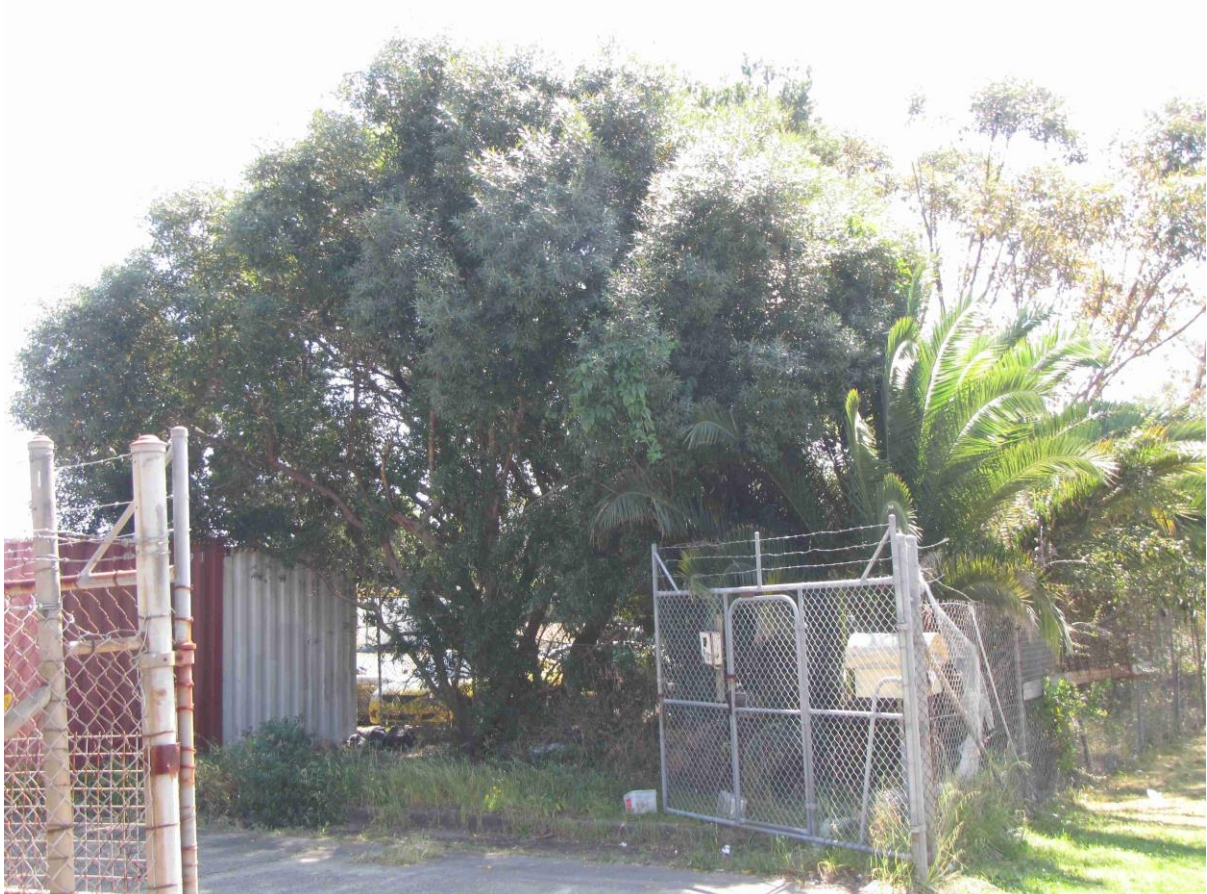
Figure 10 Shows Trees 5 from a distance being an African olive required to be removed.

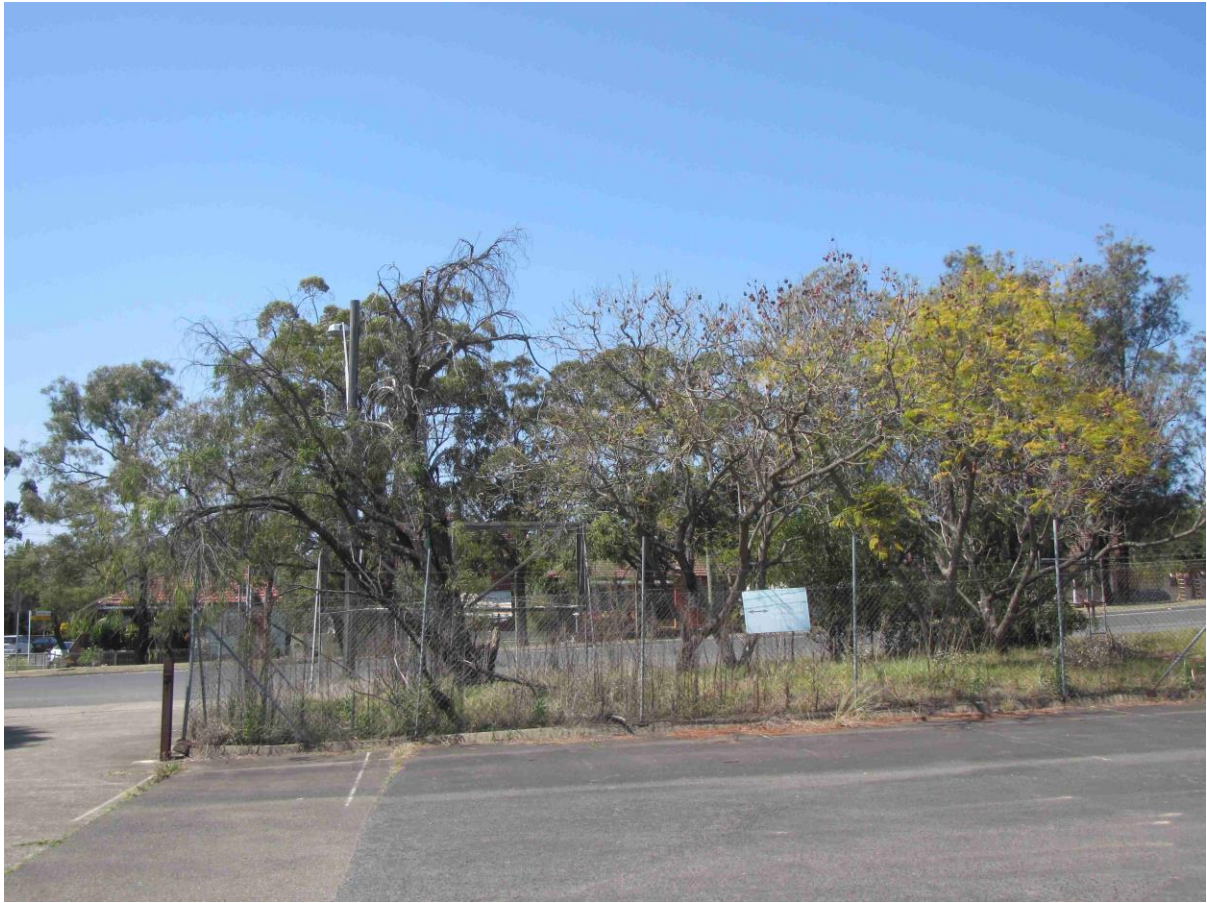
8	Jacaranda <i>Jacaranda mimosifolia</i>	6	220	250	N/A	N/A	Mature	Poor	Poor	4A	Nil	Nil	Nil	No
	Comments: This tree was previously approved for removal under Canterbury Bankstown DA-56/2019. Based on the site inspection, this tree is in poor declining health and condition with noted deadwood, thinned, and failed canopy foliage. This tree is required to be removed due to its location within the proposed development, site excavations, and building scope of works support this trees removal. It is anticipated this tree will be replaced in the appropriate landscape master plan upon completion.

10	Jacaranda <i>Jacaranda mimosifolia</i>	6	220	250	N/A	N/A	Mature	Poor	Poor	4A	Nil	Nil	Nil	No
	Comments: This tree was previously approved for removal under Canterbury Bankstown DA-56/2019. This tree was previously approved for removal under Canterbury Bankstown DA-56/2019. Based on the site inspection, this tree is in poor declining health and condition with noted deadwood, thinned, and failed canopy foliage. This tree is required to be removed due to its location within the proposed development, site excavations, and building scope of works support this trees removal. It is anticipated this tree will be replaced in the appropriate landscape master plan upon completion.													
11	Jacaranda <i>Jacaranda mimosifolia</i>	5	200	220	N/A	N/A	Mature	Poor	Poor	4A	Nil	Nil	Nil	No
	Comments: This tree was previously approved for removal under Canterbury Bankstown DA-56/2019. Based on the site inspection, this tree is in poor declining health and condition with noted deadwood, thinned, and failed canopy foliage. This tree is required to be removed due to its location within the proposed development, site excavations, and building scope of works support this trees removal. It is anticipated this tree will be replaced in the appropriate landscape master plan upon completion.

Figure 11 Shows Trees 7 to 11 from a distance in poor health and condition to be removed.

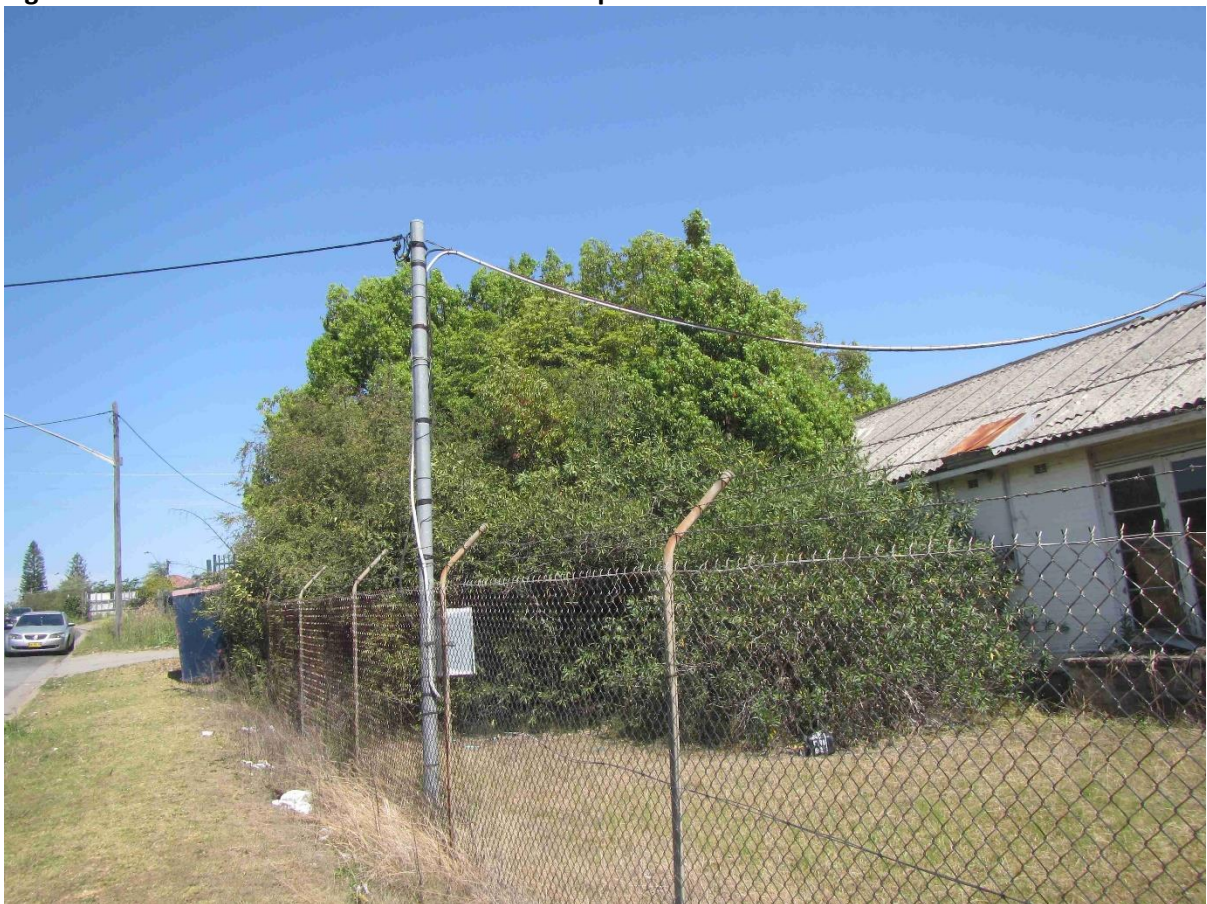
Figure 12 Shows Trees 12, 13 and 14 all being exempt due to weed species or height along Auburn Road.

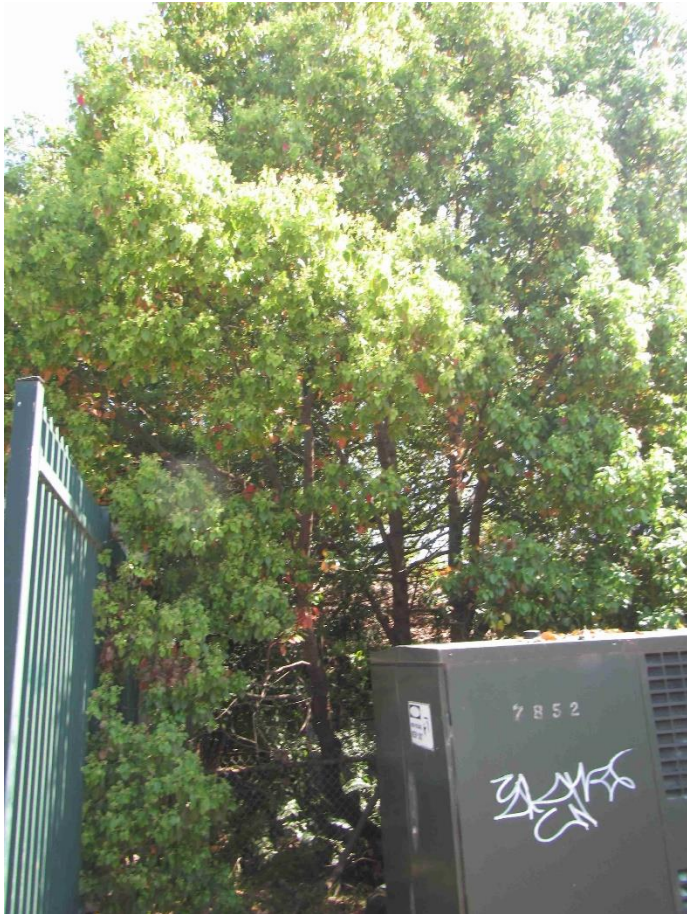
Figure 13 Shows Tree 14 being a Camphor laurel to be removed.

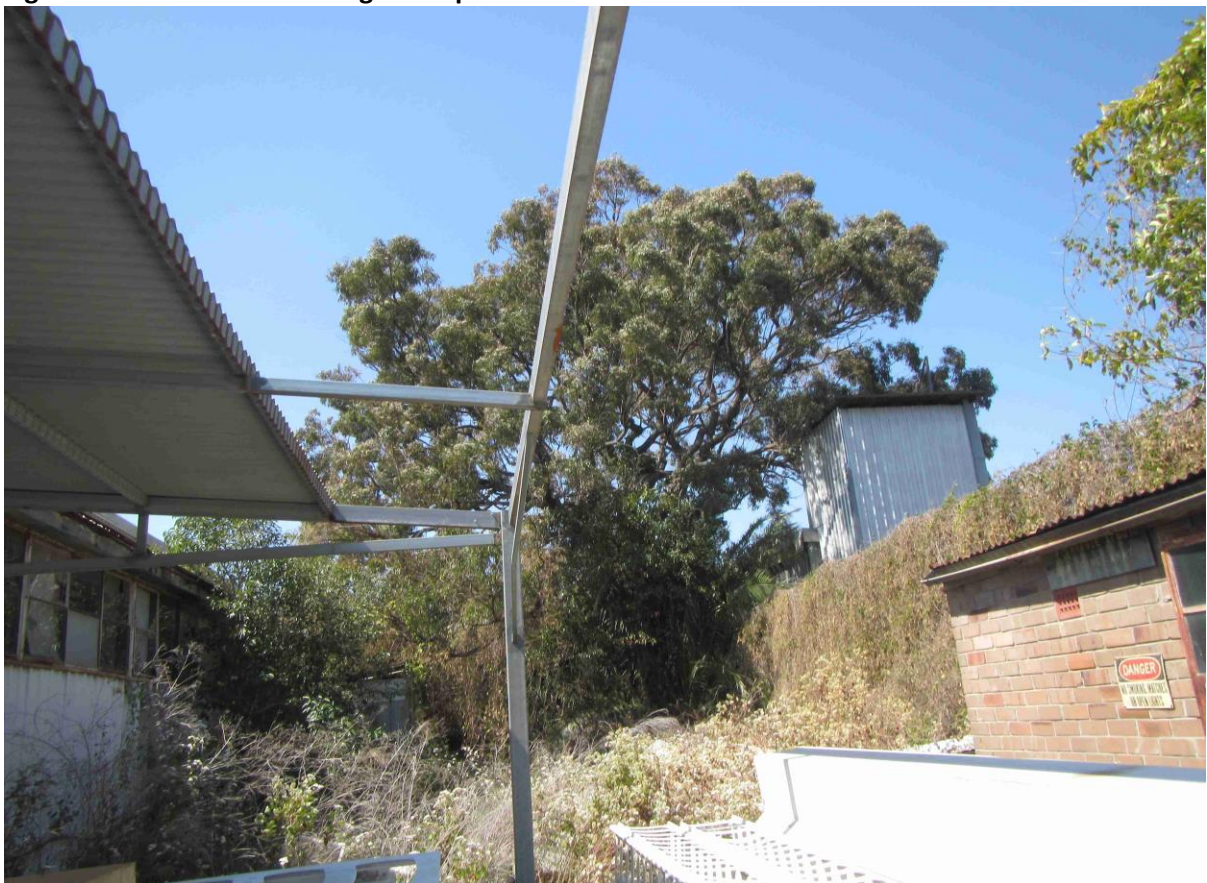
Figure 14 Shows Tree 15 with a retaining wall that is unable to be retained and will be replaced upon completion.

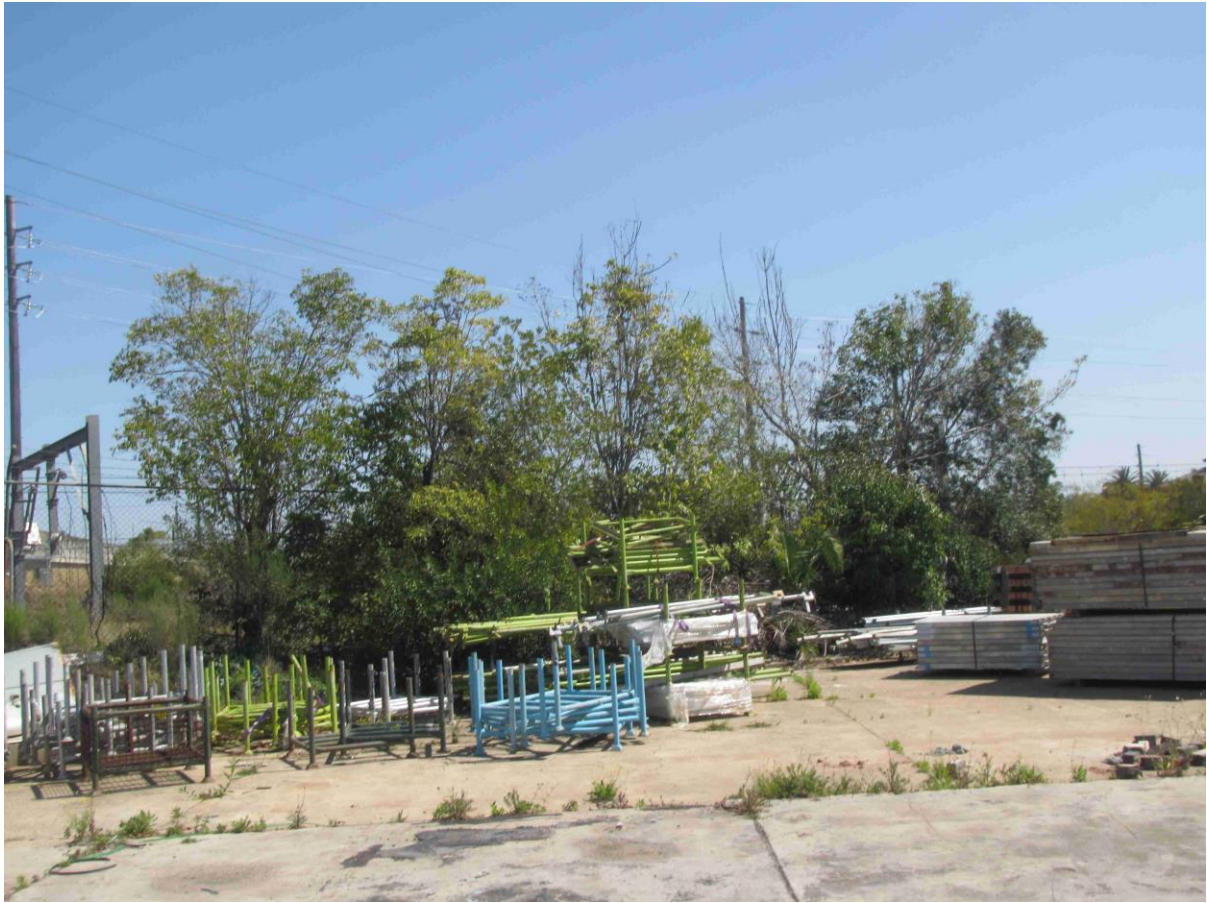
Figure 15 Shows self-seeded Privet growing along the rear rail corridor boundary.

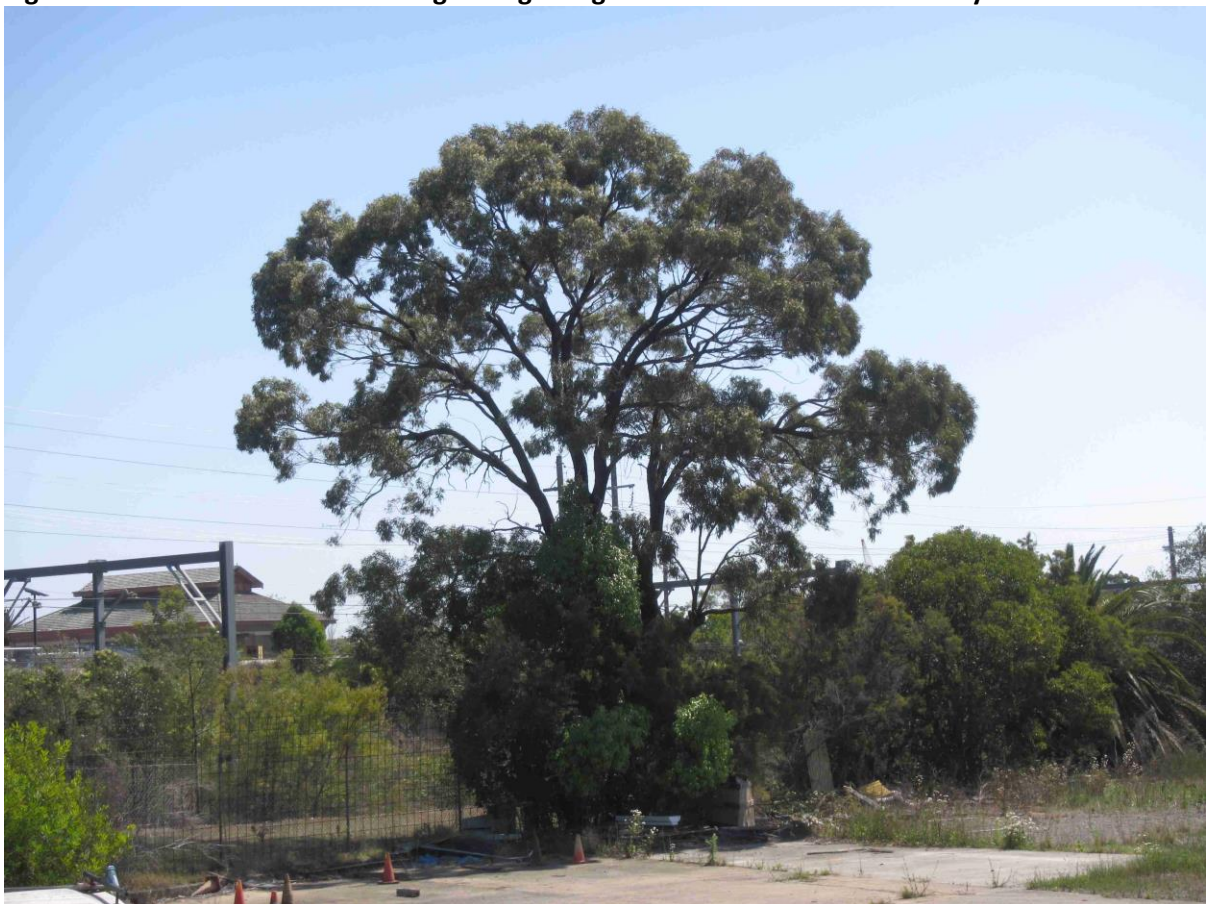
18	Mugga Mugga <i>Eucalyptus sideroxylon</i>	12	540	580	N/A	N/A	Mature	Good to Fair	Fair to Poor	4C	Low	Low	Nil	No
	Comments: This tree was previously approved for removal under Canterbury Bankstown DA-56/2019. Based on the trees present form, the tree appeared to be in good to fair visual health and thinning/declining upper canopy. Observations of minor and major deadwood, previous pruned limbs and scaffold branches were noted with noted weeping resin from its branch trunk union indicating movement within the union, thus having considered poor structural integrity, hence its full removal is warranted due to these WH&S concerns as it has the potential to cause death or damage to persons or assets. In summary, this tree is unable to be safely retained and is required to be removed.													
19	Canary Island Date Palm <i>Phoenix canariensis</i>	4	500	500	N/A	N/A	Mature	Good	Good	5	Nil	Nil	Nil	No

Figure 16 Shows Tree 18 to be removed due to its poor structural condition and replaced upon completion in the landscape. This tree was previously approved to be removed.

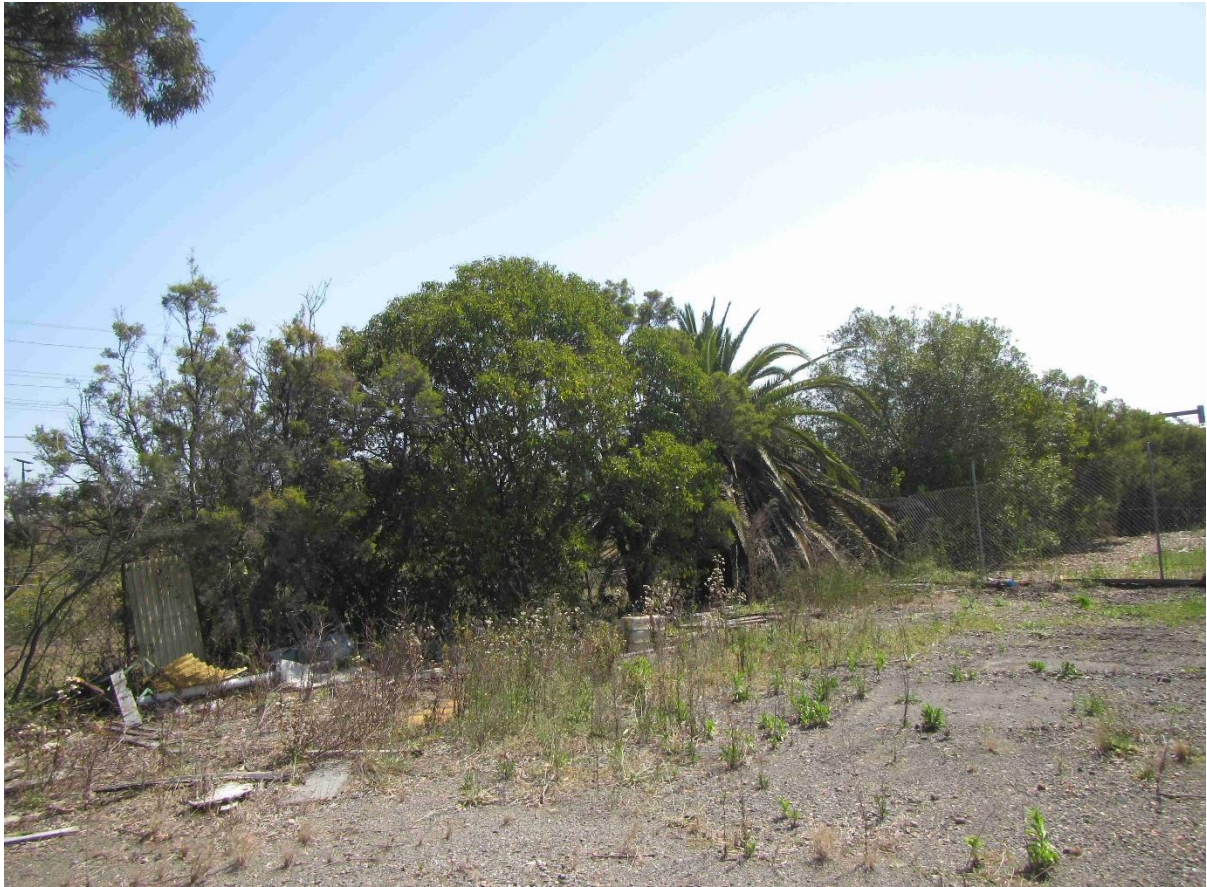
Figure 17 Shows Privet, Green Cestrum, and date palm along the rear boundary, all being TPO Exempt.

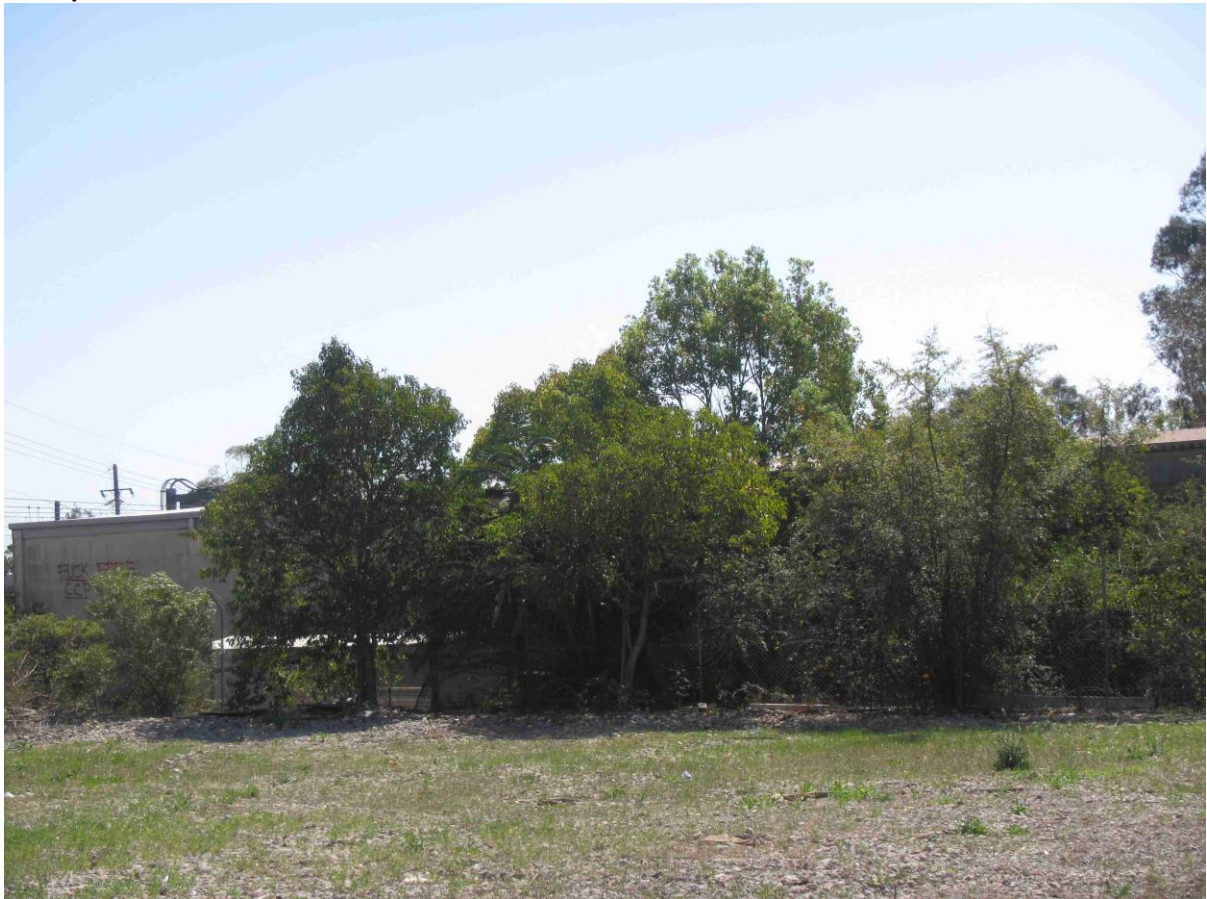
Figure 18 Shows Privet, Cestrum and Firethorn, all being TPO Exempt to be removed.

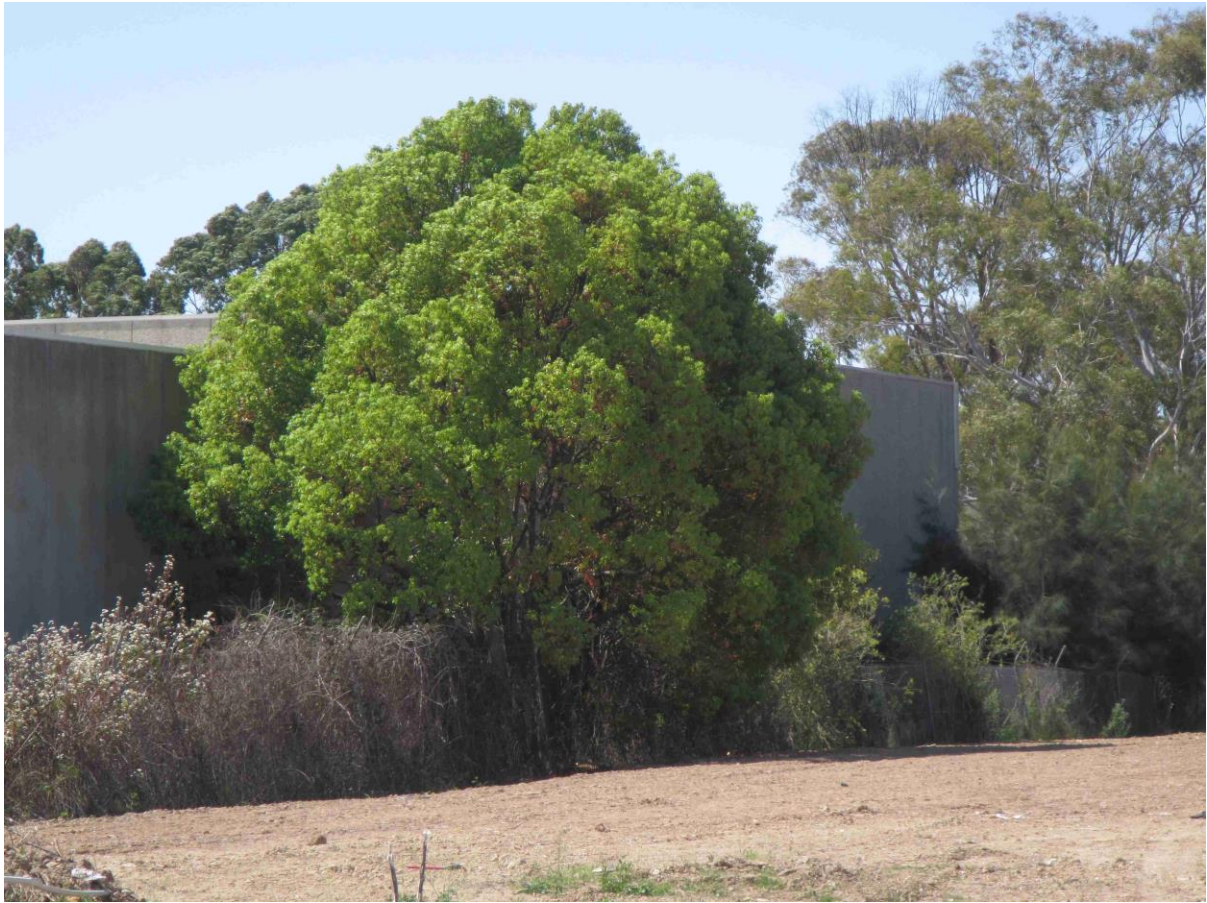
Figure 19 Shows Tree 22 being a Camphor laurel to be removed.

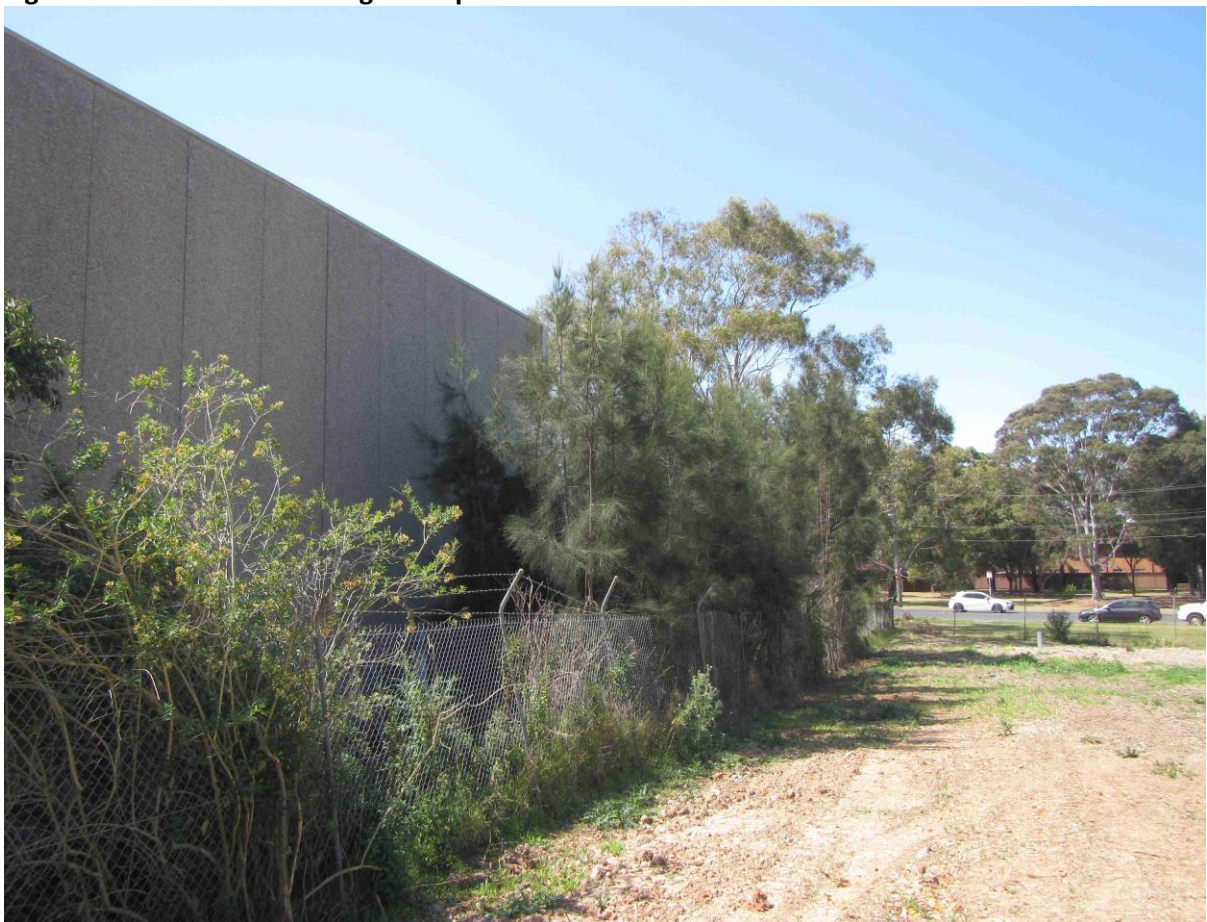
25	Swamp oak <i>Casuarina glauca</i>	7	240	280	N/A	N/A	Mature	Good	Good	3	Low	Low	Low	No
	<p>Comments: Based on the plans tabled, this self-seeded tree is growing within close proximity to an adjoining factory unit, and it is required to be removed due to its location within the proposed development roadway envelope and scope of works that supports its removal. It is anticipated this tree will be replaced in the appropriate landscape master plan upon completion.</p>													
26	Swamp oak <i>Casuarina glauca</i>	8	250	280	N/A	N/A	Mature	Good	Good	3	Low	Low	Low	No
	<p>Comments: Based on the plans tabled, this self-seeded tree is growing within close proximity to an adjoining factory unit, and it is required to be removed due to its location within the proposed development roadway envelope and scope of works that supports its removal. It is anticipated this tree will be replaced in the appropriate landscape master plan upon completion.</p>

27	Swamp oak <i>Casuarina glauca</i>	8	240	280	N/A	N/A	Mature	Good	Good	3	Low	Low	Low	No
	<p>Comments: Based on the plans tabled, this self-seeded tree is growing within close proximity to an adjoining factory unit, and it is required to be removed due to its location within the proposed development roadway envelope and scope of works that supports its removal. It is anticipated this tree will be replaced in the appropriate landscape master plan upon completion.</p>

Figure 20 Shows Trees 24 to 28 being self-seeded clumping Swamp oaks to be removed.
