**WOOLLOOMOOLOO BAY SSD 6471  
SYDNEY MODERN -  
ART GALLERY OF NEW SOUTH WALES  
EXPANSION PROJECT**

DAVID NUTLEY  
GML HERITAGE  
C.2018  
AUGUST 2018

PROJECT NO.: GM333      STATUS: DRAFT

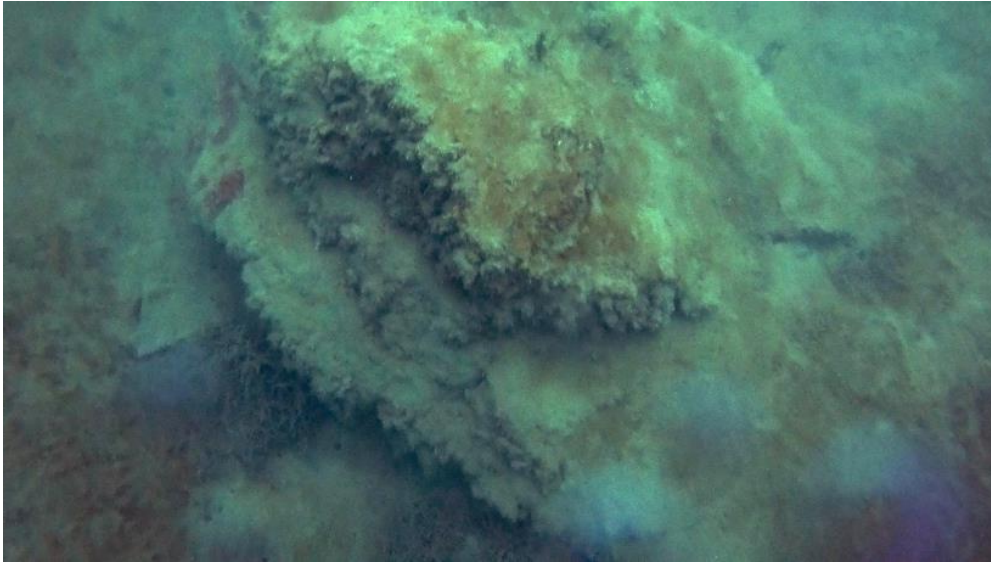
**Photograph 1:** Target 1 - natural rock

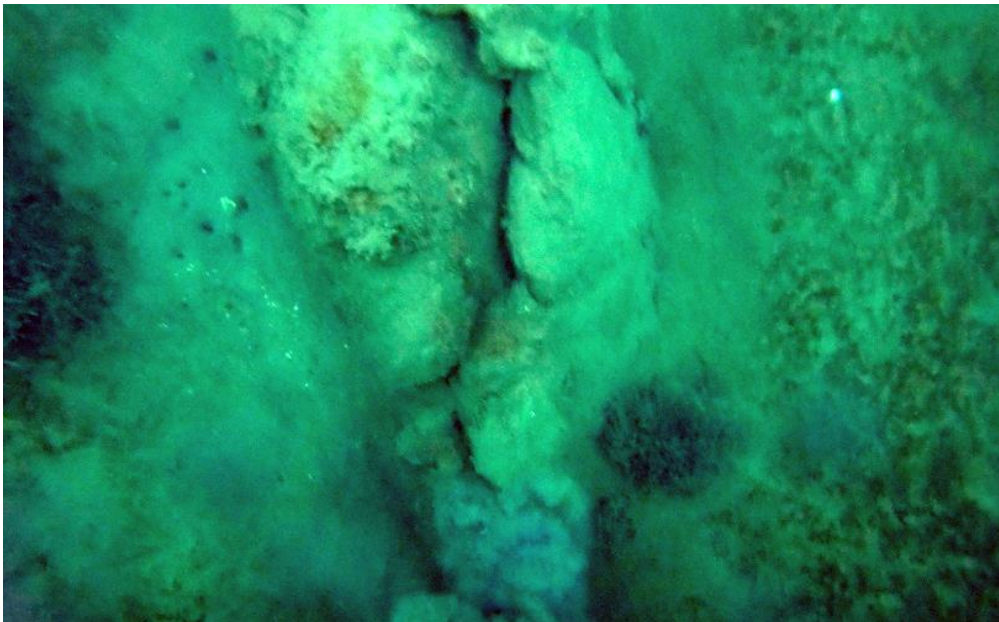
**Photograph 2:** Target 2 – natural rock

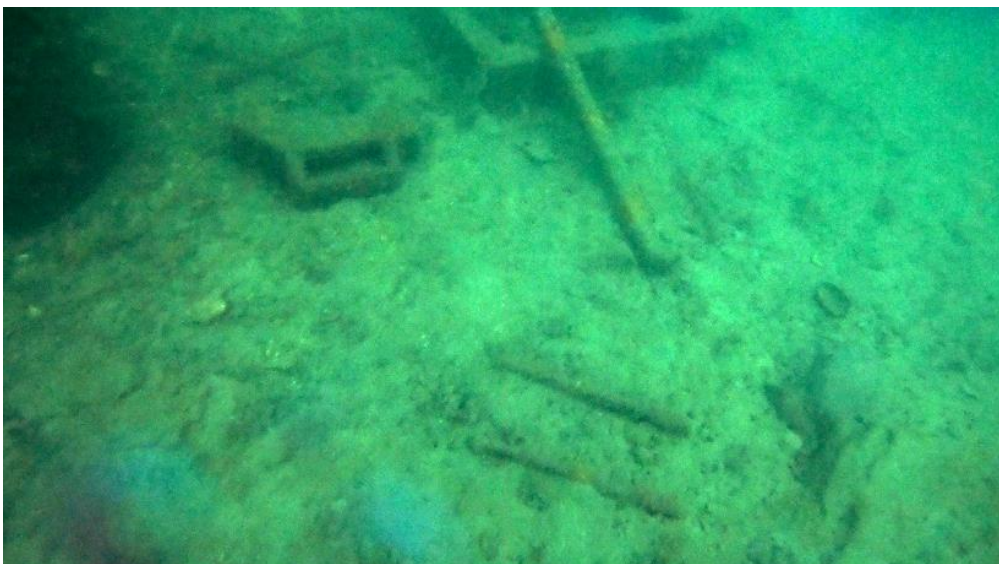
**Photograph 3:** Target 4 metallic debris

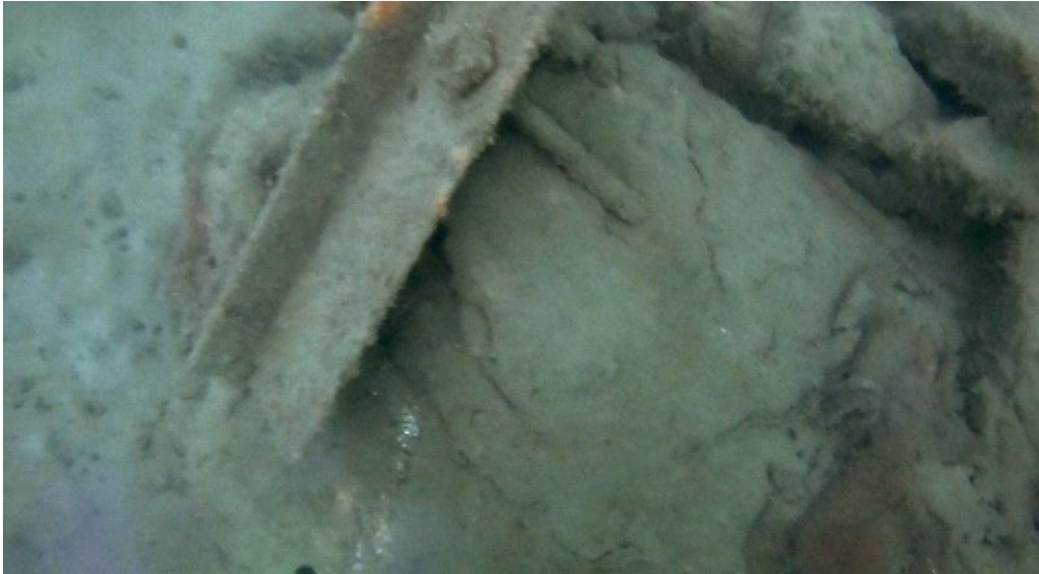
**Photograph 4:** Target 5 –  
angle iron and bolt

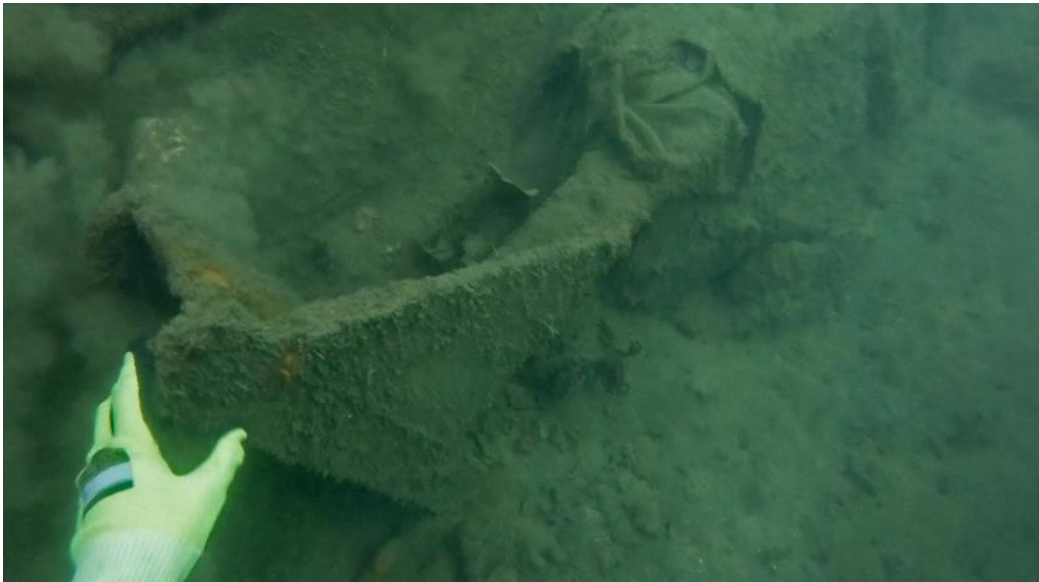
**Photograph 5:** Target 6 –  
small section of scaffolding

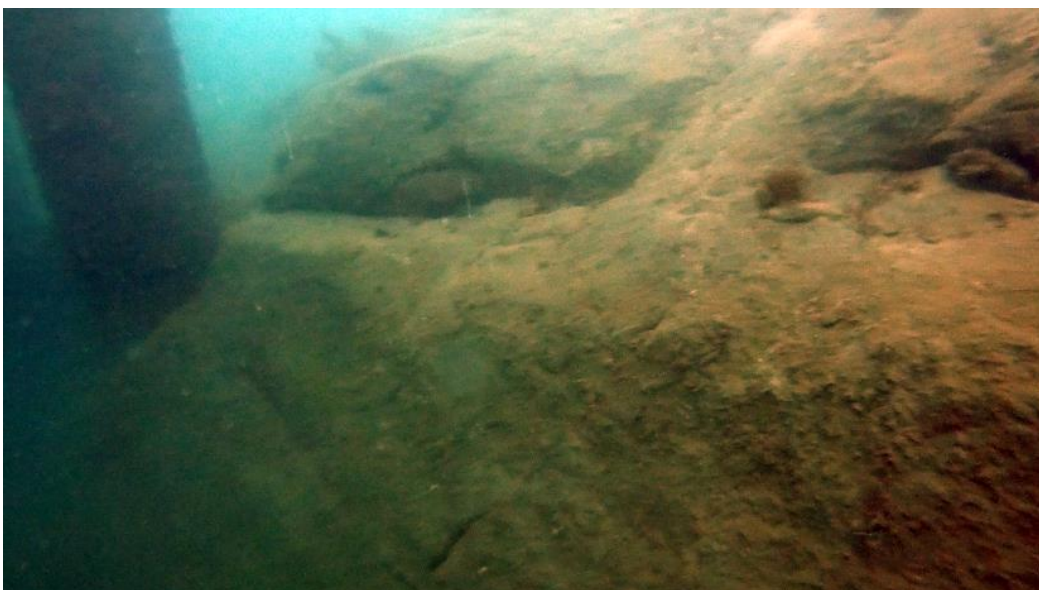
**Photograph 6:** Target 7,  
natural rock adjacent to pile  
associated with marina berth

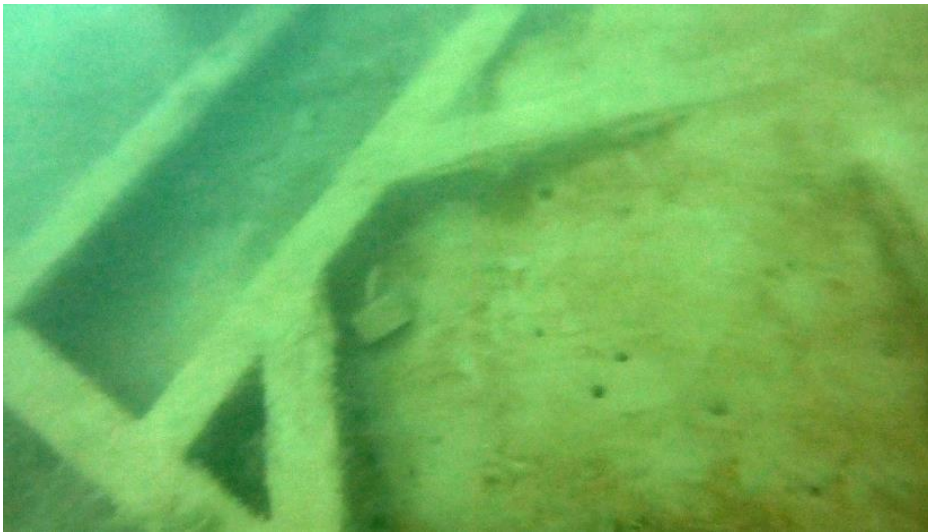
**Photograph 7:** Target 8 – isolated section of steel framing

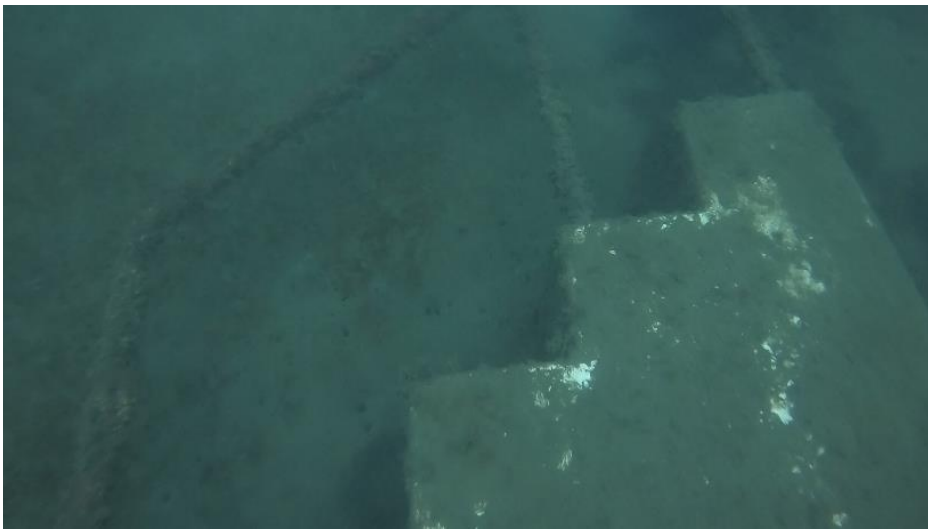
**Photograph 8:** Target 23 – Set of stairs with four risers and handrail

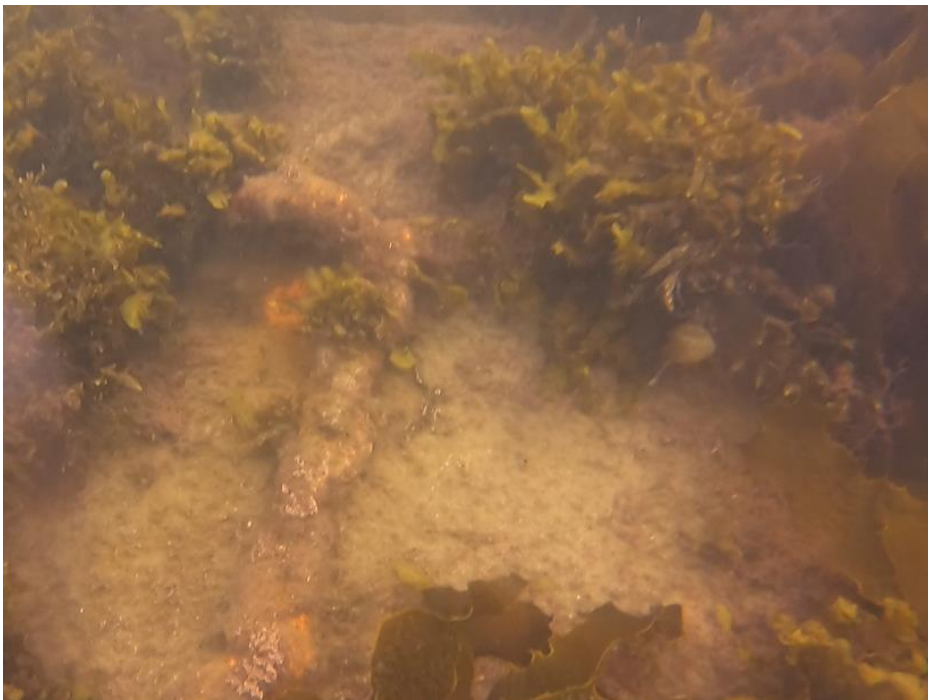
The origin of the mooring blocks is unknown. They are located on the rock platform once occupied by the ‘Ladies Baths’ which date from the 1880s to the first half of the 20<sup>th</sup> century. No documented association with those baths has been found, though it is possible that they may have been used to aid structural stability. Alternatively, they may have been recovered from earlier moorings within the bay and relocated to avoid fowling dredging equipment.

**Photograph 9:** Target 24 – section of chain lying on one of the six identical mooring blocks in Zone 3
