ARBORICULTURAL ASSESSMENT REPORT

Barangaroo South – Hickson Road Remediation

Lend Lease (Millers Point) Pty Limited

28th July 2017

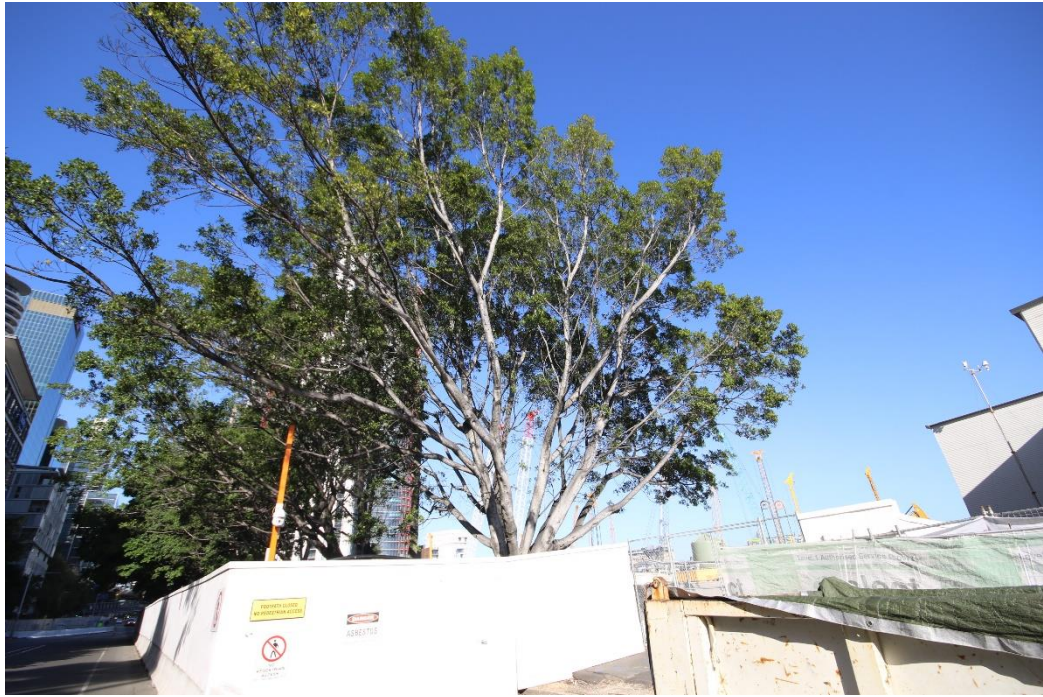
Plate 1: Tree 12

1. Tree 12 *Ficus microcarpa* var. “Hillii” shows fair vitality and stability with thinning canopy density – refer plate 1. This tree has exclusion barricades (Tree Protection) installed to prevent access by any user of Hickson Road. This tree is now required to be removed to enable the Hickson Road Remediation Works. In consultation with Lend Lease, the removal has been determined following detailed contractor designs which includes for works compounds and access ways in the area of this tree. Removal is supported on the basis of replacement trees will be planted at the completion of remediation works.

Tree No	Botanical Name	Age Class	Height – m	Spread - m	D.B.H (cm)	D.R.B (cm)	TPZ & SRZ Rad.m	Condition comments on trees as seen on site	ULE
12	<i>Ficus microcarpa</i> var. “Hillii” (Hills Weeping Fig)	M	12	10	62	68	7.4, 2.7	F vitality & structure. Previous pruning evident on N side. Thin canopy density. Bifurcations in main stems. Street tree	2
50	<i>Ficus microcarpa</i> var. “Hillii” (Hills Weeping Fig)	M	7	8	36	36	4.3, 2.2	G vitality. Canopy skewed to W. Street tree	2

- a. The removal of Trees 12 and 50 to enable the Hickson Road Remediation works;
- b. Approval to remove Trees 12 & 50 is required from the landowner and relevant consent authority;
- c. Tree removal work shall be carried out by an experienced tree surgeon in accordance with NSW WorkCover Code of Practice for Amenity Tree Industry (1998);
- d. That the two (2) removed trees be replaced with appropriately advanced trees of the same species at the completion of Option 2 works, or in accordance with any other street tree design approved by the relevant authority; &
- e. The tree location plan can be found on Annexure B.

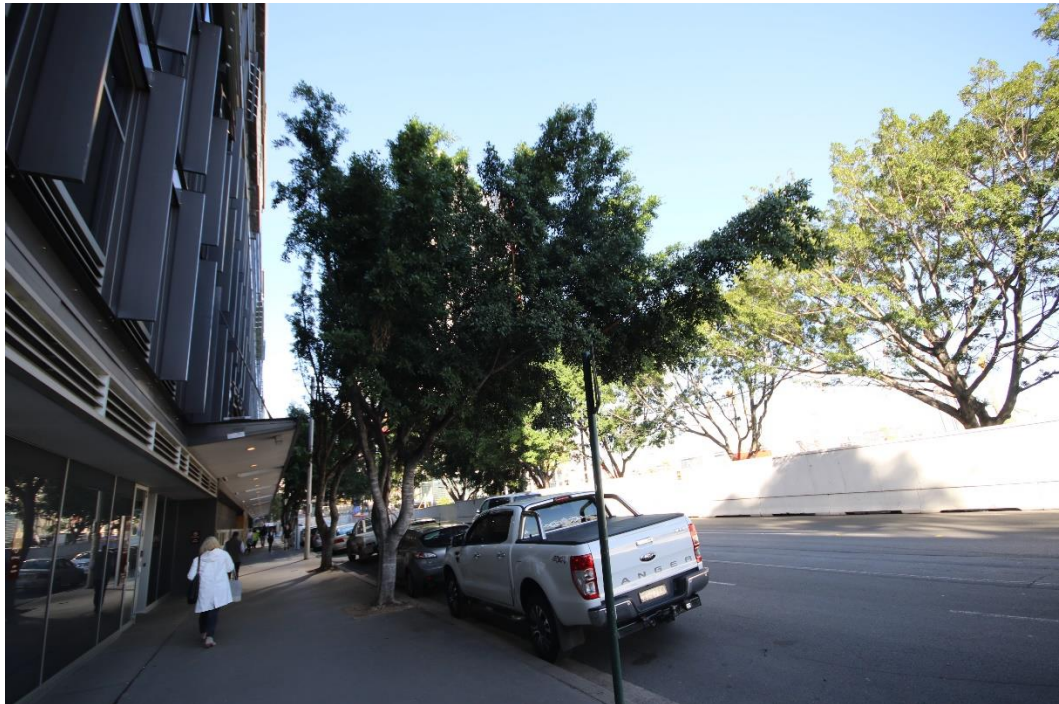
Plate 3: Tree 50

2. Tree 50 *Ficus microcarpa* var. “Hillii” shows good vitality and stability with good canopy density – refer plate 3. This tree is located on the eastern side of Hickson Road. This tree is now required to be removed to enable the Hickson Road Remediation Works. In consultation with Lend Lease, the removal has been determined following detailed contractor designs which includes for works compounds and access ways in the area of this tree. Removal is supported on the basis of replacement trees will be planted at the completion of remediation works.
