## UNSW Biological Sciences Project

### TREE REPORT and ARBORICULTURAL DEVELOPMENT IMPACT ASSESSMENT – Design Review Revision C

27 January 2015

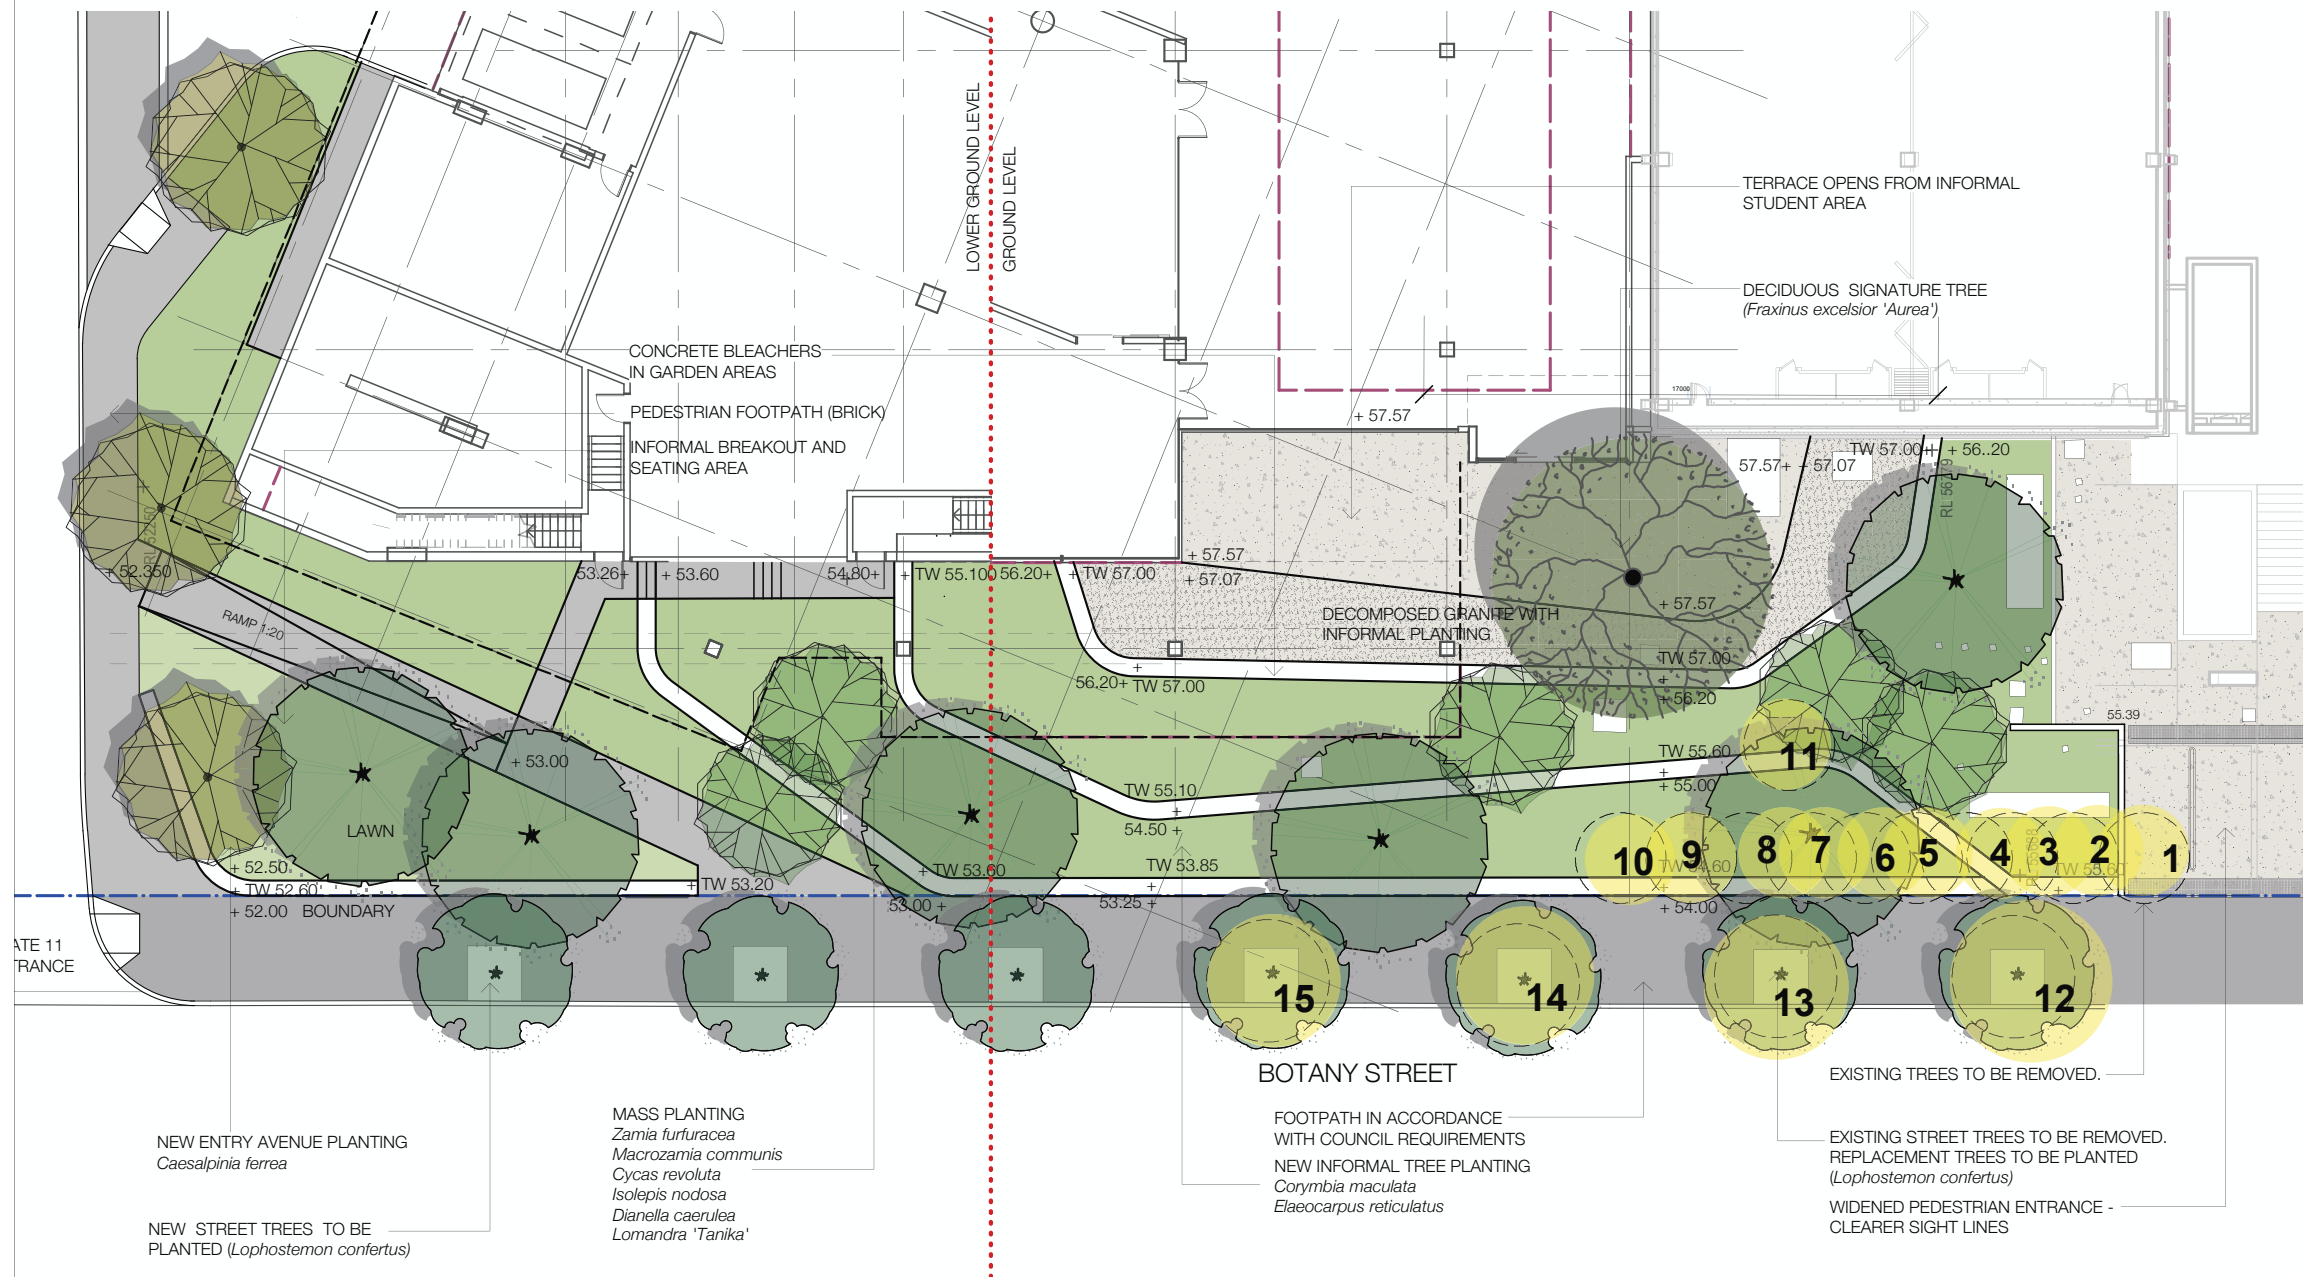
**A02 – Tree Location Plan 2 – D26**

Trees 1 to 15 are not viable to be retained due to the total encroachment of Tree Protection Zones by the proposed construction works, in particular the class B hoarding and site accommodation that is proposed to be constructed in this area. Trees 1 to 15 will be required to be removed due to the proposed construction works.

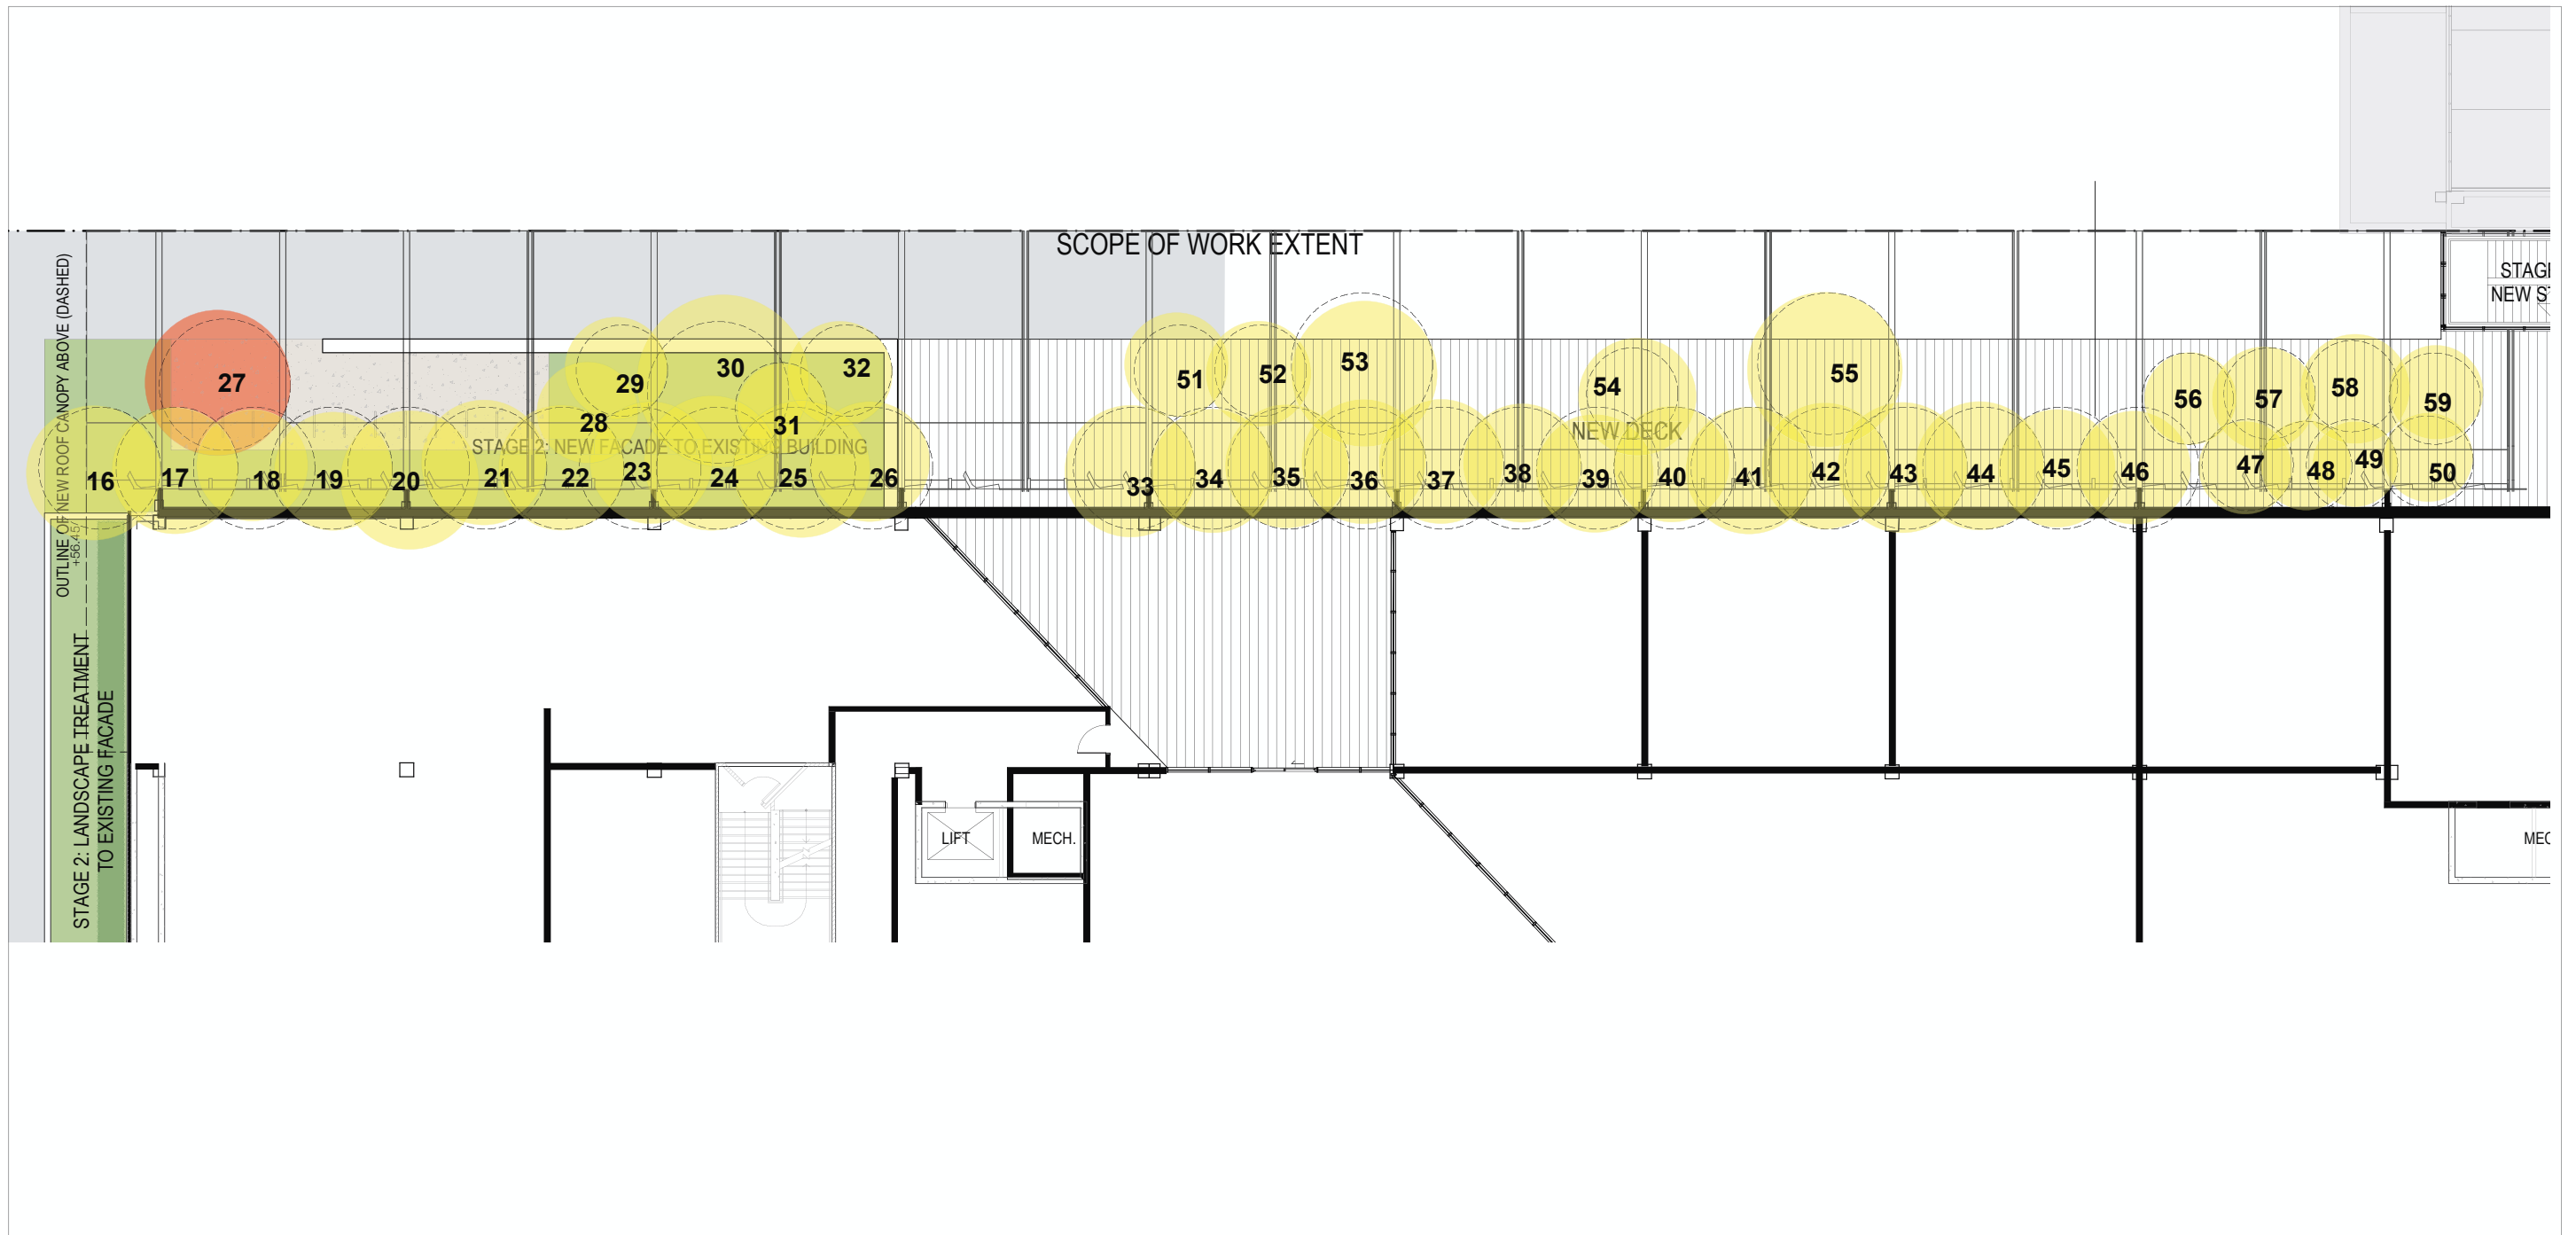
Project: UNSW Biosciences Building  
Client: BROOKFIELD MULTIPLEX  
DWG: A01  
Plan: Tree Location Plan 1  
Date: 27 January 2015  
Scale : Not to Scale

Trees 16 to 59 are not viable to be retained due to the total encroachment of Tree Protection Zones and the tree canopies by the proposed construction works, in particular the facade and canopy that is proposed to be constructed in this area. Trees 16 to 59 will be required to be removed due to the proposed construction works.
