UNSW Biological Sciences Project

ARBORICULTURAL DEVELOPMENT IMPACT ASSESSMENT

15 November 2016 REVISION E

Prepared for Multiplex

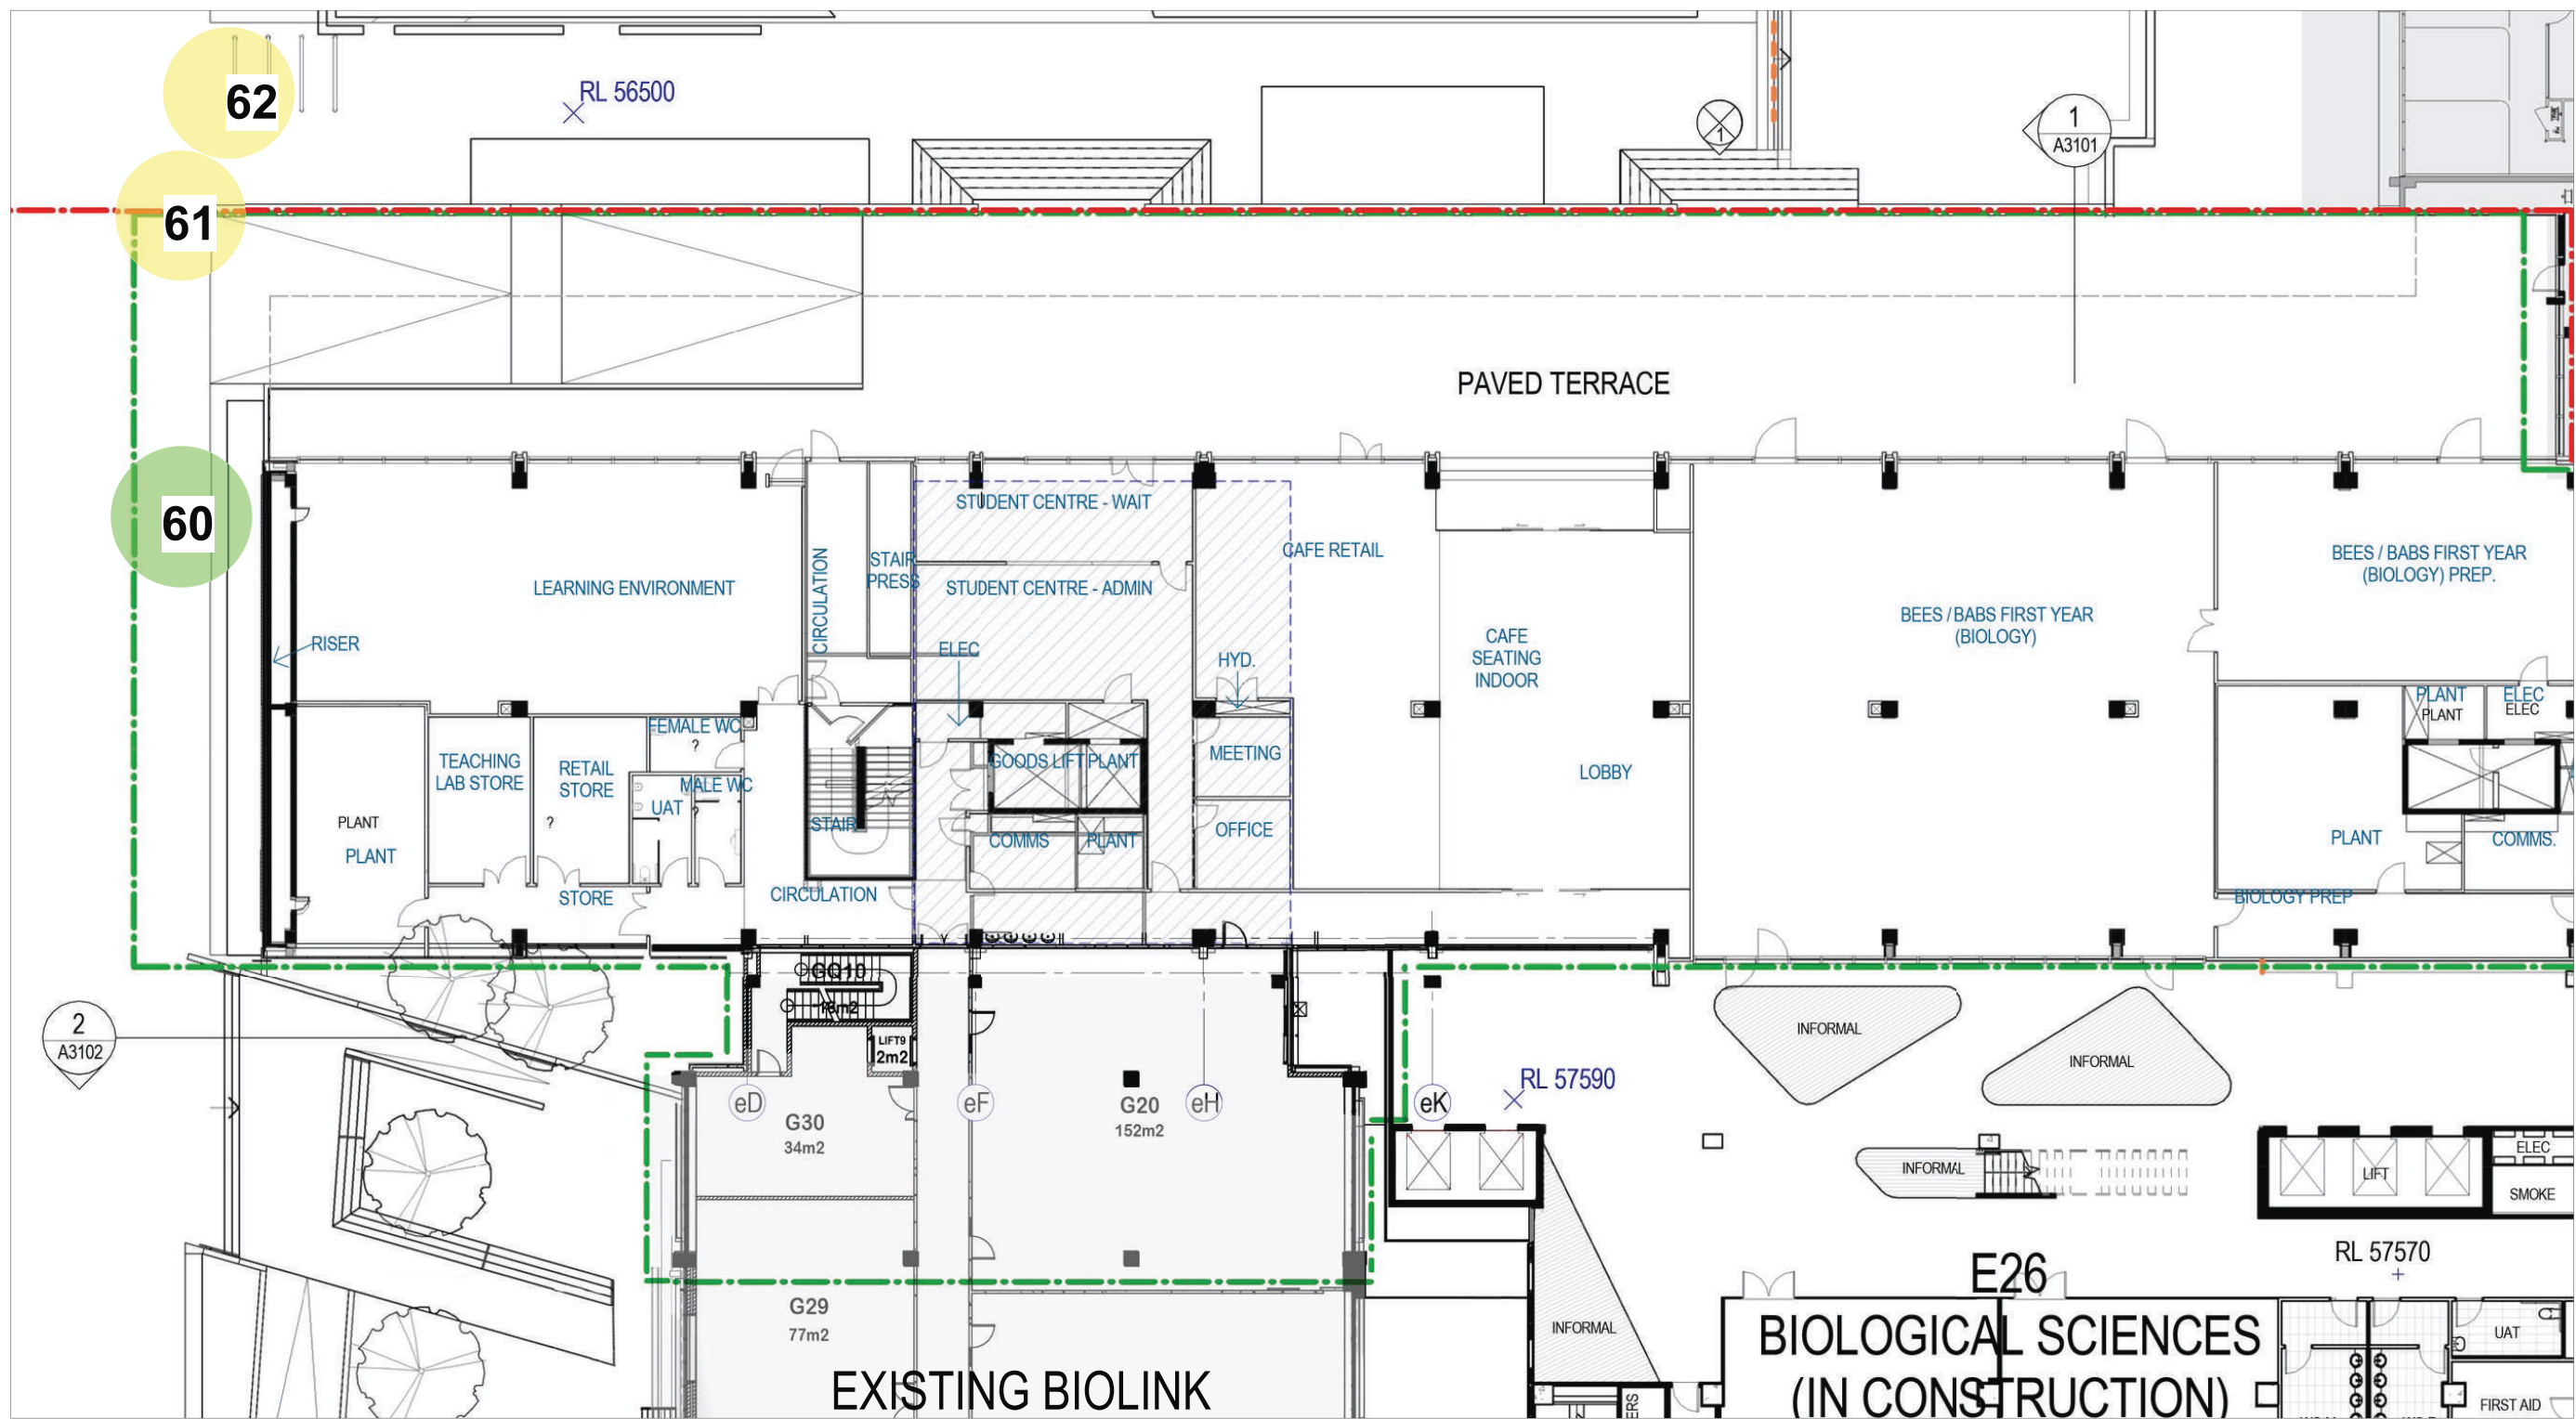
Appendix B – A01 - Tree Location Plan

Trees 61 and 62 are not viable to be retained due to the total encroachment of Tree Protection Zones. Trees 61 and 62 will be required to be removed due to the proposed construction works. Trees 61 and 62 are suitable to be transplanted.

Tree 60 is viable to be retained and protected on the condition that it is incorporated with the landscape treatment and there is no excavation within the Tree Protection Zones as shown in Appendix B.

Trees 61 and 62 are completely encroached by the proposed façade and canopy installation which are to be completed as part of the Stage 2 Works. These trees will not be viable to be retained.

Tree 60 is viable to be retained and protected on the condition that it is incorporated with the landscape treatment and there is no excavation within the Tree Protection Zones as shown in Appendix B.
