# Arboricultural Impact Assessment

**Project Address:** 84 Gavenlock Road Mardi NSW 2259

**Prepared for:** Catholic Schools Broken Bay (CSBB)

**Date:** July 2025

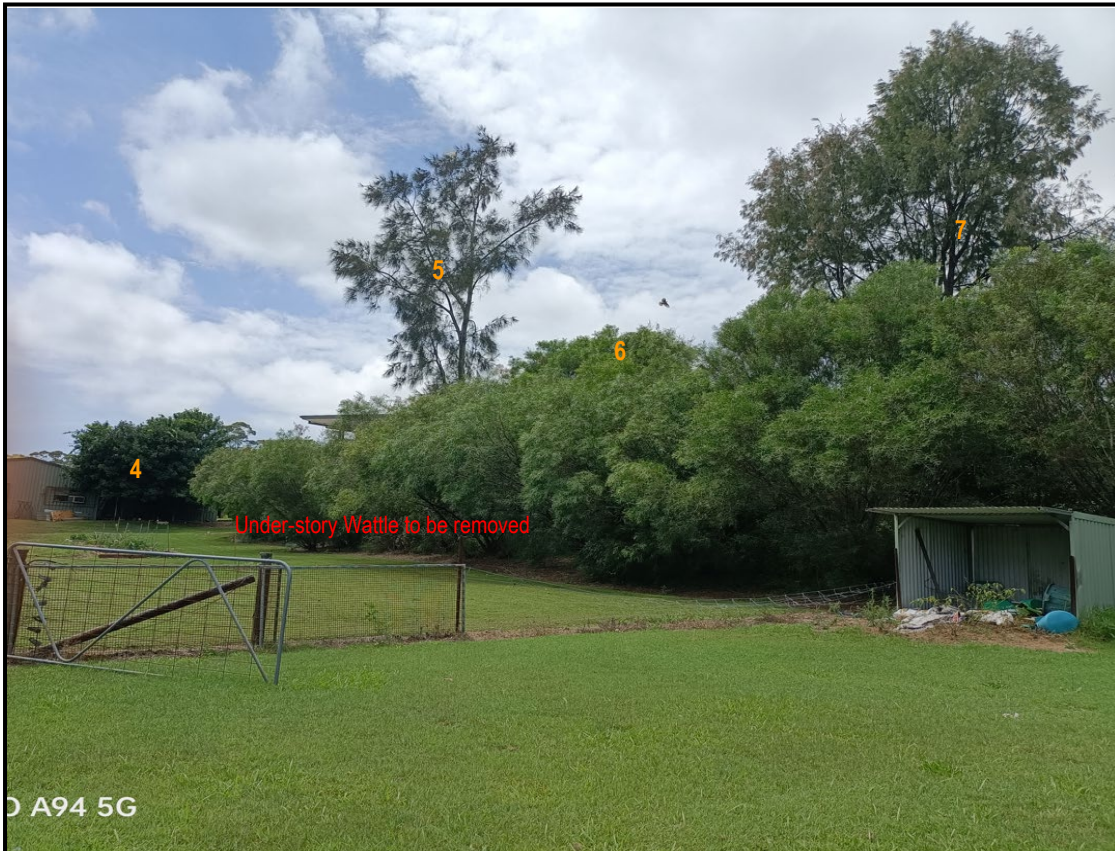
**Photo 1.** Trees 4, 5, 6, 7. Under-story Wattle to be removed.

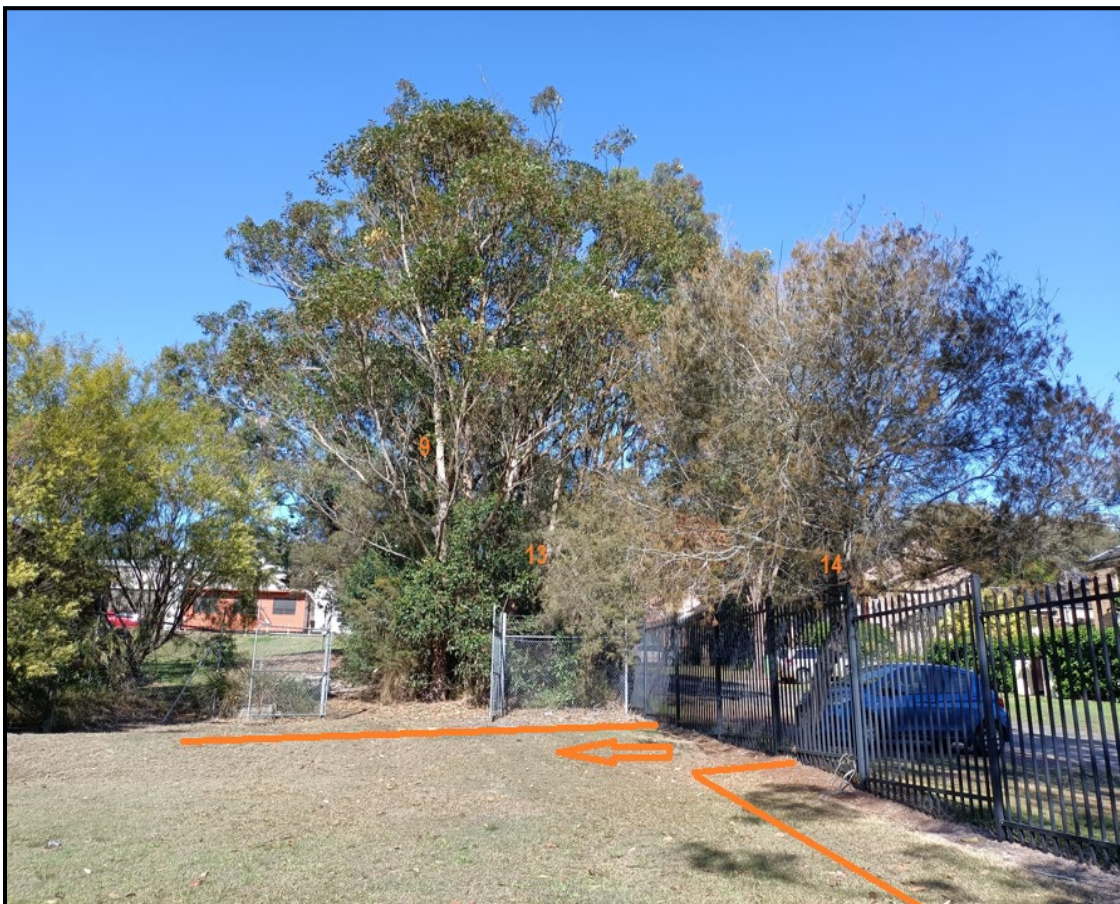
**Photo 2.** Trees 9,13,14 with line of proposed driveway entry & carparking.

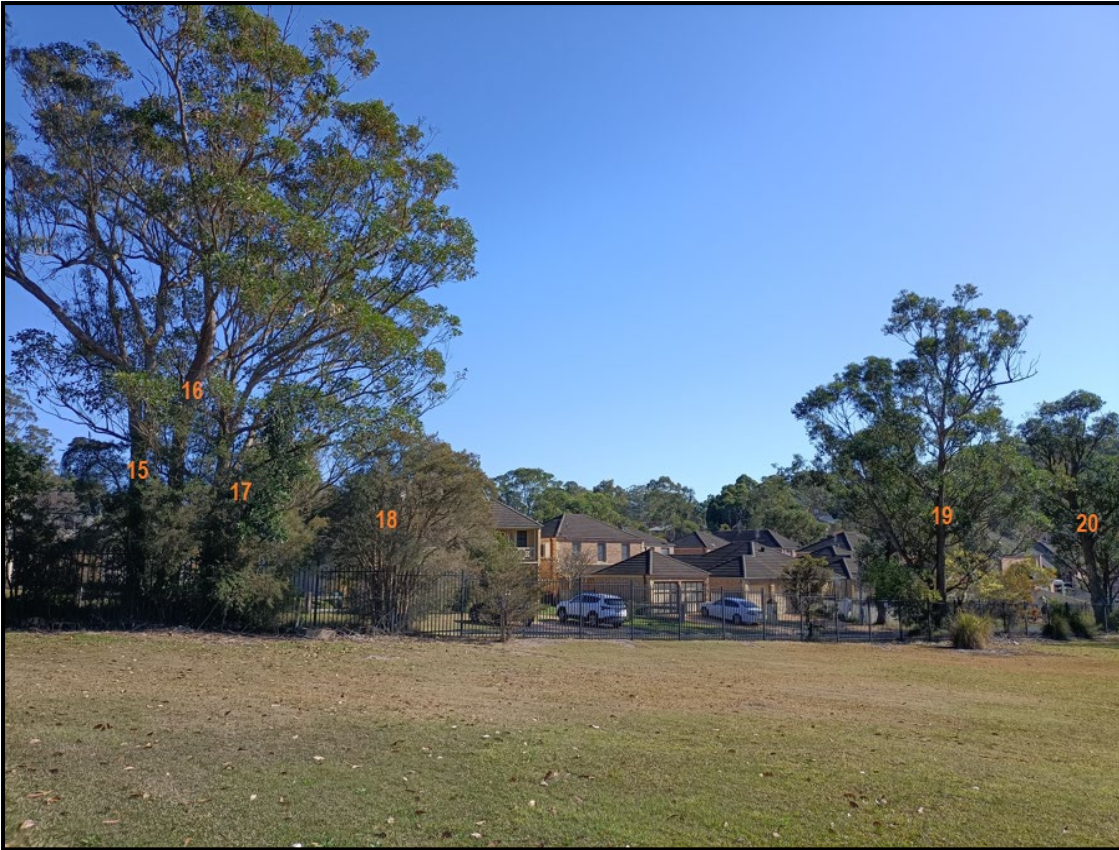
**Photo 3.** Trees 15,16,17,18,19,20 adjacent to Western boundary within street verge Keefers Glen.

| 15 | <i>Eucalyptus longifolia</i><br>(Woollybutt) | M | 20 | 470<br>530 | 5.6<br>2.5 | 6.0 | 15-<br>40 | Fair | Fair | High | Co | 70 | 2 | Fork @ 8m union appears sound. Overcrowded with neighbouring trees. Crown bias to North. Street tree (Keefers Glen). Exposed & damaged surface roots within TPZ radius. |
| 16 | <i>Eucalyptus robusta</i><br>(Swamp Mahogany) | M | 20 | 520<br>600 | 6.2<br>2.7 | 6.0 | 15-<br>40 | Fair | Fair | High | Co | 70 | 2 | Fork @ 9m union appears sound. Overcrowded with neighbouring trees. Crown bias to North. Street tree (Keefers Glen). Exposed & damaged surface roots within TPZ radius. |
| 17 | <i>Eucalyptus robusta</i><br>(Swamp Mahogany) | M | 20 | 485<br>550 | 5.8<br>2.6 | 5.0 | 5-15<br>3.b | Poor | Fair | High | Co | 60 | 2 | Fork @ 8m union with deadwood-stub with decay. High probability of failure. Overcrowded with neighbouring trees. Crown bias to North. Street tree (Keefers Glen). Exposed & damaged surface roots within TPZ radius. |
| 18 | <i>Melaleuca styphelioides</i><br>(Prickly Paperbark) | M | 8 | 380<br>800 | 4.5<br>3.1 | 3.0 | 5-15 | Poor | Fair | Low | Co | 70 | 6 | Poor pruning history. Multi-trunked @base with sound unions. Street tree (Keefers Glen). Exposed & damaged surface roots within TPZ radius. |
| 19 | <i>Eucalyptus robusta</i><br>(Swamp Mahogany) | M | 19 | 660<br>675 | 7.9<br>2.8 | 6.0 | 15-<br>40 | Fair | Fair | High | Dom | 60 | 2 | Poor pruning history. Multi-trunked @base with sound unions. Street tree (Keefers Glen). Exposed & damaged surface roots within TPZ radius. |
| 20 | <i>Eucalyptus robusta</i><br>(Swamp Mahogany) | M | 19 | 950<br>1.1 | 11.<br>3.5 | 6.0 | 15-<br>40 | Poor | Fair | High | Dom | 50 | 2 | ≥20% deadwood. 1m long wound with decay @ 7m. Poor wound-wood development. Self-correcting trunk bias to North |

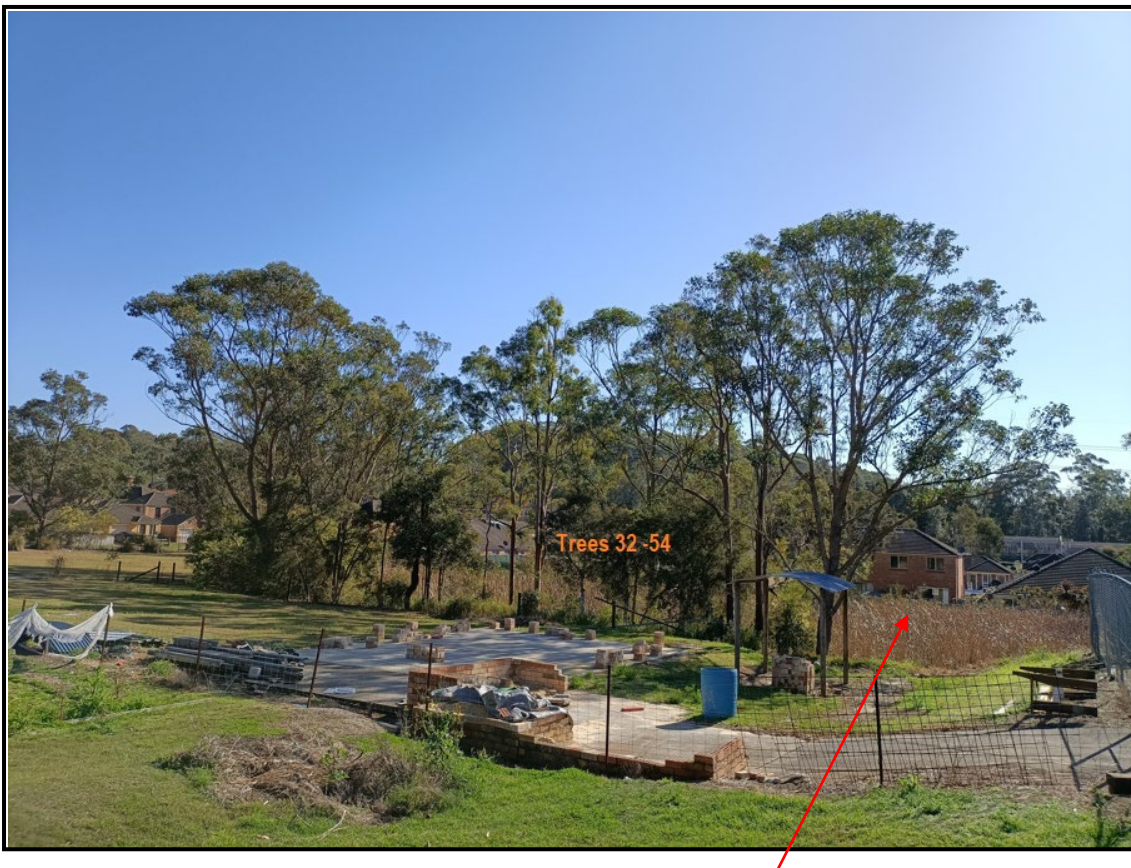
6.2.3. Trees 25 to 54 border the existing dam that is to be filled and levelled ( $\geq 500\text{mm}$ ) to provide space for classrooms, recreational facilities, amenities, driveway access and drainage systems. Trees are wholly (100%) within the development footprint. There are no design alterations or building techniques that can reduce the impact. Trees are not suitable for transplant and are recommended for removal.

**Photo 4.** Trees 32-54 adjacent to existing dam to be filled & levelled

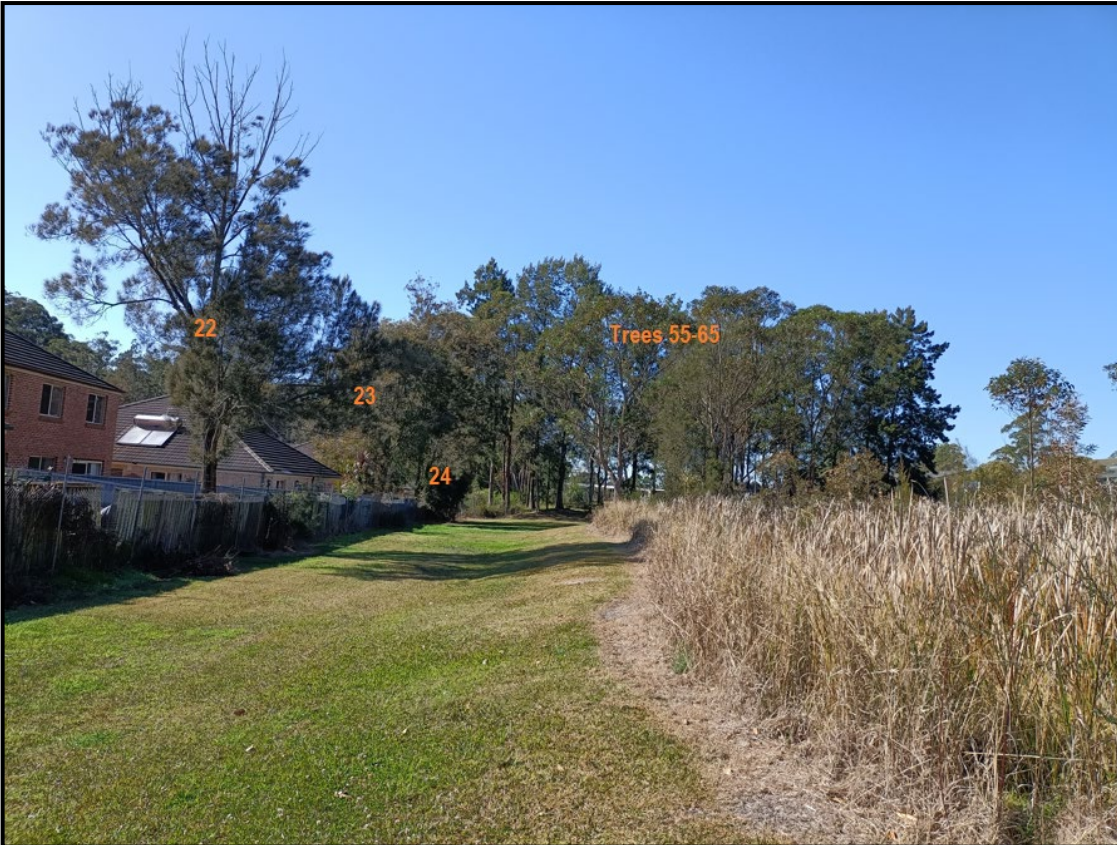
**Photo 5.** Trees 22,23,24 within neighbouring properties Northern Boundary. Trees 55-65 adjacent to existing netball court.

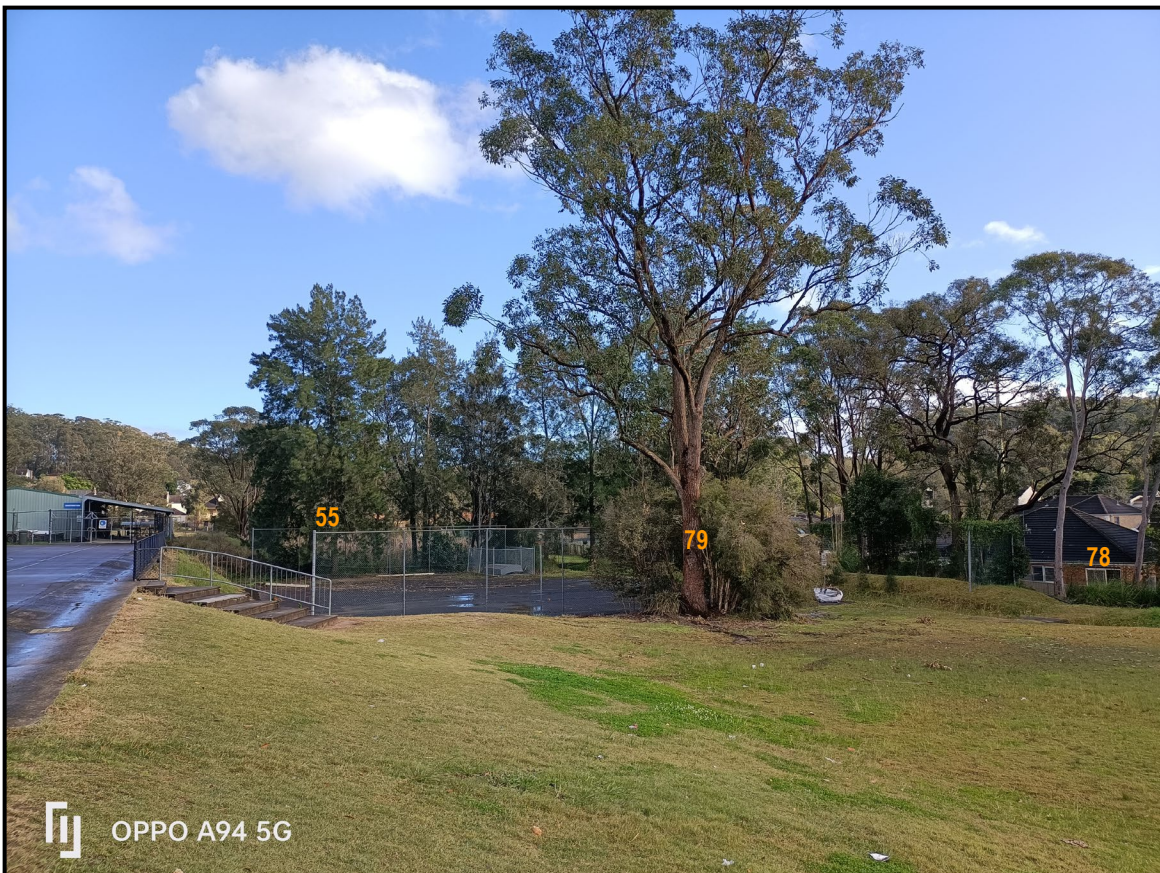
6.2.4. Trees 64 to 79 and trees 80,81,82,83 will be impacted by the demolition of the existing netball court and the establishment of a new Eastern carpark with associated driveway access and significant earthworks works with level changes ( $\geq 500\text{mm}$ ) for stormwater drainage. The trees are wholly (100%) or partially ( $\geq 35\%$ ) within the development footprint representing a significant level of impact that is not tolerable for the species. There are no design alterations or building techniques that can reduce the impact. Trees are not suitable for transplant and are recommended for removal.

**Photo 6.** Trees 55-83 adjacent to existing netball court.

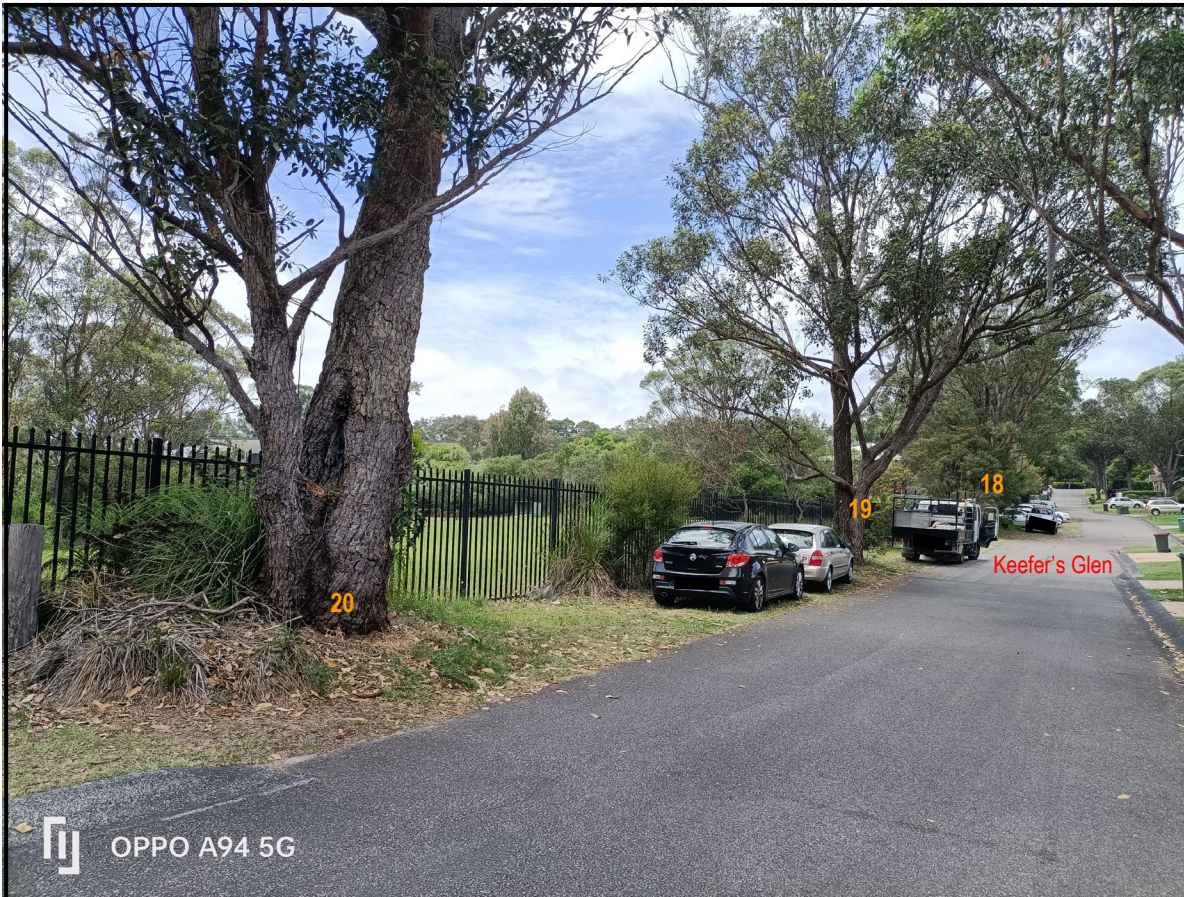
**Photo 7.** Trees adjacent to Western boundary, Keefer's Glen Looking South

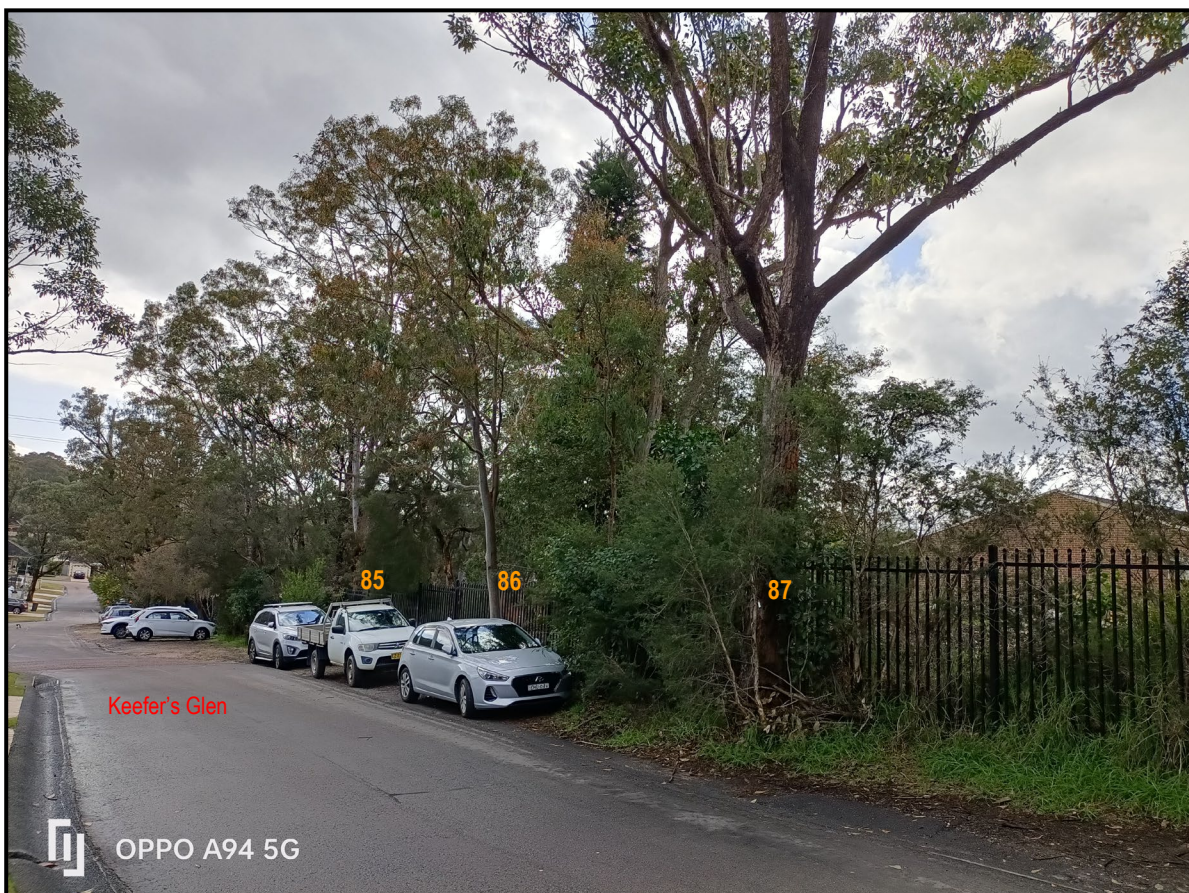
**Photo 8.** Trees adjacent to Western boundary, Keefer's Glen Looking North

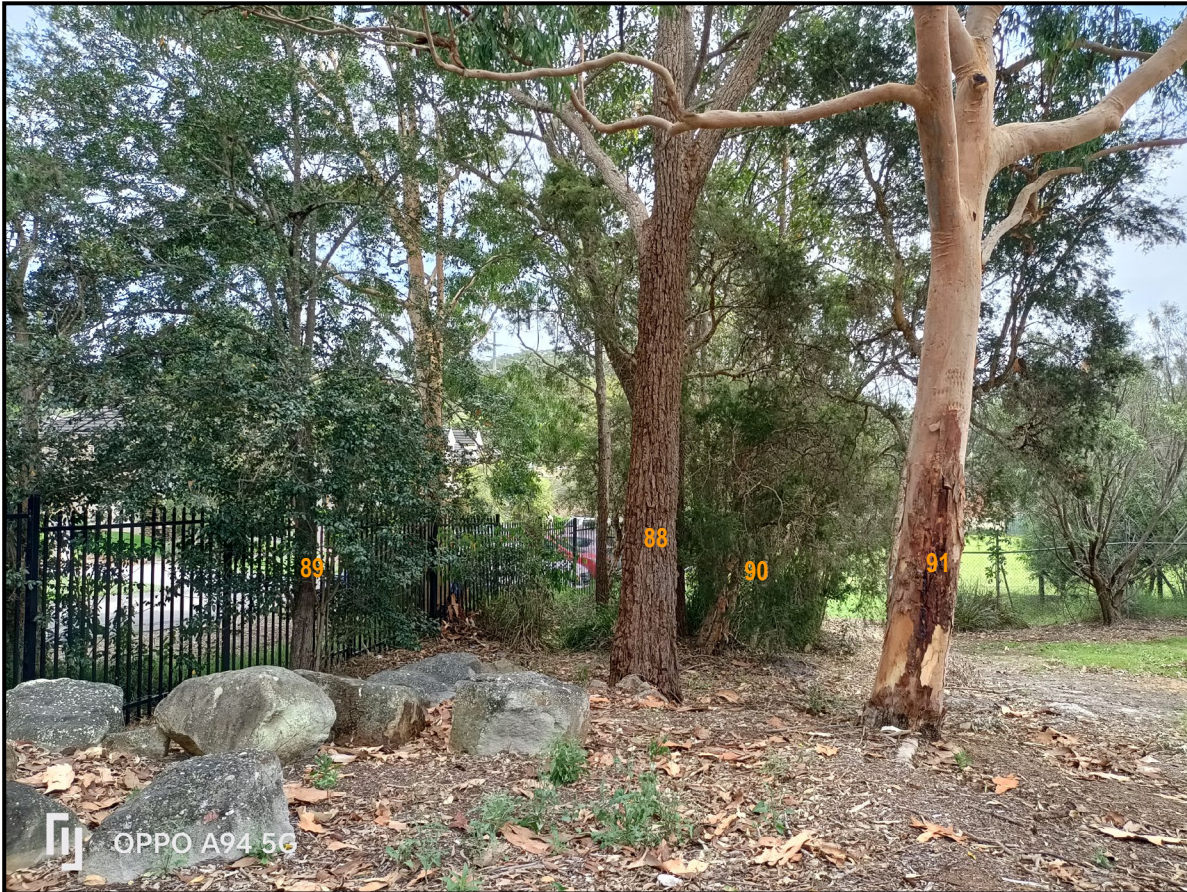
**Photo 9.** Trees inside the Western boundary looking North.

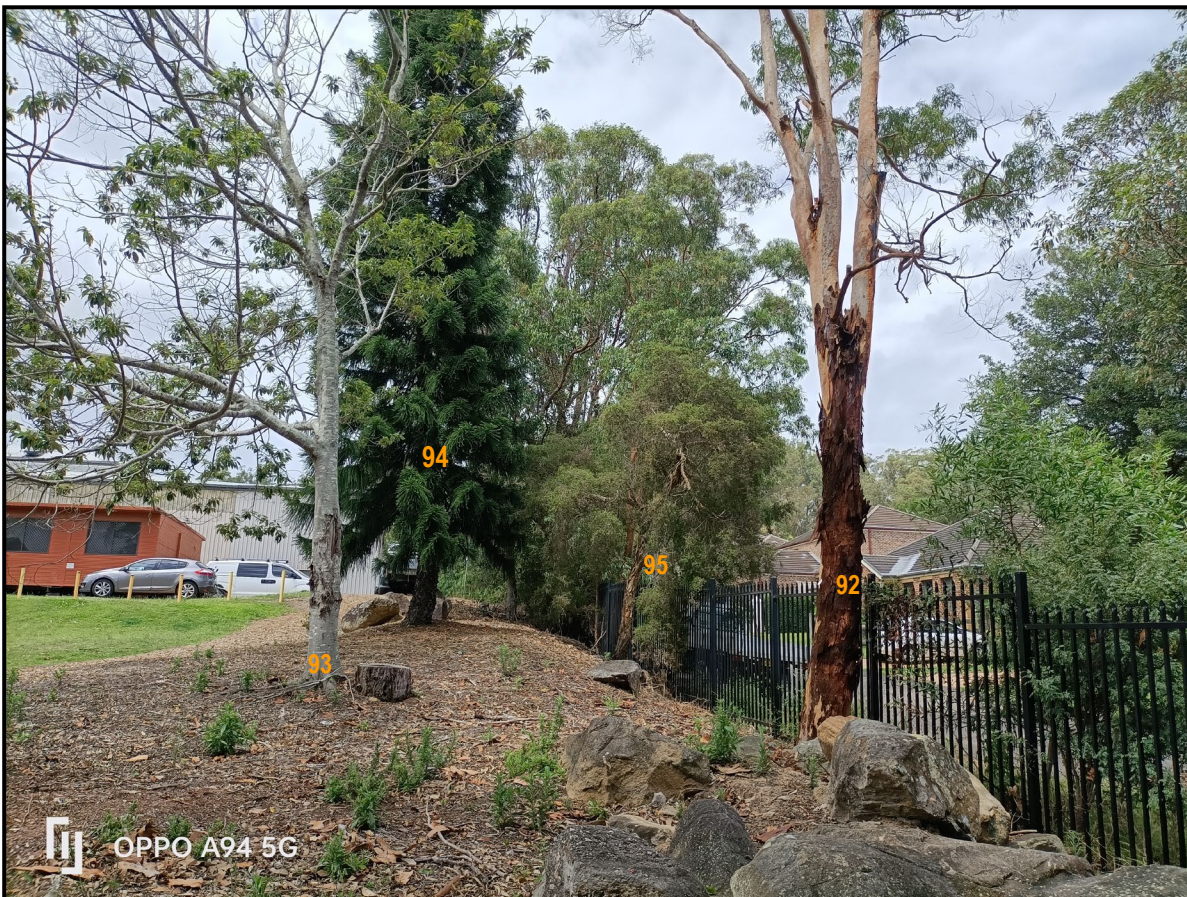
**Photo 10.** Trees inside the Western boundary looking South.
