**Arboricultural Impact Assessment**

Leeds Investments Pty Ltd

Llewellyn St Rhodes NSW 2138  
(2a Llewellyn St Rhodes, 43- 57 Blaxland Rd, 448-  
458 Concord Rd and 2a, 2b 2d Cavelle Ave)

1<sup>st</sup> August 2025

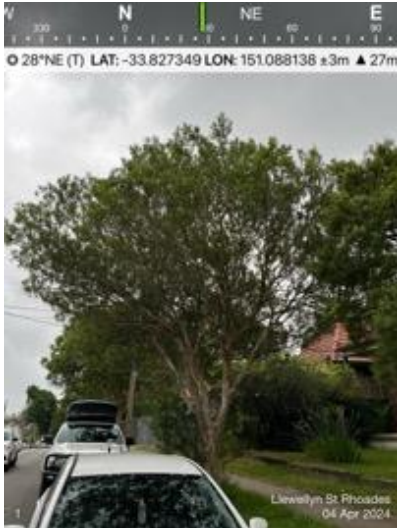
Plate 1: Tree 1 *Tristaniopsis laurina* (Water Gum).

Tree No.	Location	Botanical Name Common Name	Canopy (m)	Height (m)	DBH* DRC* (cm)	TPZ* SRZ* (m)	Visual Tree Assessment (VTA) – Tree Health & Condition	TULE* A-Z	Retention Value
1	Council street tree, 57 Blaxland Road.	<i>Tristaniopsis laurina</i> Water Gum	6	7	10/12/15/20 50	3.5 2.5	Mature, previously pruned, with 60% pre-existing hard-surface impacts.	2d A2	Low-Moderate
2	Council street tree, 55 Blaxland Road.	<i>Tristaniopsis laurina</i> Water Gum	4	5	10/12 25	2.0 1.9	Mature, with twin stems, physical damage to the west at 50cm height, and over 60% dehydration.	5e Z10	Very Low
3	Council street tree, 53a Blaxland Road.	<i>Tristaniopsis laurina</i> Water Gum	3	4	14 20	2.0 1.7	Semi-mature, with decay at the base of the tree, and over 20% dieback. (Exempt size).	3d A2	Low
4	Council street tree, 53 Blaxland Road.	<i>Tristaniopsis laurina</i> Water Gum	6	7	15/26 32	3.6 2.1	Semi-mature, good condition but poor development, with three (3) co-dominant stems.	2d A1	Moderate

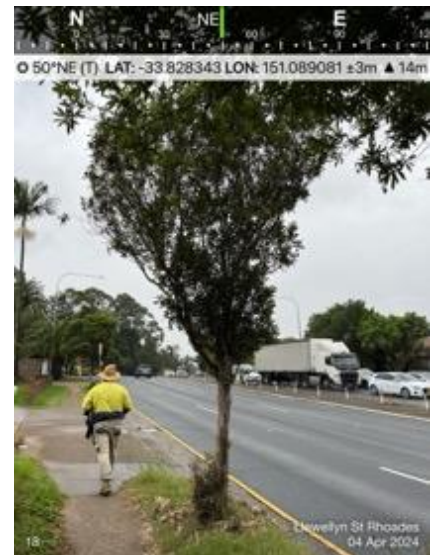
Plate 15: Tree 18 *Tristaniopsis laurina* (Water Gum).

Tree No.	Location	Botanical Name Common Name	Canopy (m)	Height (m)	DBH* DRC* (cm)	TPZ* SRZ* (m)	Visual Tree Assessment (VTA) – Tree Health & Condition	TULE* A-Z	Retention Value
18	Council street tree, 450 Concord Road.	<i>Tristaniopsis laurina</i> Water Gum	3	4	10 12	2.0 1.5	Immature, good condition but poor development, with epicormics at the base of the tree. Under 5m in height - exempt	2d A2	Low
19	Council street tree, 454 Concord Road.	<i>Tristaniopsis laurina</i> Water Gum	4	5	20 26	2.4 1.9	Immature, previously pruned, with epicormics at the base of the tree, and 45% pre-existing hard-surface impacts.	2a A2	Low-Moderate
20	Council street tree, 458 Concord Road.	<i>Archontophoenix spp.</i> Phoenix Palm*	6	6	20 30	3.5 2.0	Semi-mature, good condition but poor development.	2d A1	Moderate
21	Council street tree, 458 Concord Road.	<i>Acer negundo</i> Boxelder Maple	4	6	25 45	3.0 2.4	Post-mature, with decay, a suppressed canopy, and borers.	5e Z10	Low

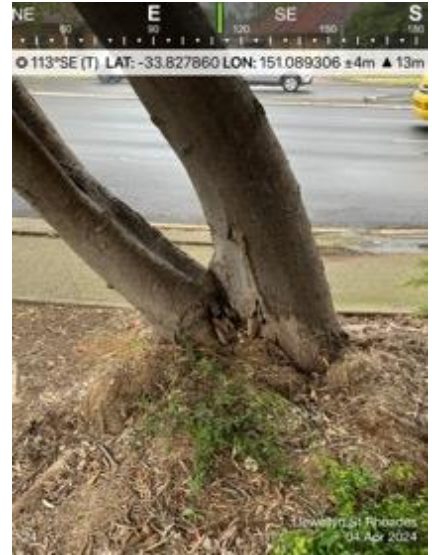
Plate 21: Tree 24 has a lean and an unbalanced canopy to the east.

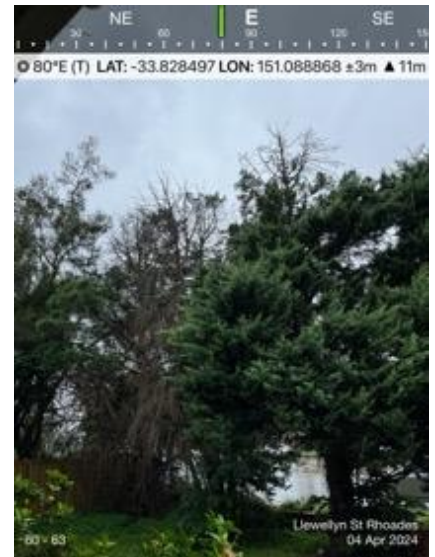
Plate 33: Trees 60-63, *Cupressus* spp. (*Cypress*).

62	Front garden, 450 Concord Road.	<i>Cupressus spp.</i> Cypress	8	14	12/20/20/20 50	4.4 2.5	Mature, poor condition, with two (2) dehydrated stems.	5e Z10	Low-Moderate
63	Front garden, 450 Concord Road.	<i>Cupressus spp.</i> Cypress	7	14	40 42	4.8 2.3	Mature, heavily pruned at the base of the tree, with a suppressed canopy.	3a A2	Moderate
64	Front garden, 450 Concord Road.	<i>Murraya spp.</i> Murraya	3-6	6	10 10	2.0 1.5	Semi-mature hedge, good condition but poor development.	2d A1	Low
65	Rear yard, 450 Concord Road.	<i>Cedrus deodara</i> Deodar Cedar	6	8	22 24	2.6 1.8	Immature, in decline, with a dehydrating canopy.	2d A2	Low-Moderate
66	Rear yard, 450 Concord Road.	<i>Callistemon viminalis</i> Weeping Bottlebrush	8	10	18/22/34 45	5.3 2.4	Semi-mature, good condition but poor development.	2a A1	Moderate
67	448a Concord Road.	<i>Leptospermum spp.</i> Tea Tree	6	8	10/10/25 40	3.5 2.3	Semi-mature, moderate condition, with fungal attack to the east at 2m height.	2d A2	Low-Moderate

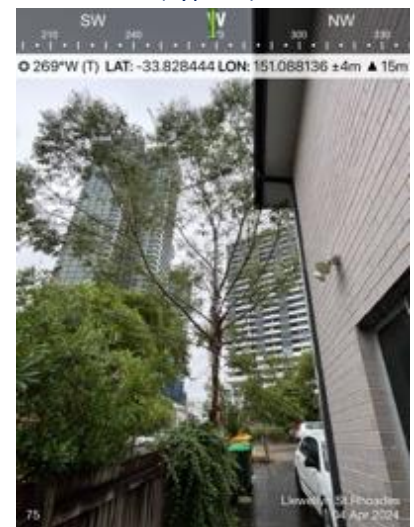
Plate 36: Tree 75 *Eucalyptus grandis* (*Flooded Gum*).

74	Front garden, 43a Blaxland Road.	<i>Spiraea cantoniensis</i> May Bush	7	5	10/10/10 18	2.0 1.6	Semi-mature, good condition but poor development, previously pruned.	2d Z1	Low
75	Adjacent driveway, 43a Blaxland Road.	<i>Eucalyptus grandis</i> Flooded Gum	8	9	22 24	2.6 1.8	Immature, good condition but poor development, with physical damage from the fence at 1m height, and root damage.	2a Z6	Low-Moderate
