Photographs Sutherland Hospital - A - Main Building 14-11-2011

Sutherland Hospital - A - Main Building 14-11-2011 Sample Analysis Results

NSW 2219 Re: Asbestos Identification Analysis - Building A, Sutherland Hospital, 430 Kingsway, Caringbah

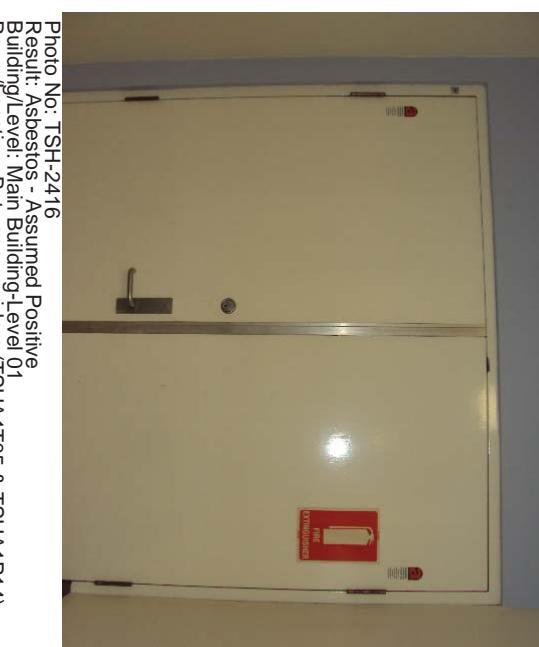
Photo No: TSH-2416 Result: Asbestos - Assumed Positive Building/Level: Main Building-Level 01 Room/Location: Between corridors (TSHA1T05 & TSHA1P14)-Feature/Material: Fire Door-Insulation

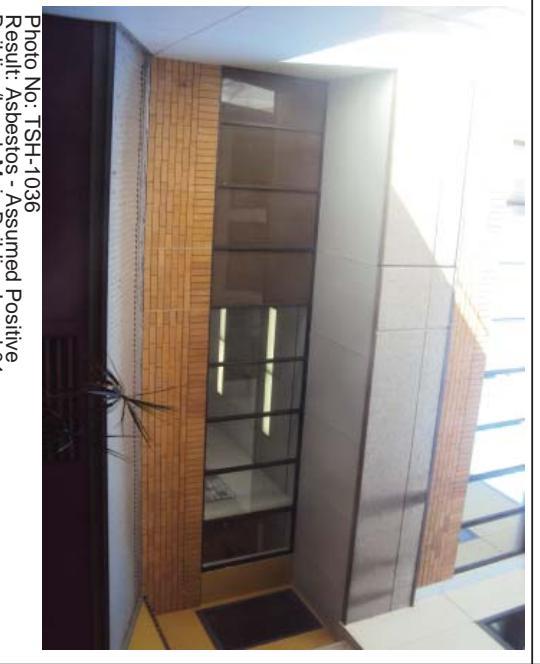
Photo No: TSH-1036 Result: Asbestos - Assumed Positive Building/Level: Main Building-Level 01 Room/Location: Exterior East Courtyard (TSHA1CY4)-Throughout Feature/Material: Awning-Flat Cement Sheeting

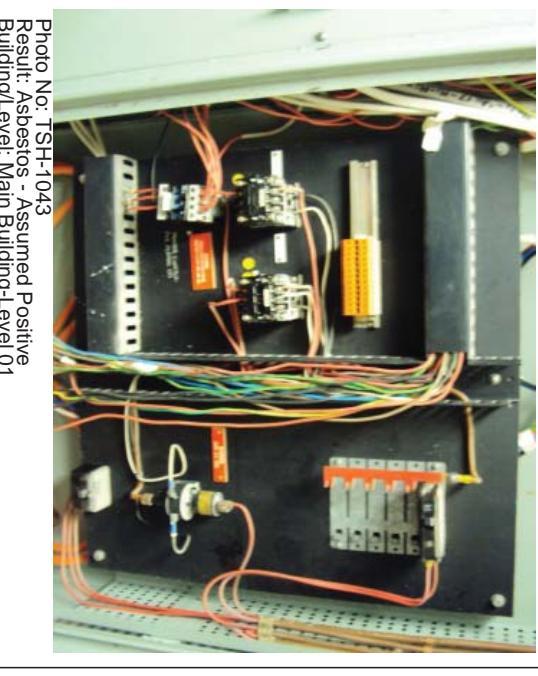
Photo No. TSH-1043 Result: Asbestos - Assumed Positive Building/Level: Main Building-Level 01 Room/Location: Corridor opposite QFS Kitchen 18 (TSHA1K33)-Feature/Material: Electrical Distribution Board-Bituminous Material

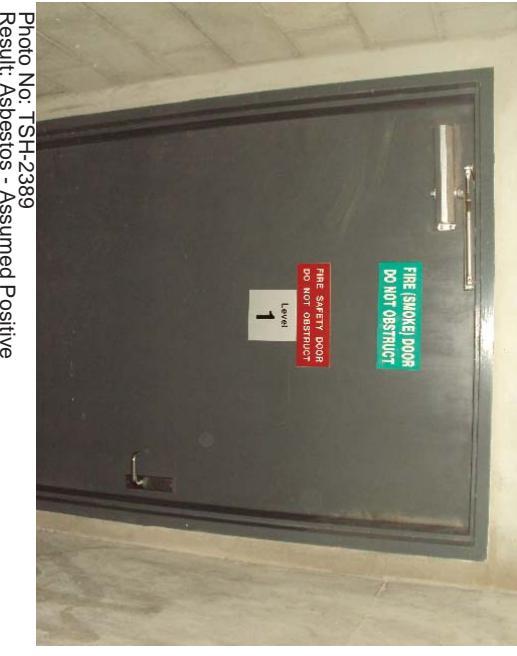
Photo No: TSH-2389 Result: Asbestos - Assumed Positive Building/Level: Main Building-Level 01 Room/Location: Fire Stairs (TSHA1ST3)-South East Feature/Material: Fire Door-Insulation

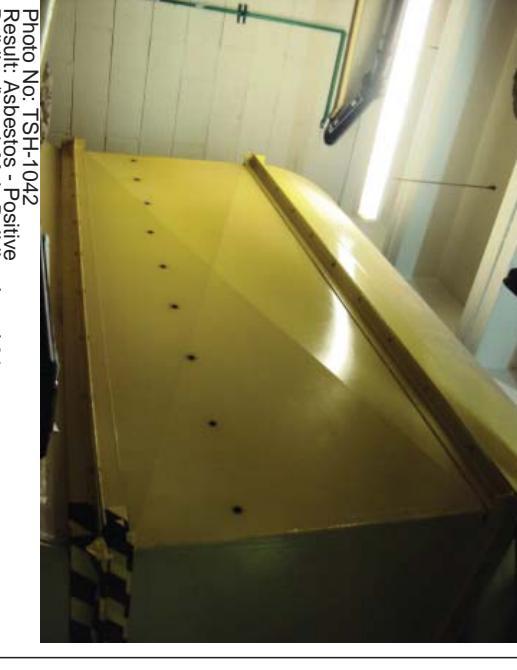
Photo No: TSH-1042 Result: Asbestos - Positive Building/Level: Main Building-Level 01 Room/Location: QFS Kitchen 15 (TSHA1K30)-Air Handling room Feature/Material: Air Conditioning Ductwork-Mastic Sealant

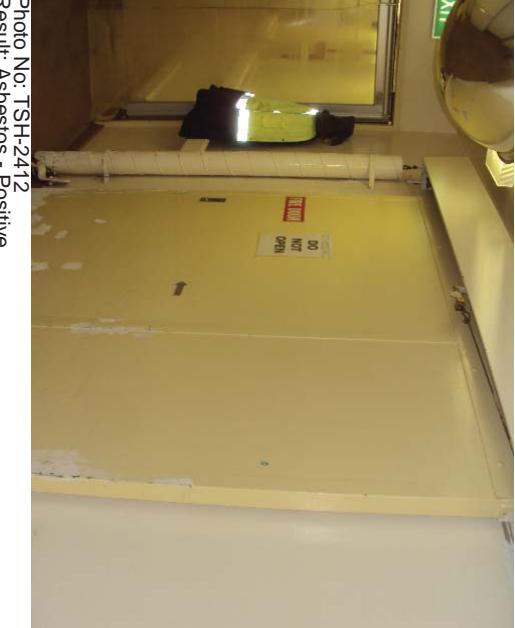
Photo No: TSH-2412 Result: Asbestos - Positive Building/Level: Main Building-Level 01 Room/Location: QFS Kitchen 9 (TSHA1K24)-Feature/Material: Fire Door-Insulation

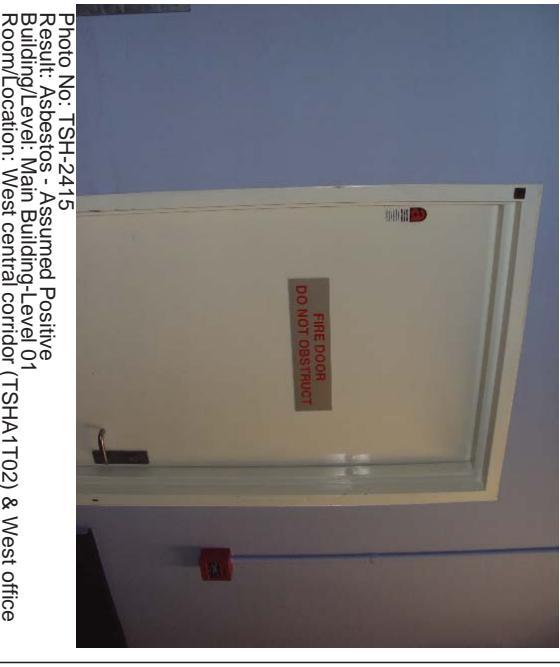
Photo No: TSH-2415 Result: Asbestos - Assumed Positive Building/Level: Main Building-Level 01 Room/Location: West central corridor (TSHA1T02) & West office (TSHA1P30)-West Feature/Material: Fire Door-Insulation

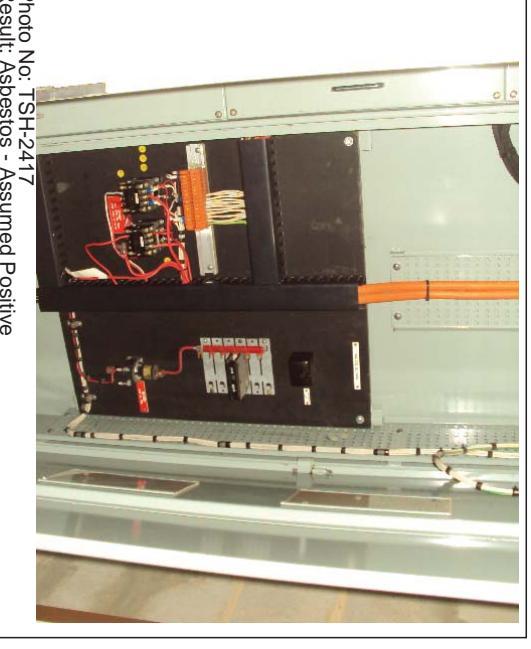
Photo No: TSH-2417 Result: Asbestos - Assumed Positive Building/Level: Main Building-Level 01 Room/Location: West Corridor (TSHA1T03)-West Feature/Material: Electrical Distribution Board-Bituminous Material

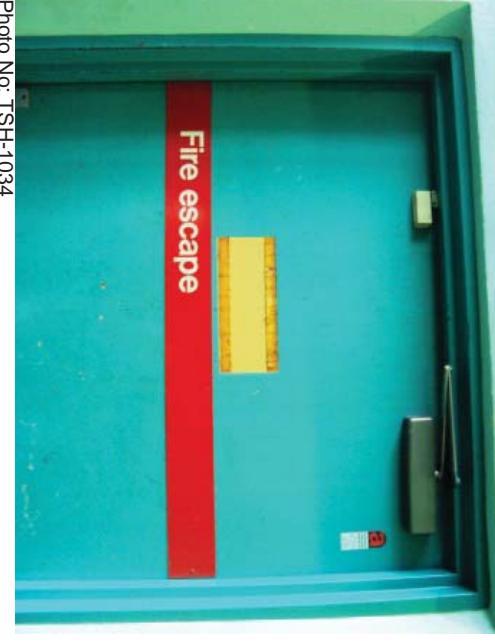
Photo No: TSH-1034 Result: Asbestos - Assumed Positive Building/Level: Main Building-Level 02 Room/Location: South West Fire Stairs (TSHA2ST2)-North Feature/Material: Fire Door-Insulation

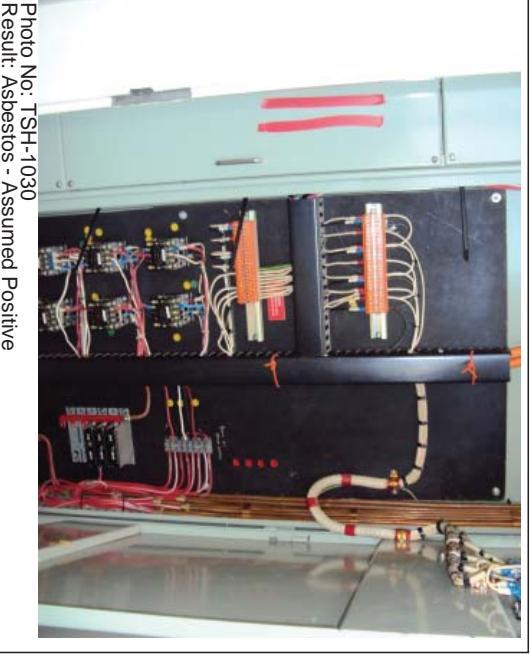
Photo No: TSH-1030 Result: Asbestos - Assumed Positive Building/Level: Main Building-Level 03 Room/Location: CSSD, Corridor (TSHA3JC2)-North Feature/Material: Electrical Distribution Board-Bituminous Material

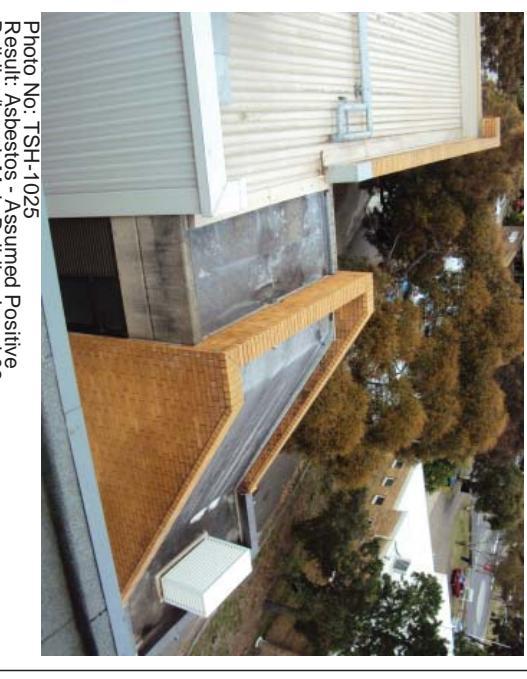
Photo No: TSH-1025 Result: Asbestos - Assumed Positive Building/Level: Main Building-Level 03 Room/Location: Exterior Fire Stairs (TSHA3ST3)-South Plant Room Feature/Material: Roof Lining-Bituminous Membrane

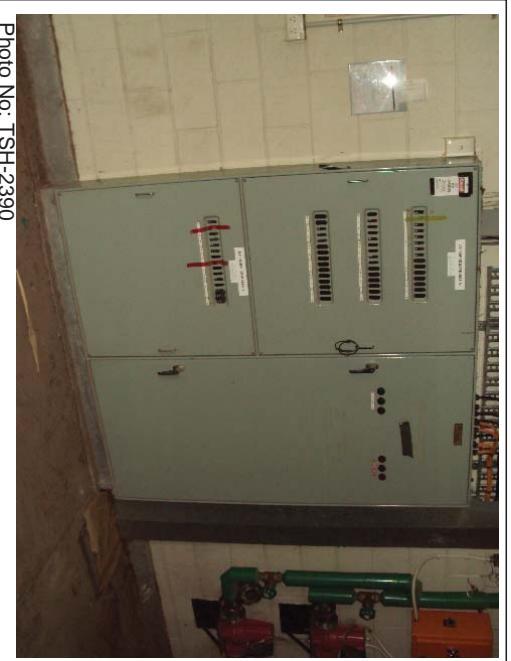
Photo No: TSH-2390 Result: Asbestos - Assumed Positive Building/Level: Main Building-Level 03 Room/Location: Plant Room (TSHA3PR6)-Feature/Material: Electrical Distribution Board-Bituminous Material

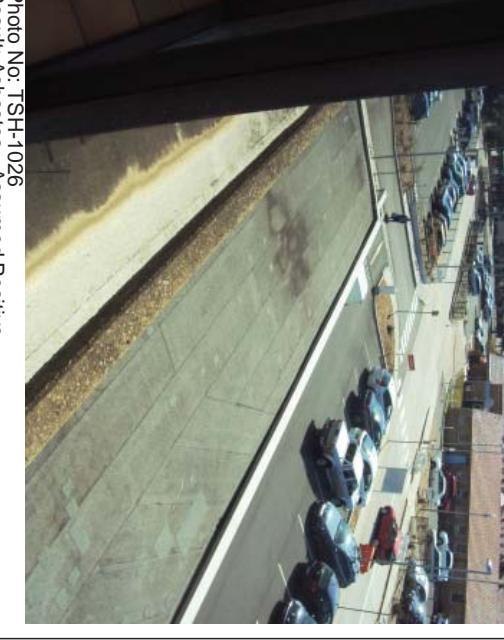
Photo No: TSH-1026 Result: Asbestos - Assumed Positive Building/Level: Main Building-Level 03 Room/Location: Platform (Level 2 Roof)-North West Feature/Material: Waterproof Membrane-Bituminous Membrane

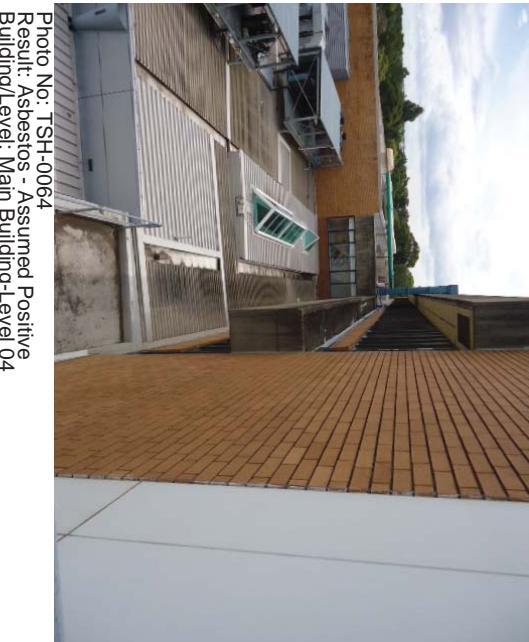
Photo No: TSH-0064 Result: Asbestos - Assumed Positive Building/Level: Main Building-Level 04 Room/Location: Exterior Platform-Surrounding Feature/Material: Waterproof Membrane-Bituminous Material

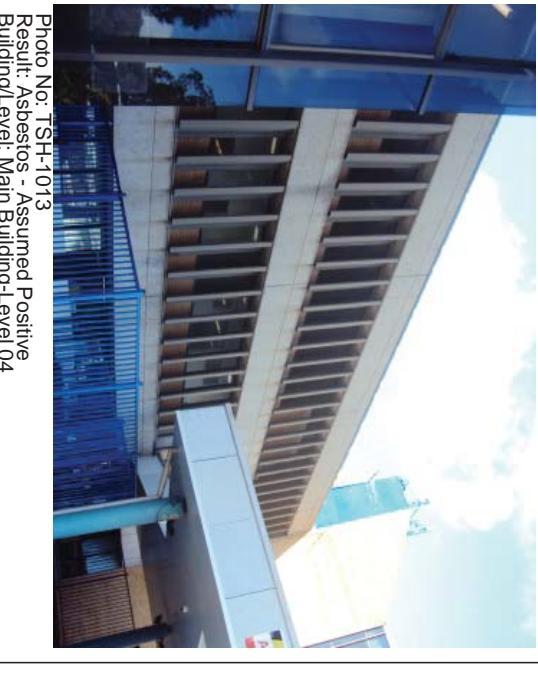
Photo No: TSH-1013 Result: Asbestos - Assumed Positive Building/Level: Main Building-Level 04 Room/Location: Exterior Perimeter-West Feature/Material: Window louvers-Compressed Cement Sheeting

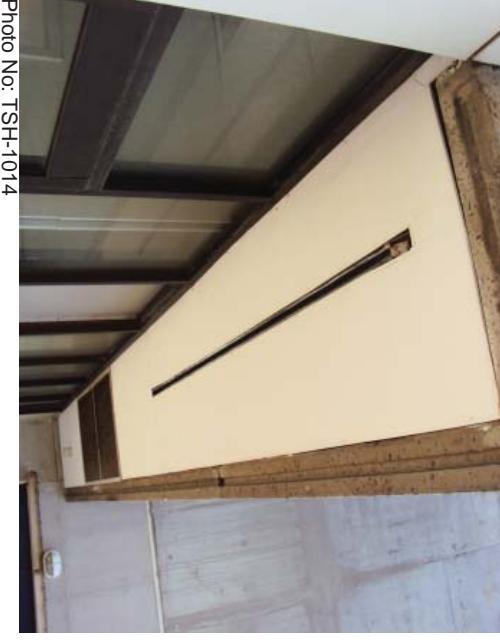
Photo No: TSH-1014 Result: Asbestos - Positive Building/Level: Main Building-Level 04 Room/Location: Exterior Roof (TSHA4R05)-North East Feature/Material: Eaves-Fibre Cement Sheeting

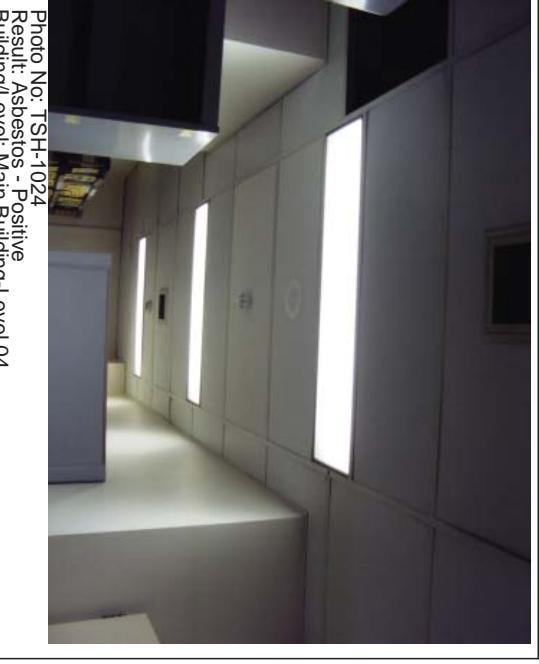
Photo No: TSH-1024 Result: Asbestos - Positive Building/Level: Main Building-Level 04 Boom/Location: Records Active Room (TSHA4C24)-Room/Location: Records Active Room (TSHA4C24)-Feature/Material: Suspended Ceiling-Compressed Ceiling Tiles

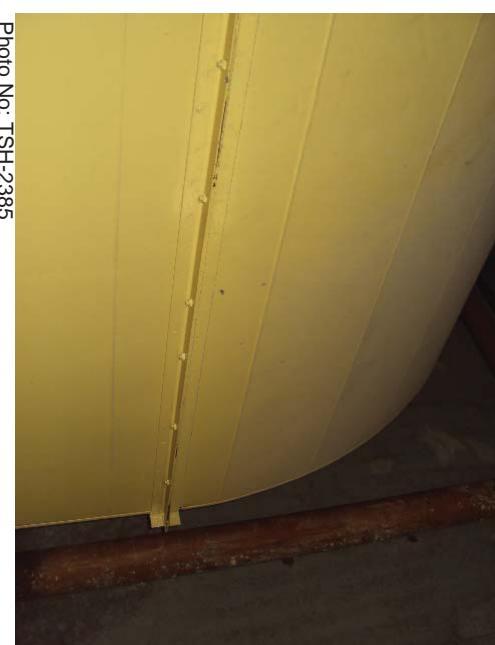
Photo No: TSH-2385 Result: Asbestos - Positive Building/Level: Main Building-Level 05 Room/Location: South East Riser (TSHA5DU3)-Feature/Material: Air Conditioning Ductwork-Mastic Sealant

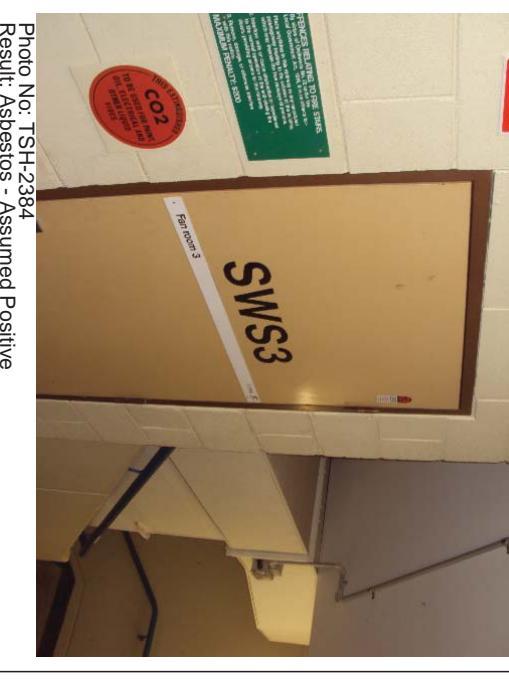
Photo No: TSH-2384 Result: Asbestos - Assumed Positive Building/Level: Main Building-Level 05 Room/Location: South East Riser (TSHA5DU3)-Fan Room 3 Feature/Material: Fire Door-Insulation - Fire Door

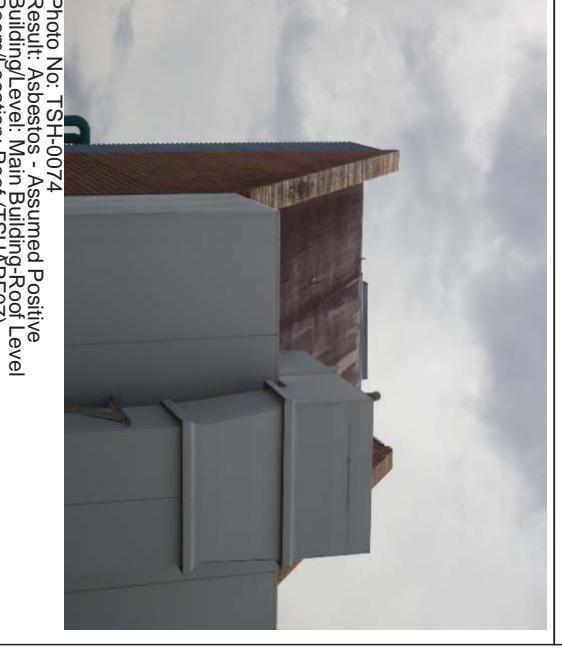
Photo No: TSH-0074 Result: Asbestos - Assumed Positive Building/Level: Main Building-Roof Level Room/Location: Roof (TSHARF07)-Feature/Material: Lining-Bituminous Membrane
