DEVELOPMENT IMPACT ASSESSMENT REPORT.

Campbells Stores

7-27 Circular Quay West-The Rocks-Sydney.

Prepared by: Tom Hare AQF Level 5.

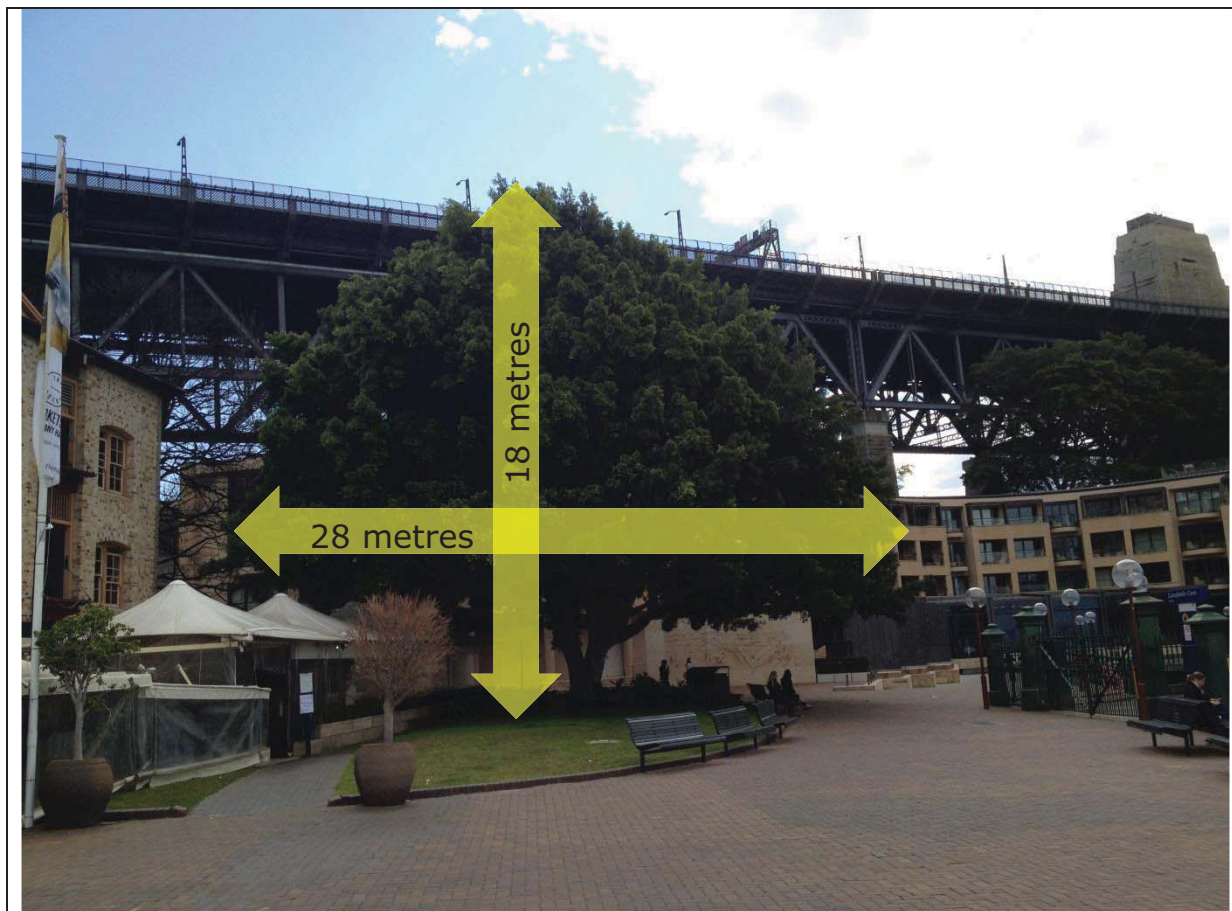
species	Height (m)	Dbh (mm)	TPZ (m)	Health & Vigour	Structure	Significance	ELE
<i>Ficus microcarpa</i> var. hillii	18	630 660 560	12.8	Fair- Trees canopy is noticeably lacking in vigour on Eastern side	Fair	High	Long
Canopy spread	North/South	East/West	Dgl (mm)	SRZ (m)	Pest + Disease	Age Class	Comments
	24metres	28 metres	910	3.2m	Citrus Black fly and associated sooty mould.	Mature	4.5m from centre of tree to Sandstone wall. 6.6m from Sandstone wall to existing building alignment. Sandstone wall and pavers appear to be undisturbed.

- 7. A plant health care specialist should be engaged to address the reduced vigour on the Eastern side of the tree and the Citrus Blackfly infestation.*

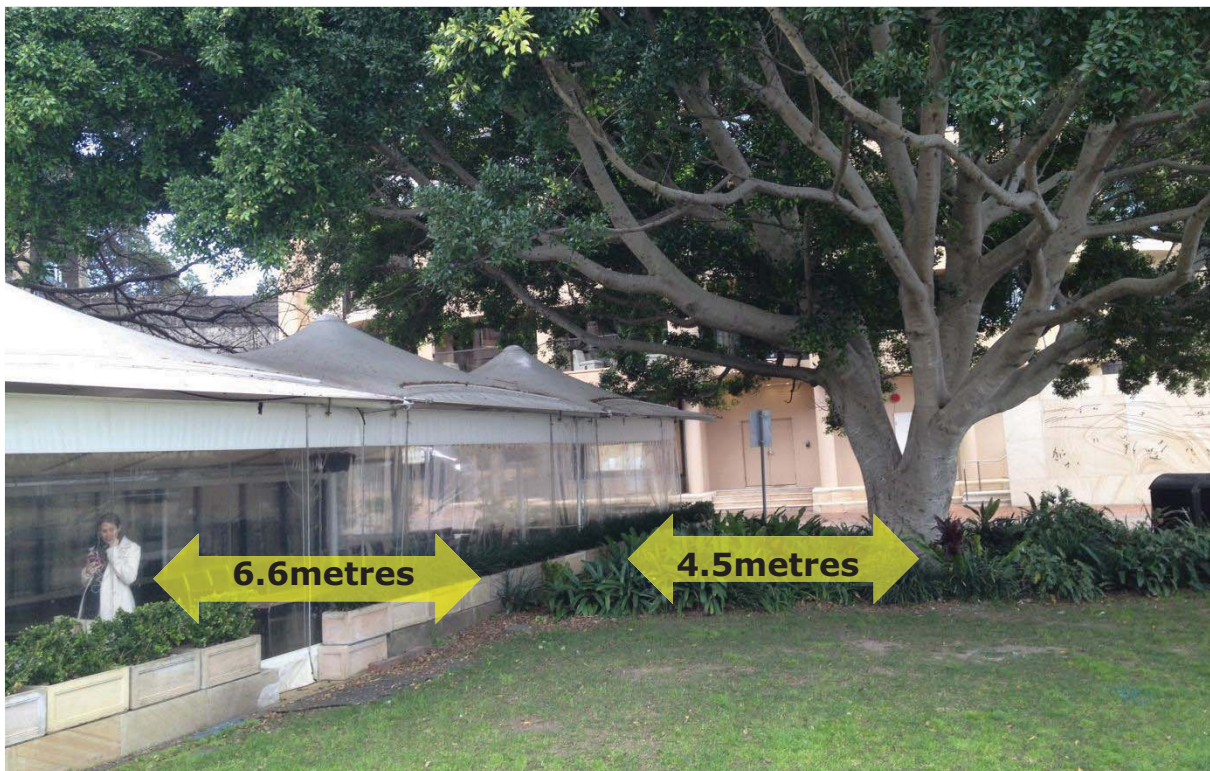
Figure 5: This shows the subject tree and the lawn and garden bed surrounding it. The centre of the tree is 4.5metres from the low Sandstone wall which appears to be undisturbed and in good condition. The distance from the Sandstone wall to the existing building line is 6.6metres. This means that the distance from the centre of the tree to the existing building line is 11.1metres.

The low Sandstone wall is 4.5 metres from the centre of the main stem, this is outside of the SRZ but equates to an encroachment of 28% of the TPZ. This level of encroachment is unacceptable so the Sandstone wall should be retained if possible. If it is not possible to retain the wall, non-destructive excavation must be employed to assess the location of tree roots directly adjacent to the wall. If significant roots are abutting the wall, the wall and its foundations must remain in situ and only the top course (s) of Sandstone blocks may be removed.

- 4. The works to remove the Sandstone wall and install the drainage must be done without the use of heavy machinery using non-destructive excavation methods such as air spade or vacuum excavation, under direct supervision of an AQF Level 5 Arborist.*

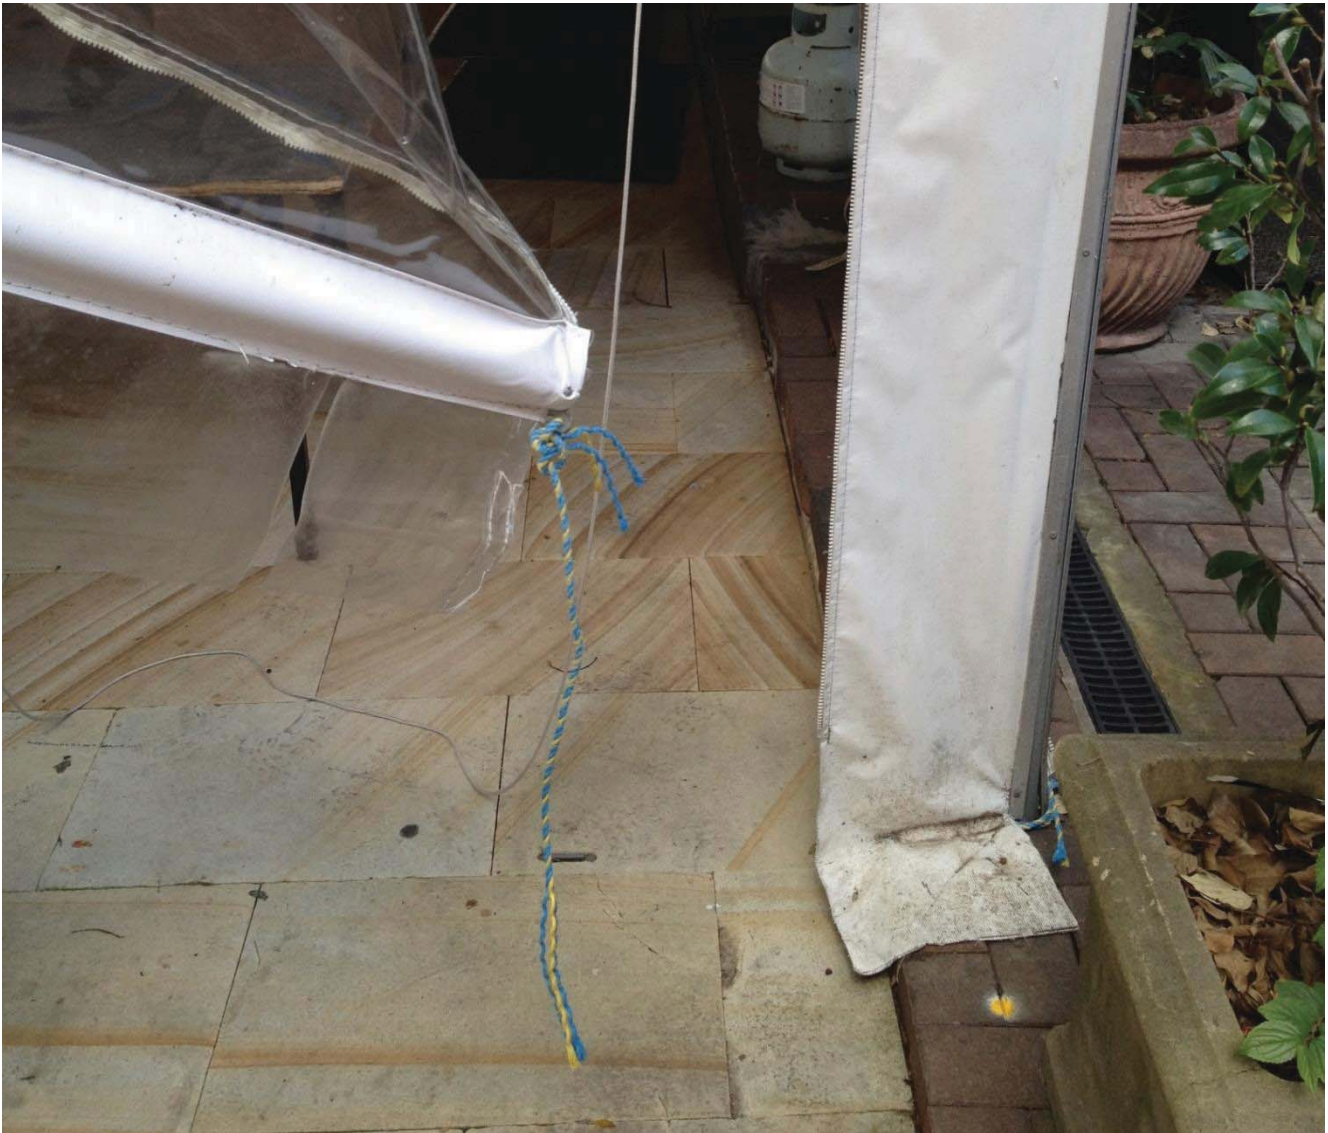
The removal of the existing floor covering and replacement with permeable paving appears unlikely to pose significant impacts upon the tree as the condition of the existing flagging would suggest that there are few significant tree roots directly below the pavers. This will need to be confirmed through the careful removal of existing flagstones and assessment of the root matter found beneath. The main concern from the installation of permeable paving would be mechanical damage to the roots directly beneath the stones and all of the Sandstone flagging between the tree and the building is within the TPZ so this should be done under supervision of a suitably qualified Arborist.

Figure 6: The existing ground covering is Sandstone paving. This paving appears to be in good condition suggesting that it is possible that minimal significant tree roots will be found directly beneath this surface.

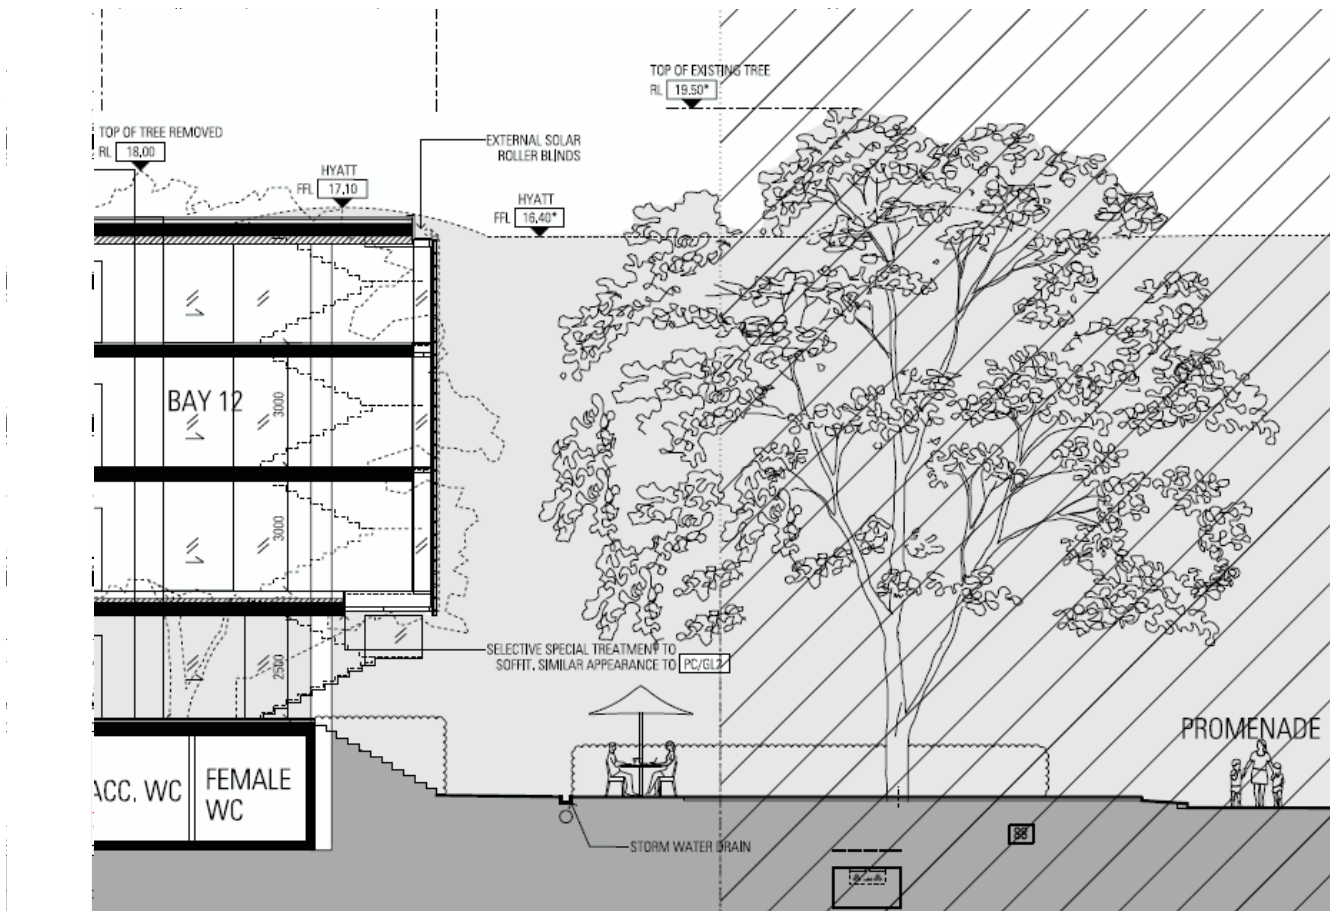
Figure 7: The proposed drainage can be seen here and appears to be approximately 7.5metres from the centre of the tree.

The encroachment for this drainage trench has been calculated at approximately 15% of the TPZ which is classified as a major encroachment.

The proposed drainage trench is approximately 7.5-8metres from the proposed building line; this is an encroachment of 13-15% of the TPZ. Due to the fact that other works are proposed by others on the Northern and Eastern sides of the tree, the area which would ordinarily be used to compensate for the encroachment will not be suitable. This will mean that the drainage may need to be redesigned to be located closer to the building line to reduce encroachment. If the drain were to be located closer to the exterior wall of the proposed structure it may reduce the encroachment back to a more acceptable level.

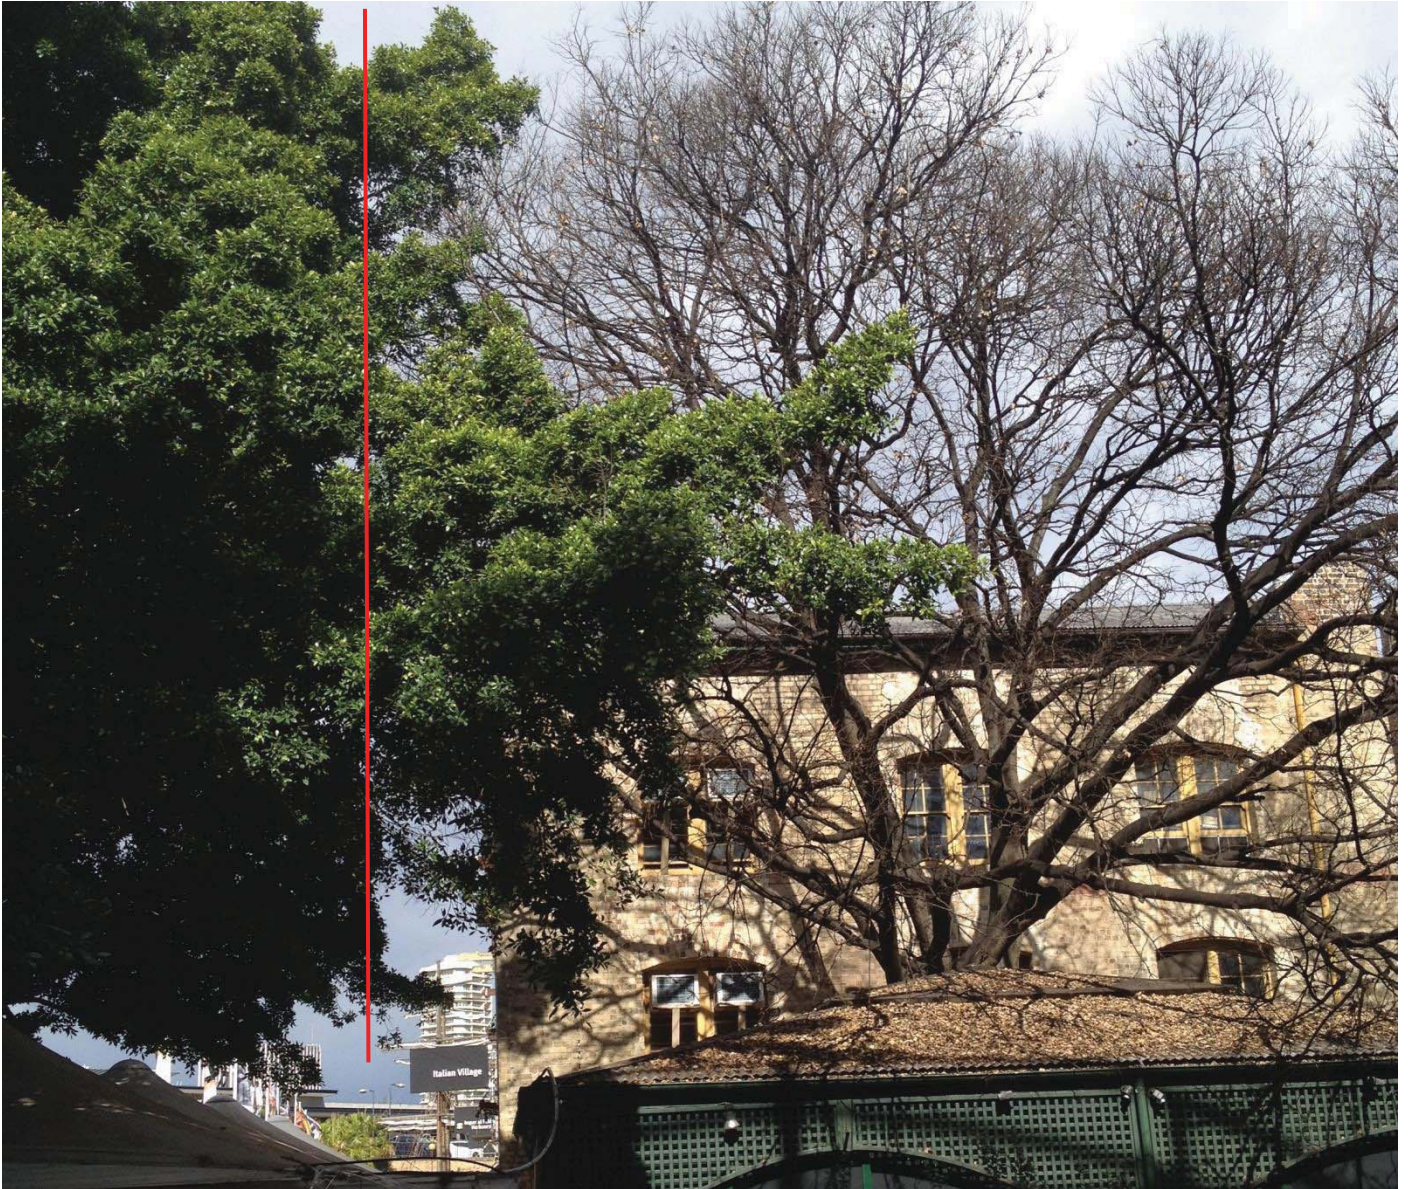
There will need to be some minor pruning on the Western side of the canopy to enable sufficient construction access. It appears that this would be fairly minor as per the representation in figure 8 below. The minor pruning should be conducted under council approval by a suitably qualified Arborist who holds AQF Level 3 in Arboriculture. This level of pruning should have no long-term impact upon tree health, however the tree currently displays a reduction of vigour and an infestation of Citrus Blackfly which is predominantly affecting the Eastern side of the canopy, this should be addressed prior to construction.

Figure 8: A representation of the approximate pruning dose required to enable construction.
