**Re: ECOLOGICAL SURVEY FOR ADDITIONAL VEGETATION REMOVAL FOR THE  
EUROBODALLA WATER SUPPLY PROJECT**

Please find below an ecological assessment of areas requested for additional clearing for the Eurobodalla Water Supply Project. This report relates to an area identified as **Zone 3**.

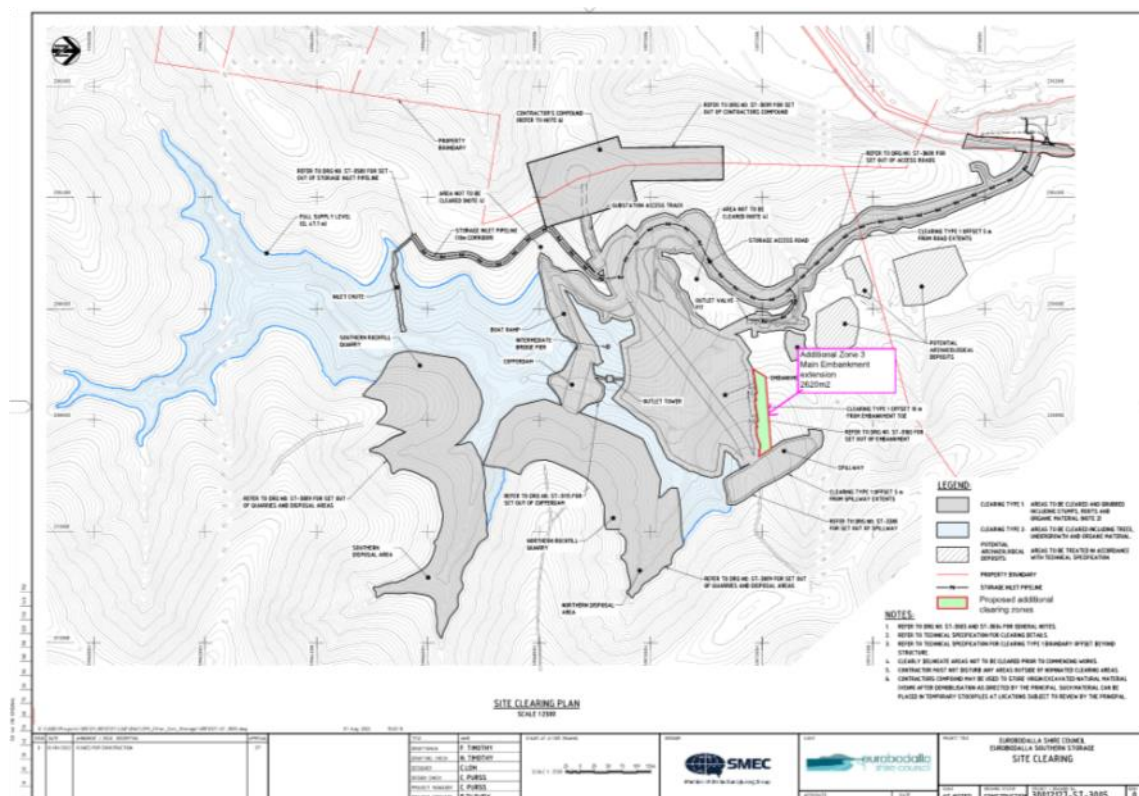
Figure 1. Additional Zone 3 clearing area- Southern Water Storage footprint

Path-Co Pty Ltd was requested by Haslin Pty Ltd to assess an additional area outside of the clearing boundaries of the Eurobodalla Water Supply Project that have been identified as requiring additional clearing for earthwork activities related to the main embankment wall of the dam. The area is identified as Zone 3 (Figure 1).

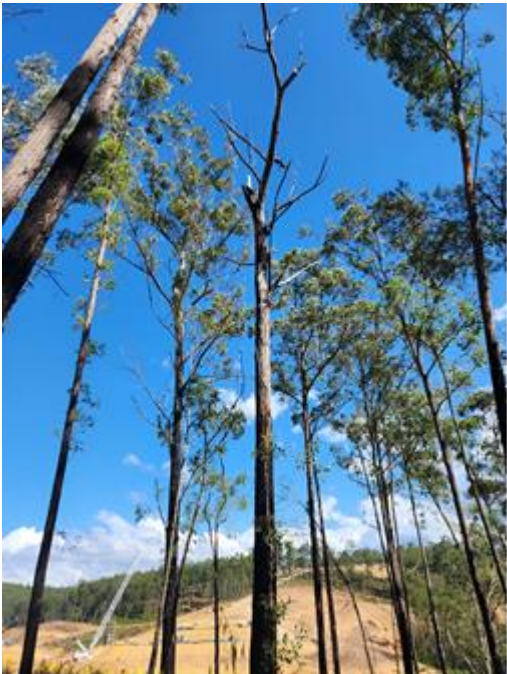
| | | | | | |
|---|---|---|---|---|---|
| 1 | <i>Eucalyptus muelleriana</i> | 70cms | 230820.61 | 5997194.90 | <div> <div>1 large open top (Chimney)- poor quality</div> </div> |

The clearing request is for the clearing of HBT1 in a timeframe outside of that stipulated in the conditionals of consent for the Southern Water Storage project. To minimize the threat to fauna species the following recommended management actions are suggested:

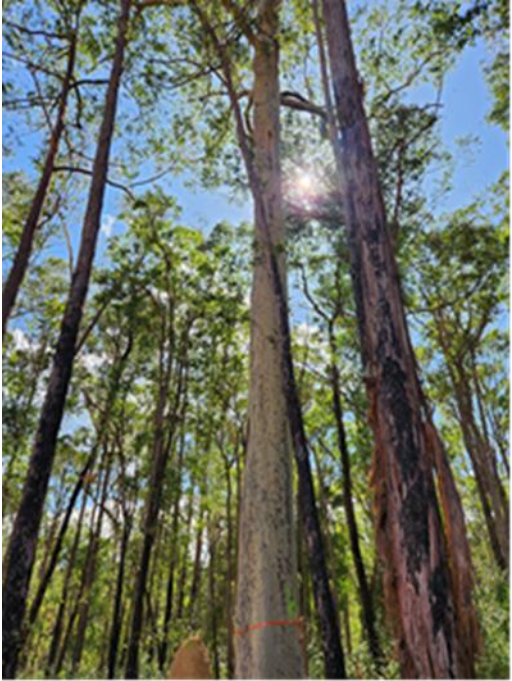
| 2 | <i>Corymbia maculata</i> | 90cms | 230777.68 | 5997199.24 | Fissures suitable for microbats/small gliders. Scratches on trunk | |

8. If HBT2 is required to be removed, it will be done between first week of February and second week of March.

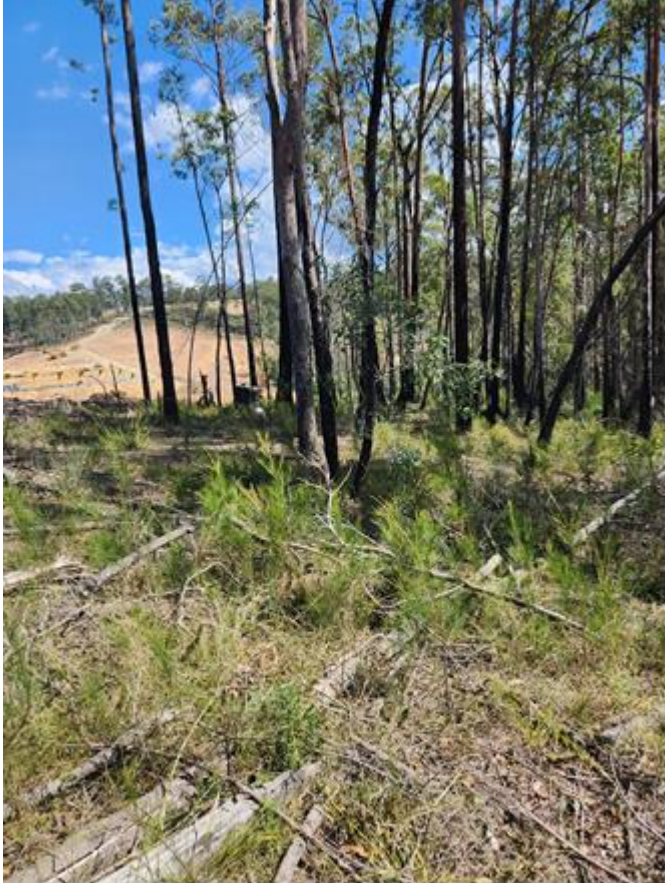
| Site | Required clearing | HBTs | Other habitat features & area assessment |
|---|---|---|---|
| Additional Zone 3- Main Embankment area | 2620m <sup>2</sup> | 2 | <p>No threatened flora/EEC seen. Nesting birds assessed, with none seen.</p> <p>Two HBTs- details at Table 1.</p> <p>Mixed vegetation- thick patches of Black She-oak seedlings, <i>Goodenia ovata</i> and open areas. Photo 1.</p> <p>No wombat burrows noted- some wombat/wallaby tracks/scats.</p> |

**Photo 1. Upper area (eastside) of Zone 3- indicative vegetation in zone small saplings/regrowth with few scattered larger canopy trees.**
