arboricultural impact assessment report

AIA-01

Revision A, Issued for SSDA
18 October 2024

FITZGERALD AVENUE, MAROUBRA

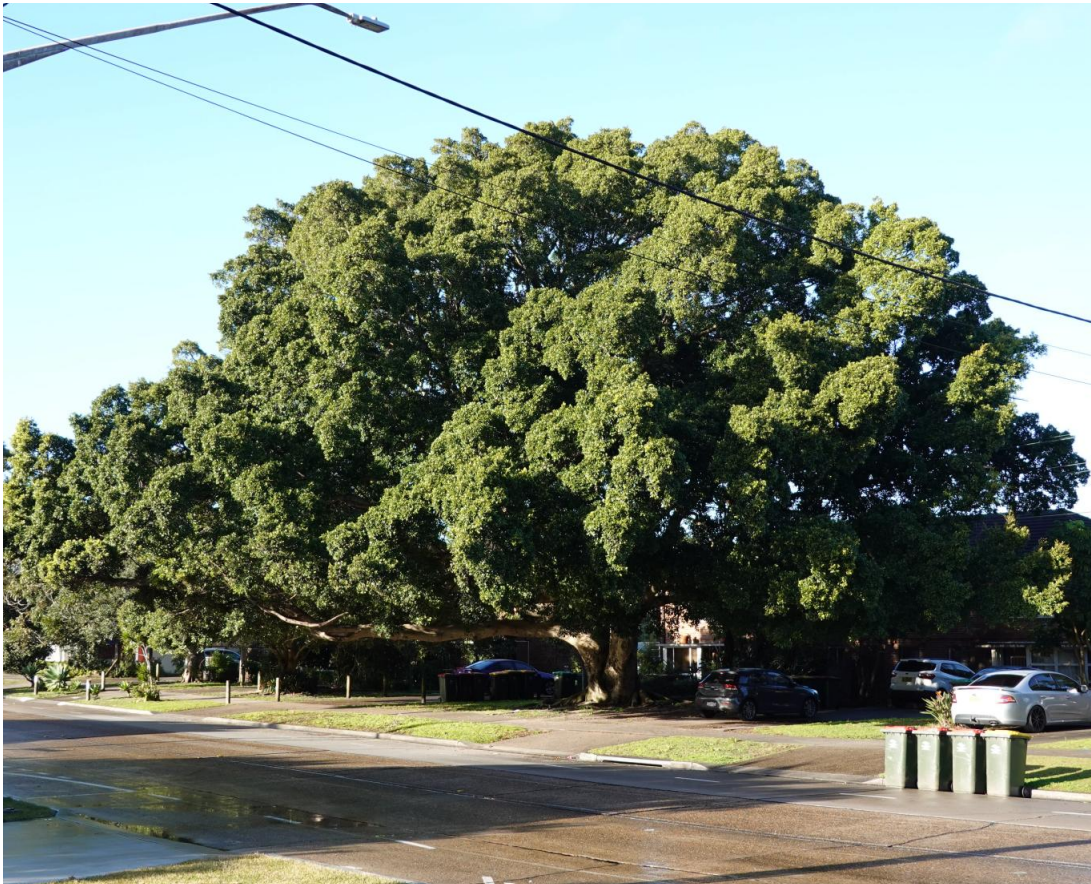
Figure 7 – View to **T140** *Ficus microcarpa var hillii* (Hills Weeping Fig) fronting 207-209 Fitzgerald Avenue. This is a High retention value tree, with excellent street prominence and a large, significant, spreading canopy. The tree is located within a generous verge setback on the southern side of Fitzgerald Avenue and is a street tree. Serious consideration will need to be taken with regards to building setbacks to retain the expansive canopy and extensive root system. This tree is to be retained and protected (Photos: Arterra 02/07/24).

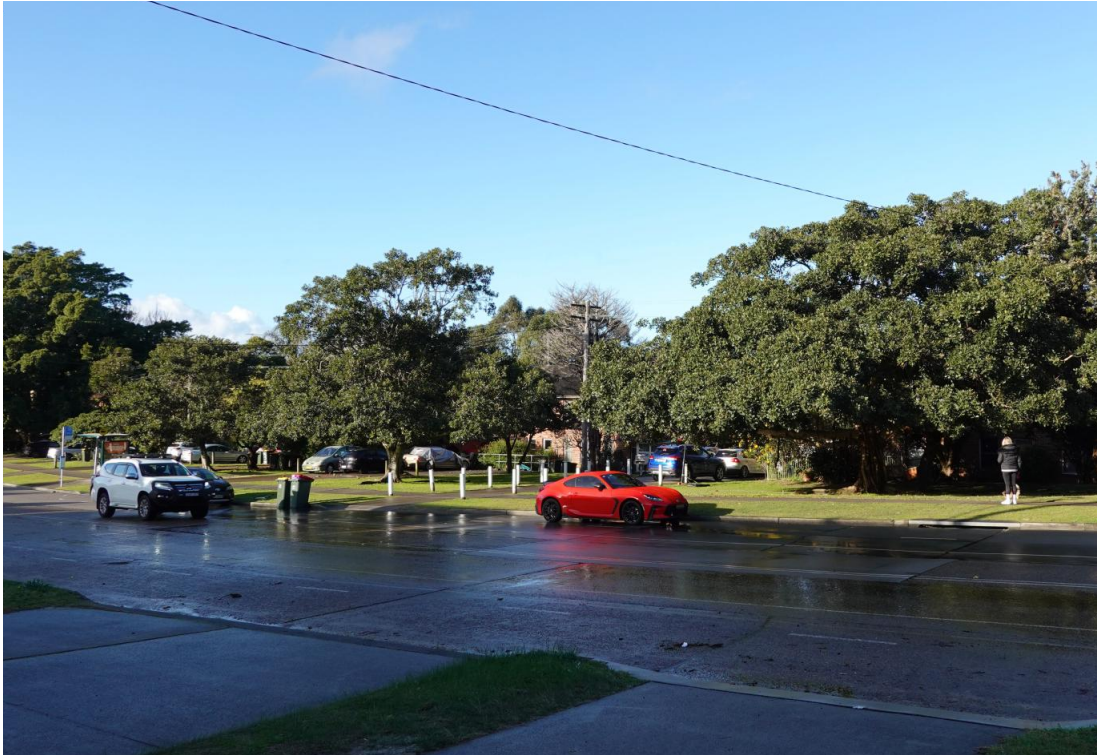
Figure 8 – Street trees fronting Fitzgerald Avenue to the north of the site are a mix of 'High' and 'Moderate' retention values, with only a few being rated 'Low' retention. These trees are to be a focus of protection, particularly with regards to construction, as some of their TPZs extend into the site. Though they are located within a generously wide verge, consideration will need to be given of the proposed services locations and potential driveway entries to avoid impacts to these trees (Photo: Arterra 04/06/24).

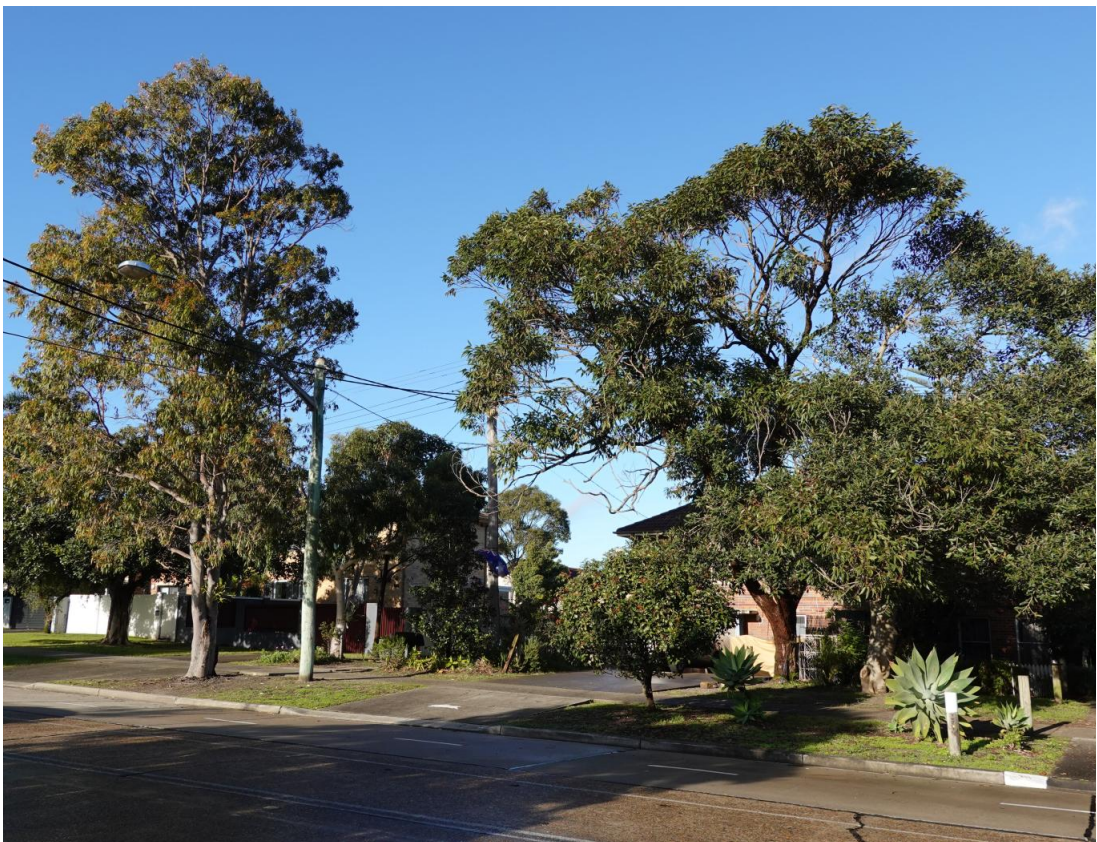
Figure 9 – The trees pictured above are street trees to the eastern end of Fitzgerald Avenue and are predominantly 'Moderate' retention values, with only a few being rated 'Low' retention. These trees are to be a focus of protection, particularly with regards to construction, as some of their TPZs extend into the site. Though they are located within a generously wide verge, consideration will need to be given of the proposed services locations and potential driveway entries to avoid impacts to these trees (Photo: Arterra 04/06/24).

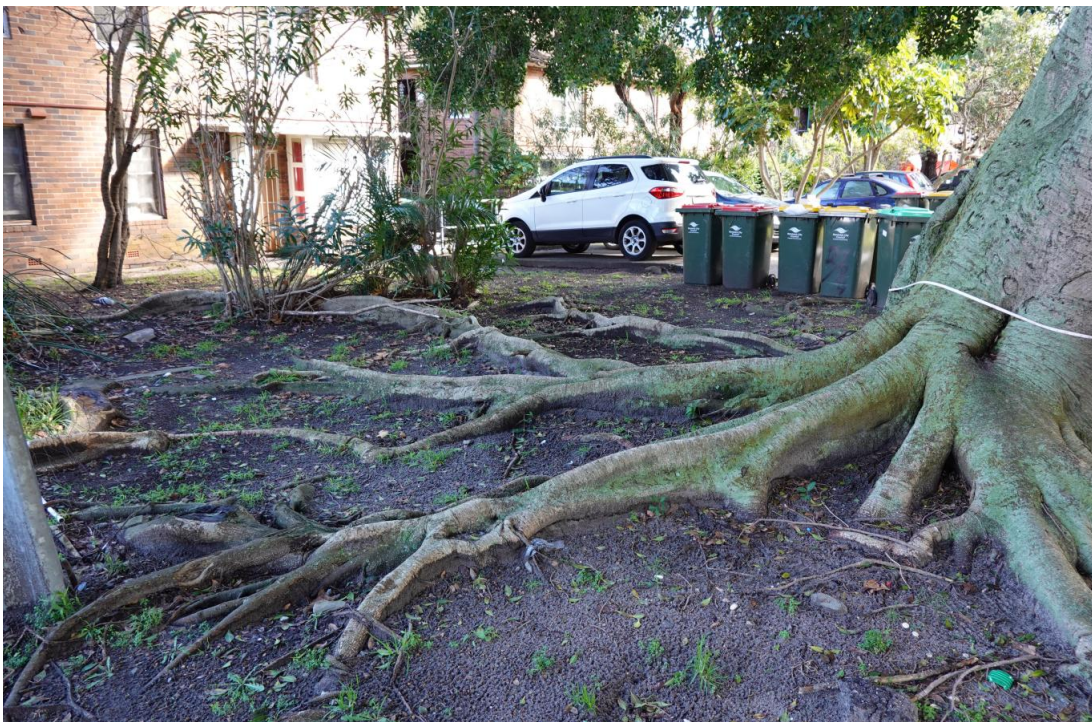
Figure 11 – View of the base of **T140** *Ficus microcarpa var hillii* (Hills Weeping Fig) fronting 207-209 Fitzgerald Avenue. As shown above, this tree has a large and extensive buttress root system extending around the base of this tree, predominantly to the trees southern side. Serious consideration will need to be taken with regards to appropriate setbacks of the developable area to protect these roots. Roots are to be covered over with sandy soil to protect them from disturbances. The buttressing roots of a *Ficus* sp. are often above the surface ground level, with a weblike structure of roots immediately under the surface. These roots often pose difficulties with traditional installation of concrete footpaths. In this instance an alternate method needed to be considered to install the proposed footpath which works with and protects the existing tree roots of the adjoining fig tree (Photo: Arterra 02/07/24).

To aid in retaining and protecting the existing tree roots of **T140**, which are currently buttressing above the existing soil level, the nominal TPZ is to be backfilled with 300-400mm of sandy soil to cover over the exposed roots. This will enable landscape access pathways to be installed above the existing levels without impacting on the existing root system. It is recommended that the proposed pathways be concrete installed directly on top of the sandy fill, rather than suspended decking or pavements. Though suspended decking and pavements are typically considered appropriate around existing trees, they can often lead to conflicts with the existing root system, particularly when considering the position and placement of screw piles and/or posts. This tree is likely to have a vast weblike structure of roots of varying sizes immediately below the ground surface. This weblike structure of roots makes the positioning of screw piles/posts very difficult to achieve and may potentially lead to unnecessary ground and root disturbances. Alternatively, by filling around the existing surface roots with sandy soil, a standard concrete footpath can be installed above the existing buttressing roots with little to no impact to the existing ground surface and existing roots. Refer to the images and detail below for reference.

Care will need to be taken to ensure that there is no cutting or excavation proposed around the base of this tree (or any other tree) below the existing surveyed levels (ie: swales). It is recommended to build up the existing levels and manipulate swales and/or a bund into the fill to direct any stormwater/overland flows away from the proposed built form. The existing stormwater service is to be retained in place under this tree and utilised as part of the diversion works. No canopy pruning is expected to be undertaken.

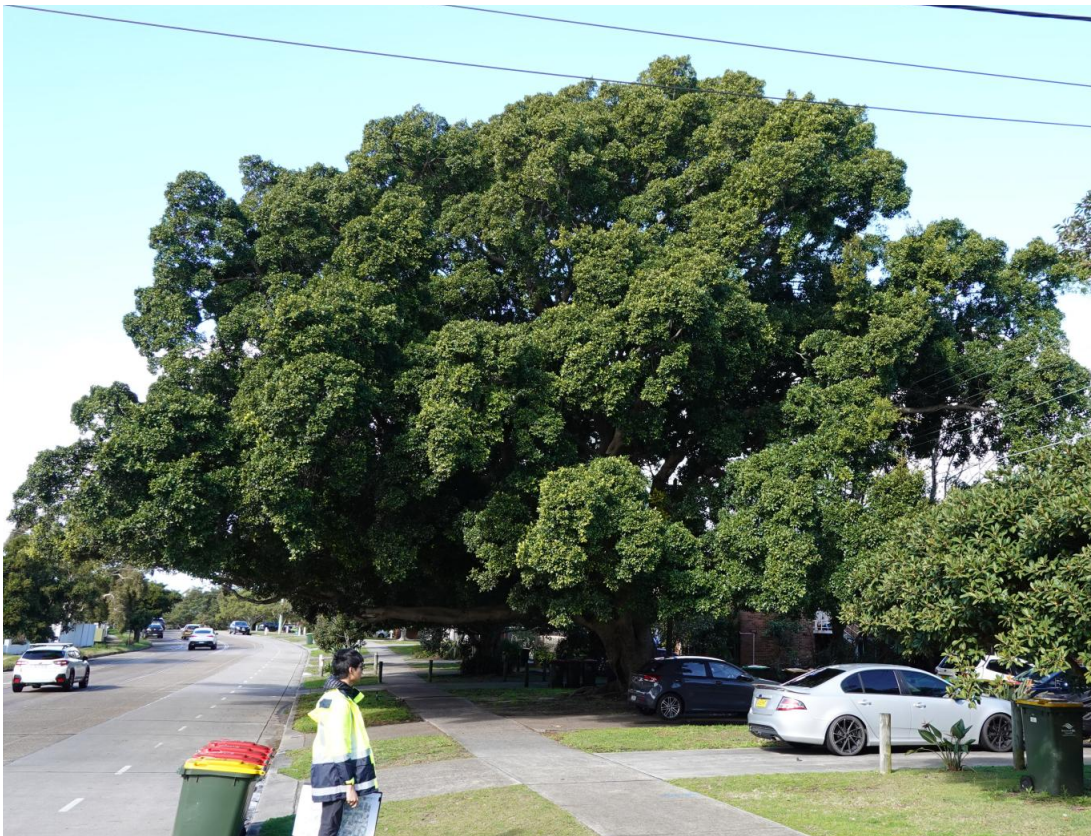
Figure 15 – View of tree **T140** *Ficus microcarpa var hillii* (Hills Weeping Fig) fronting 207-209 Fitzgerald Avenue. This is a large and significant tree, that is the focus of retention and protection (Photo: Arterra 02/07/24).

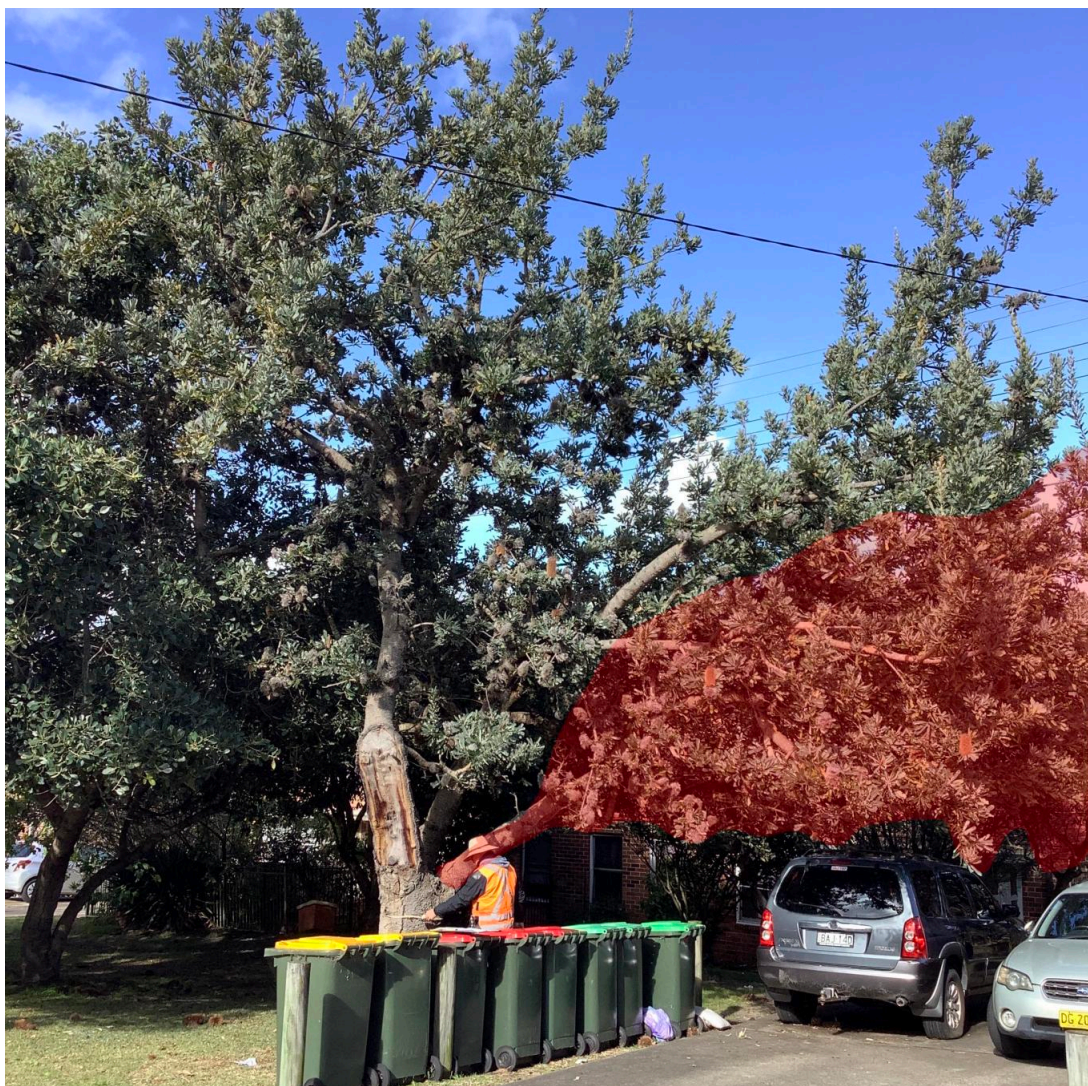
T41 & T42 *Banksia serrata* (Old Man Banksia) – Minor Incursion of 10%, Minor Surface Impacts and Minor Pruning
 These trees are ‘Moderate’ retention value trees, growing to the north of the site. They are street trees within the large and generous verge fronting Fitzgerald Street. Though the trees are located outside of the site, the nominal TPZ of these trees enters the site on the northern boundary. There is a minor incursion of 10% to the southern side of T42 to allow for the excavation of the proposed basement and the basement access driveway and the installation of a new electrical substation.

Figure 16 – Tree **T42** *Banksia serrata* – extent of pruning required to achieve basement access. Given the wide spreading canopy, this area is not suitable for construction access (Photo: Arterra 04/06/24).

The proposed driveway to the west of tree T42 and east of T41 is to be constructed at or above existing levels. Pavement depths are to be minimised and the extent of pavement is to be modified to limit impacts within the tree protection zone. It is to be noted, to further minimise root disturbances to these trees, the proposed electrical

Selective and incremental pruning is likely to be required to the west of this tree to achieve standard vehicle clearances for general basement access. Pruning is to be undertaken to a maximum height of 3.5m from the driveway pavement level, with only low-level branches to be pruned. The upper western canopy of the tree is to be retained and protected. Given the area of canopy that will be retained that overhangs the proposed driveway, primary construction access is not suitable adjacent to this tree. Refer to image below for extent of pruning required. This pruning is considered acceptable and is dealt with more specifically in Section 3.3 - Canopy Pruning and Pruning Methodology.

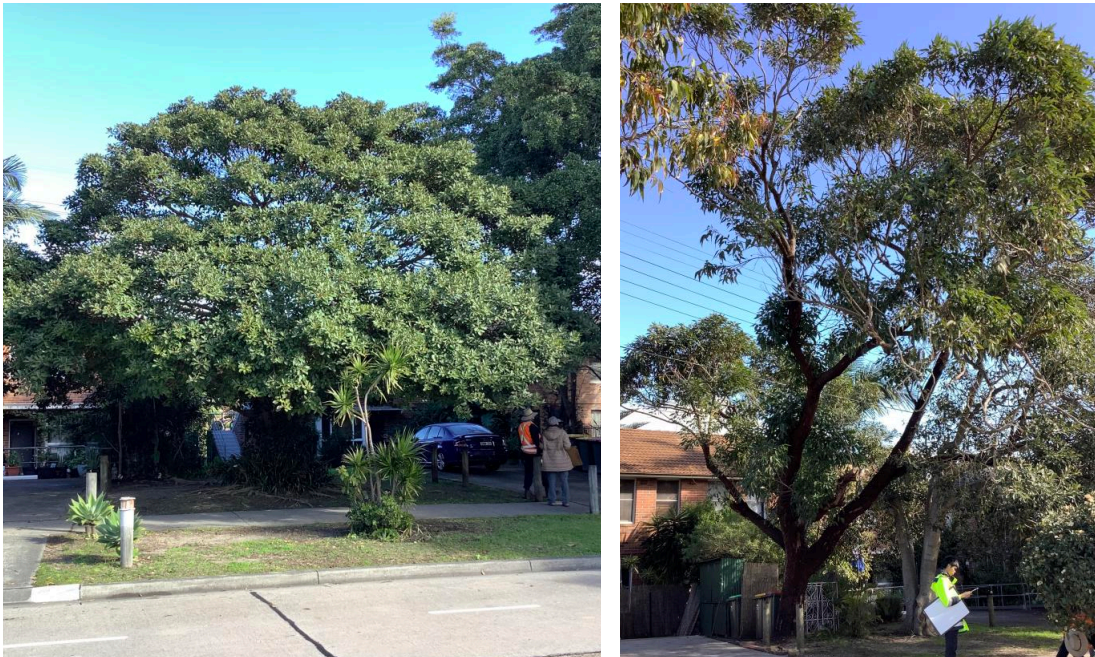
T139 & T137 *Ficus rubiginosa* (Port Jackson Fig)– Minor Incursion of 8% and T136 *Eucalyptus robusta* (Swamp Mahogany)– Major Incursion of 18%

These trees are 'Moderate' retention value trees, growing to the northeast of the site and within the very wide and generously sized verge fronting Fitzgerald Avenue. Though the trees are located within the verge, the nominal TPZ of these trees enters the site on the northeastern boundary. To accommodate the nominal TPZs, the proposed building has been set back from the boundary to minimise disturbance, however, there is a minor incursion expected to tree T139 and a major incursion expected to tree T136 to install and construct the proposed stormwater services to the southern side of these trees.

Though this level of theoretical incursion within the trees TPZ is not desirable, the trees are located within a generous, wide verge that is unlikely to be disturbed. This allows for a contiguous area surrounding each tree that should compensate and appropriately offset the anticipated expected root loss.

Figure 17 – Trees **T139** *Ficus rubiginosa* (left) and **T136** *Eucalyptus robusta*–Minor incursions expected to the southern side of these trees for the installation of new stormwater services (Photo: Arterra 04/06/24).

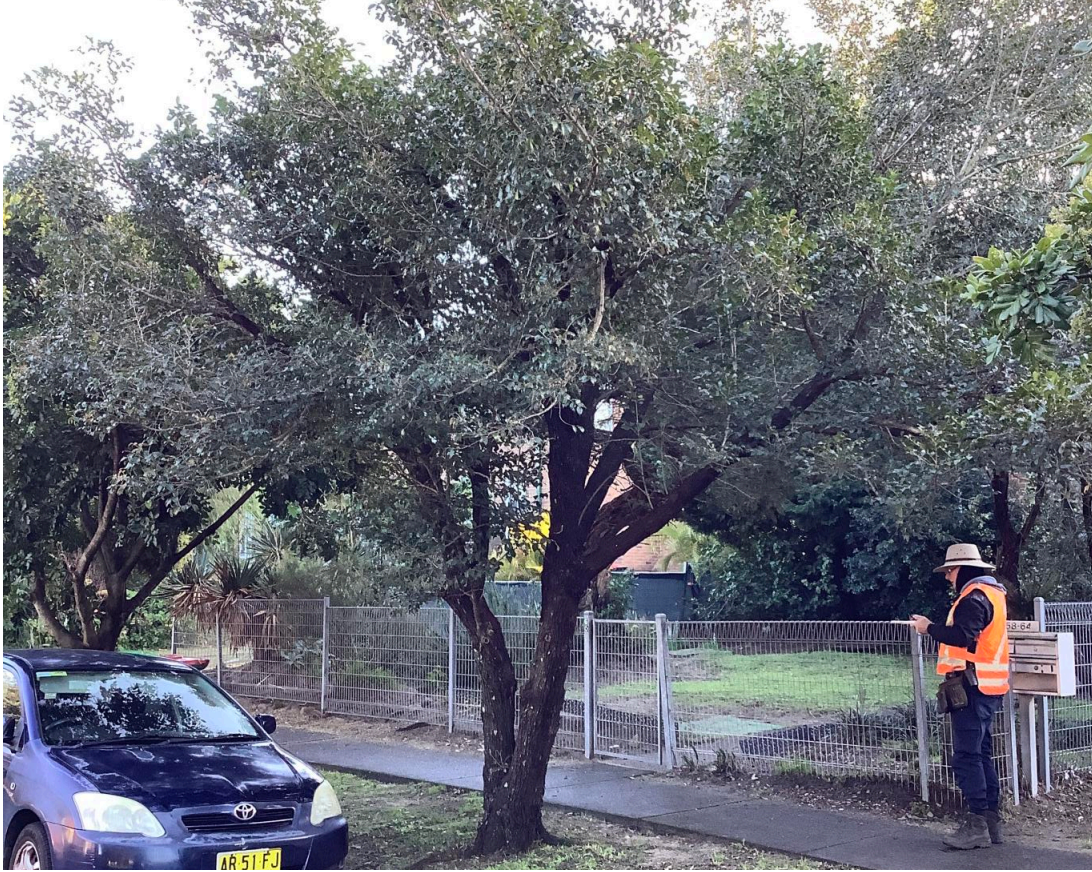
T04 *Glochidion ferdinandi* (Cheese Tree)– Minor Incursion of 10%

This tree is a 'Low' retention value tree, growing to the south east of the site fronting Yorktown Parade. Though the tree is located within the verge, the nominal TPZ of this tree enters the site on the southeastern boundary. To accommodate the nominal TPZ, the proposed building has been set back from the boundary to minimise disturbance, however, there is likely to be a minor incursion expected to the northern side of the tree to install and construct the new stormwater services. This incursion is considered acceptable, as it is only a minor encroachment into the nominal TPZ and is unlikely to affect the long term health of this tree.

Figure 18 – Tree **T04** *Glochidion ferdinandi*– Minor incursion expected to the northern side of this tree for the installation of new landscape structures (Photo: Arterra 04/06/24).

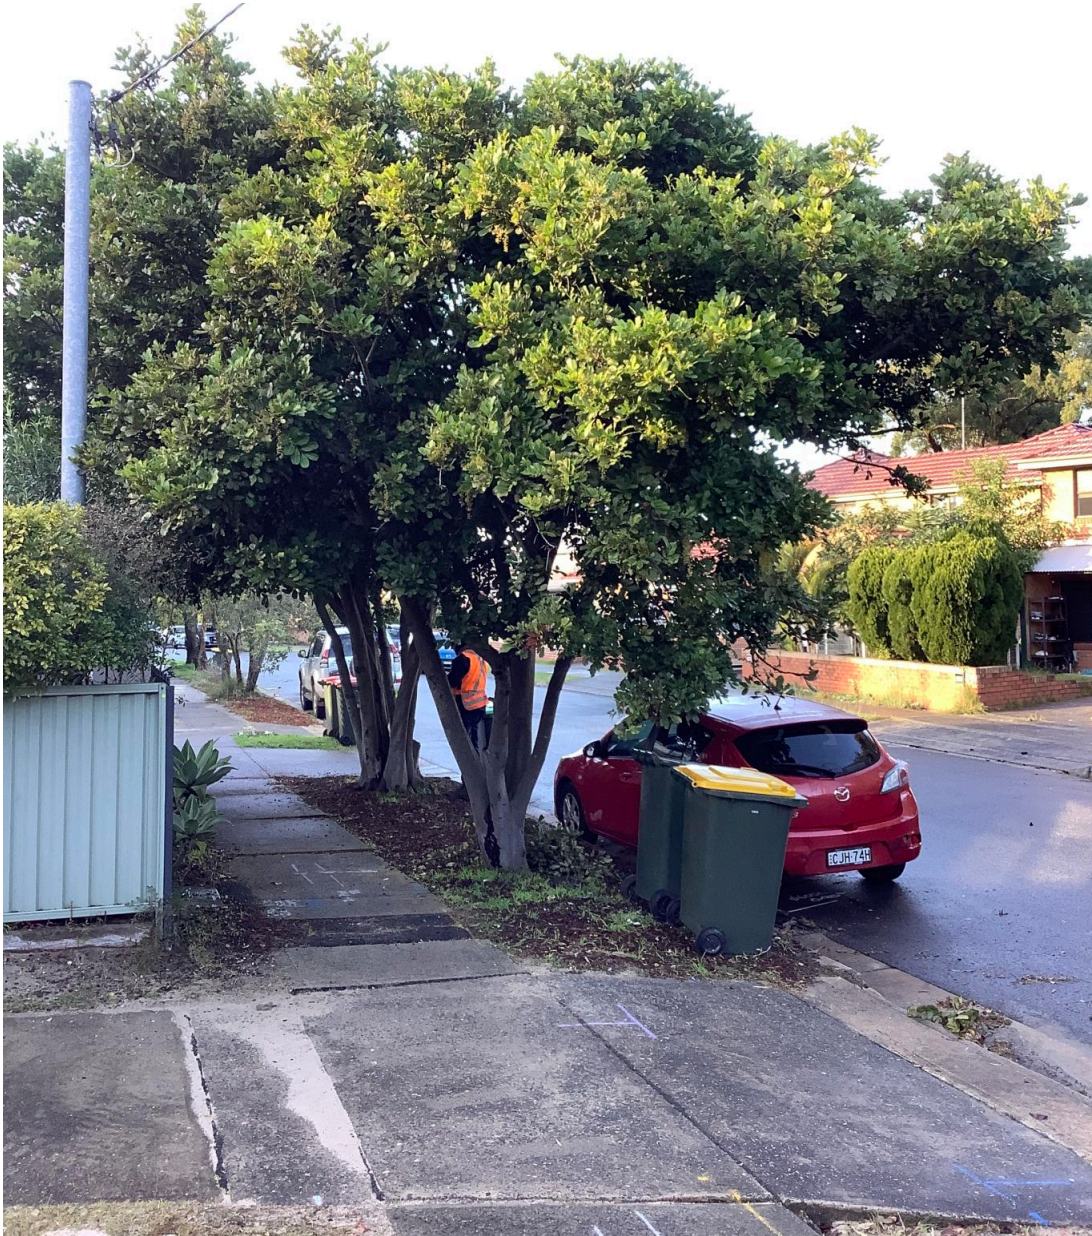
T02 *Cupaniopsis anacardioides* (*Tuckeroo*)– Surface Impacts Expected

This tree is a 'Low' retention value tree, growing to the southeast of the site fronting Yorktown Parade. Though the tree is located within the verge, the nominal TPZ of this tree enters the site on the southeastern boundary. The proposed stormwater service, which connects across the verge and into an existing kerb inlet pit, passes well within the TPZ and also the SRZ of this tree. Given the close proximity of the proposed stormwater service to the tree it must be installed non-destructively using either hand digging, compressed air (air spade), water vacuum extraction or underbore techniques to minimise impacts. All non-destructive works must be undertaken with Project Arborist present. Roots greater than 40mm in diameter are to be retained and protected and the proposed service is to be carefully threaded around and underneath the retained roots and available voids to avoid root damage and to protect the adjoining trees.

Figure 19 – Tree T02 *Cupaniopsis anacardioides* – Minor surface impacts expected for the construction of a new stormwater line installed non-destructively (Photo: Arterra 04/06/24).

Proposed Stormwater Verge Connection
Stormwater services adjacent T02 are to be installed non-destructively using either hand digging, compressed air (air spade), water vacuum extraction or underbore techniques. Non-destructive works are to be undertaken with Project Arborist present.
