**129 – 153 PARRAMATTA ROAD &
53 – 75 QUEENS ROAD
FIVE DOCK, NSW**

DEVELOPMENT PROPOSAL ARBORICULTURAL IMPACT ASSESSMENT REPORT

Ref No- 10924

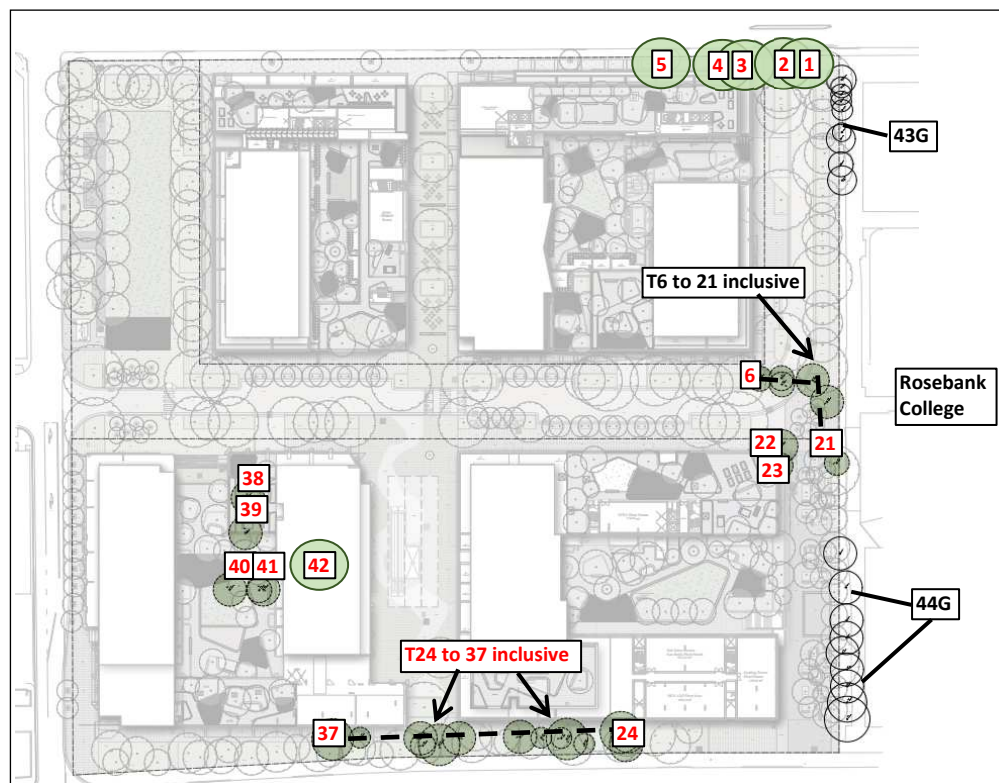
Figure 1: showing proposed design footprint & site tree removal plan

As shown within Figure 1 below, the design footprint which includes excavation for basement levels, Spencer Street extension, public domain areas, public & site access requires the removal of the trees within the development area.

- Thirty-eight (38) prescribed trees: T1 to 7, 9 - 14, 16 - 19, 21 – 38 and 40 to 42.
- Four (4) non-prescribed including dead trees: T8, 15, 20x5 & 38.

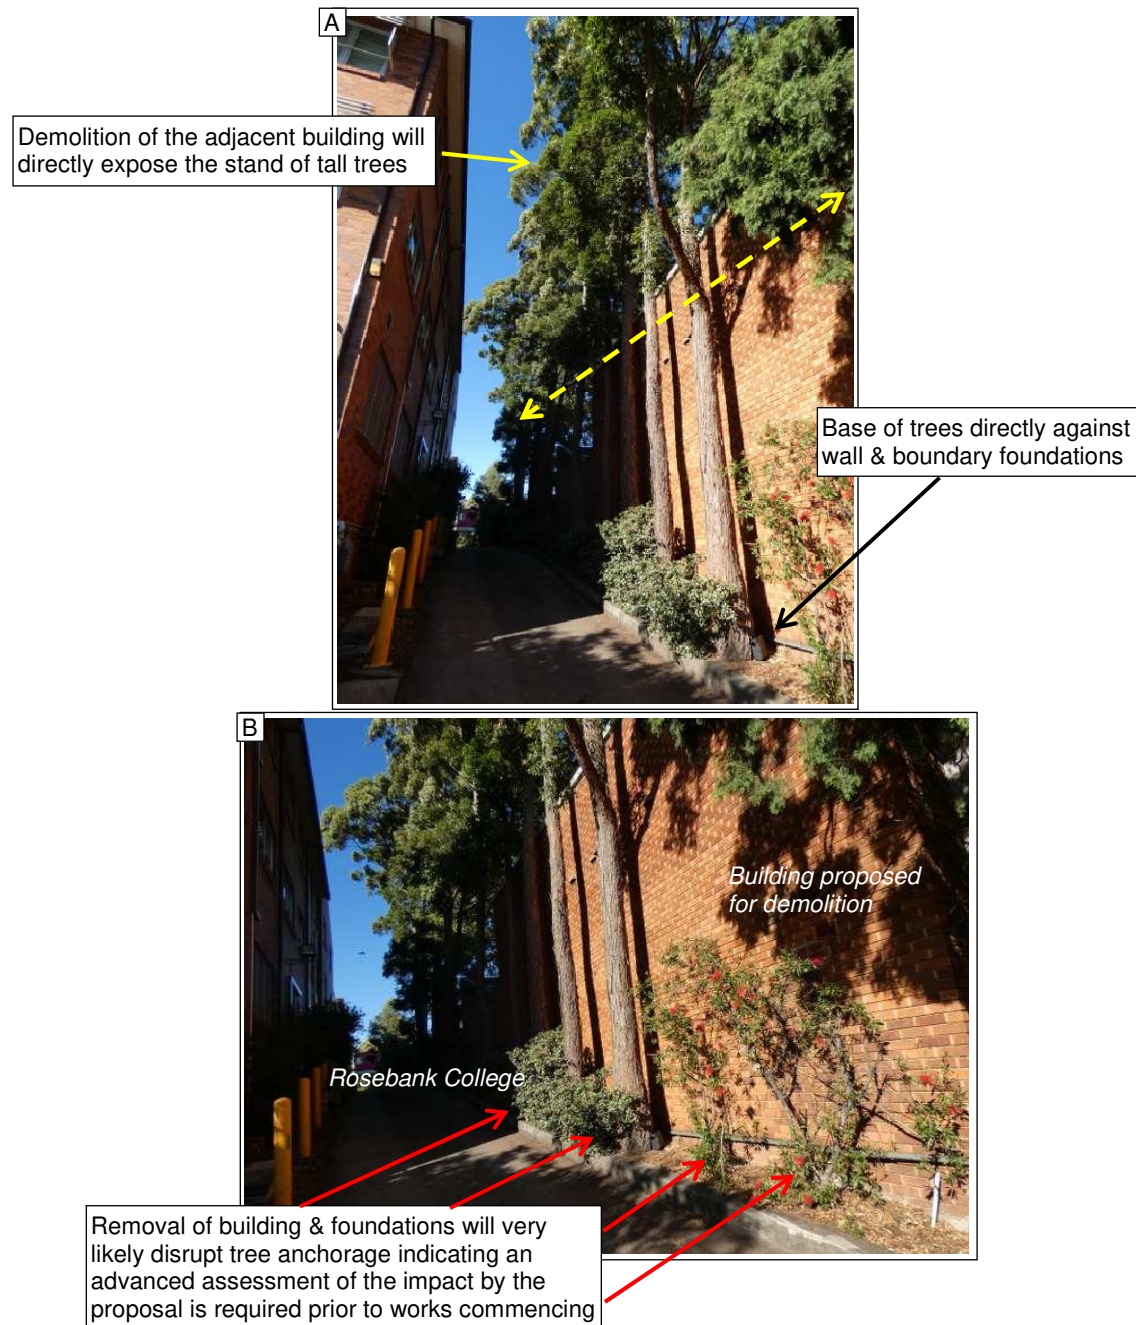
Figure 2, showing Rosebank College tree Group 43x9

Tree Group 43x9: based on limited visual access to the tree group, from Queens Street frontage these trees appear to have been planted directly adjacent to the boundary and against the existing two storey building of No: 55 Queens Street. Survey documentation identifies the building as built directly on the boundary having retaining walls and structure extending to the south. Documentation is unclear in tree location and proposed RL's adjacent the boundary with Spencer Street at or near RL7.50. Street pathway is at or near RL7.66 indicating a reduced level to accommodate design. Regardless of the proposed design and occupancy by public access and provided green space shown within Public Domain Landscape Plan 03: demolition of the existing building and removal of the building foundations will very likely result in ground-based tree failure, or failure from windthrow by sudden exposure.

- 1.4.5 Prior to any works, demolition or modifications of features within tree protection zone setbacks the principle (client) is to provide a detailed arboricultural risk assessment on the proposed impacts of demolition on tree anchorage. The assessment is to identify the risk & consequence of whole tree failure by loss of adjacent protection factors and support structures that very likely contribute to maintaining tree anchorage.
- In specific: at no stage should works within tree protection zones commence without AQF Level 5 project arborist certification that ensures the trees will not be affected by the proposal.

- a) Prior to any works commencing, specific to demolition and site modifications within tree protection zones, a detailed AQF Level 5 arboricultural risk assessment is to be provided by the client detailing the management of the trees based on the risks & consequences of removing support structures that are likely contributing factors in maintaining tree anchorage.

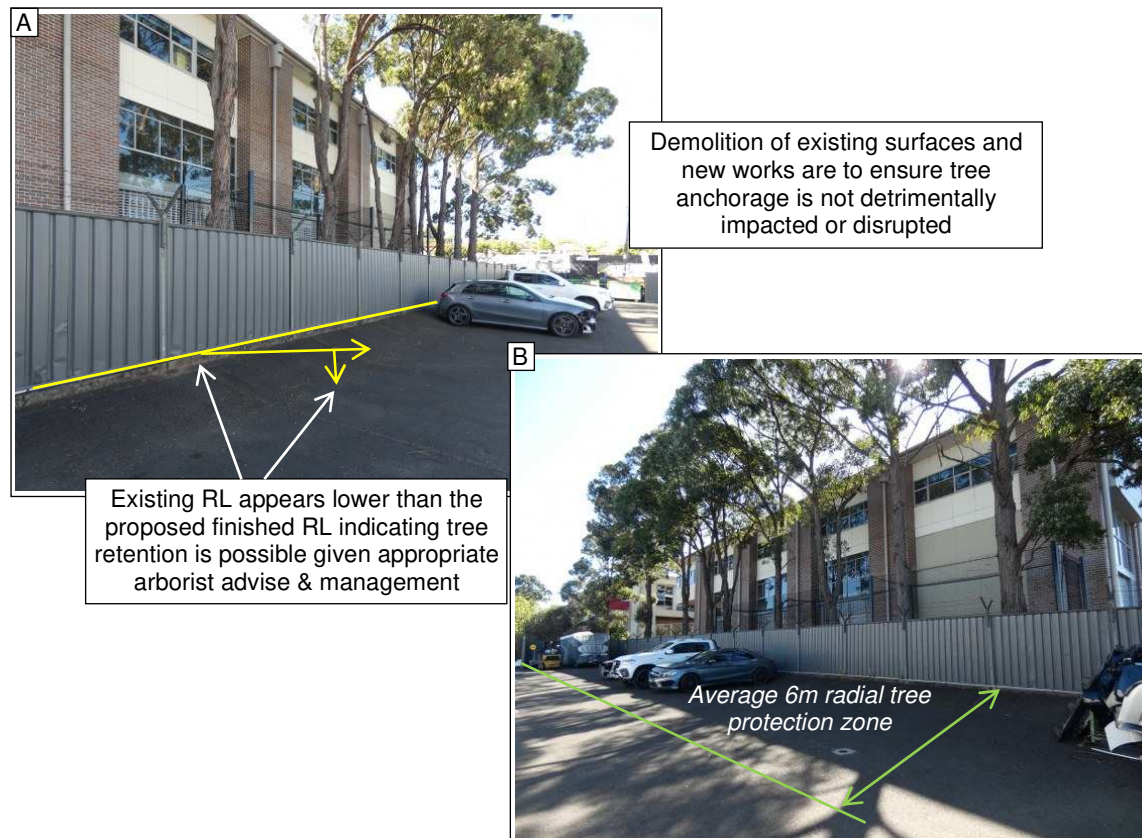
Figure 3, showing part Rosebank College tree Group 44_{x12}

- 1.4.6 Tree Group 44_{x12}: Having a 12m building setback with adjacent Public Domain works and links through to Rosebank College specific details in demolition of existing structures, tree locations, existing & proposed RL's for new works are unclear. Spencer Lane appears at or near RL7.0+ to RL8.0+ with boundary adjacent trees at or near RL7.18 to 7.39.

As Public Domain works are proposed on the existing hard surfaces and fill is likely required to accommodate design tree retention is possible. Based on the design proposal new works within the SRZ & TPZ propose a *significant (>35%) SRZ & TPZ occupancy and disturbance.*

Mitigating impacts requires further construction plan & detailed information to be reviewed and endorsed by an appointed project arborist. These should include issues such as:

- Review & endorsement of demolition plans with arborist advice on any additional tree management requirements. Visually the northern most tree of the stand may be affected by removal of a boundary retaining wall where tree removal may need to be considered.
- Review and endorsement of a detailed colour coded cut & fill plan within tree protection zone setbacks, or between the building footprint & boundary.
- Arborist involvement in ensuring civil works and Public Domain works are of tree sensitive design & construction that mitigate impacts on tree anchorage while maintaining the vitality of trees.

- b) No demolition or ground-based disturbances that have the ability to affect tree anchorage or vitality should occur within tree protection zone radiuses without arborist advice & certification.
- c) *In specific*, no alterations (change in site conditions) should occur within the Structural Root Zone (SRZ) being *the area required for tree stability* without prior arborist advice & certification.
- d) Prior to demolition, demolition plans are to be reviewed and endorsed by an appointed project arborist providing any additional tree management advice.
- e) A detailed tree group specific Tree Protection & Management Plan should be provided based on final civil design & engineering drawings that clearly identify proposed works, existing & proposed levels and changes within tree protection zone radiuses.
