14 December 2016

**PRUNING TREE 93:  
Australia Habitat and Taronga Wildlife Retreat  
Bradleys Head Road, Mosman NSW**

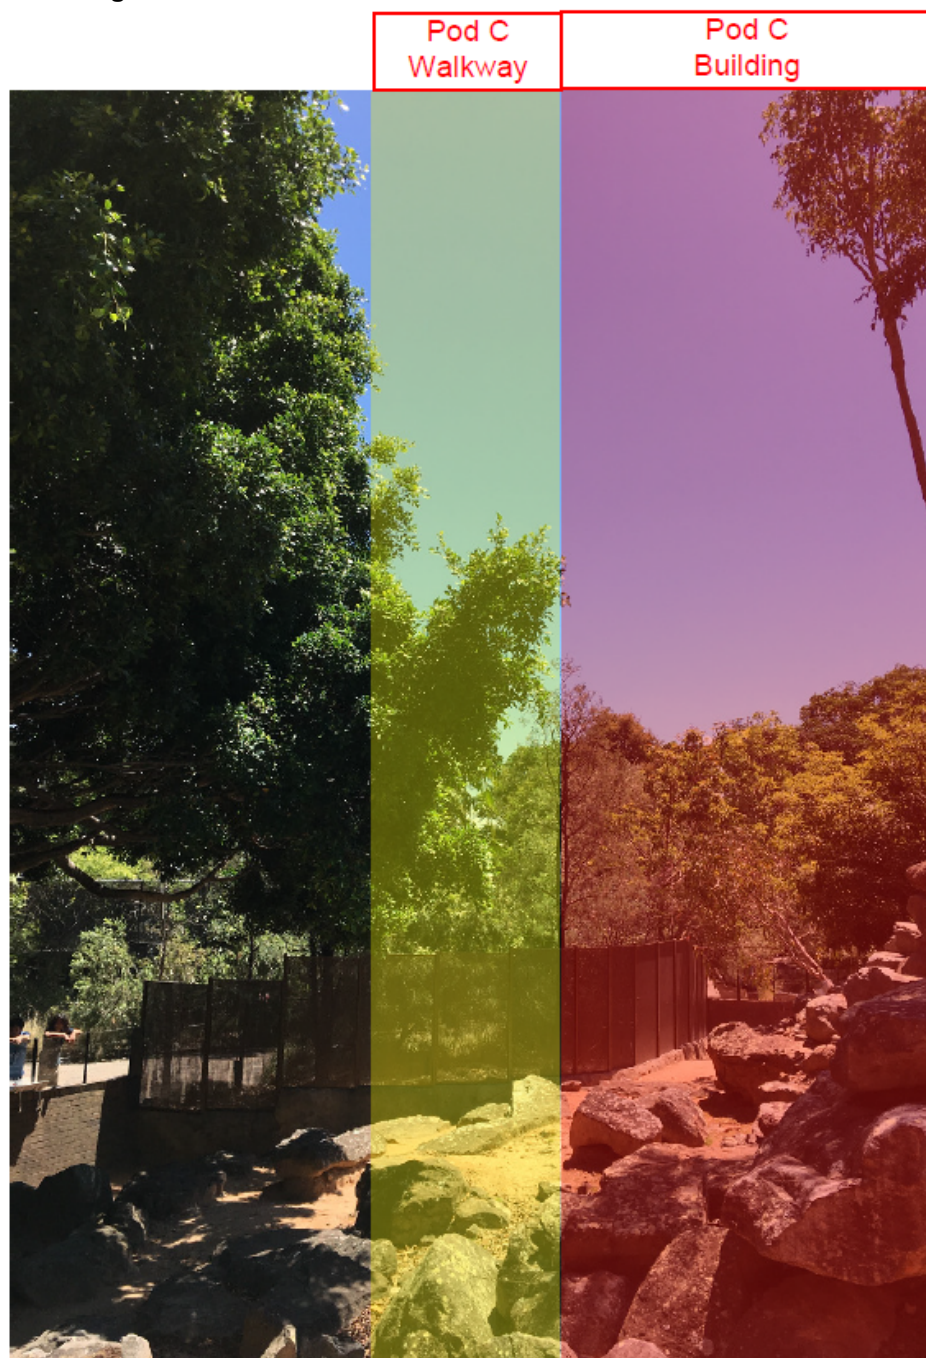
The construction of Pod C will require minor tip pruning of the northern canopy and will have no impact to the tree. The construction of Pod D, and the associated walkway, will require the pruning of several second order branches.

Figure 1: Pruning requirement for Pod C (Spooner 2016).

Based on my findings, I estimate between 15% and 20% canopy loss will occur to provide adequate clearances. The tree displays very good vigour and therefore providing the tree is pruned in accordance with AS4373 Australian Standards *Pruning of Amenity Trees*, there should be no adverse impacts to the trees longevity. It is recommended that the pruning be carried out in stages. Therefore, an initial prune is to be carried out prior to commencement of works and a second pruning to occur when Pod C and D are constructed.

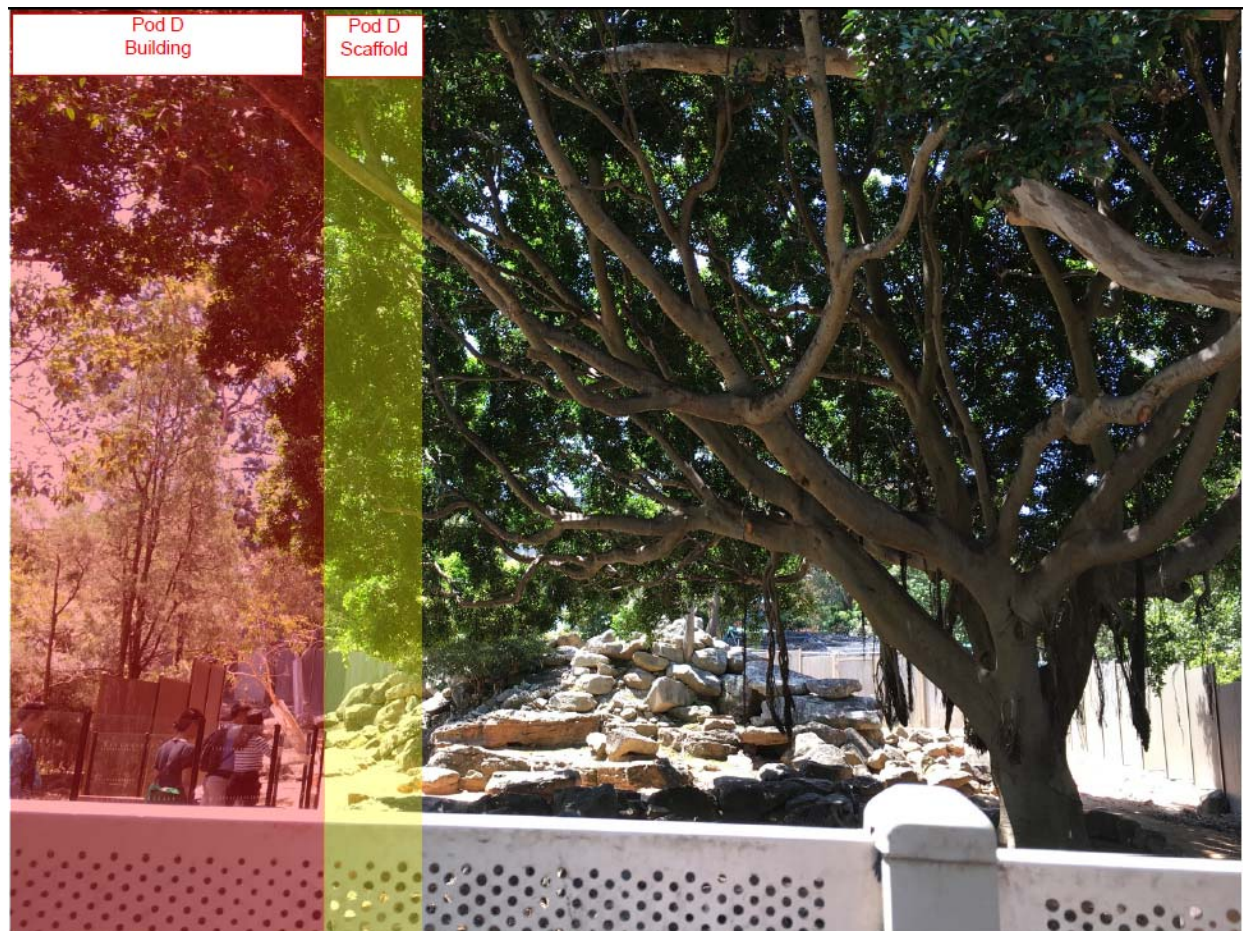
Figure 2: Pruning requirement for Pod D (Spooner 2016).
