Construction Waste Management Plan

For the proposed Mortdale Resource Recovery Facility Development SSD.7421

20 Hearne St, Mortdale NSW 2223

Rev 3 - 11th November 2016

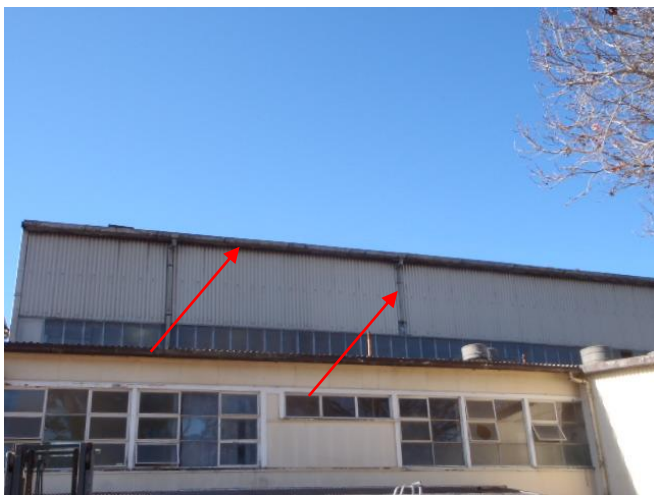
Photograph: 4755	Photograph: 4753
Description: Cement gutters and drain pipes	Description: Cement corrugated wall cladding and capping
Locations Found: Roof to workshop/shed, External	Locations Found: External to workshop/shed

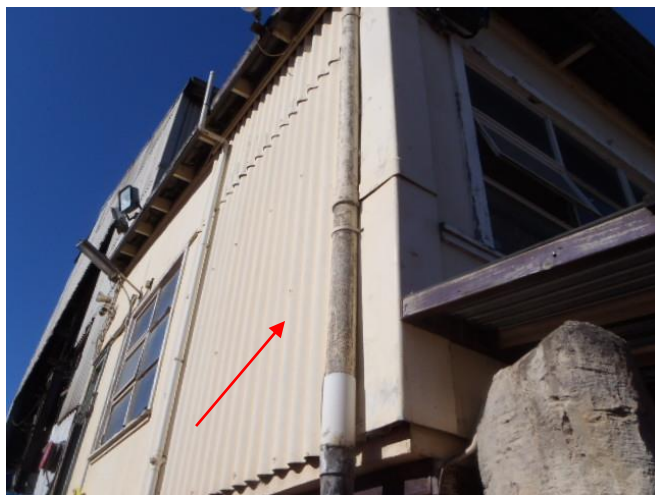
External	Cement corrugated wall cladding and capping	CHR, AMO	AQ385/R1	> 50 m ²	4753	NF	11	C	Low risk item under current use. Some damage is apparent to structure. It is recommended to repair damage and encapsulate the material, thereafter, label and monitor condition on annual basis
External	Cement textured wall cladding	CHR, AMO	AQ383	> 40 m ²	4754	NF	9	C	Low risk of exposure under current condition and use. Recommended to label as asbestos containing and reinspect condition on annual basis
External	Cement soffit lining	CHR, AMO, CRC	AQ390/R1	5 m ²	4760	NF	9	C	Low risk of exposure under current condition and use. Recommended to label as asbestos containing and reinspect condition on annual basis
External	Putty to windows	NAD	AQ382	< 1 m ²	4751	-	0	E	No further action required

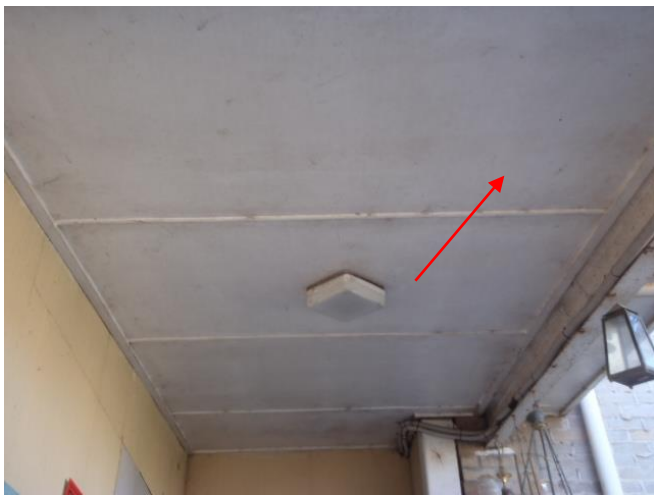
Photograph: 4760	Photograph: 4759
Description: Cement soffit lining	Description: Cement debris on ground
Locations Found: External to workshop/shed	Locations Found: External to workshop/shed

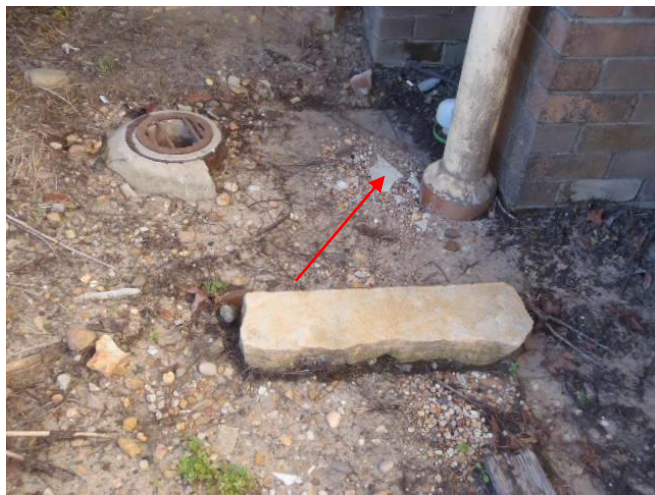
Asbestos Materials	General Location	Risk Level	Comments
Cement debris on ground	External	Low	Debris found in the soil and is thought to have been as a result of uncontrolled maintenance or accidental damage. It is recommended to pick up all surfaces asbestos and dispose of in accordance with EPA guidelines.

ASBESTOS MATERIALS	GENERAL LOCATION	CONTROL MEASURE (RECOMMENDATION)
Cement debris on ground	External	To pick up all surface asbestos and dispose of in accordance with EPA guidelines by an asbestos removalist.
Cement and presumed cement corrugated sheeting, capping, gutters, drain pipes, eaves, roof sheeting and textured and flat wall cladding.	Refer to Appendix B Table 3 – Asbestos Register	Follow the procedure from Asbestos Removal Plan. Decontaminate ACM from structure to Asbestos waste drums or bins/vehicle tray. Disposed of by nominated asbestos removalist.
Cement and presumed cement wall and ceiling lining, infill panels, capping, cisterns, fascia panels and roof sheeting	Refer to Appendix B Table 3 – Asbestos Register	Follow the procedure from Asbestos Removal Plan. Decontaminate ACM from structure to Asbestos waste drums or bins/vehicle tray. Disposed of by nominated asbestos removalist.

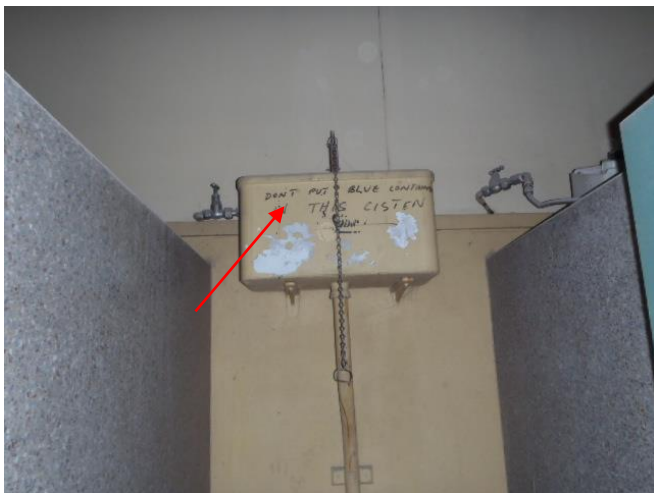
Photograph: 4729	Photograph: 4740
Description: Presumed cement cistern	Description: Cement stored broken corrugated sheets
Locations Found: G.5 Toilets	Locations Found: B.1 Storage to workshop/shed

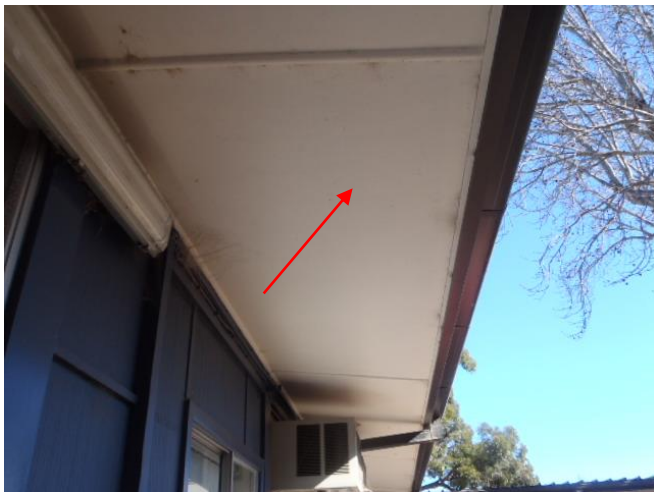
Photograph: 4710	Photograph: 4709
Description: Cement eaves	Description: Presumed resin electrical mounting board
Locations Found: External to office	Locations Found: External to office
