Darlington Terrace – Microbat inspections

Appendix 1: Results of microbat surveys at Darlington Terraces

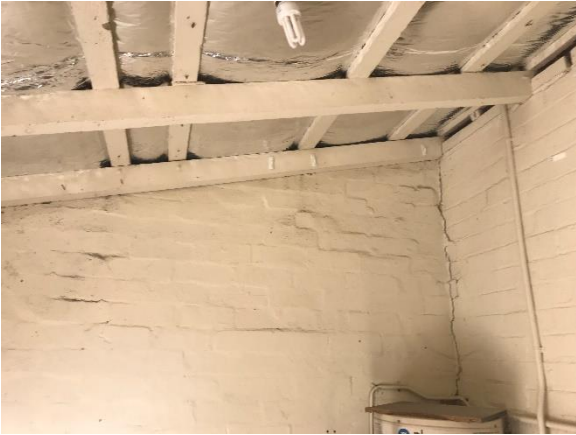
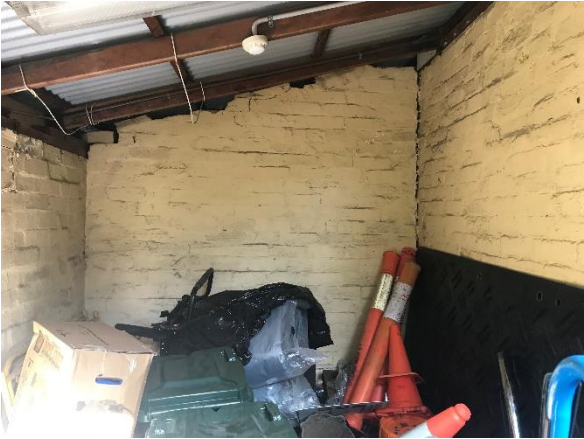
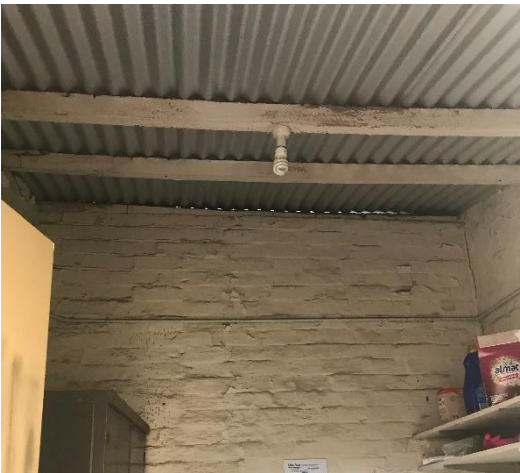
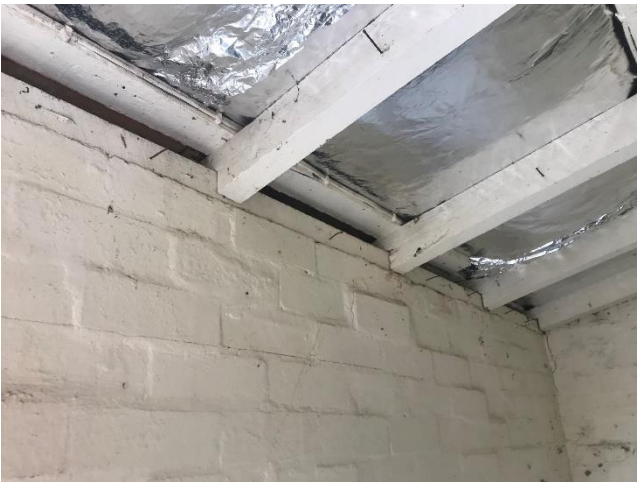
Appendix 2: Site photos show cracks, crevices and holes present within the laundry and storage areas to be removed.
