# DUBBO HEALTH SERVICES REDEVELOPMENT – STAGES 3 & 4

*Outback Tree Service Dubbo*

# Summary of Dubbo Health Services Development

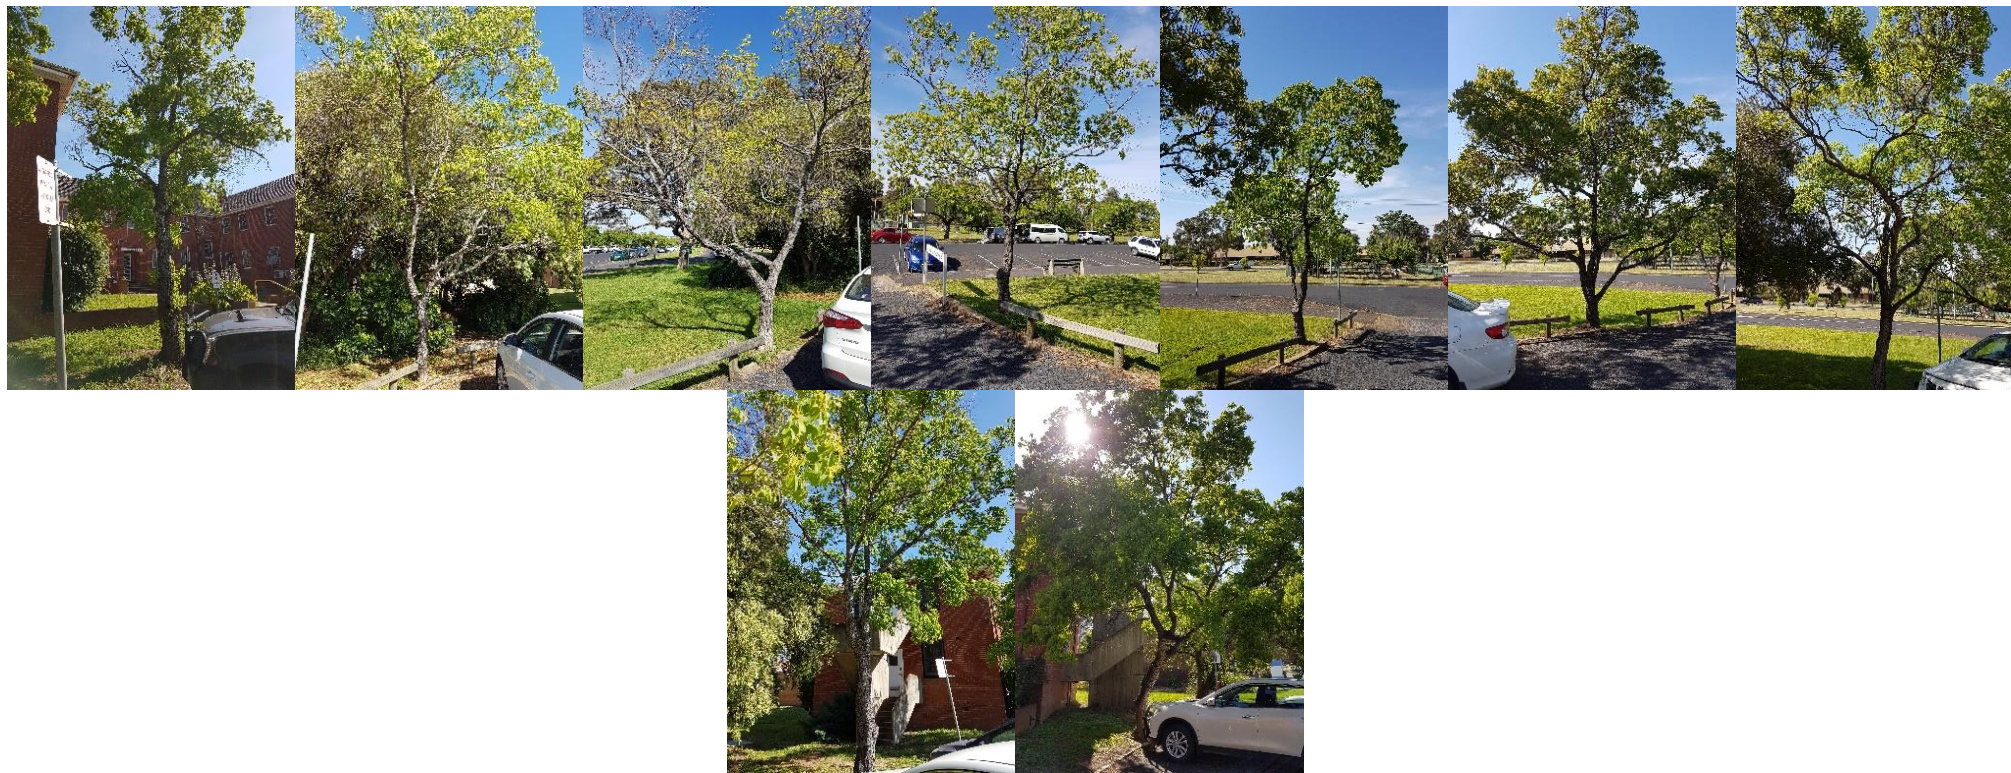
| Tree No. | Genus and Species | Common Name | Approx height in metres | Condition<br>G = Good, F = Fair<br>P = Poor,<br>D = Dead | Pest and diseases | Age<br>Y= Young<br>M=Mature<br>O= Overmature | Significance scale<br>1= High<br>2= Medium<br>3= Low |
|---|---|---|---|---|---|---|---|
| 1- 9 | <i>Triadica sebifera</i> | Chinese Tallow | 10 metres | F- P | None | Y | 3 |

**Description:** These nine trees are an Australian native species. Their position surrounding a carpark and next to asphalt has caused 50% of the root systems to become compacted. They have thin foliage and dead wood throughout the canopy and are not growing to their full capacity. They have no environmental or historical impact and would not improve the aesthetics of the new hospital entrance.

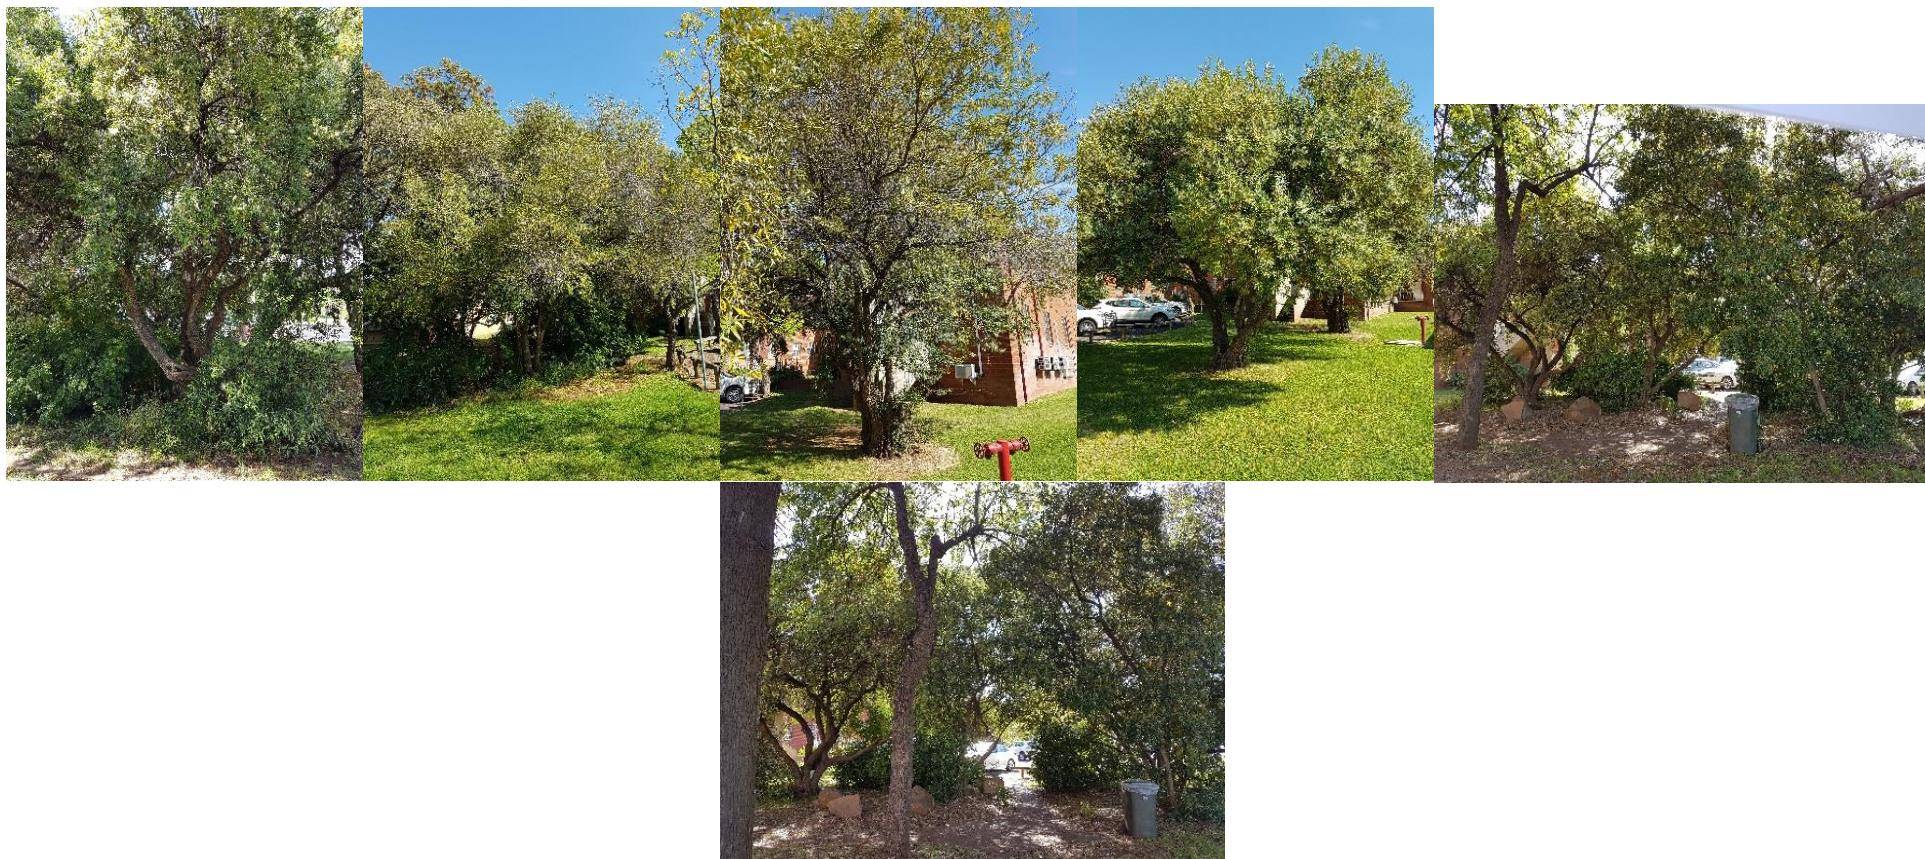
| Tree No. | Genus and Species | Common Name | Approx height in metres | Condition<br>G = Good, F = Fair<br>P = Poor,<br>D = Dead | Pest and diseases | Age<br>Y= Young<br>M=Mature<br>O= Overmature | Significance scale<br>1= High<br>2= Medium<br>3= Low |
|---|---|---|---|---|---|---|---|
| 10- 14 | <i>Olea europaea subsp. cuspidata</i> | African Olive | 10 metres | F- P | Yes | O | 3 |

**Description:** This is a weed species that needs to be removed. Information can be found at Department of Primary Industries site listed in References.

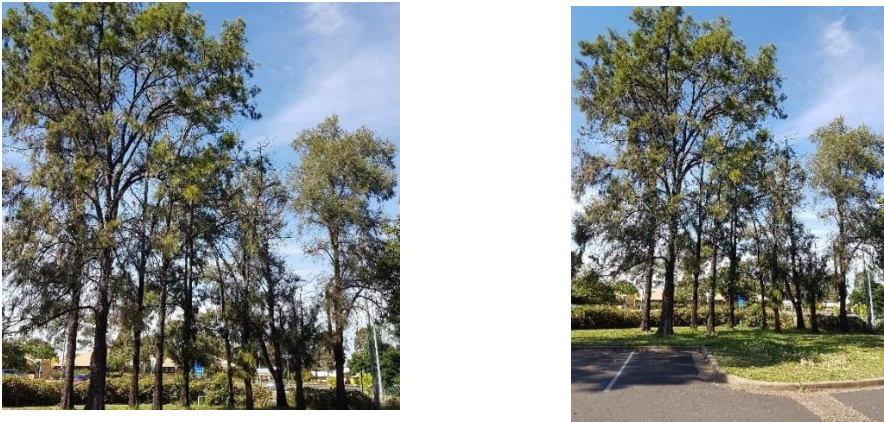
| Tree No. | Genus and Species | Common Name | Approx height in metres | Condition<br>G = Good, F = Fair<br>P = Poor,<br>D = Dead | Pest and diseases | Age<br>Y= Young<br>M=Mature<br>O= Overmature | Significance scale<br>1= High<br>2= Medium<br>3= Low |
|---|---|---|---|---|---|---|---|
| <p style="text-align: center;"><b>Photos</b></p> <div> </div> | | | | <p><b>Description:</b> The 10 She Oak trees are an Australian species. They are over mature and contain a lot of dead wood in the canopy. They have no environmental or historical significance to the site. The new entrance directly off a main road round-a-bout requires these trees to be removed and new trees planted during re-vegetation.</p> | | | |

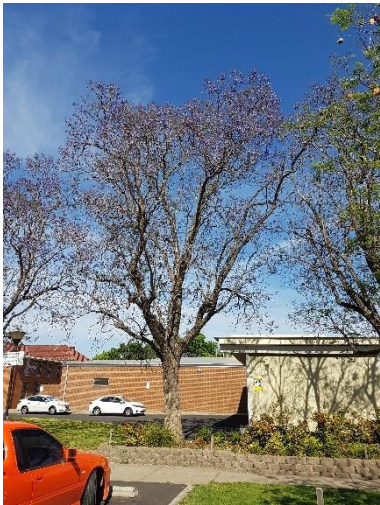
| Tree No. | Genus and Species | Common Name | Approx height in metres | Condition<br>G = Good, F = Fair<br>P = Poor,<br>D = Dead | Pest and diseases | Age<br>Y= Young<br>M=Mature<br>O= Overmature | Significance scale<br>1= High<br>2= Medium<br>3= Low |
|---|---|---|---|---|---|---|---|
| <p><b>Photo</b></p> <div> </div> | | | | <p><b>Description:</b> This Jacaranda tree is a healthy, mature tree and a row of the same species. This tree sits within the area set for a new foot path connecting the new car park to the hospital entrance. The tree is significant to the surrounding landscaping but having a footpath wrap around the tree base will result in the root system becoming compacted, leading to a decline in the trees health. Any path could also be damaged as the tree roots seek water, leading to future trip hazards and liability.</p> | | | |

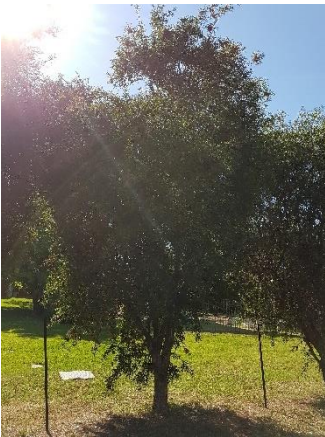
| Tree No. | Genus and Species | Common Name | Approx height in metres | Condition<br>G = Good, F = Fair<br>P = Poor,<br>D = Dead | Pest and diseases | Age<br>Y= Young<br>M=Mature<br>O= Overmature | Significance scale<br>1= High<br>2= Medium<br>3= Low |
|---|---|---|---|---|---|---|---|
| <b>Photo</b><br> | | | | <b>Description:</b> this bottlebrush tree is a mature specimen and is in a row of trees of the same species. This tree sits within the area set for a new foot path connecting the new car park to the hospital entrance.<br>The tree is significant to the surrounding landscaping but cannot have a footpath wrap around the base as it is too small. A Tree Protection Zone will need to be put into place for the trees on either side as outlined in Australian Standards (AS 4970—2009 Protection of trees on development sites). | | | |

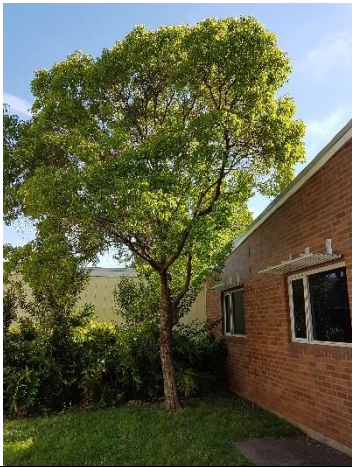
| Tree No. | Genus and Species | Common Name | Approx height in metres | Condition<br>G = Good, F = Fair<br>P = Poor,<br>D = Dead | Pest and diseases | Age<br>Y= Young<br>M=Mature<br>O= Overmature | Significance scale<br>1= High<br>2= Medium<br>3= Low |
|---|---|---|---|---|---|---|---|
| <b>Photo</b><br> | | | | <b>Description:</b> This is a common Australian native tree positioned close to a building to be demolished and where a new section will be built. This species has no environmental or historical significance and would not be able to be transplanted due to size, the site restraints to access and the substantial cost. | | | |

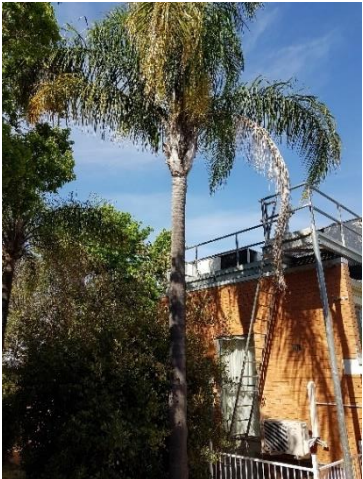
| Tree No. | Genus and Species | Common Name | Approx height in metres | Condition<br>G = Good, F = Fair<br>P = Poor,<br>D = Dead | Pest and diseases | Age<br>Y= Young<br>M=Mature<br>O= Overmature | Significance scale<br>1= High<br>2= Medium<br>3= Low |
|---|---|---|---|---|---|---|---|
| Photo | | | | <b>Description:</b> This palm tree is a prolific introduced species that has been declared a weed. Removal is recommended by the Department of Primary Industries and information can be found through links on reference page. | | | |

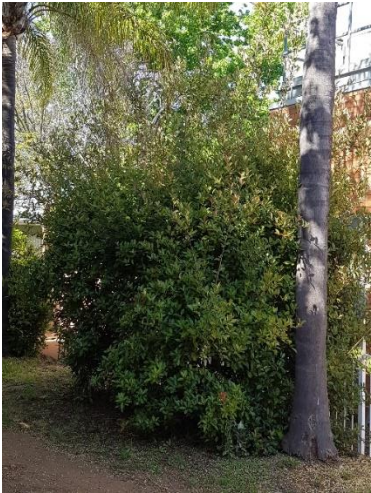
| Tree No. | Genus and Species | Common Name | Approx height in metres | Condition<br>G = Good, F = Fair<br>P = Poor,<br>D = Dead | Pest and diseases | Age<br>Y= Young<br>M=Mature<br>O= Overmature | Significance scale<br>1= High<br>2= Medium<br>3= Low |
|---|---|---|---|---|---|---|---|
| Photo | | | | <b>Description:</b> A mature shrub that has no significance and is not cost effective to remove compared to cost of purchasing a younger specimen and the plants fast growth rate. | | | |

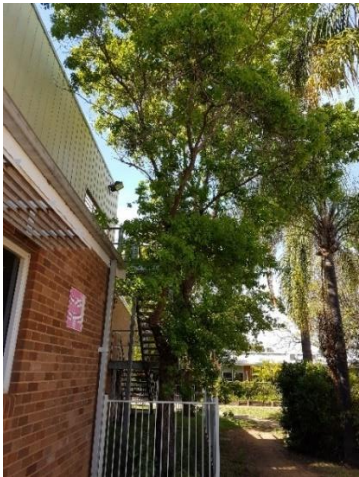
| Tree No. | Genus and Species | Common Name | Approx height in metres | Condition<br>G = Good, F = Fair<br>P = Poor,<br>D = Dead | Pest and diseases | Age<br>Y= Young<br>M=Mature<br>O= Overmature | Significance scale<br>1= High<br>2= Medium<br>3= Low |
|---|---|---|---|---|---|---|---|
| <b>Photo</b><br> | | | | <b>Description:</b> This is a common Australian native tree positioned close to a building to be demolished and where a new section will be built. This species has no environmental or historical significance and would not be able to be transplanted due to size, the site restraints to access and the substantial cost. | | | |

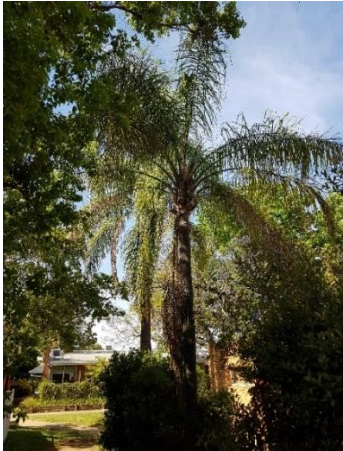
| Tree No. | Genus and Species | Common Name | Approx height in metres | Condition<br>G = Good, F = Fair<br>P = Poor,<br>D = Dead | Pest and diseases | Age<br>Y= Young<br>M=Mature<br>O= Overmature | Significance scale<br>1= High<br>2= Medium<br>3= Low |
|---|---|---|---|---|---|---|---|
| <b>Photo</b><br> | | | | <b>Description:</b> This palm tree is a prolific introduced species that has been declared a weed. Removal is recommended by the Department of Primary Industries and information can be found through links on reference page. | | | |

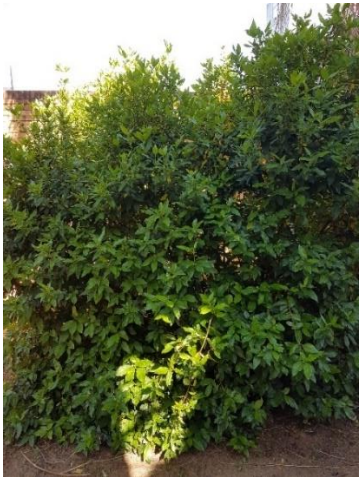
| Tree No. | Genus and Species | Common Name | Approx height in metres | Condition<br>G = Good, F = Fair<br>P = Poor,<br>D = Dead | Pest and diseases | Age<br>Y= Young<br>M=Mature<br>O= Overmature | Significance scale<br>1= High<br>2= Medium<br>3= Low |
|---|---|---|---|---|---|---|---|
| <b>Photo</b> | | | | <b>Description:</b> A mature shrub that has no significance and is not cost effective to remove compared to cost of purchasing a younger specimen and the plants fast growth rate. | | | |

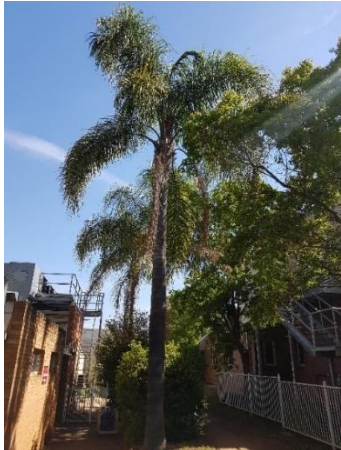
| Tree No. | Genus and Species | Common Name | Approx height in metres | Condition<br>G = Good, F = Fair<br>P = Poor,<br>D = Dead | Pest and diseases | Age<br>Y= Young<br>M=Mature<br>O= Overmature | Significance scale<br>1= High<br>2= Medium<br>3= Low |
|---|---|---|---|---|---|---|---|
| <b>Photo</b> | | | | <b>Description:</b> This palm tree is a prolific introduced species that has been declared a weed. Removal is recommended by the Department of Primary Industries and information can be found through links on reference page. | | | |

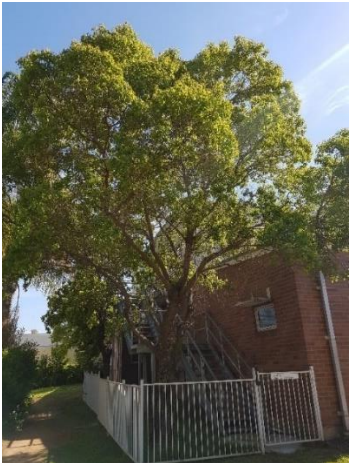
| Tree No. | Genus and Species | Common Name | Approx height in metres | Condition<br>G = Good, F = Fair<br>P = Poor,<br>D = Dead | Pest and diseases | Age<br>Y= Young<br>M=Mature<br>O= Overmature | Significance scale<br>1= High<br>2= Medium<br>3= Low |
|---|---|---|---|---|---|---|---|
| <b>Photo</b><br> | | | | <b>Description:</b> This is a common Australian native tree positioned close to a building to be demolished and where a new section will be built. This species has no environmental or historical significance and would not be able to be transplanted due to size, the site restraints to access and the substantial cost. | | | |

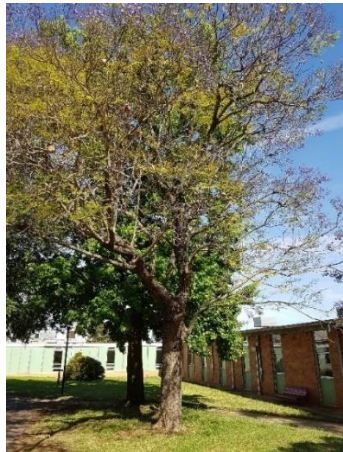
| Tree No. | Genus and Species | Common Name | Approx height in metres | Condition<br>G = Good, F = Fair<br>P = Poor,<br>D = Dead | Pest and diseases | Age<br>Y= Young<br>M=Mature<br>O= Overmature | Significance scale<br>1= High<br>2= Medium<br>3= Low |
|---|---|---|---|---|---|---|---|
| <b>Photo</b><br> | | | | <b>Description:</b> This tree is a mature introduced species positioned in a courtyard. A new building will be built at this site and the tree is to be removed. Transplanting is not viable. | | | |

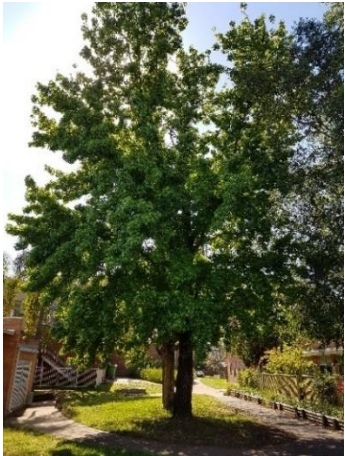
| Tree No. | Genus and Species | Common Name | Approx height in metres | Condition<br>G = Good, F = Fair<br>P = Poor,<br>D = Dead | Pest and diseases | Age<br>Y= Young<br>M=Mature<br>O= Overmature | Significance scale<br>1= High<br>2= Medium<br>3= Low |
|---|---|---|---|---|---|---|---|
| <b>Photo</b> | | | | <b>Description:</b> This tree is a mature introduced species positioned in a courtyard. A new building will be built at this site and the tree is to be removed. Transplanting is not viable due to the size and maturity of the tree as well as the substantial cost. | | | |

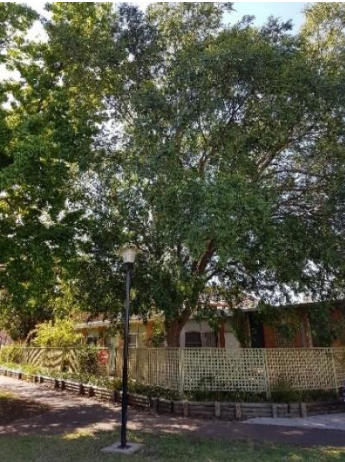
| Tree No. | Genus and Species | Common Name | Approx height in metres | Condition<br>G = Good, F = Fair<br>P = Poor,<br>D = Dead | Pest and diseases | Age<br>Y= Young<br>M=Mature<br>O= Overmature | Significance scale<br>1= High<br>2= Medium<br>3= Low |
|---|---|---|---|---|---|---|---|
| <b>Photo</b> | | | | <b>Description:</b> This tree is a mature introduced species positioned in a courtyard. A new building will be built at this site and the tree is to be removed. Transplanting is not viable due to the size and maturity of the tree as well as the substantial cost. | | | |

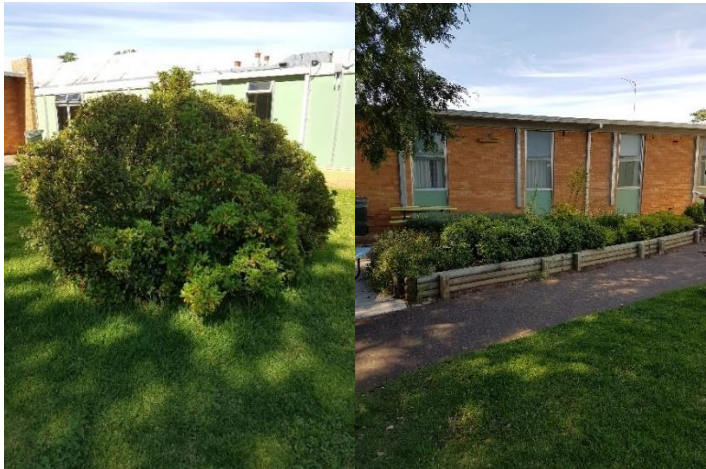
| Tree No. | Genus and Species | Common Name | Approx height in metres | Condition<br>G = Good, F = Fair<br>P = Poor,<br>D = Dead | Pest and diseases | Age<br>Y= Young<br>M=Mature<br>O= Overmature | Significance scale<br>1= High<br>2= Medium<br>3= Low |
|---|---|---|---|---|---|---|---|
| <b>Photo</b><br> | | | | <b>Description:</b> A mature shrub that has no significance and is not cost effective to remove compared to cost of purchasing a younger specimen and the plants fast growth rate.<br>The garden bed contains common mature plants that are unable to be transplanted. | | | |

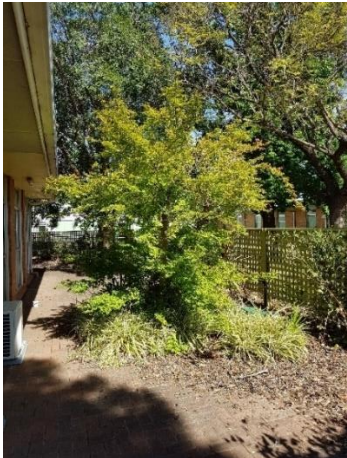
| Tree No. | Genus and Species | Common Name | Approx height in metres | Condition<br>G = Good, F = Fair<br>P = Poor,<br>D = Dead | Pest and diseases | Age<br>Y= Young<br>M=Mature<br>O= Overmature | Significance scale<br>1= High<br>2= Medium<br>3= Low |
|---|---|---|---|---|---|---|---|
| <b>Photo</b><br> | | | | <b>Description:</b> This tree is a young introduced species currently positioned between an established building and the new development. The tree may be able to stay in place depending on if the area has a re-vegetation plan. A Tree Protection Zone will need to be implemented as outlined in the Australian Standards (AS 4970—2009 Protection of trees on development sites).<br>Transplanting is a viable but expensive option depending on access to the proper machinery. | | | |

This Arboricultural Transplant Method Statement has been written to assist with the relocation of tree 40.

- For Tree 40 a circular trench should be dug at a distance of approximately two thousand (2000) millimetres from the trunk giving the overall root ball a four (4) metre spread to a depth of 900mm. The trench should then angle towards the trunk with the aim of almost severing the entire root ball. A hose set to high pressure can sometimes help expose the last roots at the base to allow them to be severed cleanly with a sharp pruning saw. Once the trench becomes deep enough, steel poles (similar to scaffold poles) should be inserted so that the root ball does not collapse to one side. It is most likely the root ball will be a dense mat of root matter.

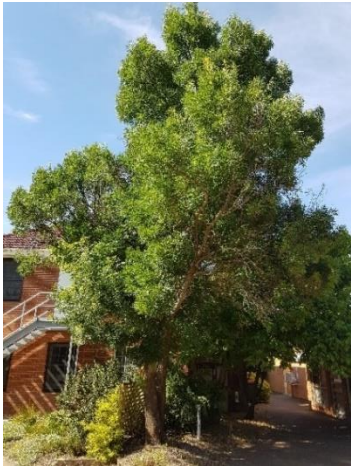
| Tree No. | Genus and Species | Common Name | Approx height in metres | Condition<br>G = Good, F = Fair<br>P = Poor,<br>D = Dead | Pest and diseases | Age<br>Y= Young<br>M=Mature<br>O= Overmature | Significance scale<br>1= High<br>2= Medium<br>3= Low |
|---|---|---|---|---|---|---|---|
| <b>Photo</b> | | | | <b>Description:</b> This tree is a mature introduced species positioned in a courtyard. A new building will be built at this site and the tree is to be removed. Transplanting is not viable due to the size and maturity of the tree as well as the substantial cost. | | | |

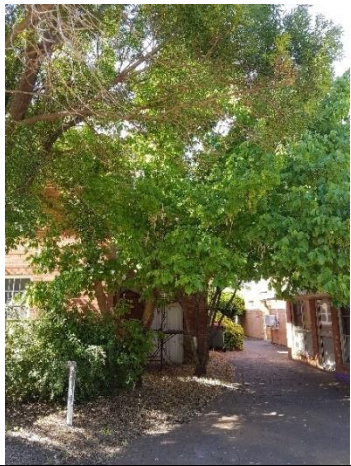
| Tree No. | Genus and Species | Common Name | Approx height in metres | Condition<br>G = Good, F = Fair<br>P = Poor,<br>D = Dead | Pest and diseases | Age<br>Y= Young<br>M=Mature<br>O= Overmature | Significance scale<br>1= High<br>2= Medium<br>3= Low |
|---|---|---|---|---|---|---|---|
| <b>Photo</b> | | | | <b>Description:</b> This tree is a mature introduced species positioned in a courtyard. A new building will be built at this site and the tree is to be removed. Transplanting is not viable due to the size and maturity of the tree as well as the substantial cost. | | | |

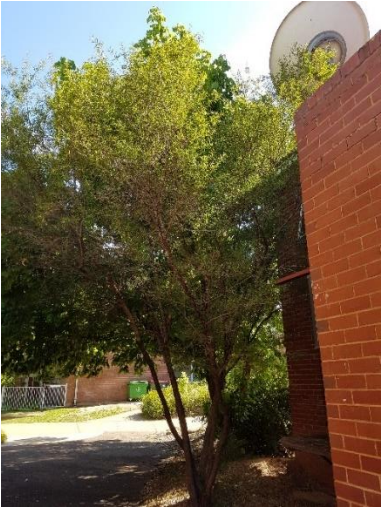
| Tree No. | Genus and Species | Common Name | Approx height in metres | Condition<br>G = Good, F = Fair<br>P = Poor,<br>D = Dead | Pest and diseases | Age<br>Y= Young<br>M=Mature<br>O= Overmature | Significance scale<br>1= High<br>2= Medium<br>3= Low |
|---|---|---|---|---|---|---|---|
| <b>Photo</b> | | | | <b>Description:</b> This is a common Australian native tree positioned close to a building to be demolished and where a new section will be built. This species has no environmental or historical significance and would not be able to be transplanted due to size, the site restraints to access and the substantial cost. | | | |

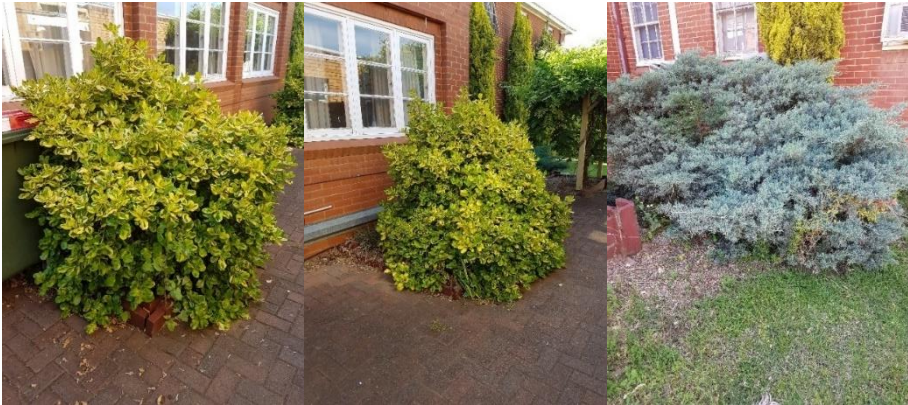
| Tree No. | Genus and Species | Common Name | Approx height in metres | Condition<br>G = Good, F = Fair<br>P = Poor,<br>D = Dead | Pest and diseases | Age<br>Y= Young<br>M=Mature<br>O= Overmature | Significance scale<br>1= High<br>2= Medium<br>3= Low |
|---|---|---|---|---|---|---|---|
| <b>Photo</b> | | | | <b>Description:</b> A mature shrub that has no significance and is not cost effective to remove compared to cost of purchasing a younger specimen and the plants fast growth rate. | | | |

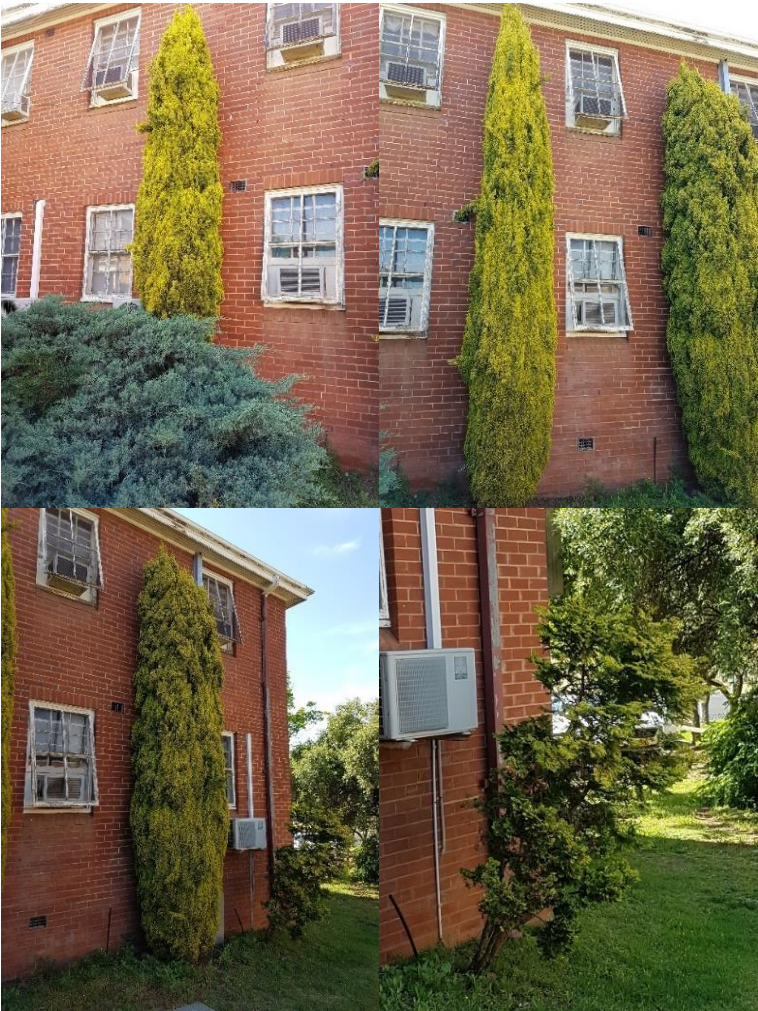
| Tree No. | Genus and Species | Common Name | Approx height in metres | Condition<br>G = Good, F = Fair<br>P = Poor,<br>D = Dead | Pest and diseases | Age<br>Y= Young<br>M=Mature<br>O= Overmature | Significance scale<br>1= High<br>2= Medium<br>3= Low |
|---|---|---|---|---|---|---|---|
| <b>Photo</b> | | | | <b>Description:</b> A row of trees along the side of a building to be demolished. They are mature trees and cannot be transplanted due to proximity to the building. Trees to be removed. | | | |

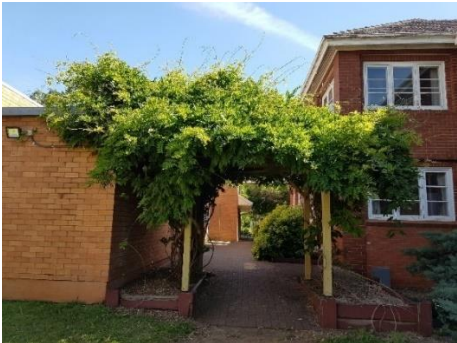
| Tree No. | Genus and Species | Common Name | Approx height in metres | Condition<br>G = Good, F = Fair<br>P = Poor,<br>D = Dead | Pest and diseases | Age<br>Y= Young<br>M=Mature<br>O= Overmature | Significance scale<br>1= High<br>2= Medium<br>3= Low |
|---|---|---|---|---|---|---|---|
| <b>Photo</b><br> | | | | <b>Description:</b> An introduced species of vine situated over a walkway. To be removed to make way for new building works | | | |

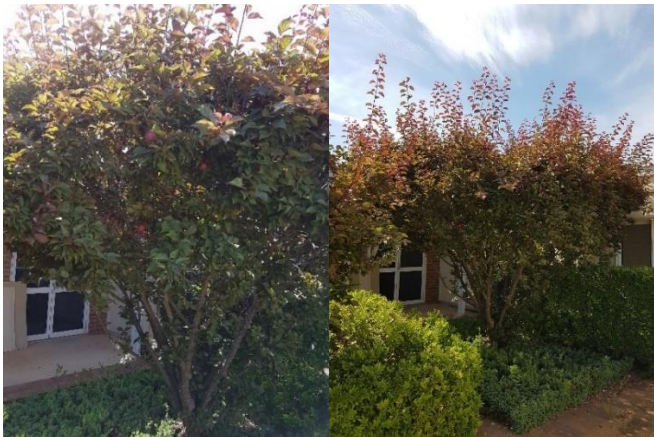
| Tree No. | Genus and Species | Common Name | Approx height in metres | Condition<br>G = Good, F = Fair<br>P = Poor,<br>D = Dead | Pest and diseases | Age<br>Y= Young<br>M=Mature<br>O= Overmature | Significance scale<br>1= High<br>2= Medium<br>3= Low |
|---|---|---|---|---|---|---|---|
| <b>Photo</b><br> | | | | <b>Description:</b> This plum tree is situated in the corner of a courtyard that will be impacted by building works. The tree offers limited shade and has limited significance to the courtyard as a whole. | | | |
