# Tree Pruning Assessment & Specification

1/-/DP1311043, 2/-/DP1311043  
3/-/DP1311043, 4/-/DP1311043  
136-148 New South Head Road  
Edgecliff  
NSW 2027

Truth About Trees Pty. Ltd.

Date: 22/05/2026

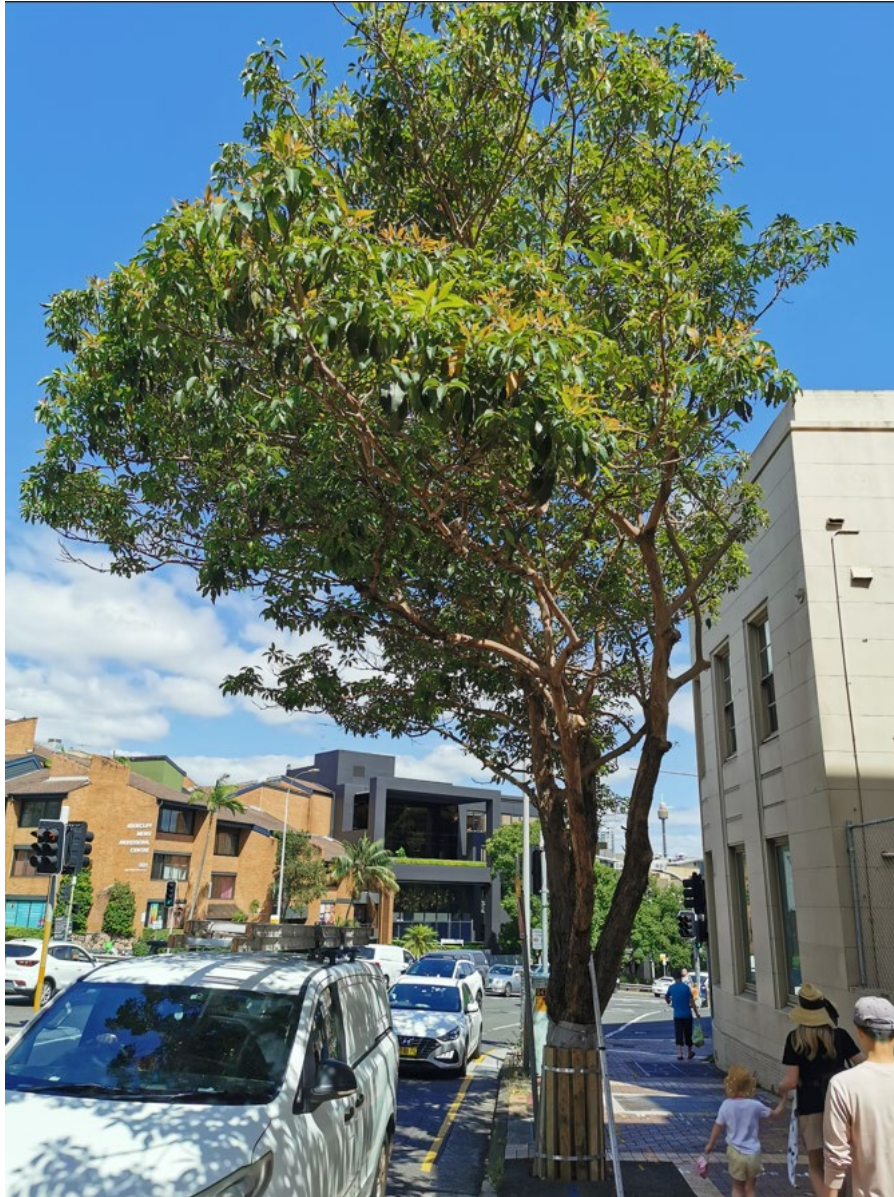
Figure 3- Tree one (1) viewed from the East.

| Tree No | Species | Height | Spread | DBH mm | DAB mm | Health | Age | Structure | Landscape Significance | ELE | Retention Value | Arborist Notes |
|---|---|---|---|---|---|---|---|---|---|---|---|---|
| 1 | Lophostemon confertus Queensland Box | 9 | 7 | 310 | 385 | Fair | Mature | Fair | Medium | Medium | Medium | |

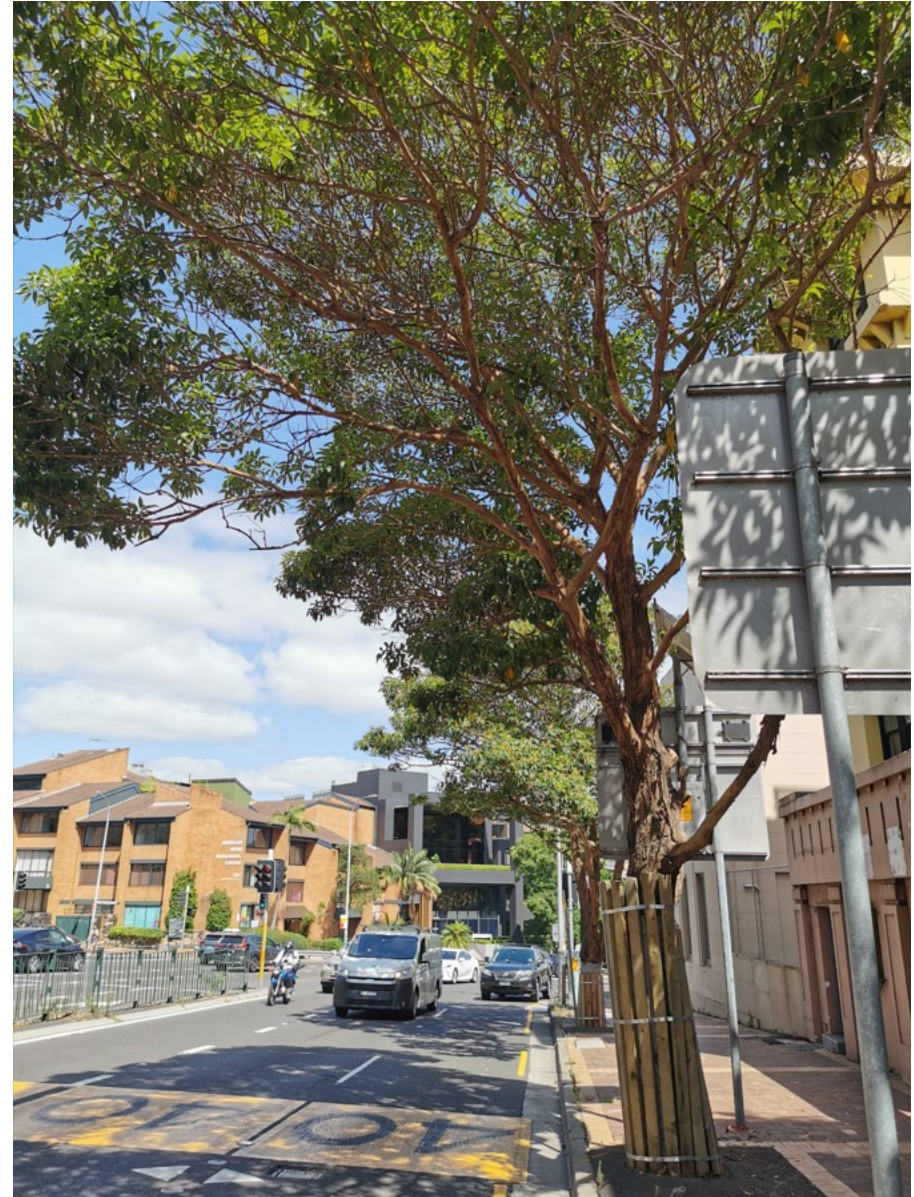
Figure 4- Tree two (2) viewed from the East.

| Tree No | Species | Height | Spread | DBH mm | DAB mm | Health | Age | Structure | Landscape Significance | ELE | Retention Value | Arborist Notes |
|---|---|---|---|---|---|---|---|---|---|---|---|---|
| 2 | Lophostemon confertus Queensland Box | 9 | 7 | 325 | 425 | Good | Mature | Fair | Medium | Medium | Medium | |

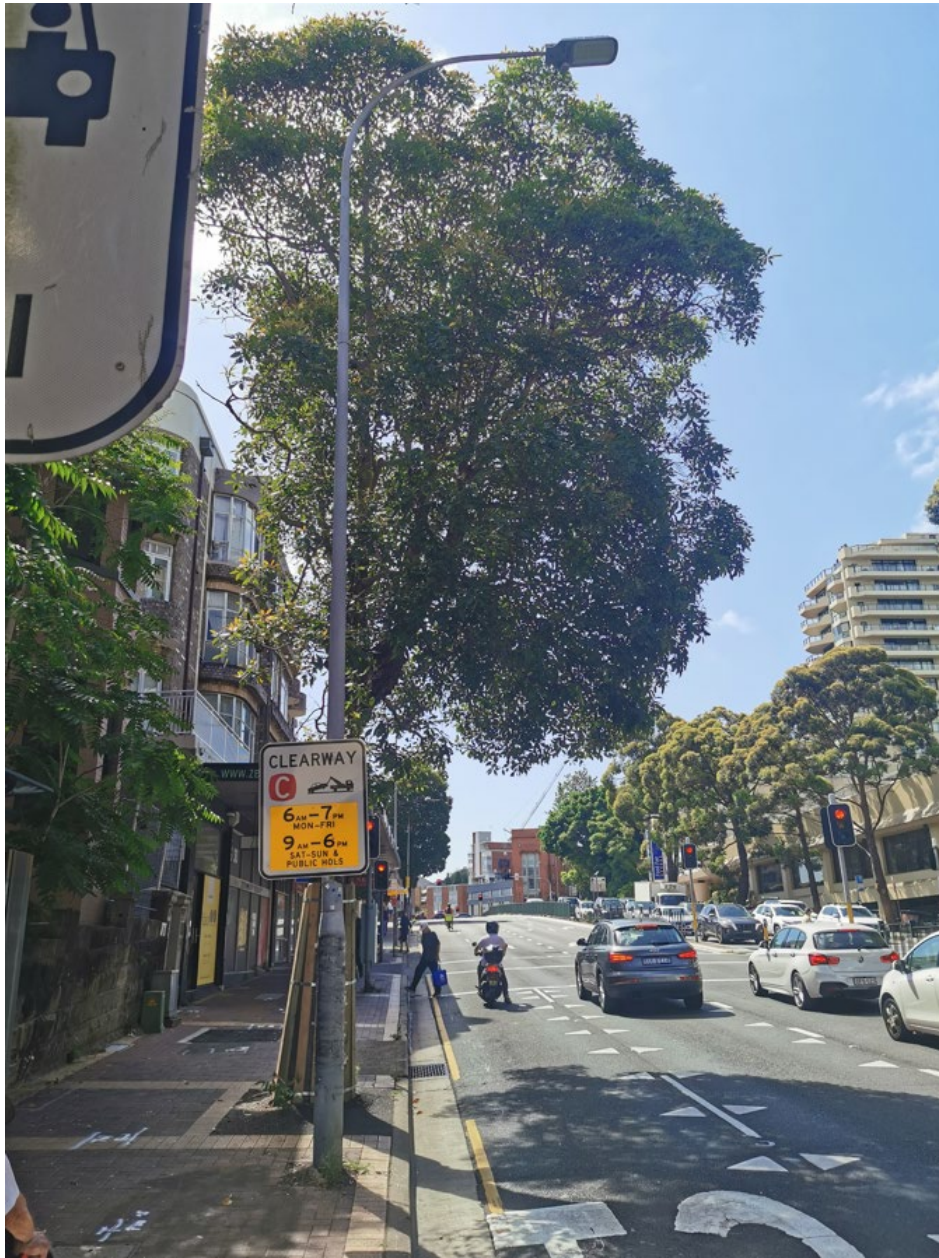
Figure 5- Tree three (3) viewed from the West.

| Tree No | Species | Height | Spread | DBH mm | DAB mm | Health | Age | Structure | Landscape Significance | ELE | Retention Value | Arborist Notes |
|---|---|---|---|---|---|---|---|---|---|---|---|---|
| 3 | Lophostemon confertus Queensland Box | 12 | 5 | 405 | 500 | Fair | Mature | Fair | Medium | Medium | Medium | Insect attack |

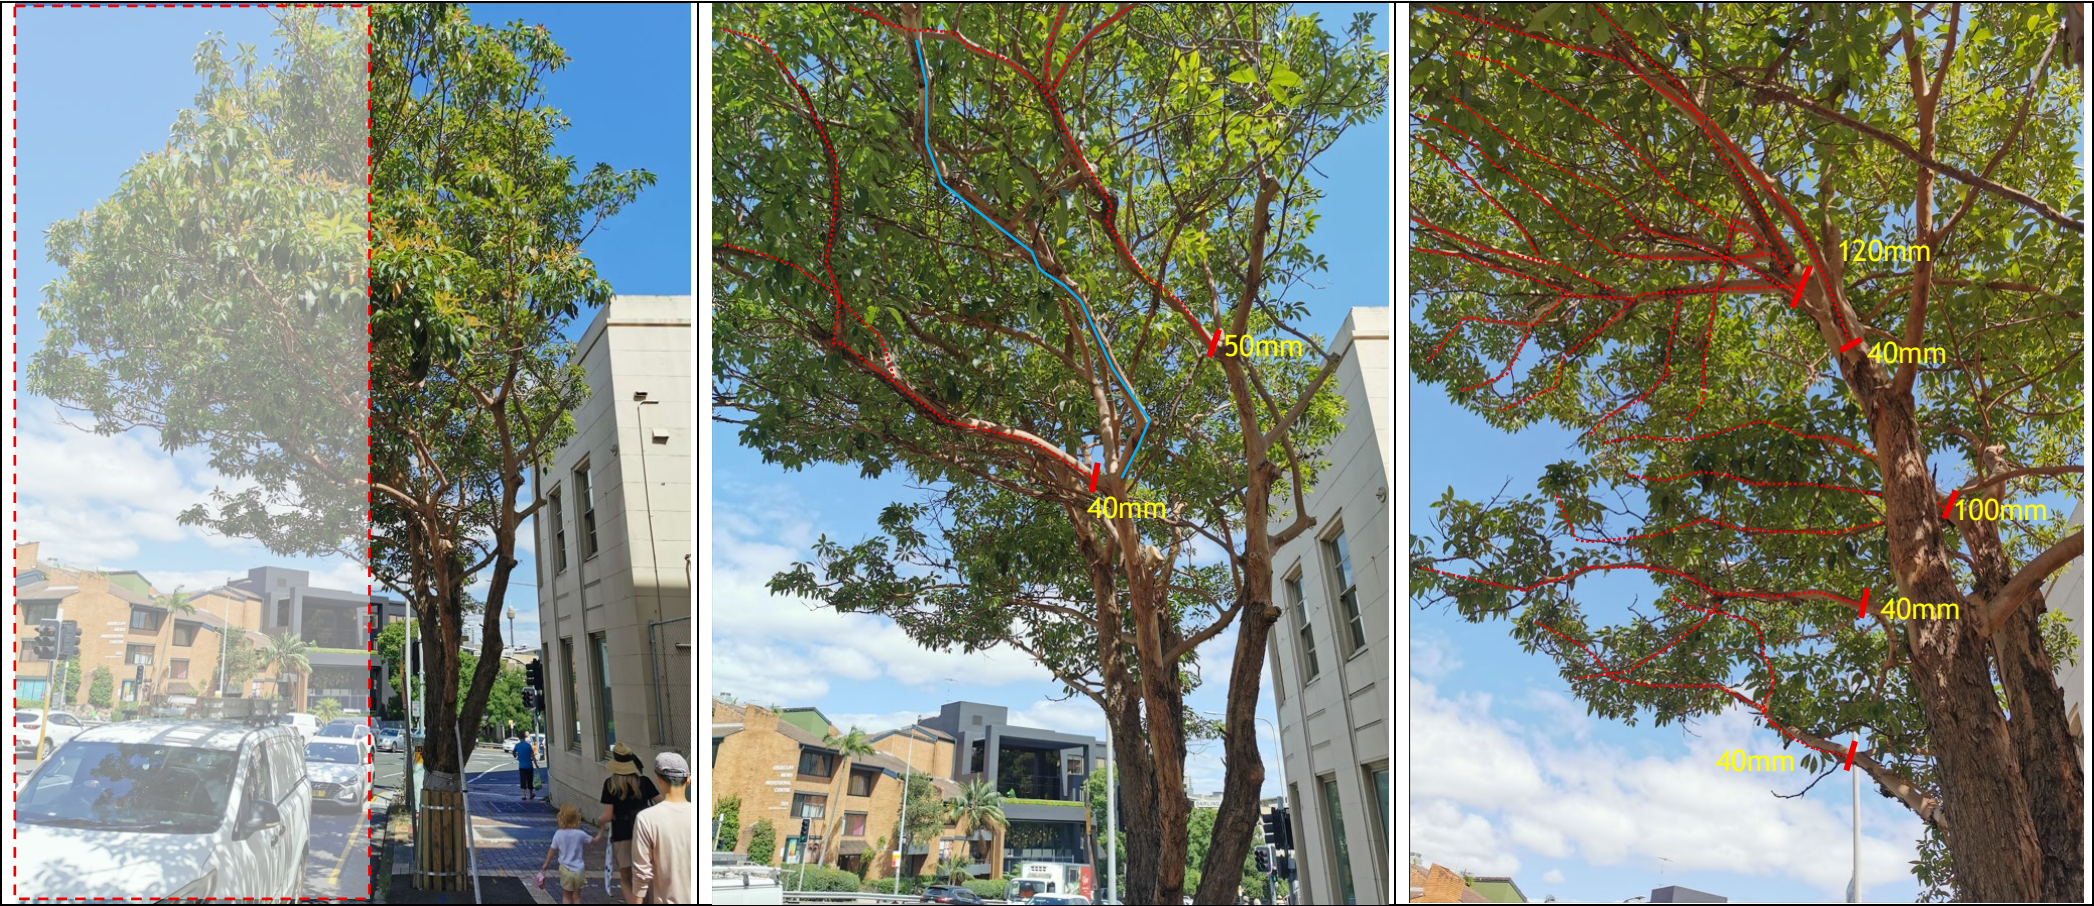
Figure 8- Tree pruning requirements for tree one (1).

| Species | Picture | Arborist Notes | Canopy % | Total % |
|---|---|---|---|---|
| TREE ONE (1)<br><i>Lophostemon confertus</i> <br>Brushbox | Centre | 1 x 40mm, 1 x 50mm diameter S/E branches from the Eastern side of the canopy. 1 x 40mm S/E branch (Blue) potentially tied back to scaffolding. | 5% | 60% |
| | Right | 1 x 40mm Eastern branch from centre of canopy, 2 x 40mm, 1 x 100mm diameter S/W branches from the lower Western side of the canopy. 1 x 120mm diameter Southern leader from the upper-central part of the canopy. | 55% | |

Trees one (1) and two (2) will be subject to substantial and unsustainable negative impacts from the tree pruning which would be required. Tree one (1) would lose approximately sixty (60%) of its canopy, whilst tree two (2) would need to have approximately 70% of its canopy removed. This level of pruning is unsustainable and would result in very poorly formed trees with limited visual amenity. Pruning to this extent would impose negative impacts upon the trees and would likely result in decline and death or proliferation of epicormic growth in response to the stress.

- The removal of trees 1 & 2 will be required to facilitate a works/hoisting zone on New South Head Road.
- The pruning dose indicated in sections 6.1 & 6.2 is deemed to be extensive and likely to impose long-term negative impacts upon the tree health and aesthetic value, for these reasons, as well as additional impacts from underground services, trees 1 & 2 are recommended for removal and replacement following the completion of the development.

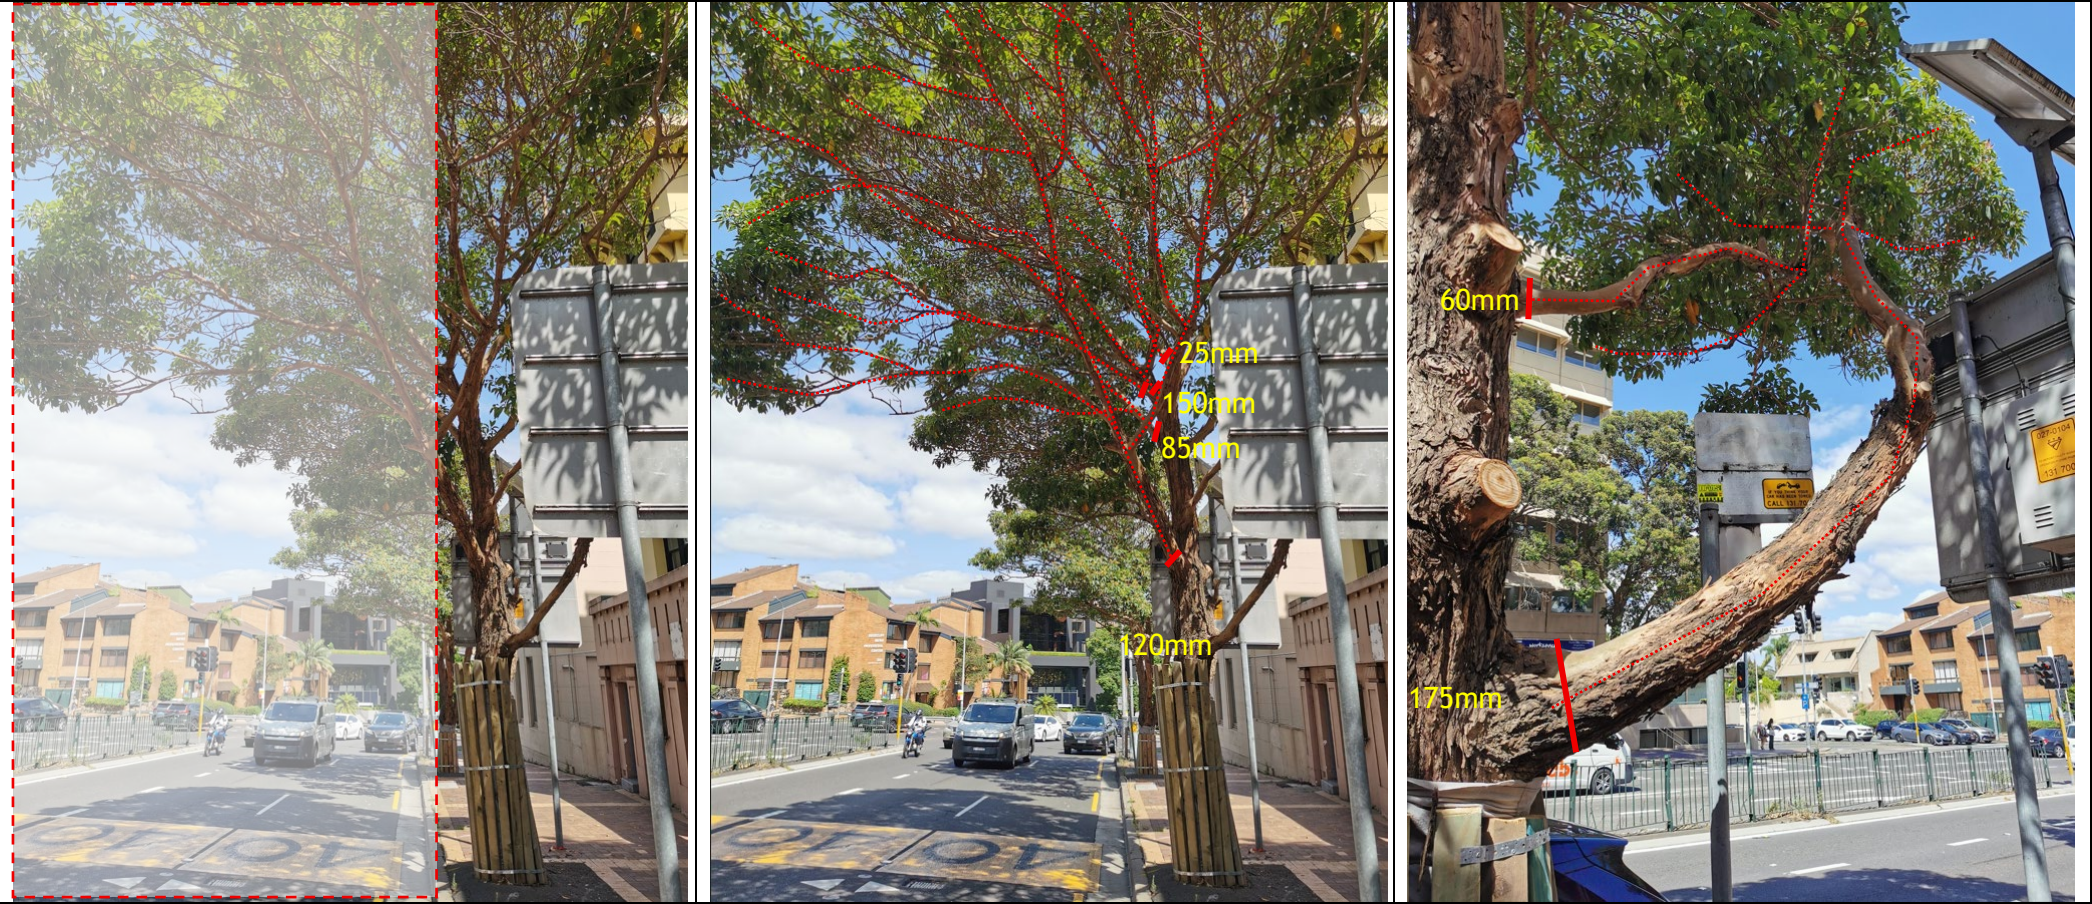
Figure 9- Tree pruning requirements for tree two (2).

| Species | Picture | Arborist Notes | Canopy % | Total % |
|---|---|---|---|---|
| TREE TWO (2)<br><i>Lophostemon confertus</i> <br>Brushbox | Centre | 1 x 120mm S/E branch from the lower- eastern side of the canopy.<br>1 x 85mm S/W branch from the mid S/W side of the canopy.<br>1 x 150mm southern stem from the upper-central canopy.<br>1 x 25mm S/W branch from the upper canopy. | 55% | 70% |
| | Right | 1 x 175mm and 1 x 60mm S/W branches from the lower western canopy. | 15% | |

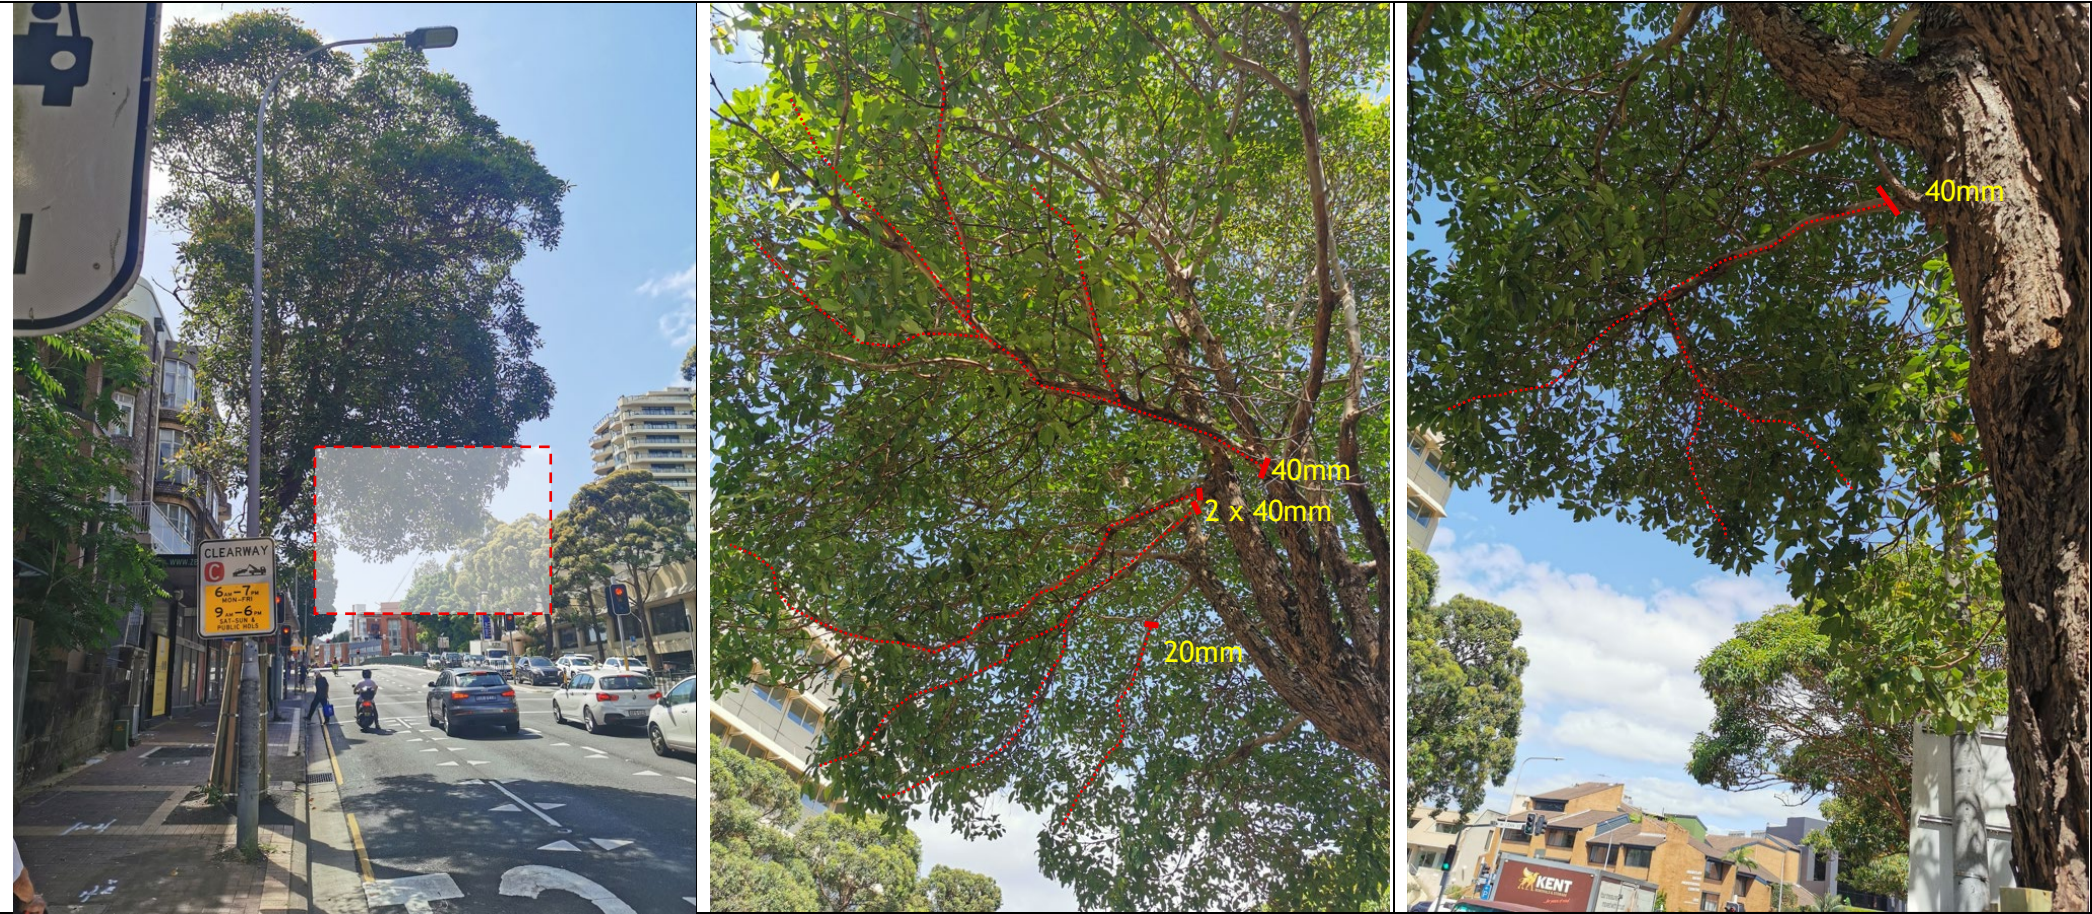
Figure 10- Tree pruning requirements for tree three (3).

| Species | Picture | Arborist Notes | Canopy % | Total % |
|---|---|---|---|---|
| TREE THREE (3)<br><i>Lophostemon confertus</i> <br>Brushbox | Centre | 1 x 40mm diameter S/E branch from the lower-eastern canopy.<br>2 x 40mm diameter Southern descending branches centre of canopy.<br>1 x 20mm diameter descending branch from the S/W side of the canopy. | 2% | 2.5% |
| | Right | 1 x 40mm diameter S/W branch from the lower-Western canopy. | 0.5% | |

Tree three (3) is the best specimen of the three (3) trees and is only minimally impacted due to the revised hoisting zone shown in figure 11 which results in approximately 2.5% of the tree canopy being pruned. This level of pruning is considered to be minor and would have no long-term impact upon tree health.

- The pruning required for tree three (3) would be approximately 2.5% of its existing foliage which is considered to be very minor from both a health and aesthetic perspective. Underground service installation and decommissioning will impose impacts upon the tree, however, this should be tolerable given the current condition of the tree.

- Pruning of tree three (3) in accordance with section 6.3 and the marked-up imagery within this report should be undertaken in order to facilitate the proposed project.

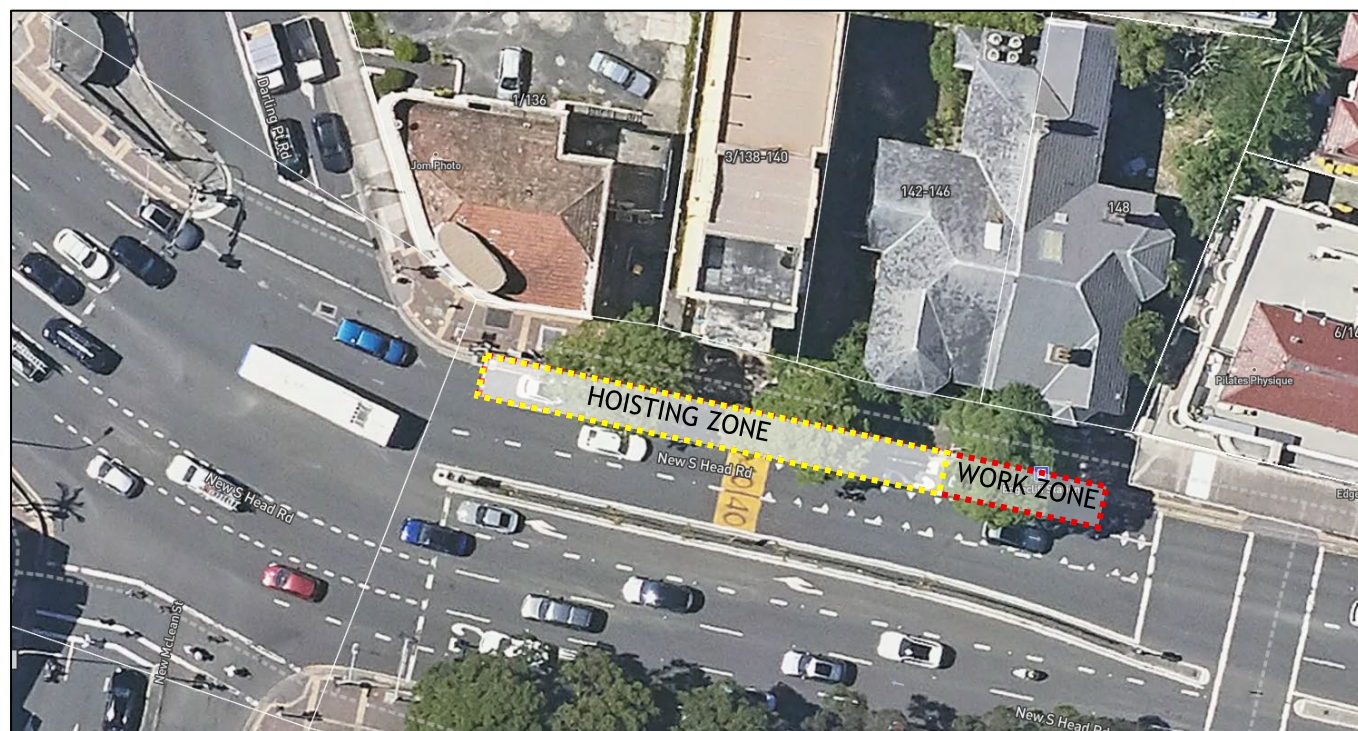
Figure 11- Showing the approximate extent of pruning required to achieve the proposed 45m hoisting zone.

Based upon this assessment, the impacts of the required pruning would be unsustainable for trees 1 & 2, with the pruning for tree three (3) considered as minor. The total percentage of tree canopy that would require removal has been estimated as follows:

- Tree one (1)- 60% of the tree canopy.
- Tree two (2)- 70% of the tree canopy.
- Tree three (3)- 2.5% of the tree canopy.

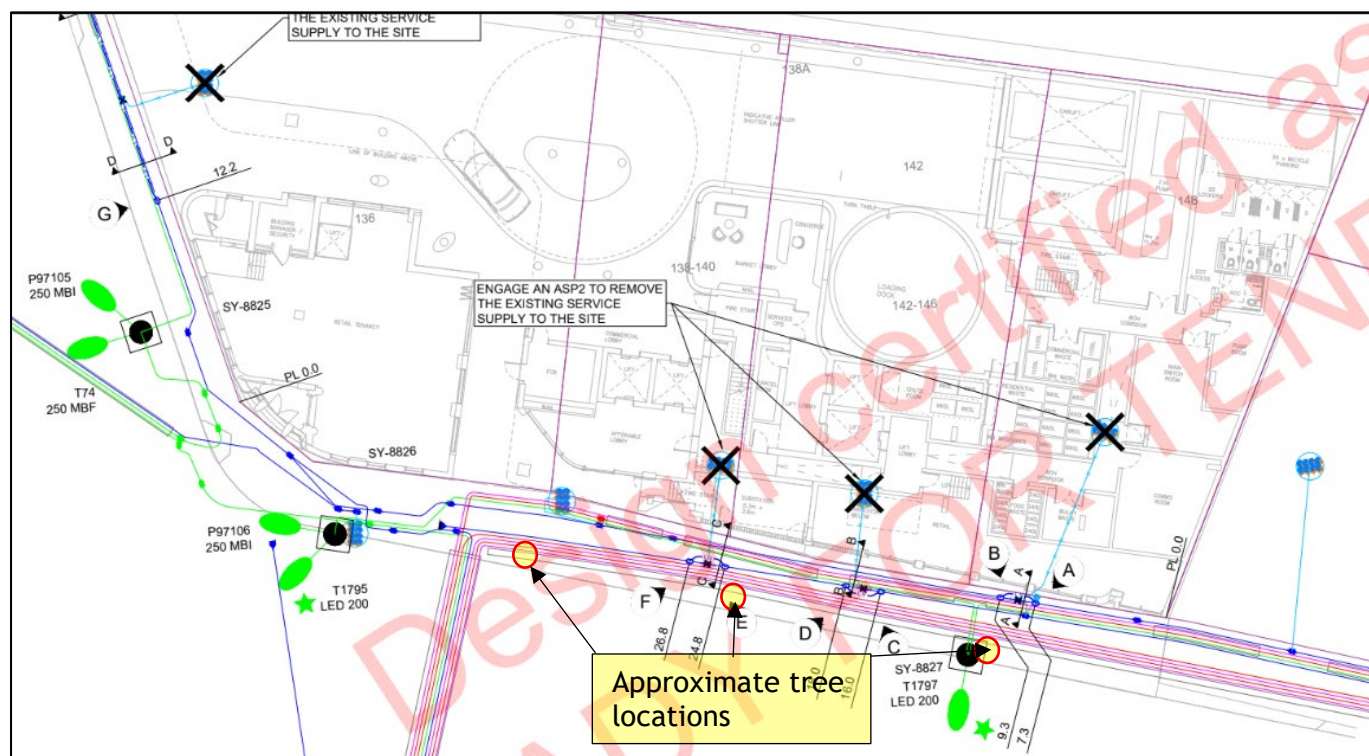
In addition to the required tree pruning impacts, there are also additional impacts upon the trees from underground service decommissioning and installation. Whilst these works will obviously need to be conducted under Arborist supervision with minimally invasive techniques, there are still likely to be negative impacts imposed by these works.

Figure 12- Underground services plans showing existing services and proposed modifications.

The three (3) trees are also impacted by works to install underground services within the Structural root zones of the trees. These would be installed using minimally invasive techniques such as vacuum excavation, however, regardless of the methods used, this would still impose negative impacts upon the trees.
