Arboricultural Impact Assessment

University of Sydney Camperdown Campus CCW Museum project

12th May 2017

Ref: University of Sydney – CCW Museum Arboricultural Impact Assessment

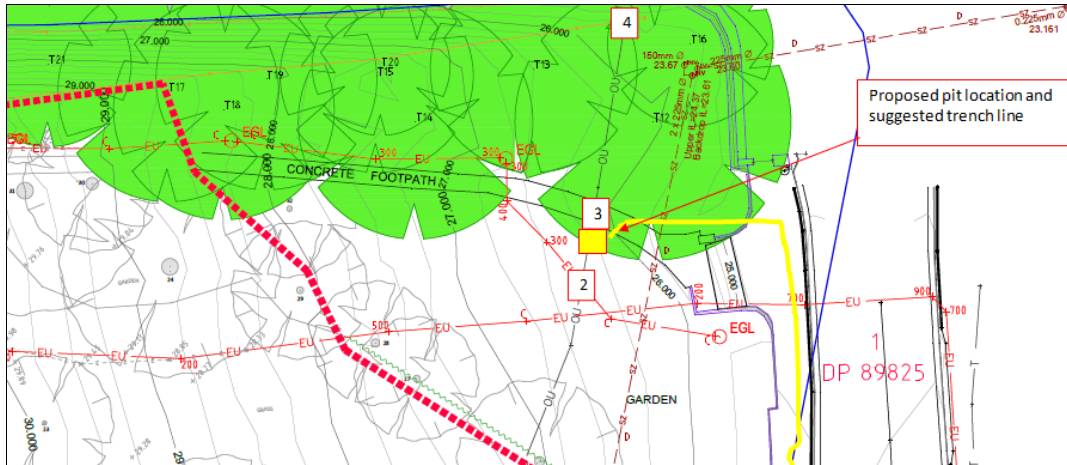
- 9.3.1 The major communications currently supplying the University run through the middle of the site and require rerouting if the proposal is to proceed.
- 9.3.2 Confirmation of the indicative service location has been completed onsite using a locating device as per Figure 12 below.
- 9.3.3 The installation of an access pit and subsequent rerouting of the fibre optic cable will require the removal of one (1) low retention value tree being tree number 74.
- 9.3.4 Hydro excavation and sensitive installation of the conduit will occur within the root zone of the High Retention value tree number 70. These works are expected to have no impact on the health and condition of Tree number 70.

Figure 12: Excerpt from plan showing current location of fibre optic cable and proposed pit locations (between 2 & 4) and rerouting marked by the yellow line. Source: USYD, C. Burns, 21/04/2017

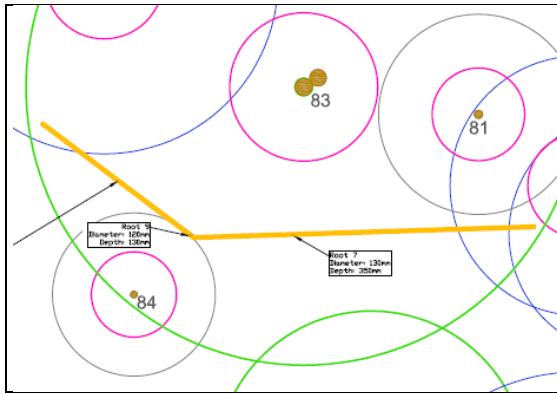
- v. The impacts to the root system of tree number 83 would at a minimum result in the severance of ten (10) roots as observed in Trench 9. Two (2) roots of significance ranging between 120-130mm diameter are included in this encroachment.

Figure 13: The location of Trench 9. Source: Preliminary Arboricultural Report and Root Investigation completed by ArborSafe and dated the 2nd September 2016, Appendix F Root Investigation Plan.

- vi. Development at the proposed excavation line is considered tolerable and a minor short term loss in tree health is expected. Tree 83 can be retained with a minor effect on tree health considered likely in the short term, providing sensitive construction practices and tree protection measures are adhered to during construction
- vii. Minor pruning of the south-western corner of the canopy may be required for construction access.

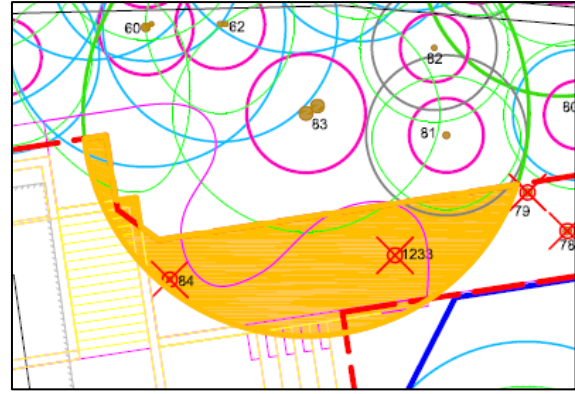
Figure 14: The proposed 23.8% incursion into the TPZ of Tree 83. Source: Tree Protection Plan

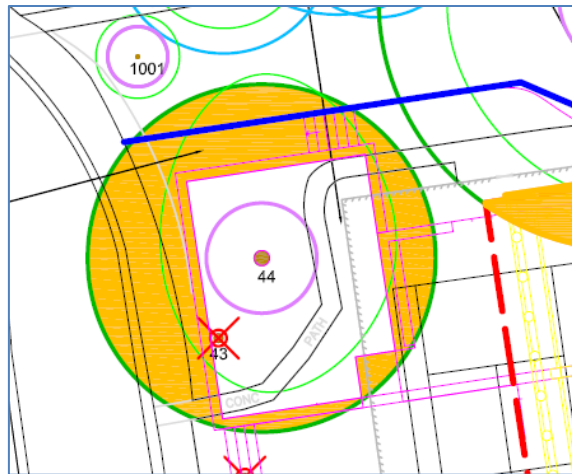
9.4.6 Tree 44 has a 56.1 % incursion into its TPZ area which is considered to be a major encroachment.

- i. Tree 44 has a TPZ of 10.4m and SRZ of 3.3m measured as a radial distance.
- ii. The building foot print encroachment is 0% and therefore, the design and placement of the proposed building layout does not impact upon this tree.
- iii. The landscape concept provides an incursion of 56.1% which is a major and detrimental impact to tree number 44.
- iv. Roots under the existing pavement to the west are unlikely to be impacted if the existing surfaces remain in situ.
- v. The path through the root zone also provides for root protection and it should be incorporated into the design.
- vi. This tree is only retainable through landscape design change that incorporates flexible pier and beam footings (for all surrounding walls), no level changes and permeable pavement surfaces above existing grade.

Figure 15: The proposed 56.1% incursion into the TPZ of Tree 83 due to landscape works. Source: Tree Protection Plan

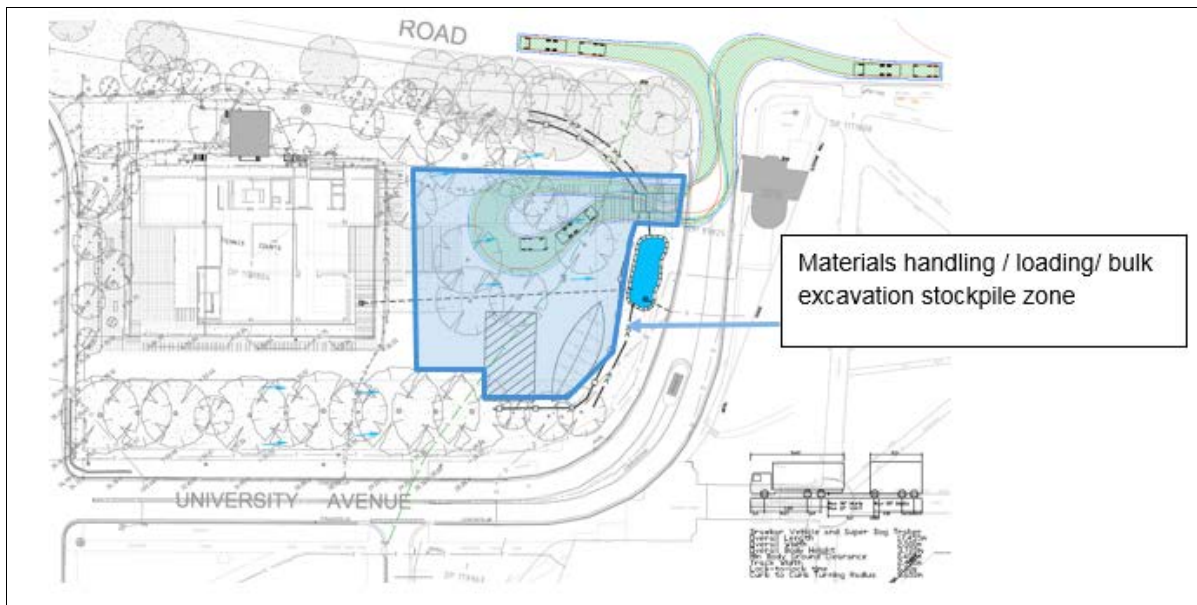
Figure 16: The proposed materials handling and construction access that results in the required removal of tree number 87. Source: Draft Construction Management Plan, April 2017

Tree 87 requires removal as part of the Construction Management Plan. Tree to be removed to facilitate truck turning and material handling area.

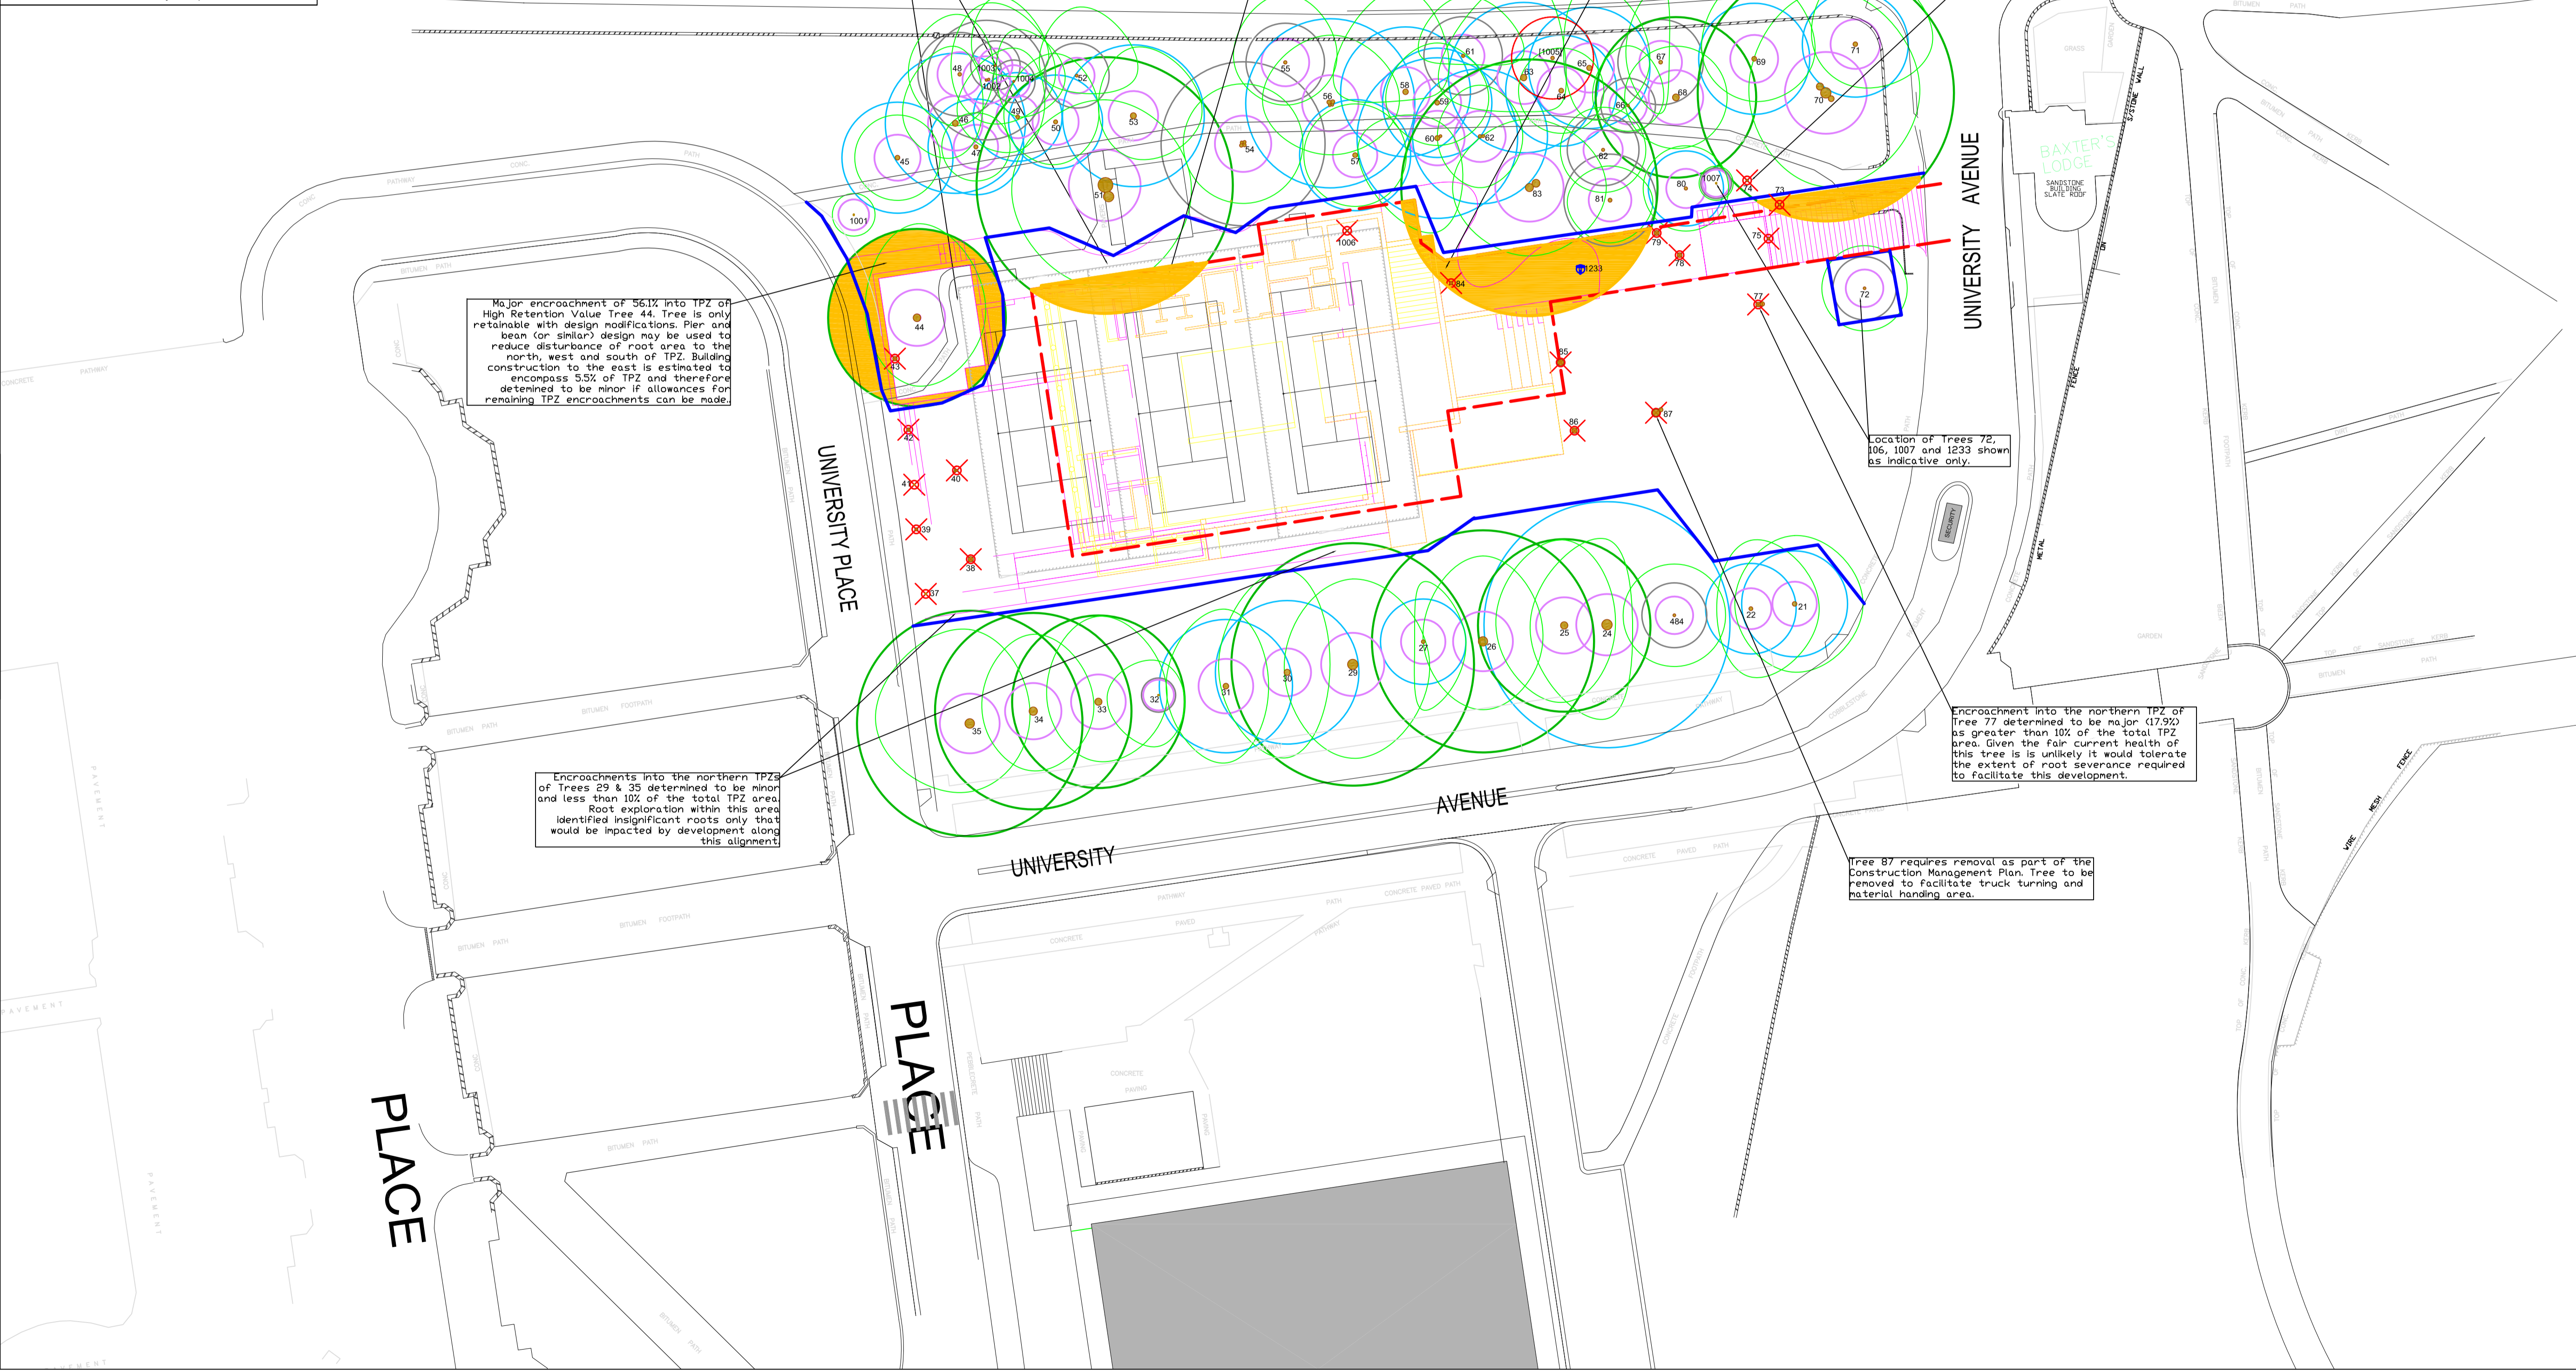
Encroachment into the northern TPZ of Tree 77 determined to be major (17.9%) as greater than 10% of the total TPZ area. Given the fair current health of this tree it is unlikely it would tolerate the extent of root severance required to facilitate this development.
