ARBORICULTURAL IMPACT ASSESSMENT REPORT

459 Chapel Road
Bankstown NSW 2200

Date: March 2025
FINAL

Prepared for: Anglican Church Growth Corporation
c/o Sustainable Development Group Limited

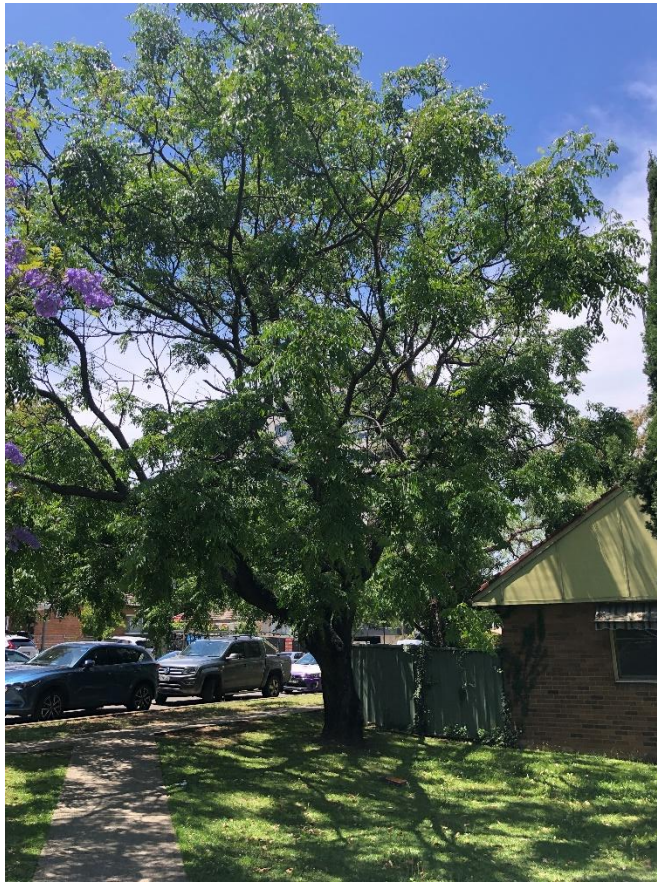
3.6 Tree 1 is a large mature White Cedar in good condition (Plate A). It has undergone pruning over the years and as a result has small decay pockets in some of the pruning wounds. Trees 2 and 3 are multi-stemmed Jacaranda specimens growing in the lawn area. These trees appear to have been damaged quite early in their life and, as such, have developed multiple stems at ground level.

Plate A: Image showing Tree 1 that will have incursions to the TPZ and also require extensive canopy pruning for the new structure. P.Vezgoff

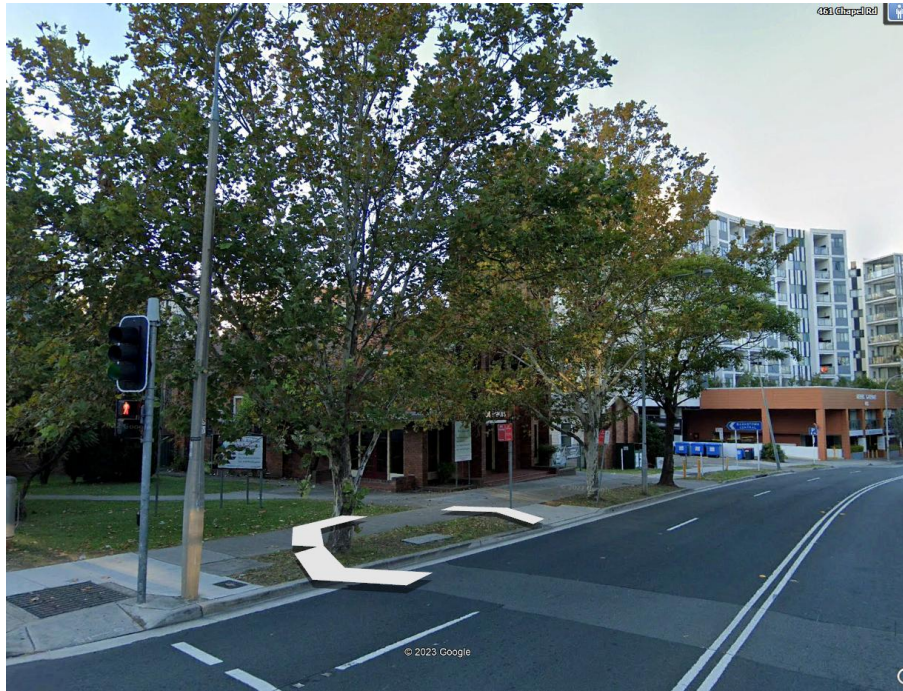
Plate B: Image showing the street trees 8, 9 and 10. Google Earth

3.13 Trees 8, 9 are both Platanus species and deciduous. This species will tolerate a degree of root loss provided it does not occur during the main growth period of spring. Tree 10, a Brushbox is a hardy species and will tolerate the encroachment. All three (3) trees will require canopy reduction pruning and based on the size of these trees at maturity will require ongoing pruning to maintain building clearance.

4.4 The proposed excavation to be undertaken within the TPZ of Trees 8, 9, 10 is to be excavated by hand (without the use of heavy machinery) to a depth of four hundred (400) millimetres as specified in the Tree Protection Plan (Appendix 1). Roots encountered while excavating this area may be pruned cleanly with a sharp saw.

4.5 Canopy reduction pruning: Trees 8, 9, 10, 13, 14 will require branches to be uplifted and reduced to allow for scaffolding clearance. These branches should be reduced back so as to maintain the canopy of the tree (ie, no lopping or ‘flat topping’) however this will be difficult to retain any natural shape due to the scaffolding pruning required. It is preferable that pruning points should be no greater than one hundred (100) millimetres in diameter. This pruning is known as selective pruning and can be read about in more detail in the Australian Standard for the Pruning of Amenity Trees (AS 4373) 2007.

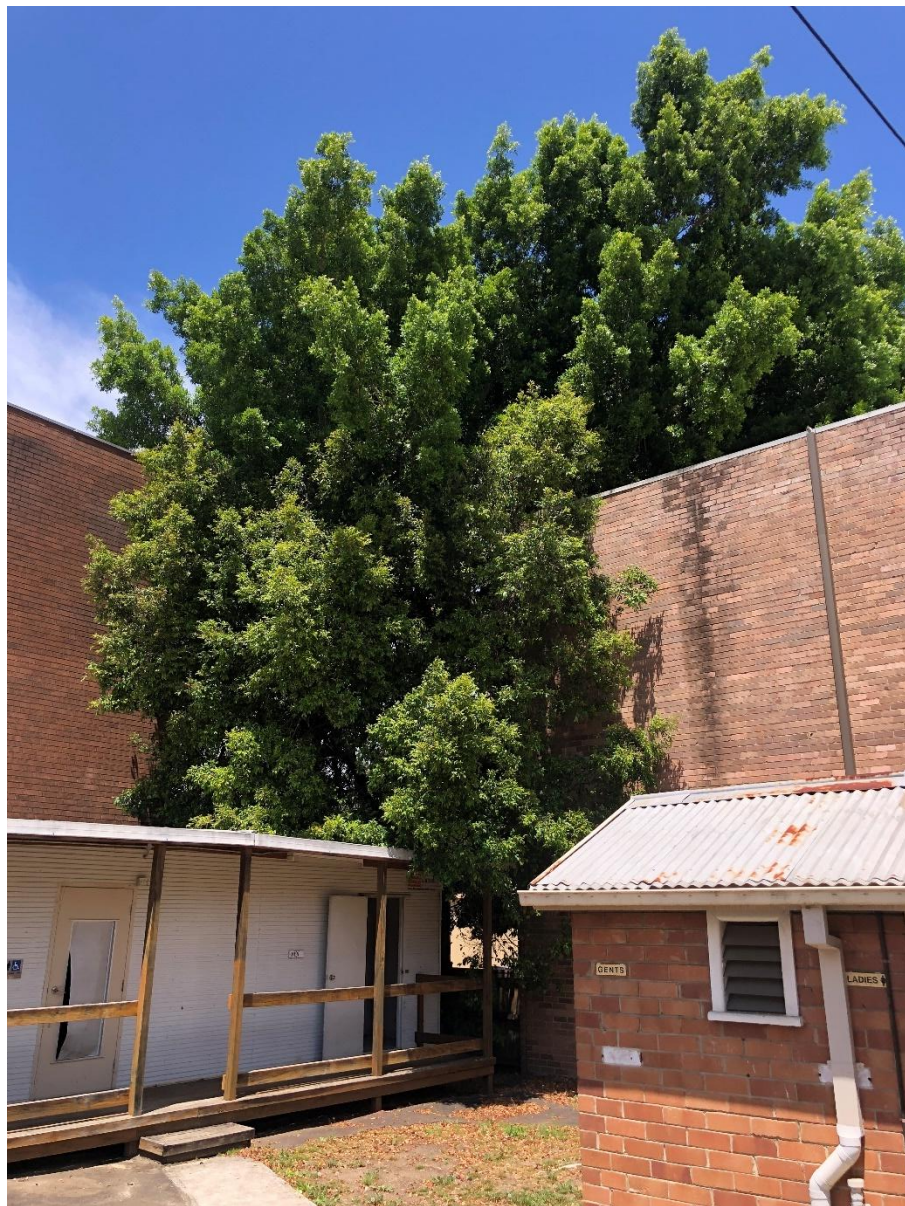
3.10 Tree 13 is a large mature Hills Weeping Fig growing in the adjoining car park area to the south-east of the site (Plate 3). This tree is approximately twenty-five (25) metres in height with an approximate twelve (12) metre canopy spread that partially overhangs the client's site. Woody roots can be found on the client's site from this tree. Below Tree 13 is Tree 14, a suppressed specimen of Lilly pilly (*Syzygium luehmannii*), also growing on the edge of the car park. Due to the more vigorous nature of the root system of Tree 13 it is unlikely the roots from Tree 14 have been able to compete and, as such, it is unlikely there will be many roots from Tree 14 within the client's property.

Plate C: Image showing the dominant Tree 13 on the adjoining property. P.Vezgoff

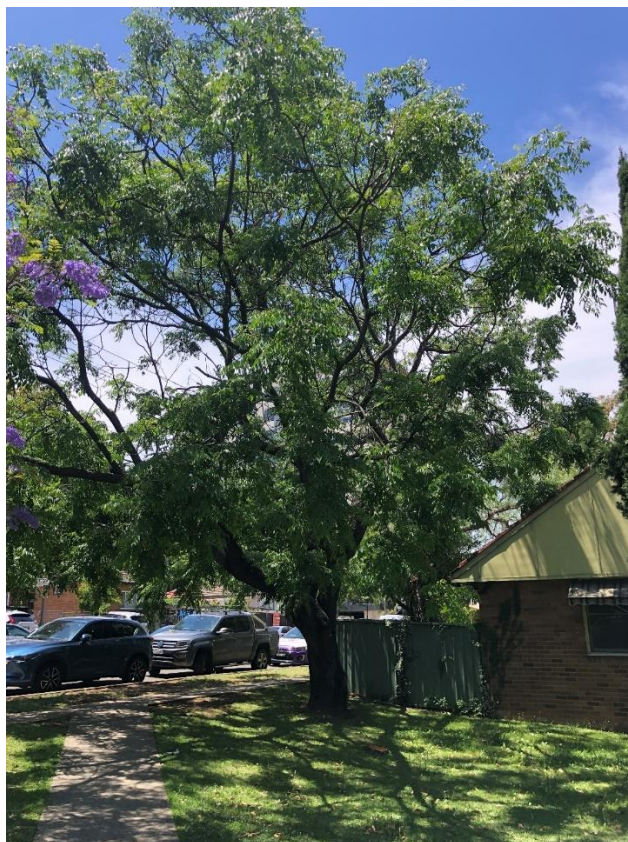
Plate 1: Image showing Tree 1. P. Vezgoff.

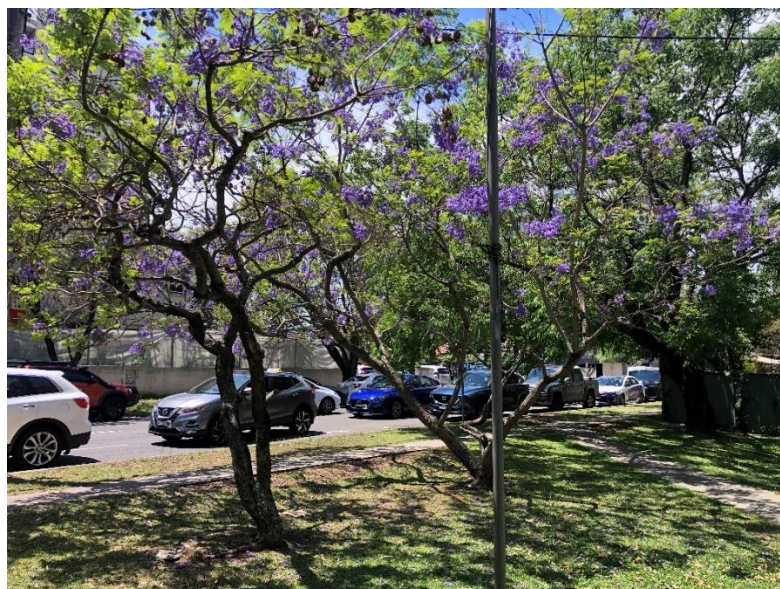
Plate 2: Image showing Tree 2 and 3. P. Vezgoff.

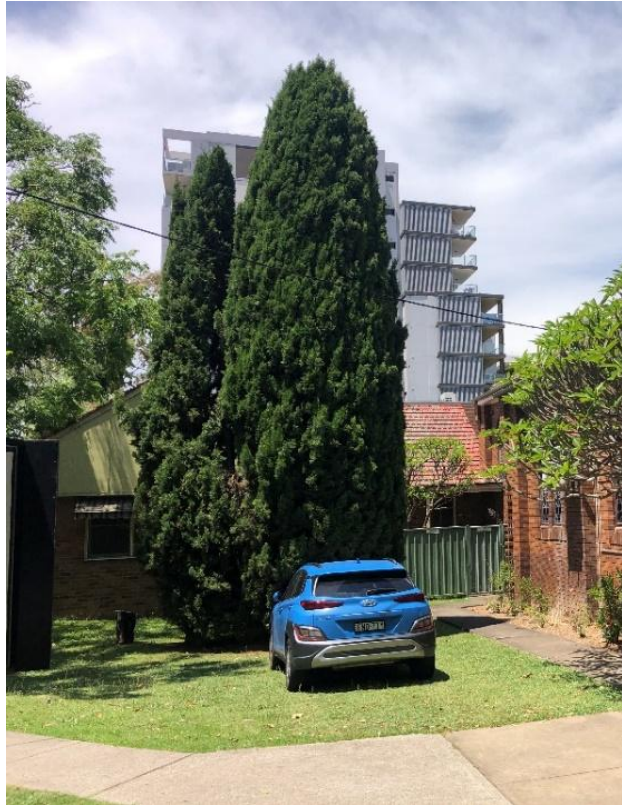
- 3.7** Trees 4 and 5 are two (2) large mature Bhutan cypress (*Cupressus torulosa*) that possibly date from when the church was originally constructed. Trees 6 and 7 are two (2) mature Frangipani trees, both in good health and condition growing close to existing buildings.
- 3.8** Trees 8, 9 and 10, along the Chapel Road frontage are street trees and, as such, are Council property (Plate B). Trees 8 and 9 are large mature London plane (*Platanus x hybrida*) that are in good health and condition with broad spreading canopies and are codominant with each other. Tree 10 is codominant with Tree 9. Tree 10 is a mature Brushbox (*Lophostemon confertus*) in fair health and condition. It appears to be under a degree of stress as evidenced by the epicormic growth along the first order limbs.

Plate 3: Image showing Trees 4 and 5. P. Vezgoff.

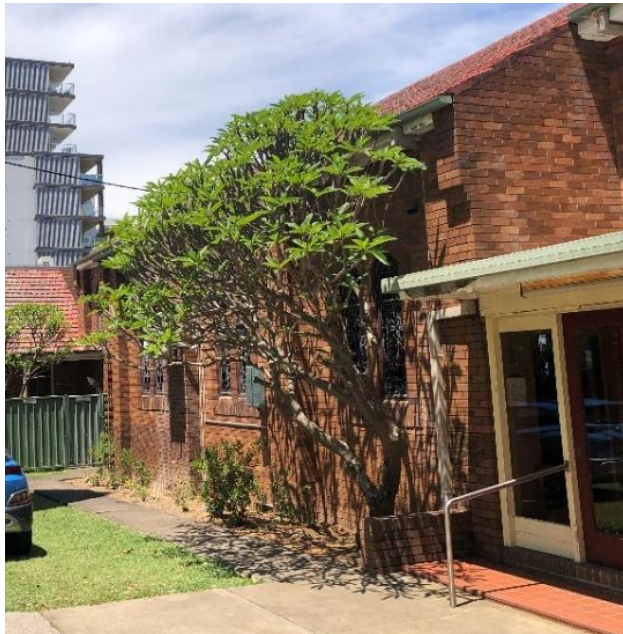
Plate 4: Image showing Tree 6. P. Vezgoff.

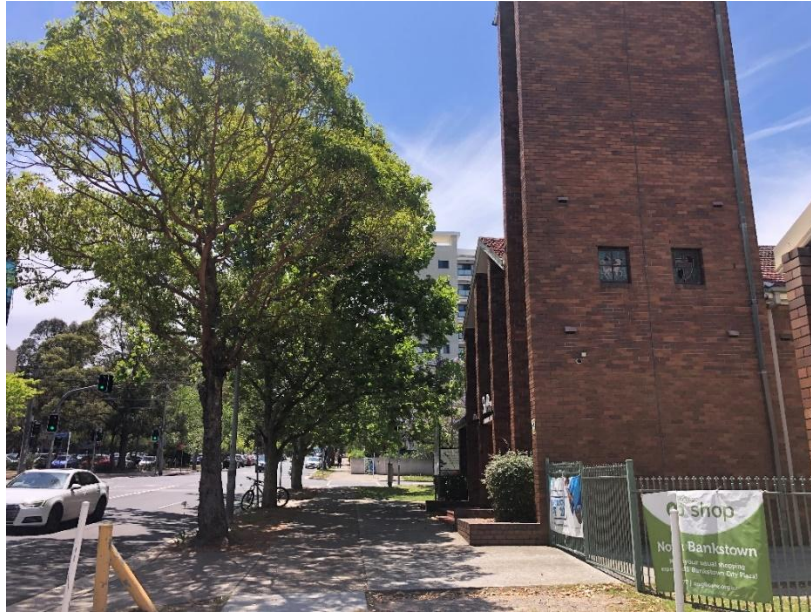
Plate 5: Image showing Tree 8, 9 and 10. P. Vezgoff.

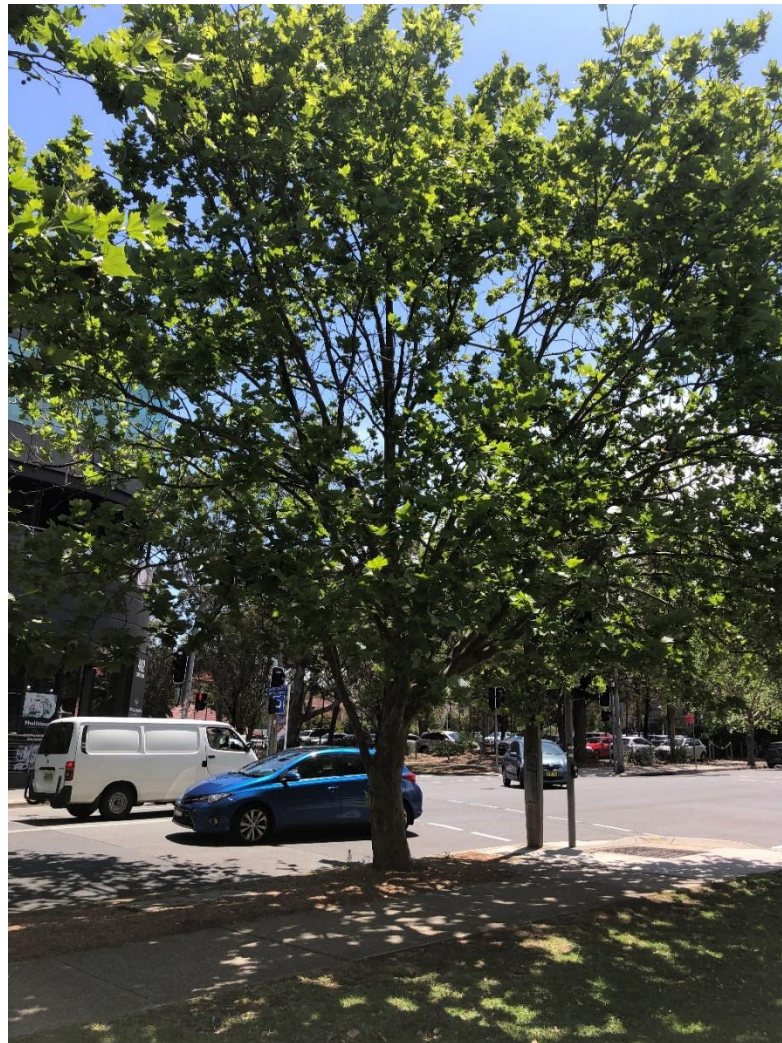
Plate 6: Image showing Tree 8. P. Vezgoff.

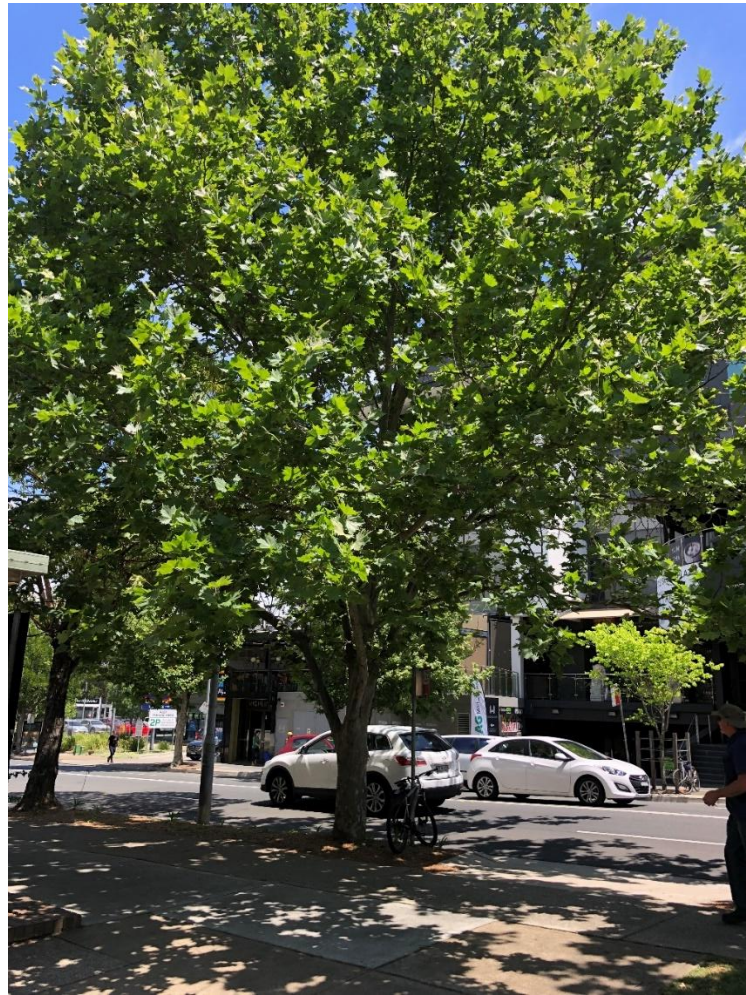
Plate 7: Image showing Tree 9. P. Vezgoff.

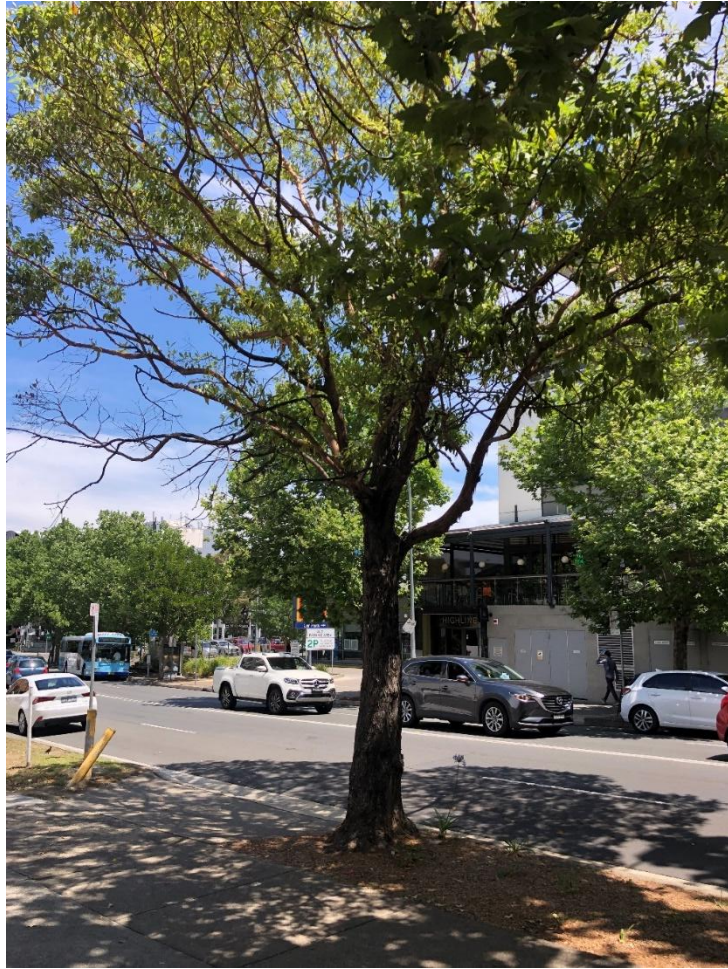
Plate 8: Image showing Tree 10. P. Vezgoff.

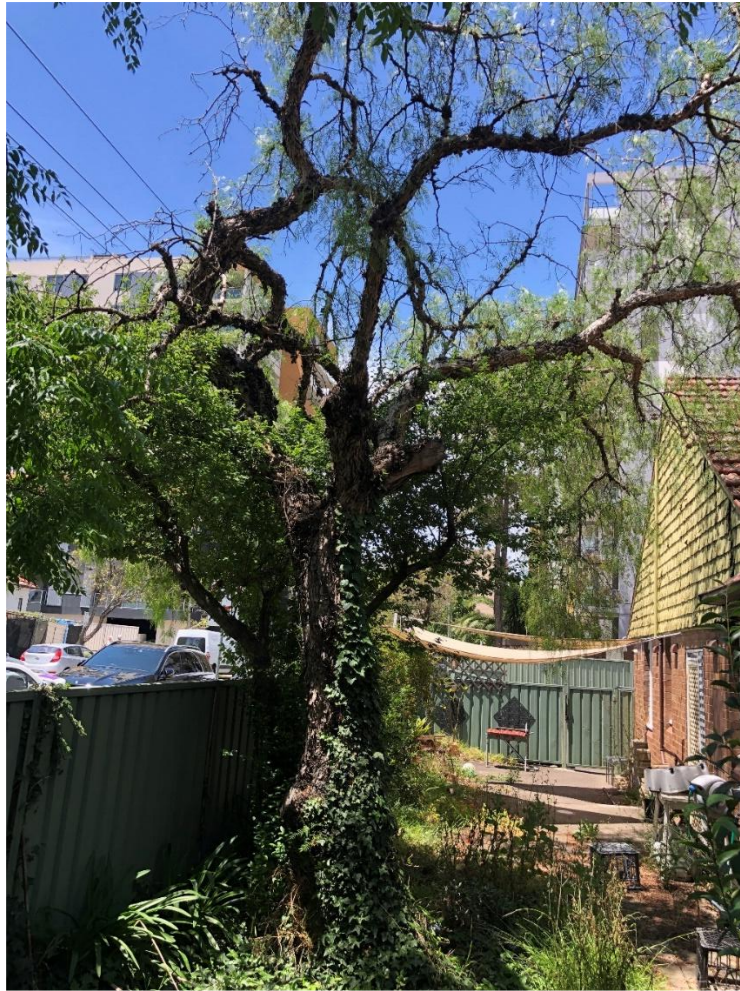
3.9 Trees 11 and 12 are located within the rectory building garden area. Tree 11 is an overmature Peppercorn tree in poor health and condition. Tree 12 is an ornamental fruit tree only in fair condition. In terms of significance, none of the site trees would be considered highly significant or be of long-term value.

Plate 9: Image showing Tree 11 and 12. P. Vezgoff.

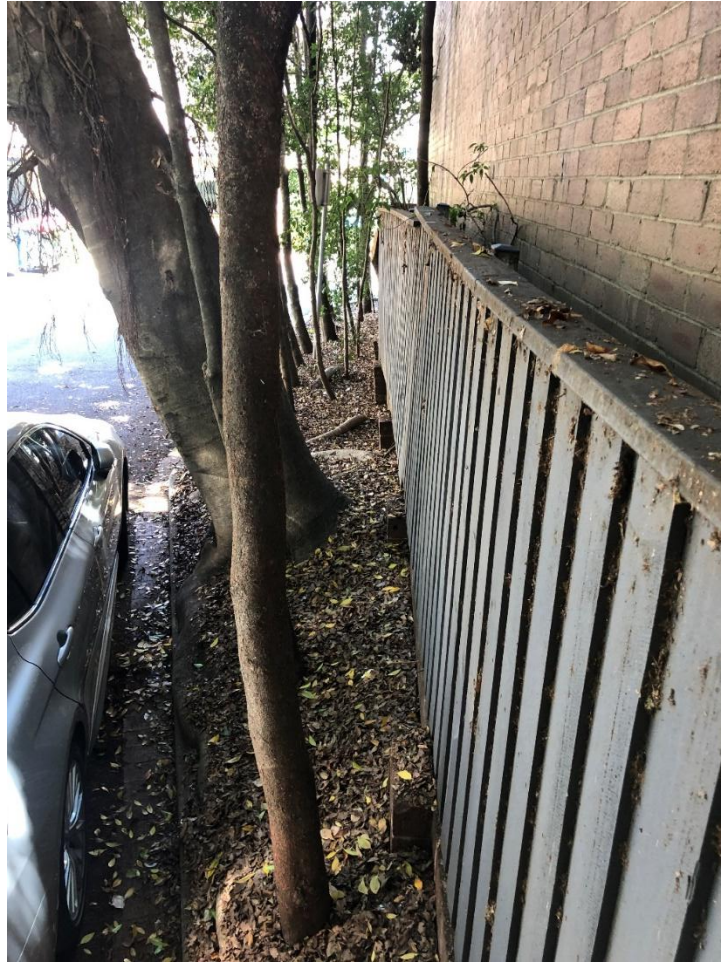
Plate 10: Image showing the trunk of Tree 13. P. Vezgoff.

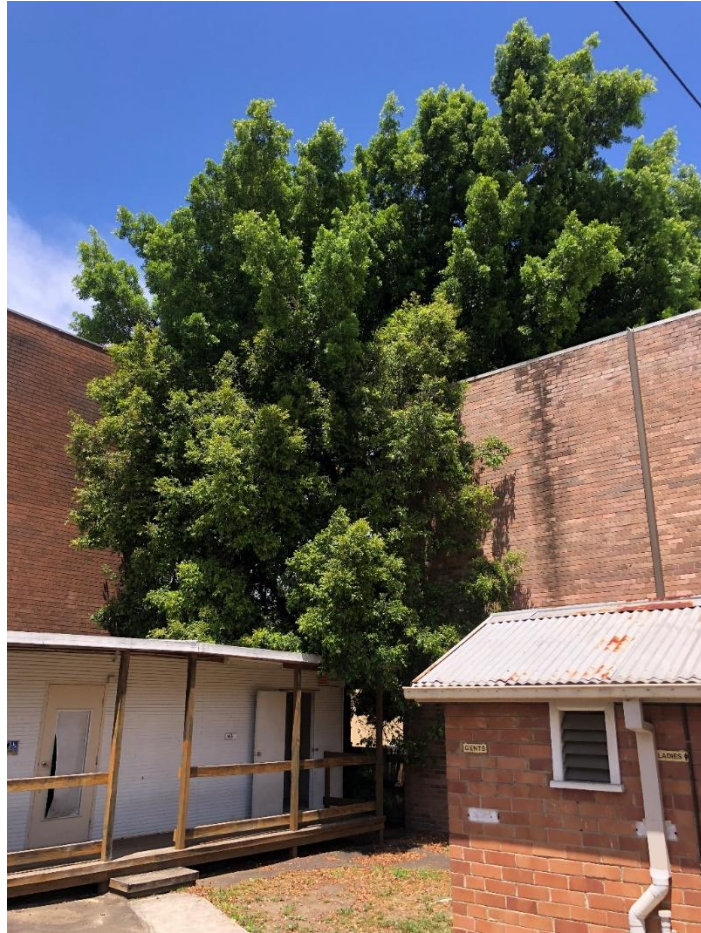
Plate 11: Image showing Tree 13. P. Vezgoff.

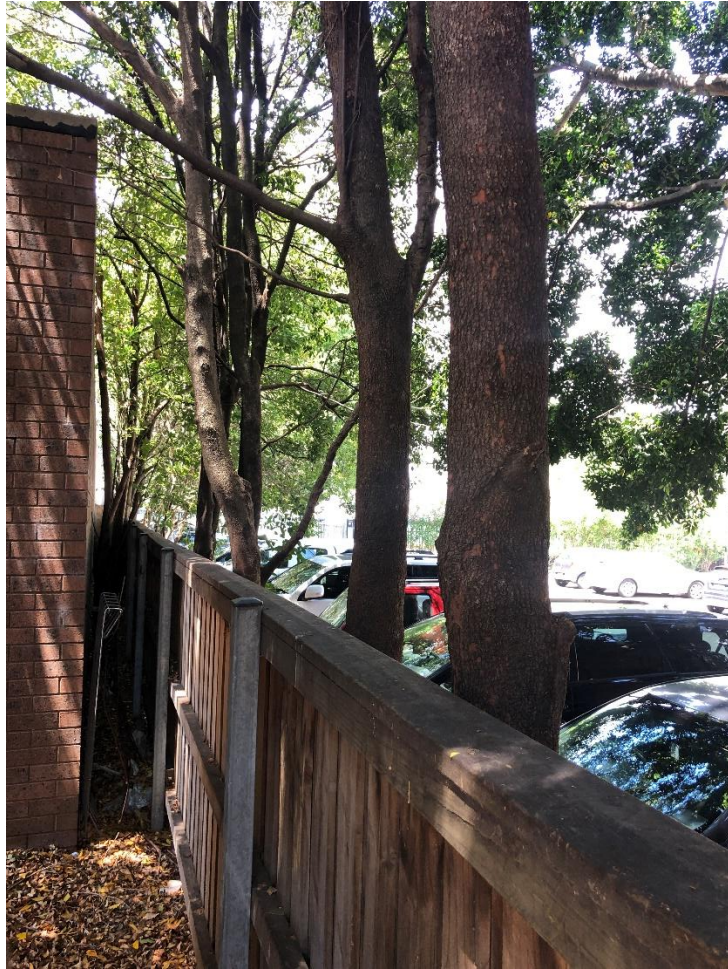
Plate 12: Image showing Tree 14. P. Vezgoff.
