# **Arboricultural Impact Assessment**

**10 Missenden Rd, Camperdown**

**Prepared by Alex Austin  
For  
ISPT  
August 2025 V006**

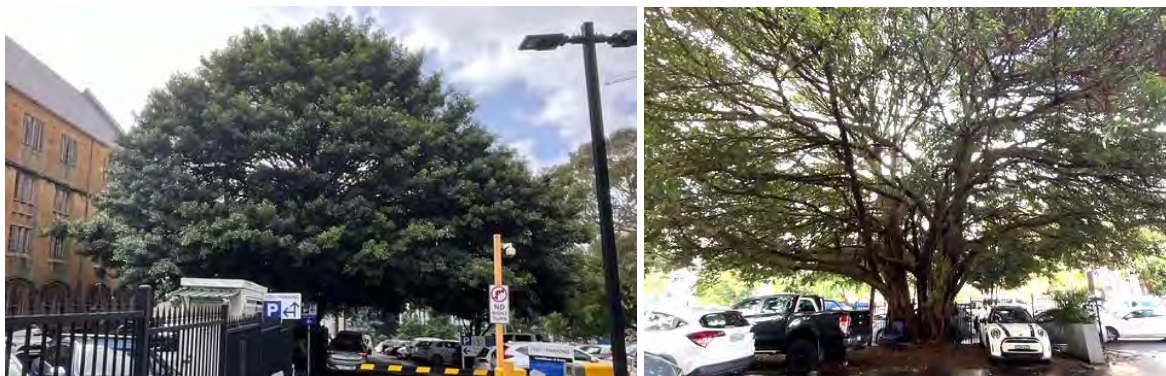
Major observations which included; Co-dominant stems, Crossing/rubbing branches, Deadwood > 60mm, Exposed roots, Hanger(s), Mechanical damage to root(s), Poor pruning, Previous branch failure(s), Soil compaction, Unbalanced crown, Wound response growth.

Arborist notes included; Minor hanger, aerial roots.

Figures 19 & 20: Tree 31 can be observed in the landscape. (Source: Austin 28<sup>th</sup> of April 2025).

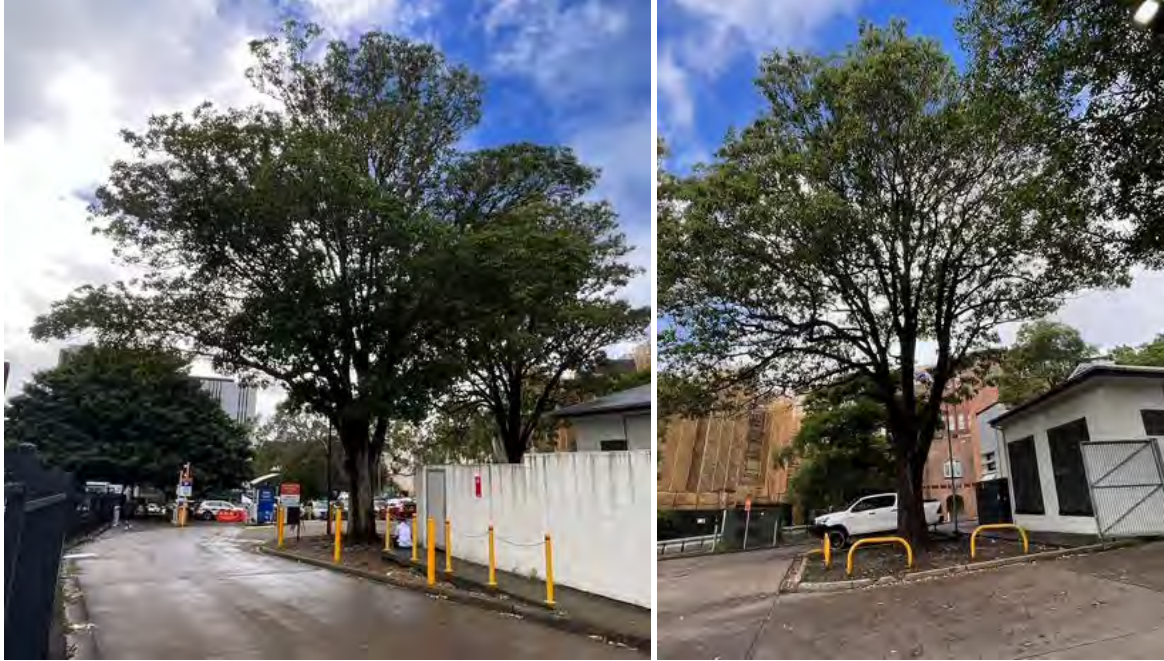
Trees 28 & 29 *Lophostemon confertus* (Qld Box) are large site trees listed as “substantial trees to be preserved” in the CMP. The trees have High retention value and High landscape prominence. The trees are in good condition and have long life expectancies of 40+ years. The trees have large NRZ’s. Considerable efforts should be made to incorporate these trees within the project.

**Figures 21 & 22:** Tree 28 (Left) and Tree 29 (Right) in the landscape (Source: Austin 28<sup>th</sup> of April 2025).

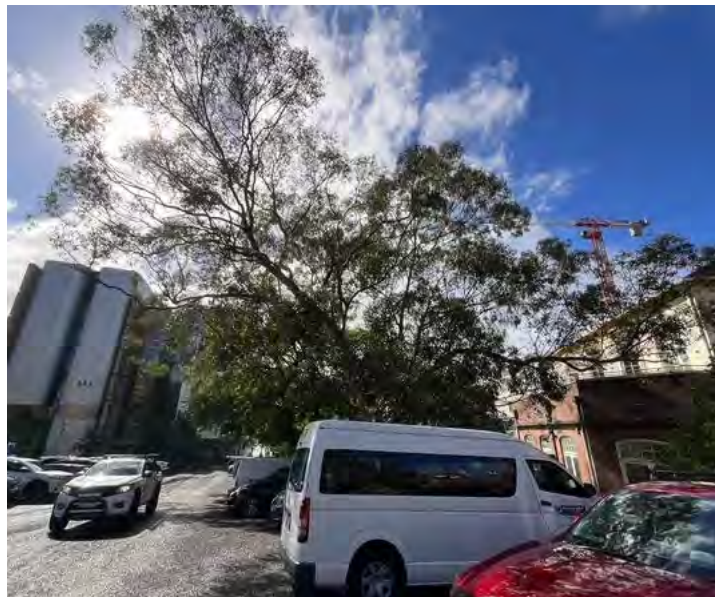
Tree 15 *Eucalyptus punctata* (Grey Gum) had major observations which included: Cavity, Crossing/rubbing branches, Previous branch failure(s), Trunk Wound(s), Wound response growth. Arborist notes included; Bees nest at three (3) m height. Canopy skewed 12m over site. Remove rubbing branch.

**Figure 23:** Tree 15 can be observed in the landscape. (Source: Austin 28<sup>th</sup> of April 2025)

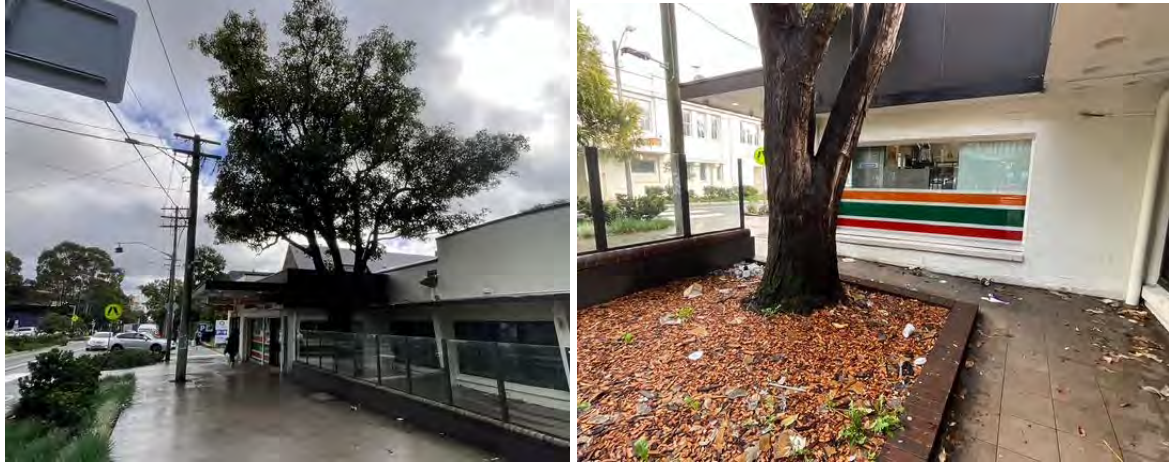
Tree 25 *Lophostemon confertus* (Qld Box) is a large site tree adjacent to a site building. The tree has a High retention value and High landscape prominence. The tree is in good condition and has a long life expectancy of 40+ years. The tree has a large NRZ. The existing structure is built within the NRZ and SRZ. Demolition of the existing structure is likely to impact the viability of the subject tree due to stability loss. Considerable efforts should be made to incorporate this tree within the project

**Figures 24 & 25:** Tree 25 in the landscape. (Left) and Tree 25's growing location (Right). (Source: Austin 28<sup>th</sup> of April 2025).

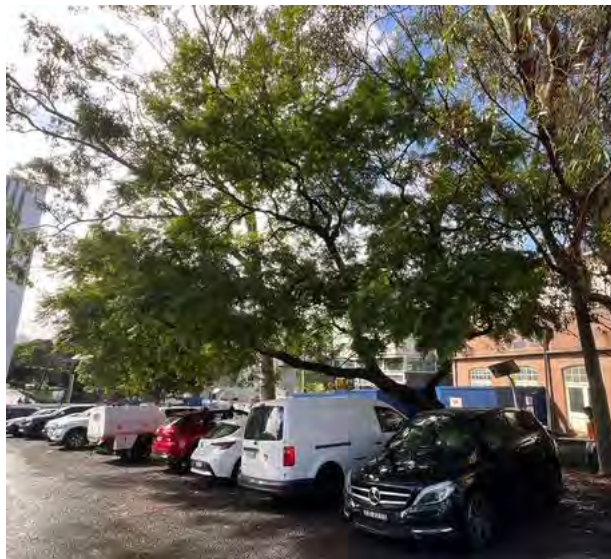
Tree 17 *Jacaranda mimosifolia* (Jacaranda) is a medium sized tree. The tree has a Medium Retention Value retention value and moderate landscape prominence. The tree is in a suppressed condition and has a long life expectancy of 40+ years. Reasonable efforts should be made to incorporate this tree within the project.

**Figure 26:** Tree 17 can be observed in the landscape. (Source: Austin 28<sup>th</sup> of April 2025).

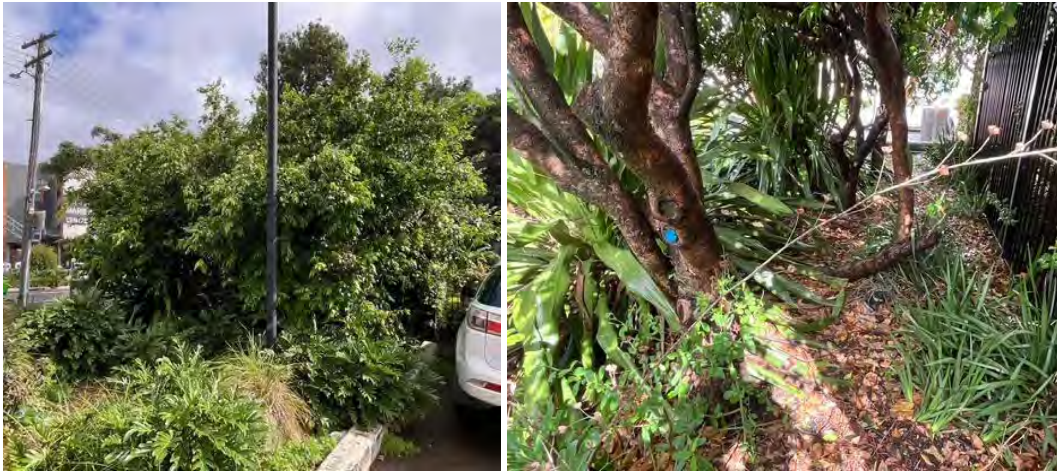
Tree 27 *Syzygium leuhmannii* (Lilly Pilly) is a group of Four (4) small trees forming a hedge row on the Missenden Road frontage. The hedge is in good condition and have a small NRZ and a medium life expectancy.

**Figures 27 & 28:** The four (4) Trees forming tree 27 can be observed in the landscape. (Source: Austin 28<sup>th</sup> of April 2025).

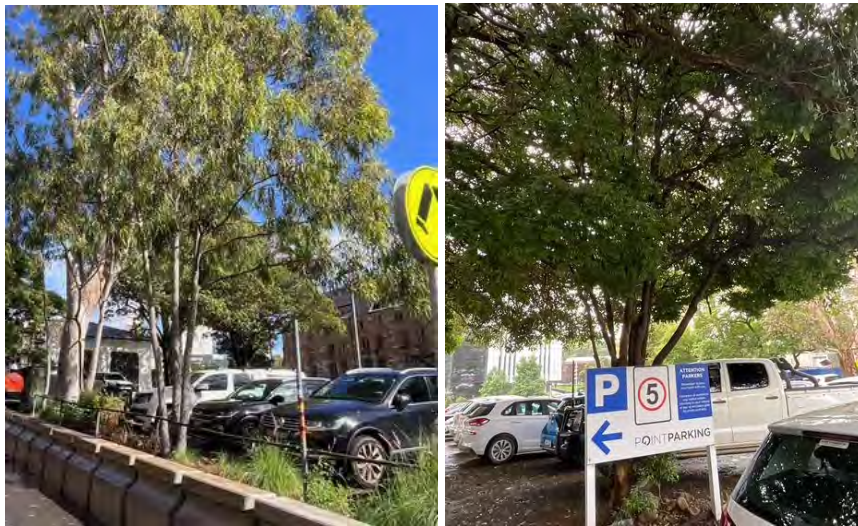
Five (5) Trees numbered 6, 12, 14, 30 & 35 form the Low Retention Value category. Trees in this category should not be considered a constraint on development as they have reduced health or condition, or have short life expectancies or have low landscape significance or are easily replaceable due to their small size.

**Figures 29 & 30:** Tree 14 *Corymbia maculata* (Spotted Gum) (Left) has multi stem form with included bark and weak unions, and Tree 30 *Syzygium leuhmannii* (Small leafed Lilly Pilly) (Right) has a suppressed form. (Source: Austin 28<sup>th</sup> of April 2025).

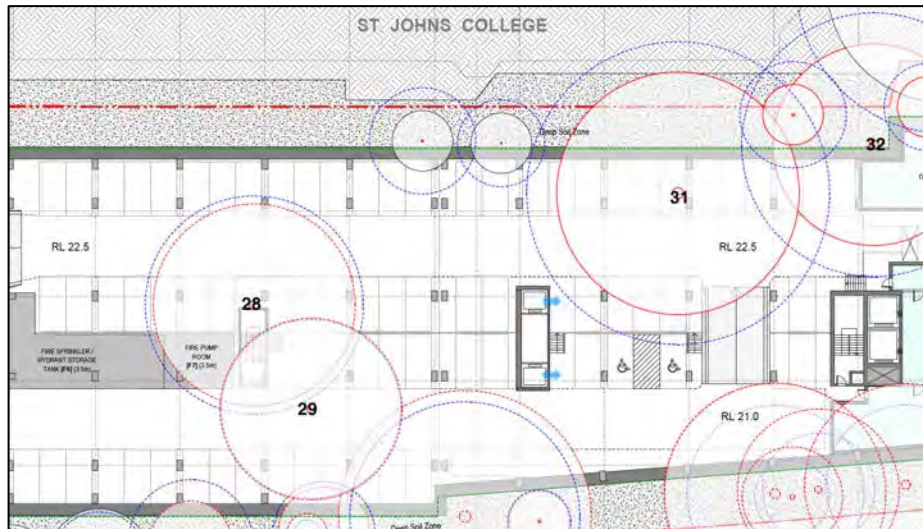
**Figure 38:** The tree impact plan showing the NRZ conflict of trees 28, 29, 31 & 32. (Source: Lower Ground plan from Preliminary Plans by architectus Rev T – TPZ Overlay, dated 16/05/2025).

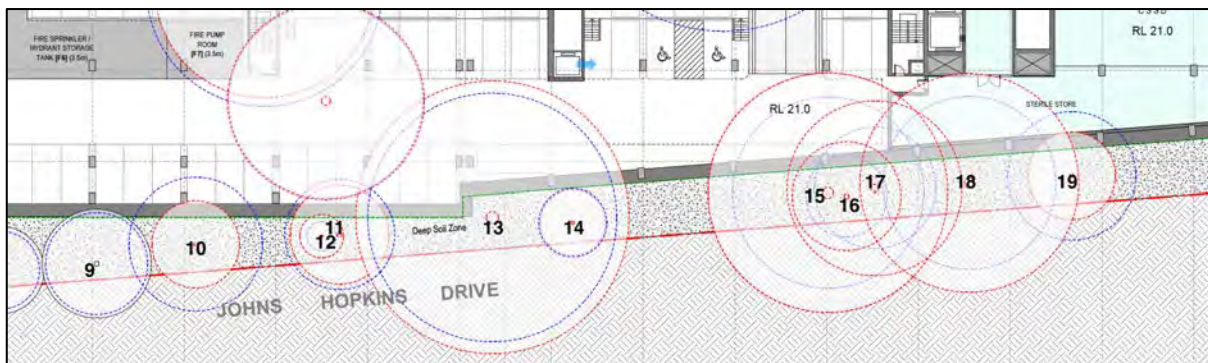
**Figure 39:** The tree impact plan showing the NRZ conflict of Trees 10-19 (Source: Lower Ground plan from Preliminary Plans by architectus Rev T – TPZ Overlay, dated 16/05/2025).

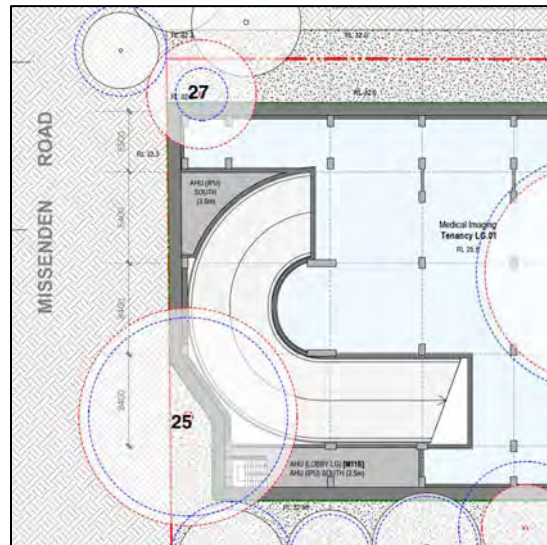
**Figure 40:** The tree impact plan showing the NRZ conflict of Trees 25 & 27 (Source: Basement 1 plan from Preliminary Plans by architectus Rev T – TPZ Overlay, dated 16/05/2025).

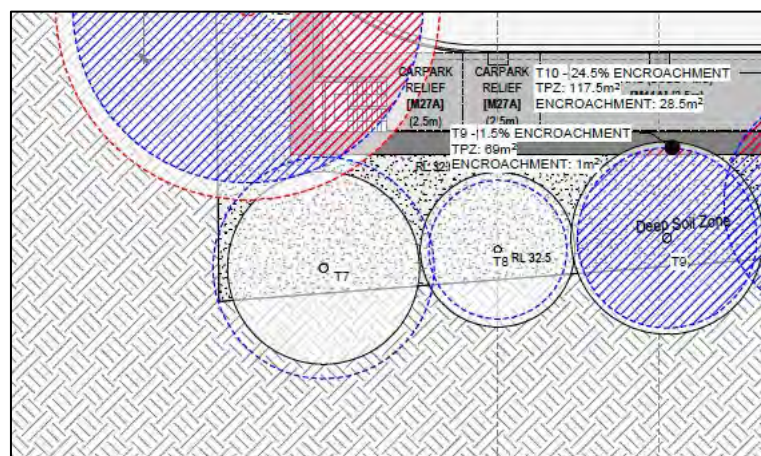
Growing conditions for Trees 7 - 9 are expected to improve following the demolition of the existing structure and viability for the trees is not expected to be impacted.

Trees 7 & 8 have no NRZ encroachment Tree 9 has a minor NRZ encroachment of 1.5% of NRZ.

**Figure 41:** The tree impact plan showing the existing building TPZ conflict of Trees 7 -9 (Source: Lower Ground plan from Preliminary Plans by architectus Rev T – TPZ Overlay, dated 16/05/2025).

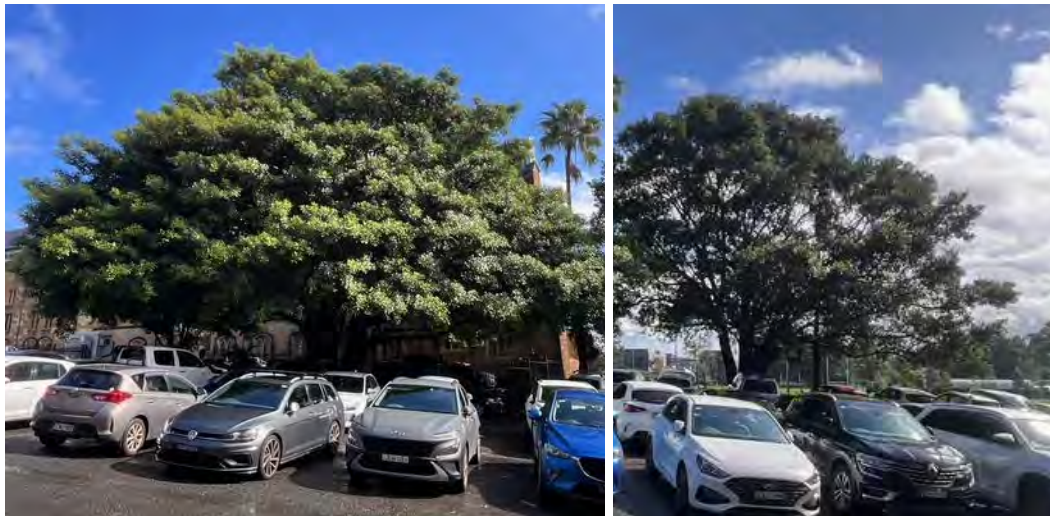
**Figures 54 & 55:** Tree 31 (Left) and Tree 32 (Right) are large site trees listed in the CMP as significant trees that are proposed to be transplanted into the St College grounds. (Source: Austin 28<sup>th</sup> of April 2025).

Four (4) trees including Two (2) mature Fig trees numbered 31, 32, and Two (2) mature Palm trees 33 & 34 are proposed to be transplanted as per the methods detailed in the Arborist Network Transplant Feasibility Study dated Jan 2023 in order to provide additional developable space.
