REPORT: Addendum Arboricultural Impact  
Assessment  
Ref No: 20113d

Lindfield Learning Village

100 Eton Road, Lindfield  
New South Wales 2070

22<sup>nd</sup> of May 2020

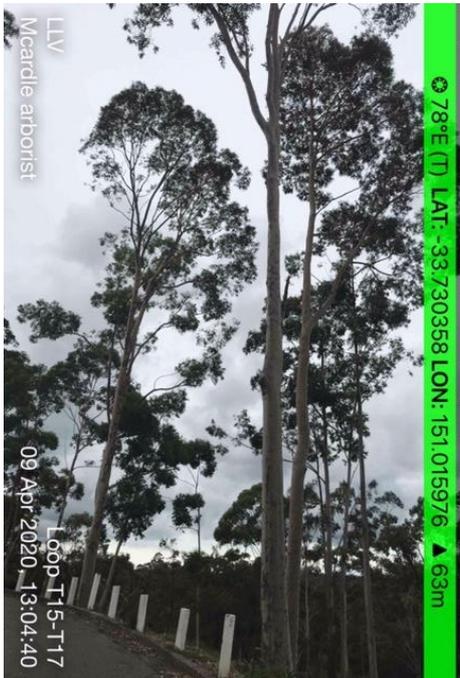
14	-33.730358 151.015976	<i>Angophora costata</i> Smooth Bark Apple	2	8	12/10 18	2 1.61	Juvenile, twin stem, damage to north stem 2m length.	2d	Low	REMOVE
15	-33.730358 151.015976 1.5m from road	<i>Corymbia maculata</i> Spotted Gum	6	18	36 42	4.32 2.3	Immature, union at 12m, unbalanced canopy south, sparse foliage crown, good condition but poor development, growing on steep slope east, root issues.	2d-3d	Mod	REMOVE
16	-33.730358 151.015976	<i>Corymbia maculata</i> Spotted Gum	7	21	46 56	5.52 2.59	Semi mature, inclusion and twin stem at 2m, unbalanced canopy south, good condition but poor development, growing on east slope.	2d	Mod-High	REMOVE
17	-33.730358 151.015976	<i>Corymbia maculata</i> Spotted Gum	6	24	47 55	5.64 2.57	Semi mature, unbalanced canopy east, good condition.	2d	Mod-High	RETAIN & PROTECT
18	-33.730358 151.015976	<i>Angophora costata</i> Smooth Bark Apple	2	8	12/10/10 20	2.28 1.68	Juvenile, dead primary leader, declining, peeling bark, poor condition.	3d	Low	REMOVE

Plate 1. Trees 15-17 *Corymbia maculata* Spotted Gum, east of road.

11.4 Twelve (12) trees are impacted by the proposed bus turning bay and cannot be retained numbered 5, 6, 7, 8, 9, 10, 12, 13, 14, 15, 16 & 18. Trees with impacts that would be detrimental to their health have been selected to be removed to ensure the minimal number of trees are being removed on site. Tree 8 has a 15% impact which could be managed using sensitive construction, however as the tree is growing on the steep embankment and the turning bay will impact the SRZ it cannot be retained as the proposed works would cause anchorage and stability issues for the tree.

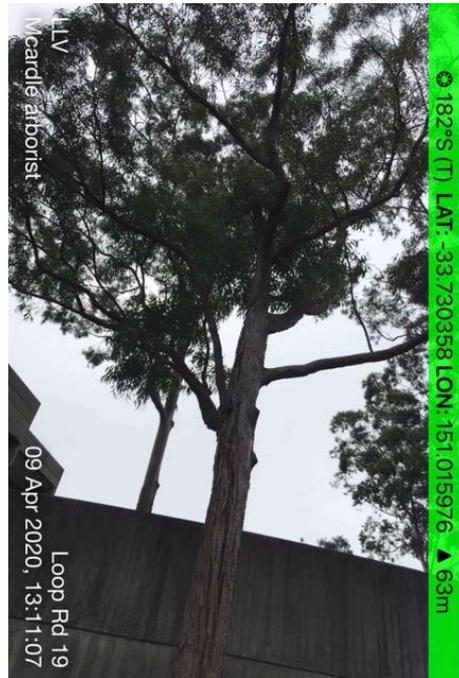
19	-33.730358 151.015976	<i>Eucalyptus resinifera</i> Red Mahogany	13	15	40* 45	4.8 2.37	Immature, bracket fungi south at 5m, epicormics, dead leader, good condition but poor development, dehydrated.	2d-3d	Mod	RETAIN & PROTECT
20	-33.730358 151.015976	<i>Eucalyptus robusta</i> Swamp Mahogany	12	26	45* 50	5.4 2.47	Semi mature, root damage from wall, lean and unbalanced canopy west, epicormics, dead wood.	2d	Mod-High	RETAIN & PROTECT

Plate 2. Tree 19 *Eucalyptus resinifera* Red Mahogany.

11.5 Eighteen (18) trees are to be retained and protected numbered 1, 2, 3, 4, 11, 17, 19, 20, 21, 22, 23, 24, 25, 26, 27, 28, 29 & 30. Eight (8) trees numbered 1, 17, 19, 21, 25, 26, 27, 30 require sensitive construction for all work within the TPZ which must be under the supervision of an AQF level 5 arborist. Sensitive construction within the TPZ of the impacted retained trees is required to ensure the root systems of the trees are not severely damaged. All work within the TPZ must be under the supervision of an AQF level 5 Arborist and no roots greater than 50mm are to be cut unless given consent. The excavations required for the bus turning bay are to be excavated by hand within the TPZ of retained trees. The impacts proposed on some of the retained trees are greater than the standards allow, however some of them have already been impacted upon and the previous footprint of the road and path will have minimal changes. The larger impacts are to be managed using sensitive construction in order to retain as many trees as possible on site due to the high biodiversity value of the site.

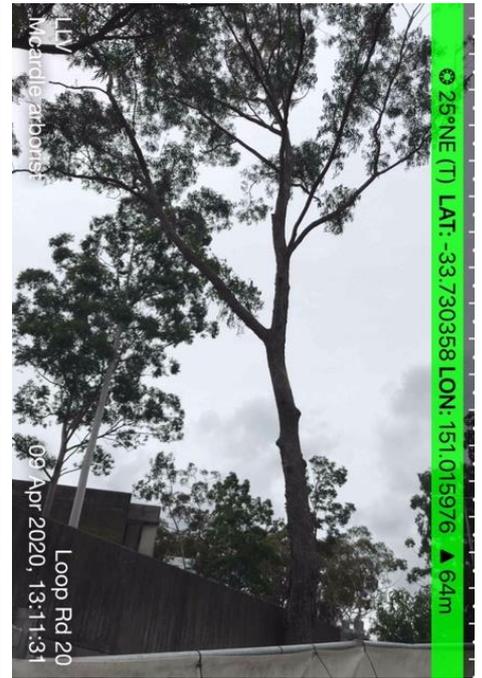
Plate 3. Tree 20 *Eucalyptus robusta* Swamp Mahogany.

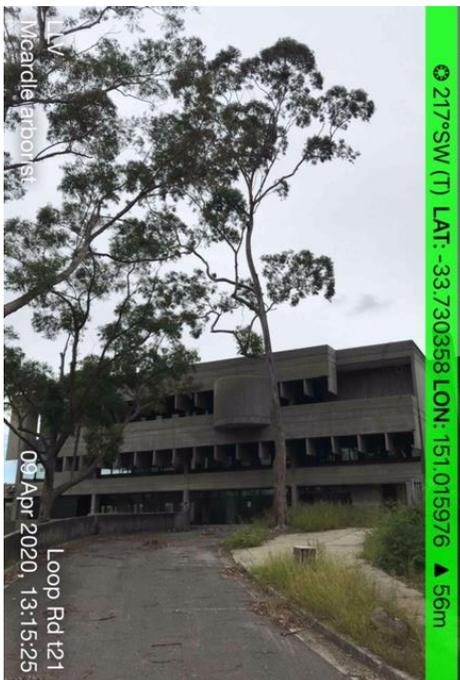
Plate 4. Tree 21 *Eucalyptus saligna* Blue Gum.

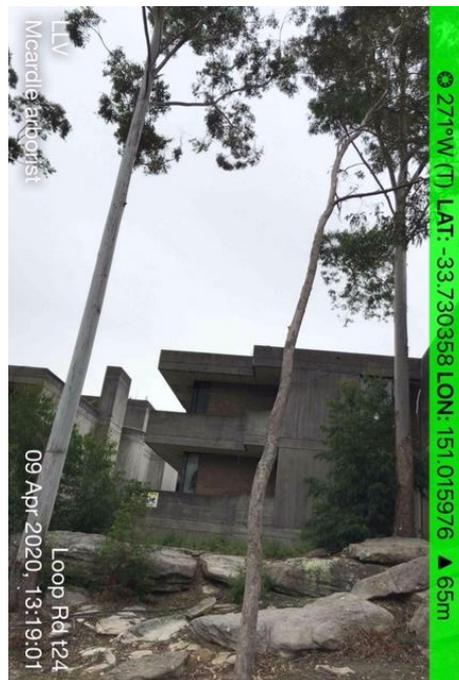
Plate 5. Tree 24 *Eucalyptus punctata* Grey Gum.

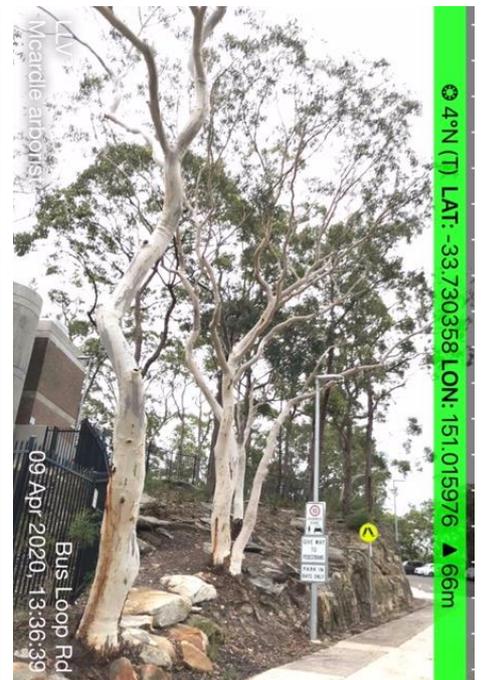
25	-33.730358 151.015976	<i>Corymbia gummifera</i> Red Bloodwood	5	17	23 25	2.76 1.85	Immature, good condition but poor development, sparse foliage crown, damage at 7m west, unbalanced canopy east.	2d	Low-Mod	RETAIN & PROTECT
26	-33.730358 151.015976 (Metal Tag 75)	<i>Eucalyptus haemastoma</i> Scribbly Gum	7	11	50 53	6 2.53	Semi mature, sparse foliage crown, unbalanced canopy, kinked trunk, epicormics, previously pruned, exposed roots, growing on slope.	2d-3d	Mod	RETAIN & PROTECT
27	-33.730358 151.015976	<i>Eucalyptus haemastoma</i> Scribbly Gum	11	12	45/23 63	6.12 2.73	Semi mature, twin stem at base, exposed roots southeast, good condition but poor development.	2d-3d	Mod-High	RETAIN & PROTECT
28	-33.730358 151.015976 (Metal Tag 61)	<i>Eucalyptus haemastoma</i> Scribbly Gum	5	9	28 30	3.36 2	Immature, good condition but poor development, previously pruned at base leader, epicormics, scar along length of trunk west, hollow 3m south 15x15cm.	3d	Low	RETAIN & PROTECT

Plate 6. Trees 26-30, west of road.
