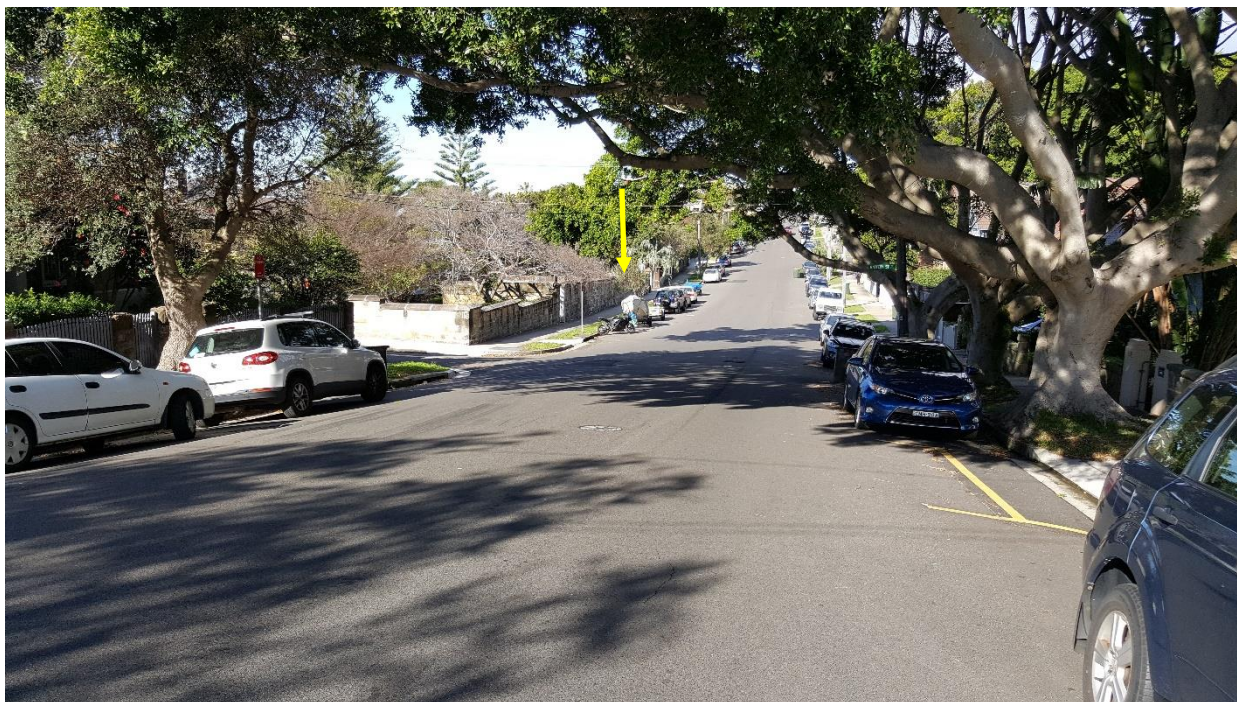
**Figure 11 – Southern view along Beach Street towards vehicular Site entrance**

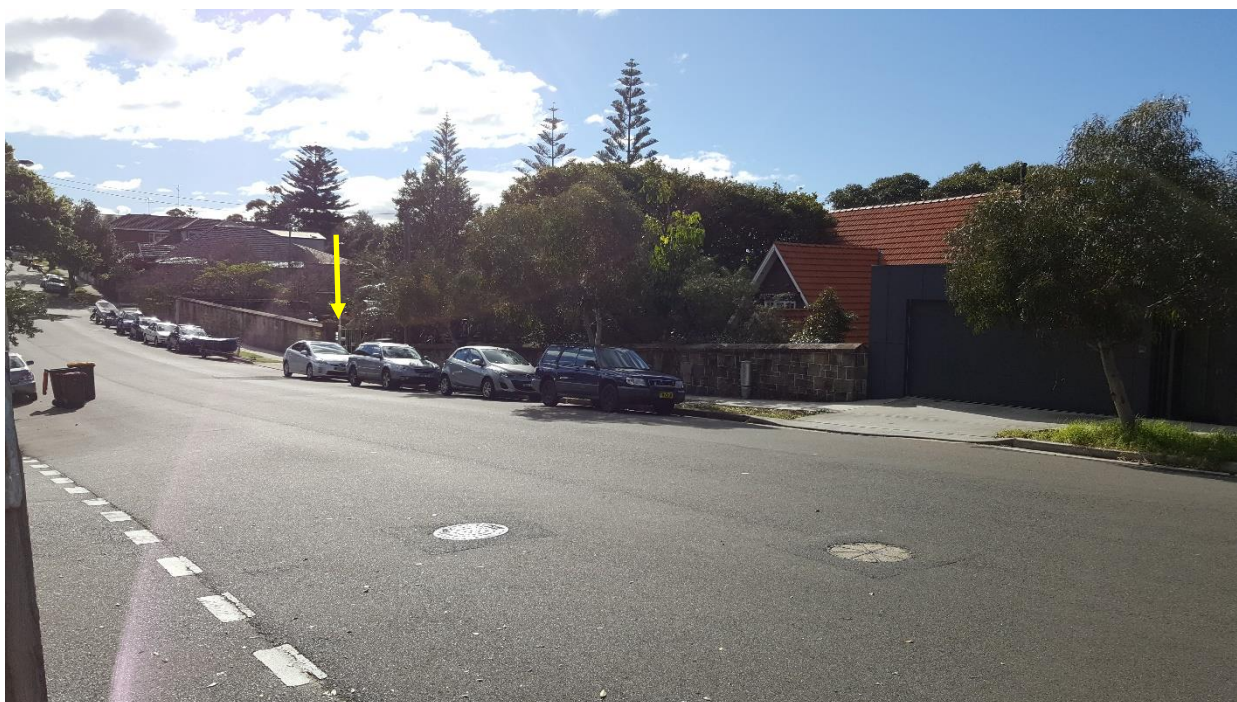
**Figure 12 – Northern view along Beach Street towards vehicular Site entrance**

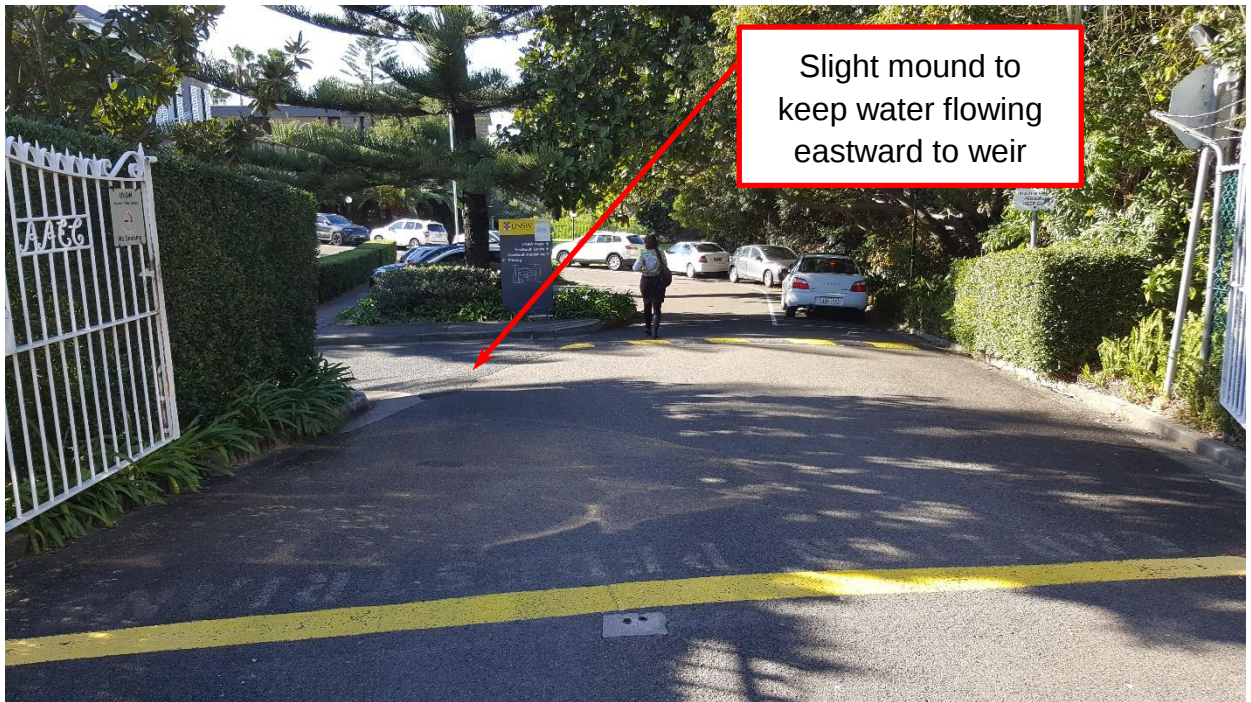
**Figure 13 – Eastern view into the Site**

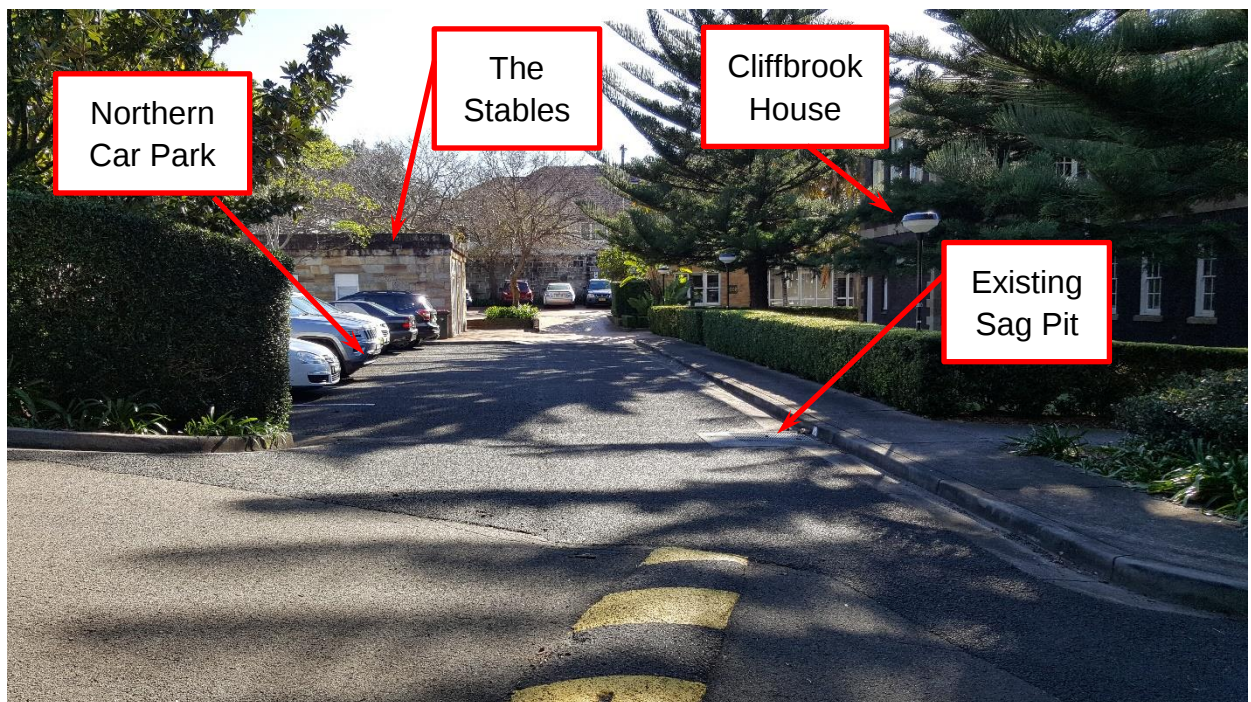
**Figure 14 – Northern view from within the Site vehicular entry**

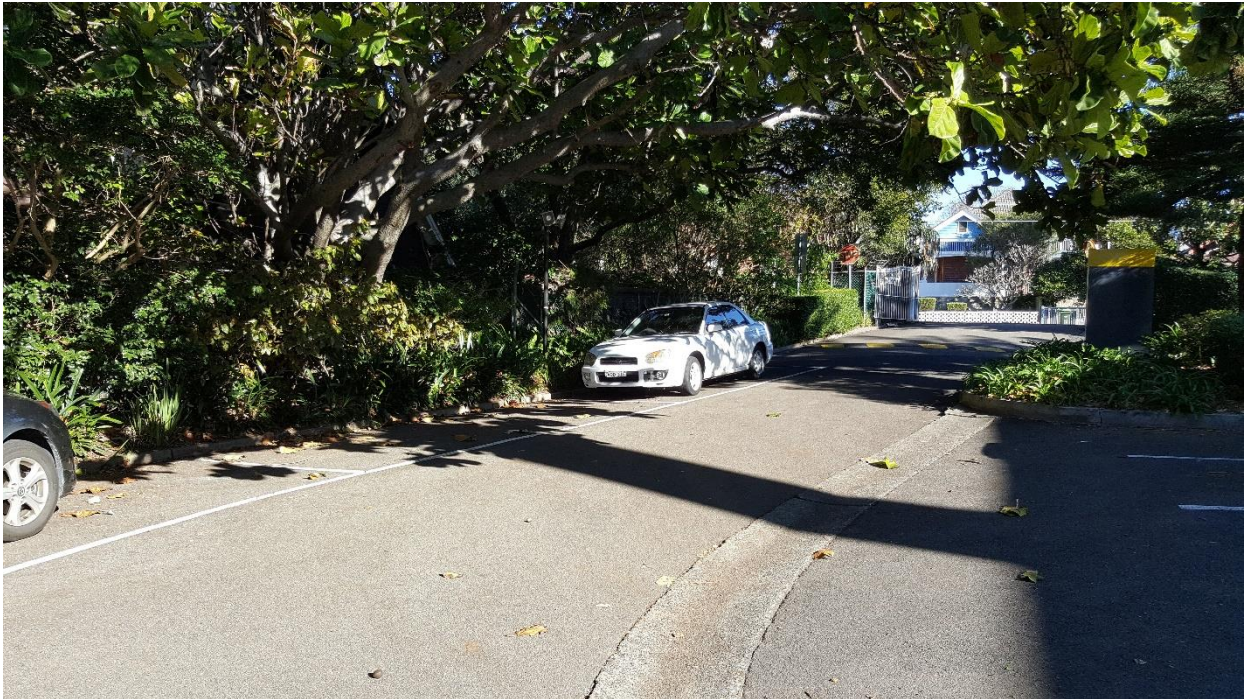
**Figure 15 – Western view towards Site vehicular entry**

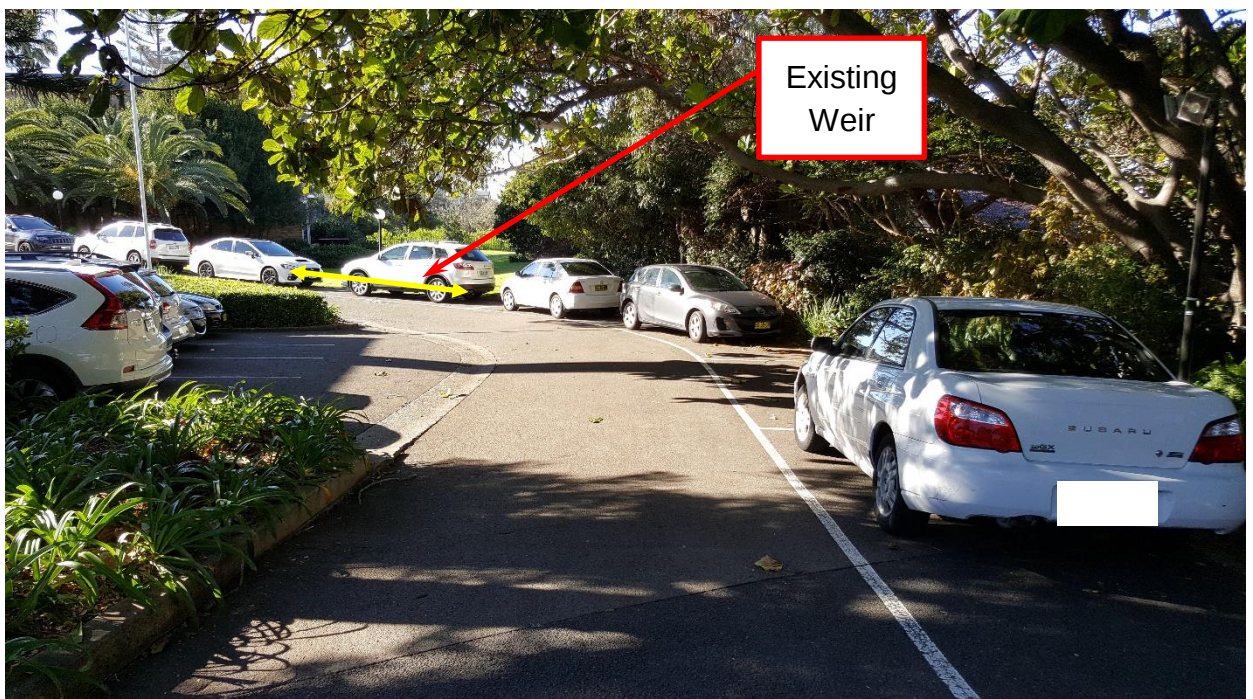
**Figure 16 – Eastern view along driveway towards overland flow weir**

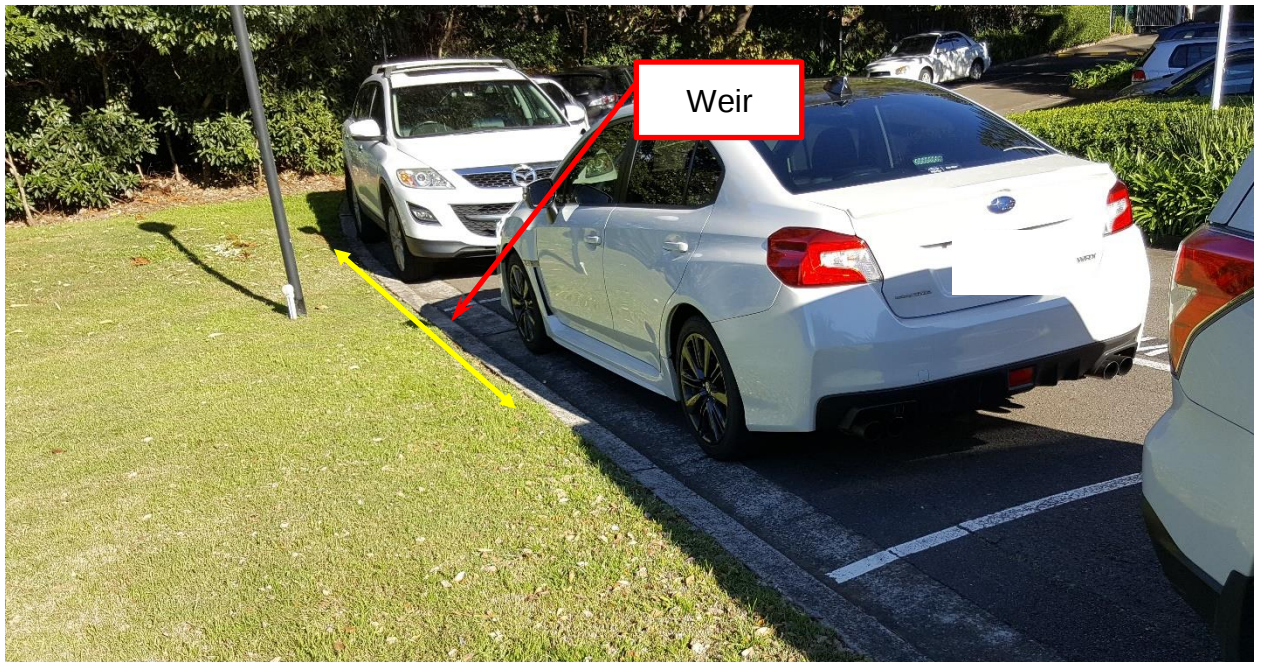
**Figure 17 – Overland flow weir downstream of the Site vehicular entrance**

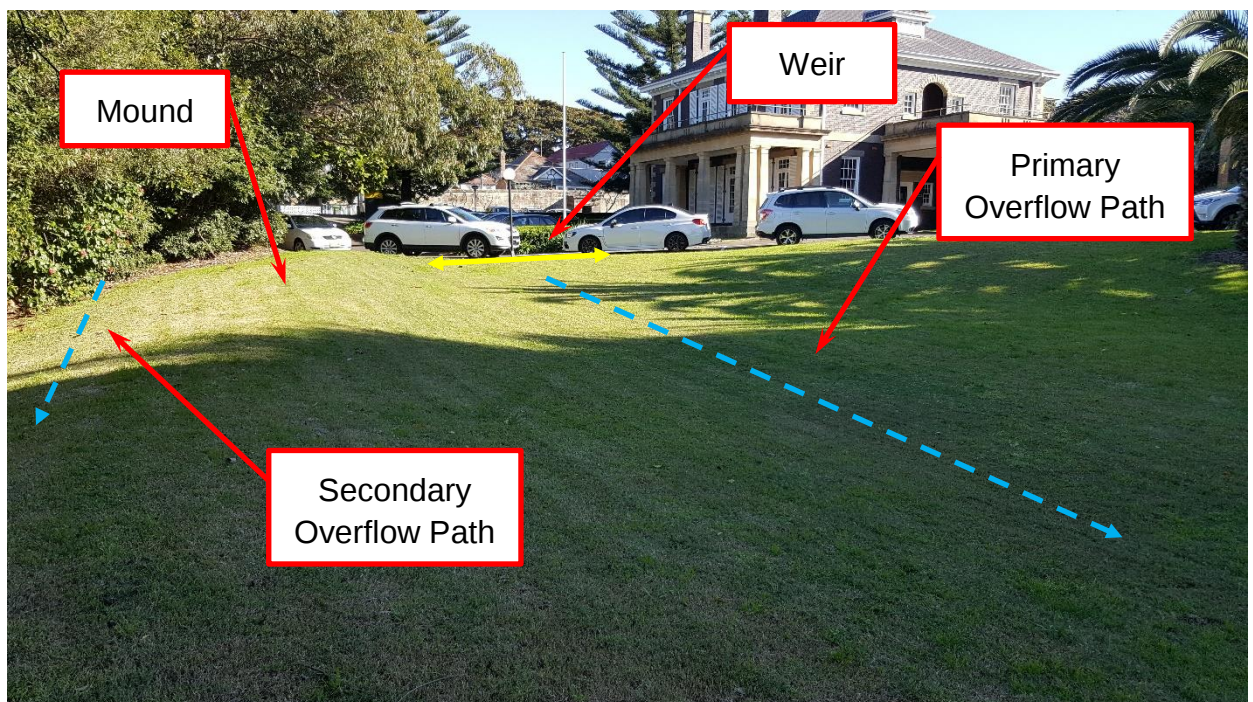
**Figure 18 – Western view of overland flow weir, mound and overflow paths**

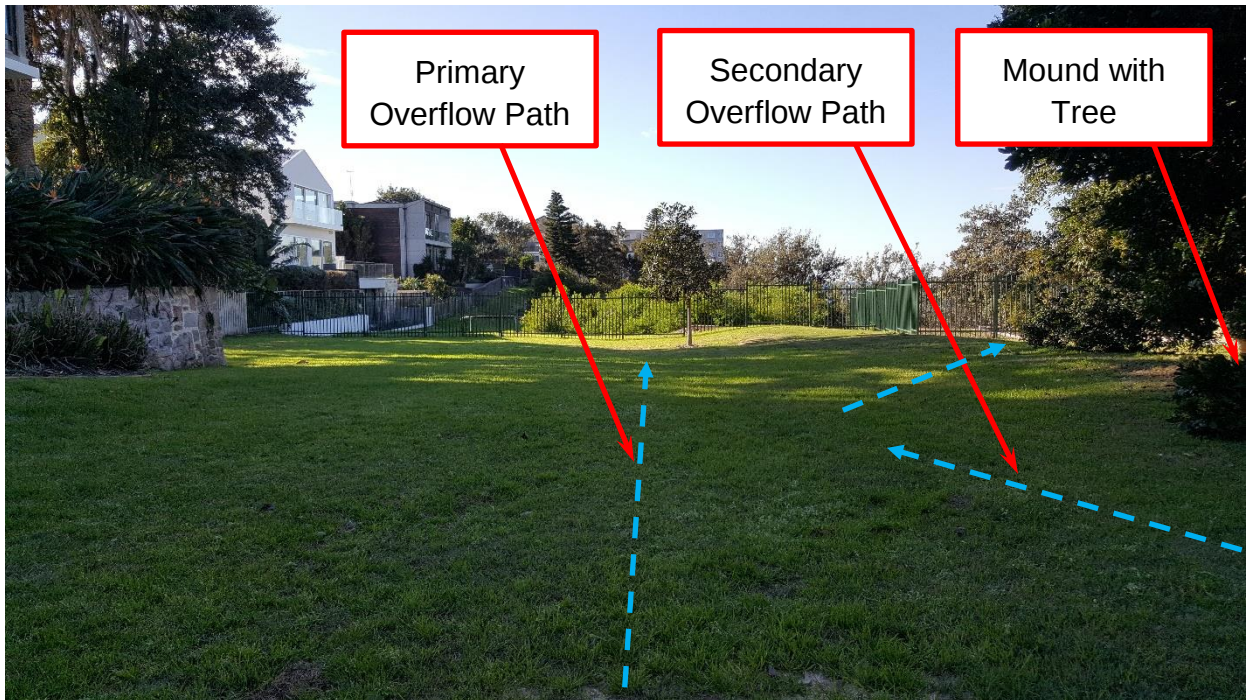
**Figure 19 – Eastern view of mound and overflow paths**

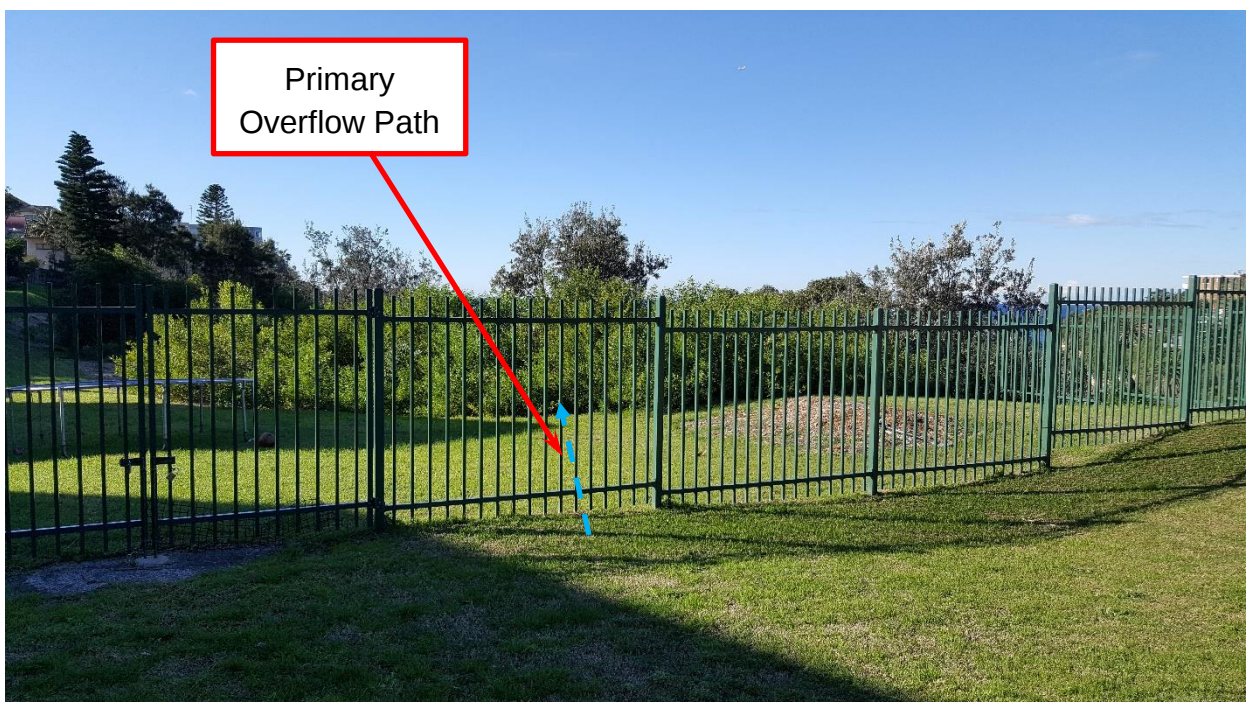
**Figure 20 – Eastern view of primary overflow path entering vegetation area**
