9 – 21 BEACONSFIELD PARADE

LINDFIELD, NSW

**STATE SIGNIFICANT DEVELOPMENT
PROPOSAL**

**ARBORICULTURAL IMPACT
ASSESSMENT REPORT**

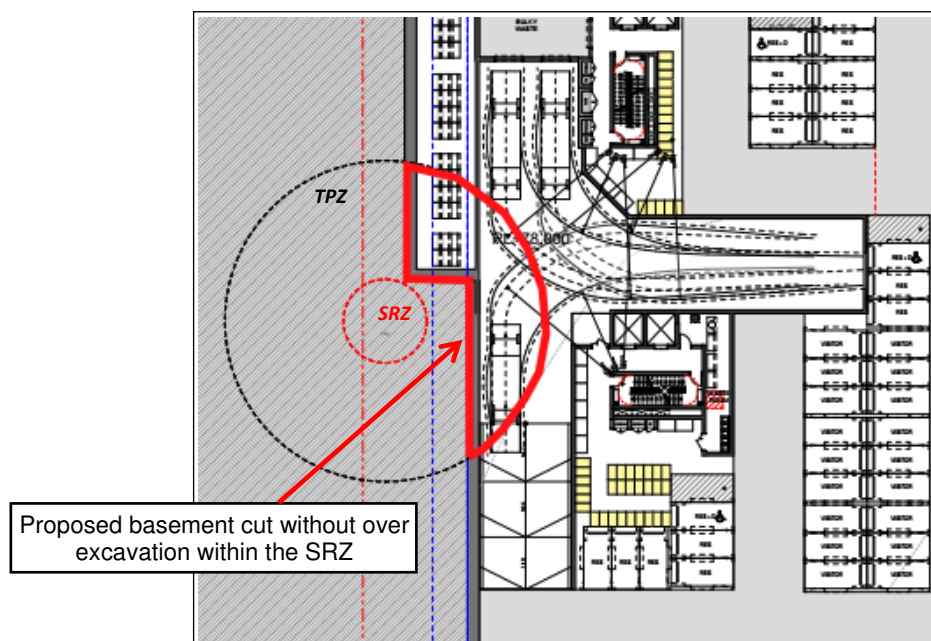
Figure 2, showing T62 encroachment area

Based on the basement footprint a *High-level (28%)* TPZ occupancy occurs by the design footprint with design located just outside the SRZ. Given the proximity of the basement cut and likely requirement for over excavation extending within the SRZ, in addressing other *TPZ considerations* noted within AS4970 / 3.3.4; tree age and establishment within the site indicates the tree may not tolerate construction disturbances, or the proposed occupancy within the TPZ.

- a) No over excavation beyond the basement footprint as shown within construction drawings.
- b) All excavations within the TPZ are to be supervised & certified by an appointed site arborist clean cutting all encountered tree roots in accordance with AS4970 – 2009 Section 4.5.4 *Root protection during works within the TPZ*, such that tree roots are not damaged or ripped beyond the point of excavation by site machinery.

- d) Given tree protection fencing would be restrictive for construction access within the site, ground or root protection mats are recommended to cover the TPZ as indicated within Appendix- B item [C] *ground protection*.

- e) At no stage should excavation occur within the SRZ.

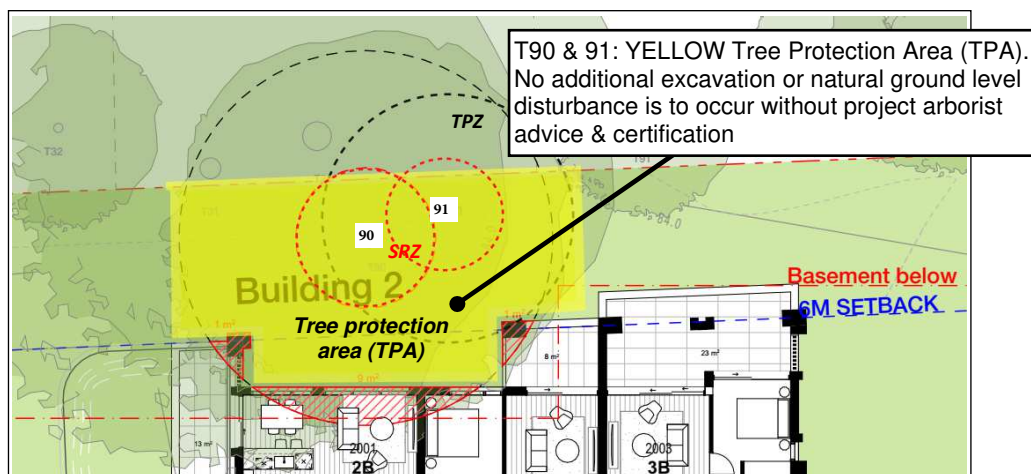
Figure 3, showing T90 & 91 protection area

1.4.7 Tree 90, incorporating T91:

Tree 90; displaying a significant lean and canopy mass over the neighbouring property receives a *Minor* (6.9%) TPZ encroachment without SRZ occupancy. In addressing other *TPZ encroachment considerations* noted within AS4970 / 3.3.4; demolition and construction occupancy is located within the tension root zone (roots taking up strain of tree lean), indicating works within the TPZ may disrupt the tension root zone (TPZ).

- b) Demolition must be conducted in a tree sensitive manner to ensure critical underlying tree roots are not damaged or disturbed by works.
- c) Prior to demolition the SRZ radiuses are to be certified as fenced off with tree protection fencing. At completion of demolition the remaining TPZ's are to be certified as protected with ground protection boards covering the TPZ or as indicated and certified by an appointed project arborist, see Appendix- B Item [C] *ground protection*.

- g) During main construction activities an appointed project arborist is recommended to inspect all tree protection at four (4) week intervals ensuring fenced SRZ radiuses remain in place and all ground protection is consistent with protecting critical roots taking up strain of tree lean within the TPZ.

- i) Given the manageable TPZ encroachment all recommendations as indicated within Section 2.3 *General tree protection requirements* apply to this tree.
