Geological Structure Review

Dendrobium Mine

Geological Structures Review

PSM3021-007R REV1 26 April 2019

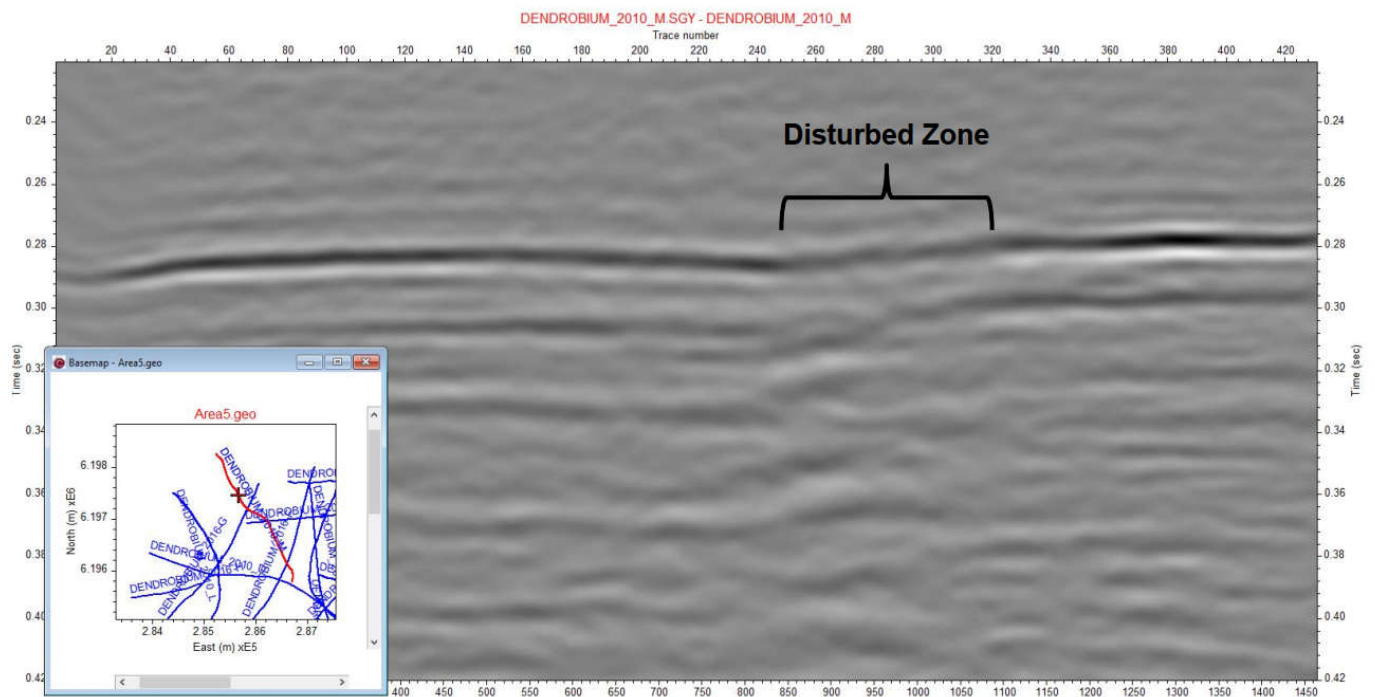
The potential Bulli Fault is located within Area 5 and is based on seismic survey. Figure 4 presents the disturbed zone of which the Bulli Fault is based. The potential fault appears to offset the Bulli Coal seam reflector by approximately 3 m with a disturbance zone estimated to be 200 mm wide. The feature was not observed in any other survey lines; however, several other less disturbed zones were observed in other seismic lines but were assessed as being of low confidence.

The orientation of this structure is uncertain but aligns with the regional scale Unnamed Faults 1 and 3. There is no apparent geomorphic feature that correlates with the Bulli Fault. There may be a low chance that the Bulli Fault is a continuation of Unnamed Fault 3.

Figure 4: Disturbed zone observed in two-dimensional seismic survey.

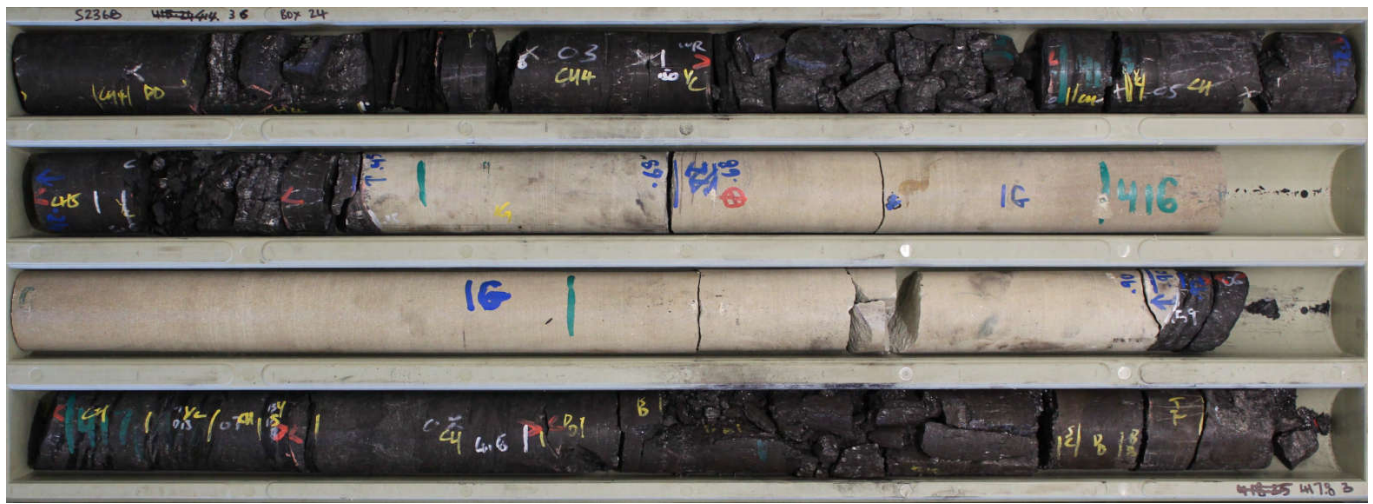
The second is an area in the northern parts of Area 5. This sill is largely confined to the Wongawilli Seam and appears to be responsible for heat affecting the Bulli Seam. Targeted boreholes have been drilled to refine the limit of the sill in the Bulli Seam in order to avoid the sill in the mine plan. The extent of the heat affected Bulli Seam is based on seismic survey and borehole intersections. The extent of the sill is relatively well understood, although its extent to the north and northwest is less certain.

Photo 1: Example fresh dolerite sill in borehole S2368 at approximately 416 m.

Additional drilling and seismic activities are required to refine the extents of sills in Area 5.

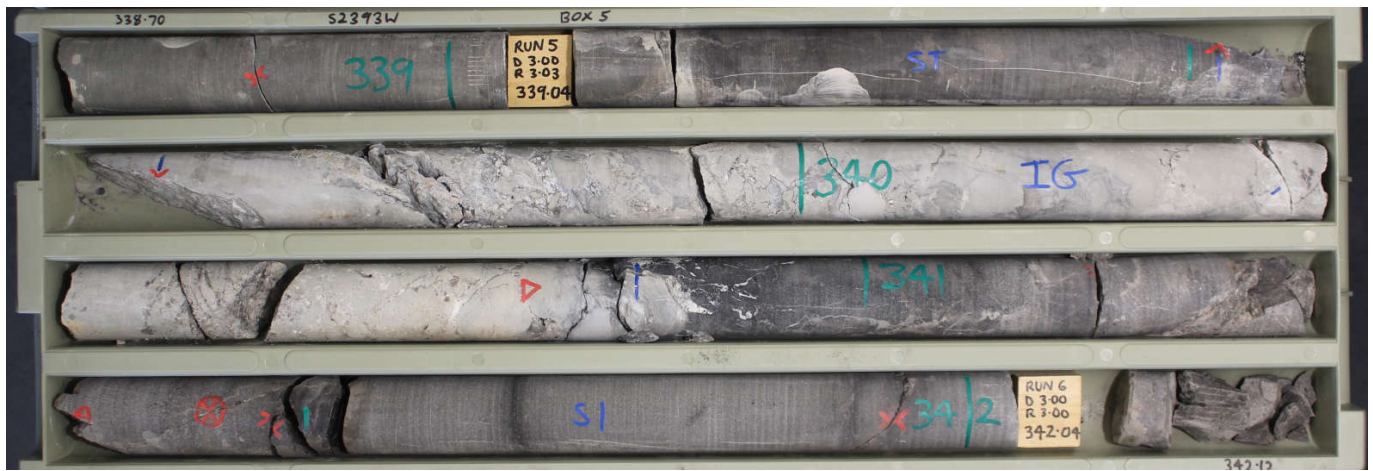
Photo 2 presents a dolerite dyke intersected in a vertical borehole. The dolerite appears fresh with a sharp contact with the surrounding sandstone. This dyke does not align with inferred dykes but does align with the potential Bulli Fault. Basaltic lavas are generally under pressure when being emplaced, which if sufficiently high, can generate its own fracture network within the host rock (Reference 14). More commonly, lavas exploit existing fractures such as faults and joints, which is likely in the case of the Bulli Fault.

Photo 2: Example of a dolerite dyke intersected in borehole S2393 at approximately 340 m depth.

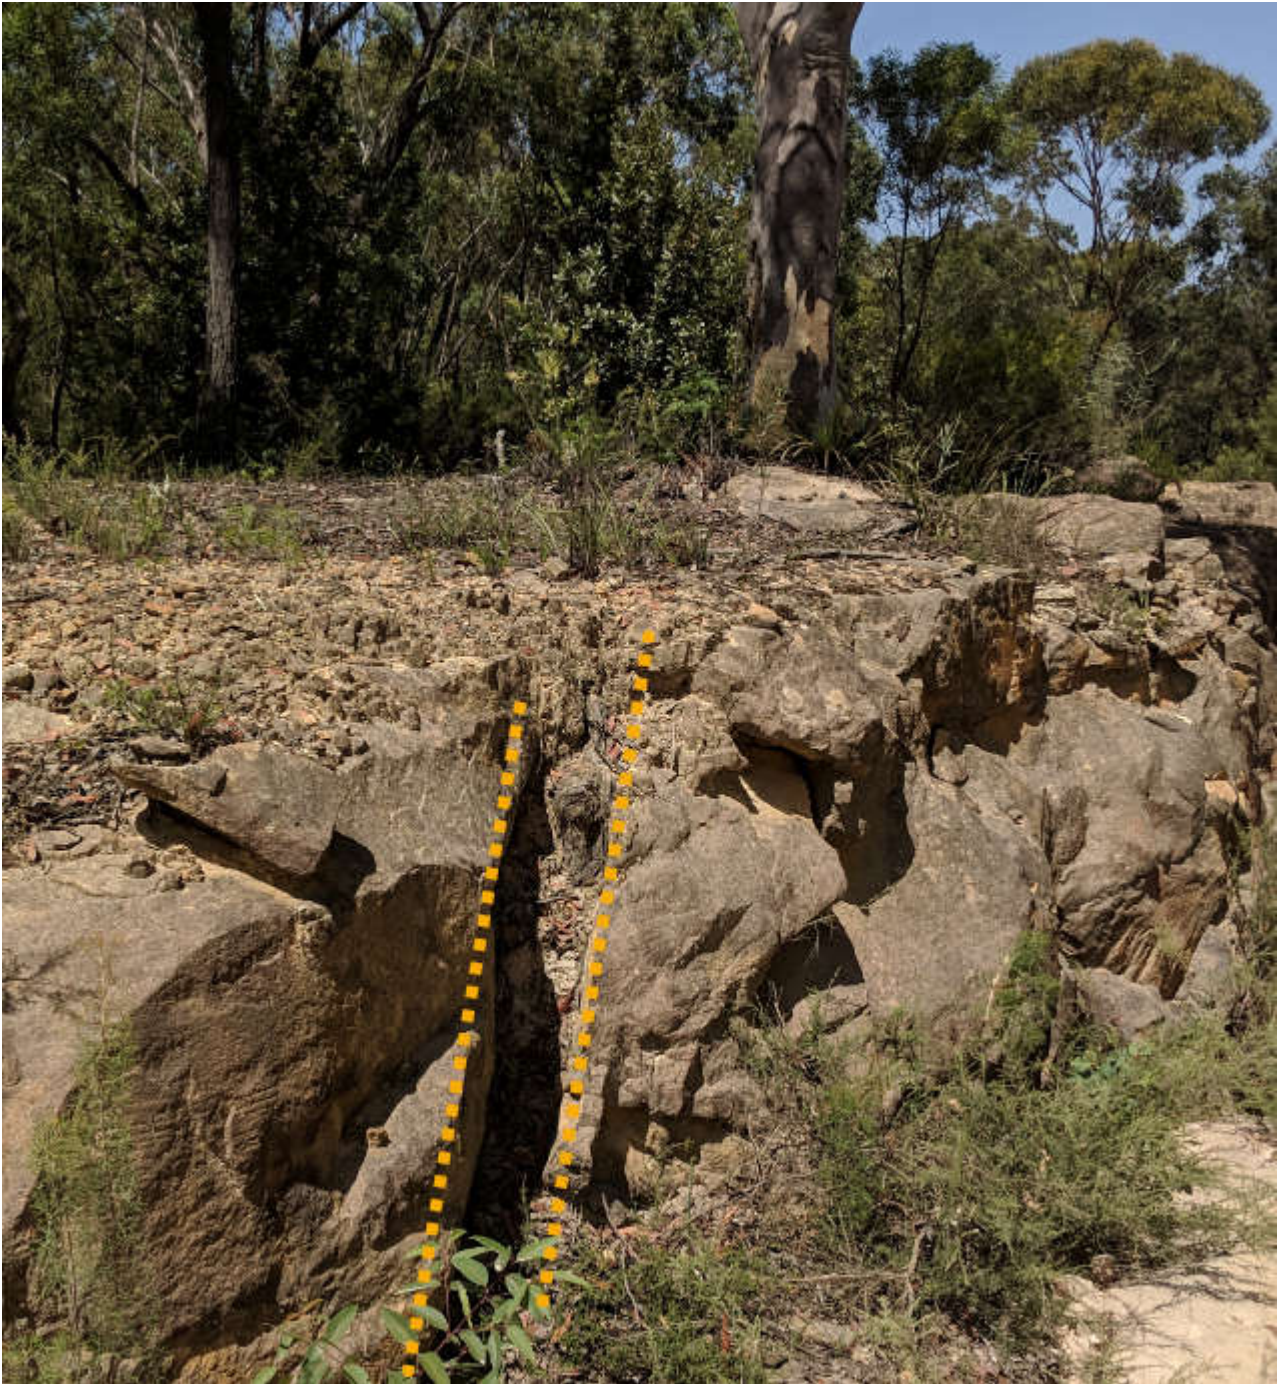
A5DN1 appears to align with both PSM derived and regional scale lineaments, and the eastern edge of Area 5, indicating the dyke may delineate the economic coal resource. Photo 3 shows a 200 mm wide dyke, located 380 m east of A5DN1 of which the minor dyke parallels. These are strong indicators the dyke extends from seam to surface.

Photo 3: Dyke, approximately 200 mm wide, observed by PSM during site visit.

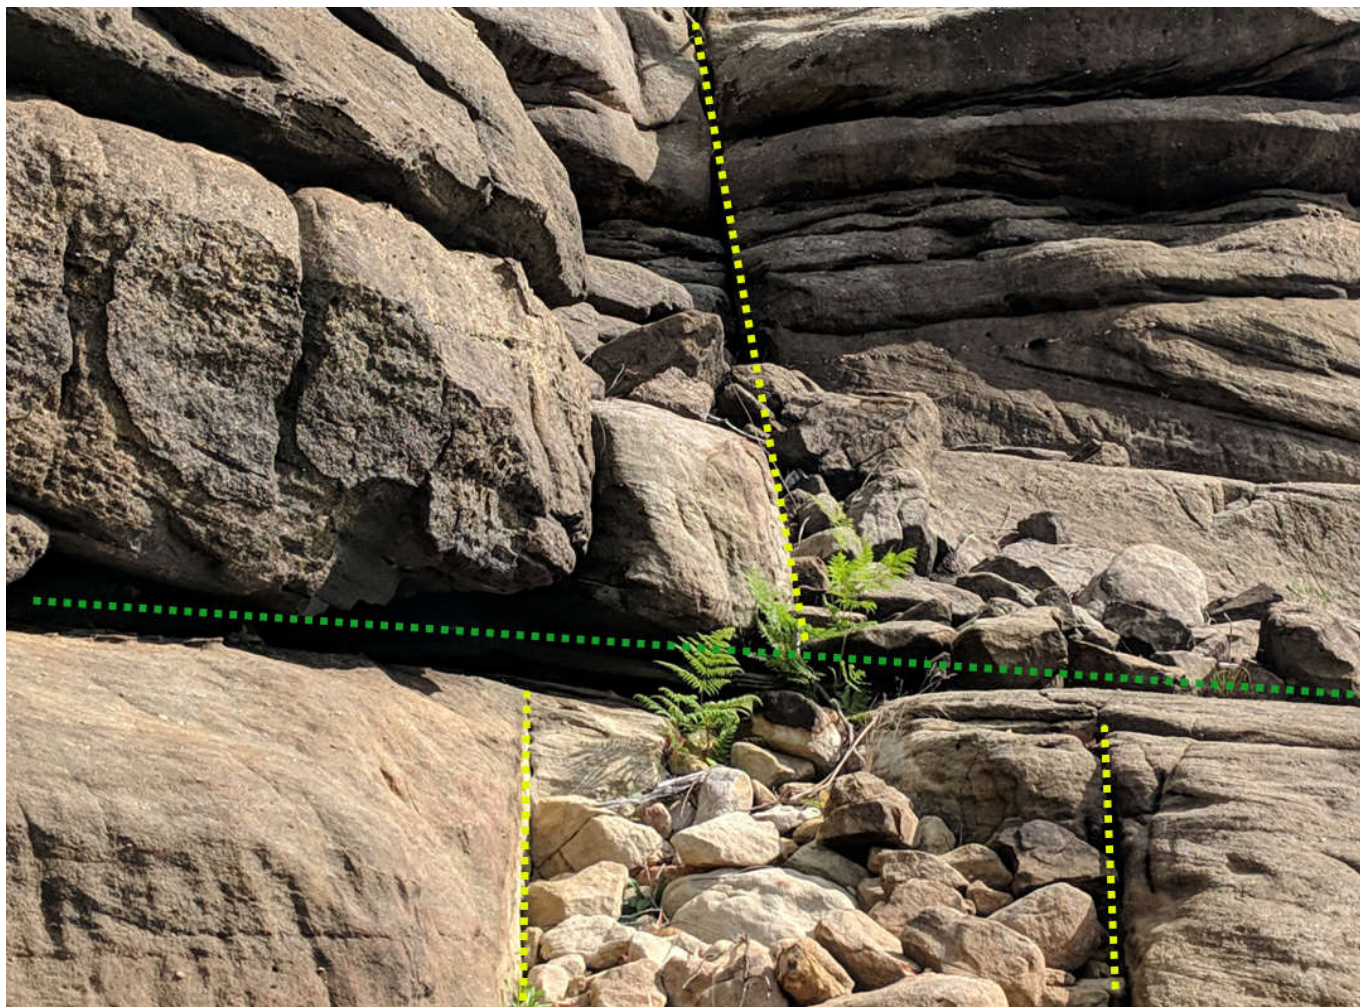
The joints observed within the study area were typically planar and often terminated against bedding partings, see Photo 4. Generally, the persistence of joints was no greater than 10 m and spaced, see Photo 5.

Photo 4: Sub-vertical joints (yellow) terminating against a horizontal bedding parting (green) near northeast shore of Cordeaux Reservoir.

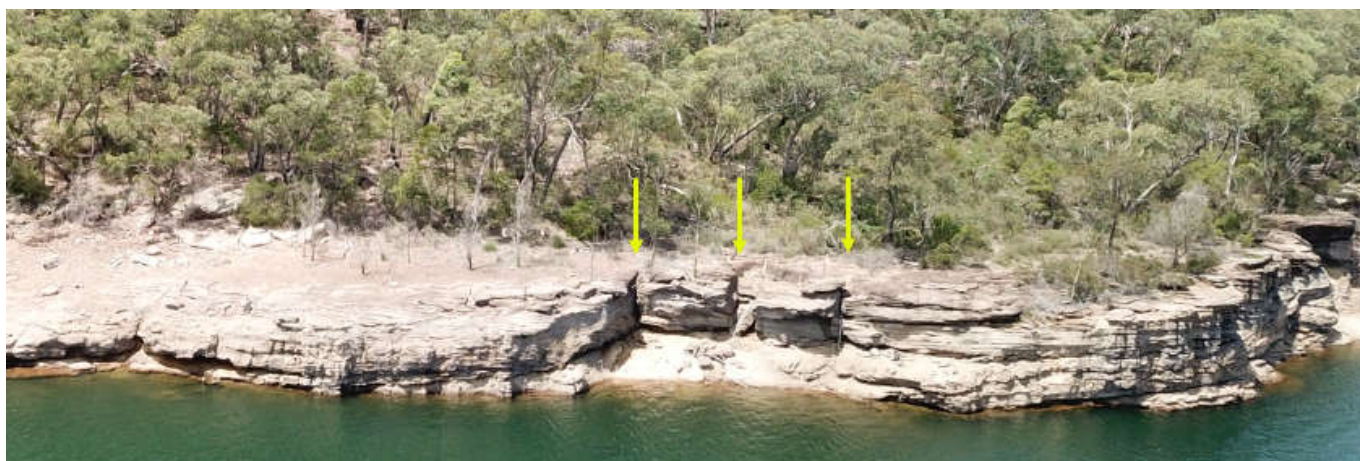
Photo 5: Joints (indicated by yellow arrows) striking northwest spaced approximately 3 m on northwest shore of Avon Reservoir.

PSM consider it is unlikely that the joints observed at the surface persist to seam level.

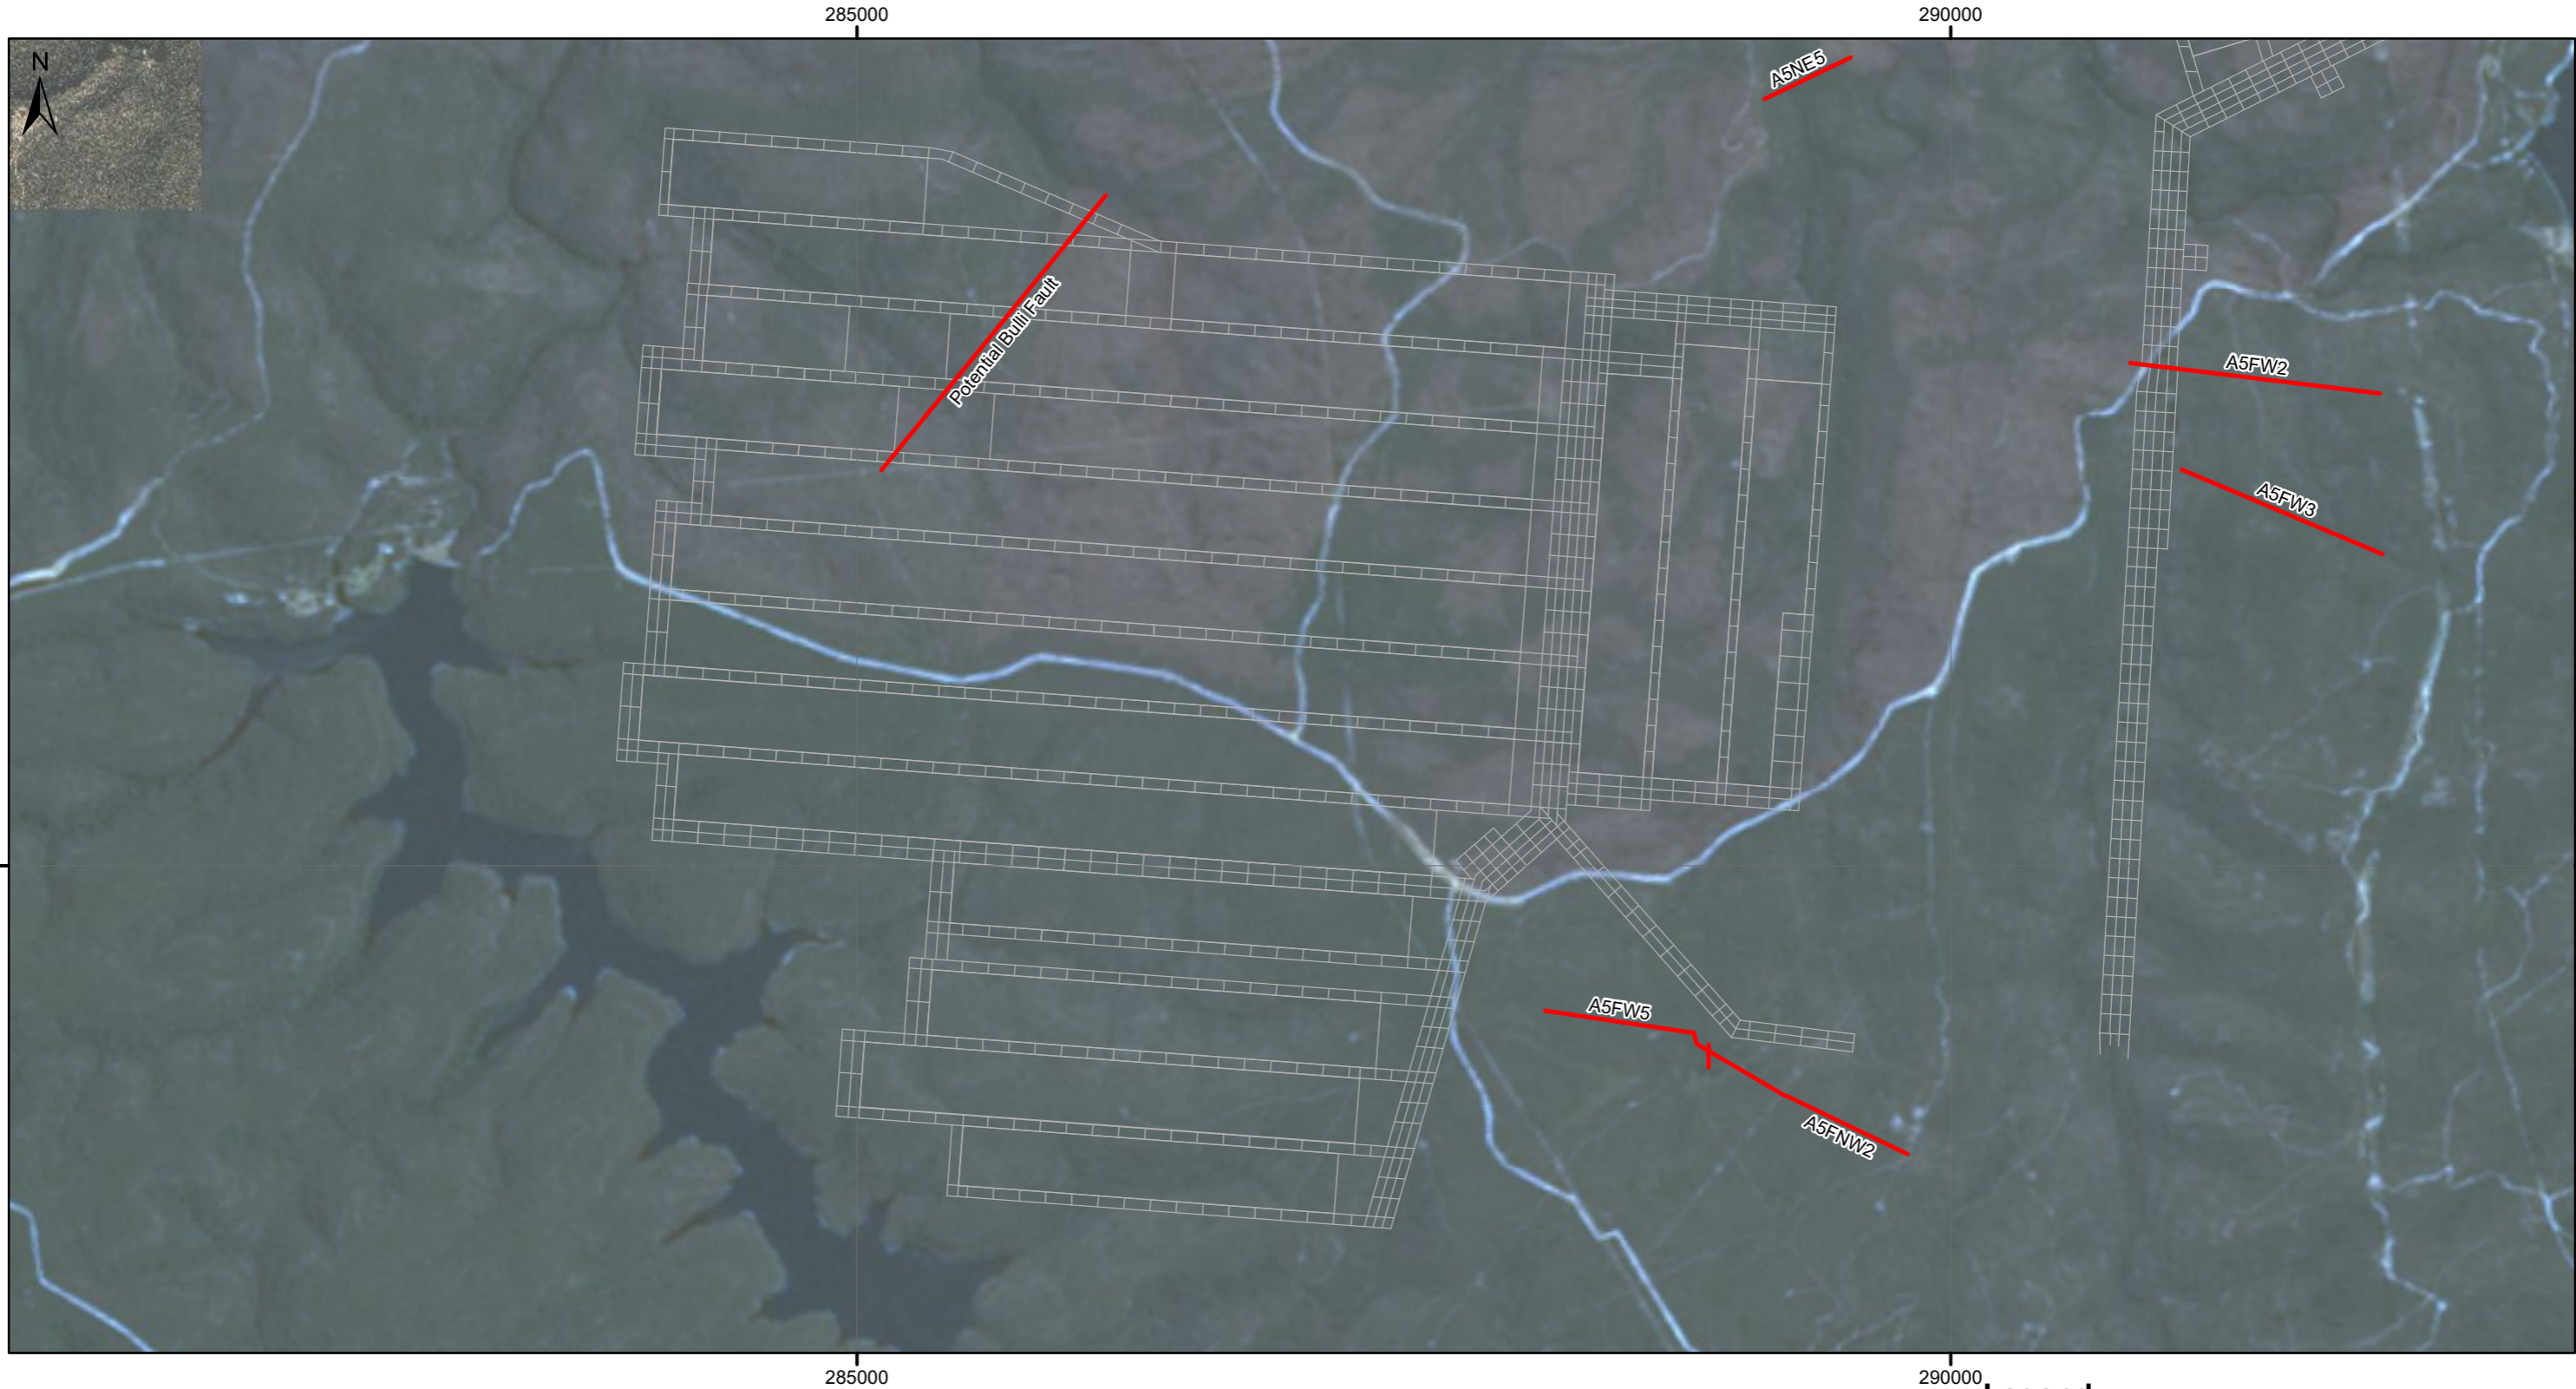
PSM FAULT ID	FAULT TYPE	DISPLACEMENT (m)	PROVENANCE	PERVASIVENESS
Potential Bulli Fault	Normal	3	Seismic survey, 1 line only; zone of disturbed reflectors rather than distinct displacement	Displacement of Bulli seam. Partially aligns with surficial lineament
A5FNE5	Possibly strike-slip	?	From aeromagnetic data - this feature appears to offset a dyke so was interpreted as a strike-slip fault	?
A5FW5	?	1	S2112 STIS hole and some evidence of structure in S0705	?
A5FNW2	?	0	Seismic sections 2009-C, 2009-A, and 2005-C in Bulli Seam only. In the middle of LW9 and no faulting was observed during mining the Wongawilli Seam; Seismic anomaly probably sill related	Low
A5FW2	?	Minor	2010 2D Seismic Survey - low confidence	
A5FW3	Normal	2-3	Projection from underground mapping at Kemira Workings (Bulli Seam)	Displacement of Bulli seam. Partially aligns with surficial lineament

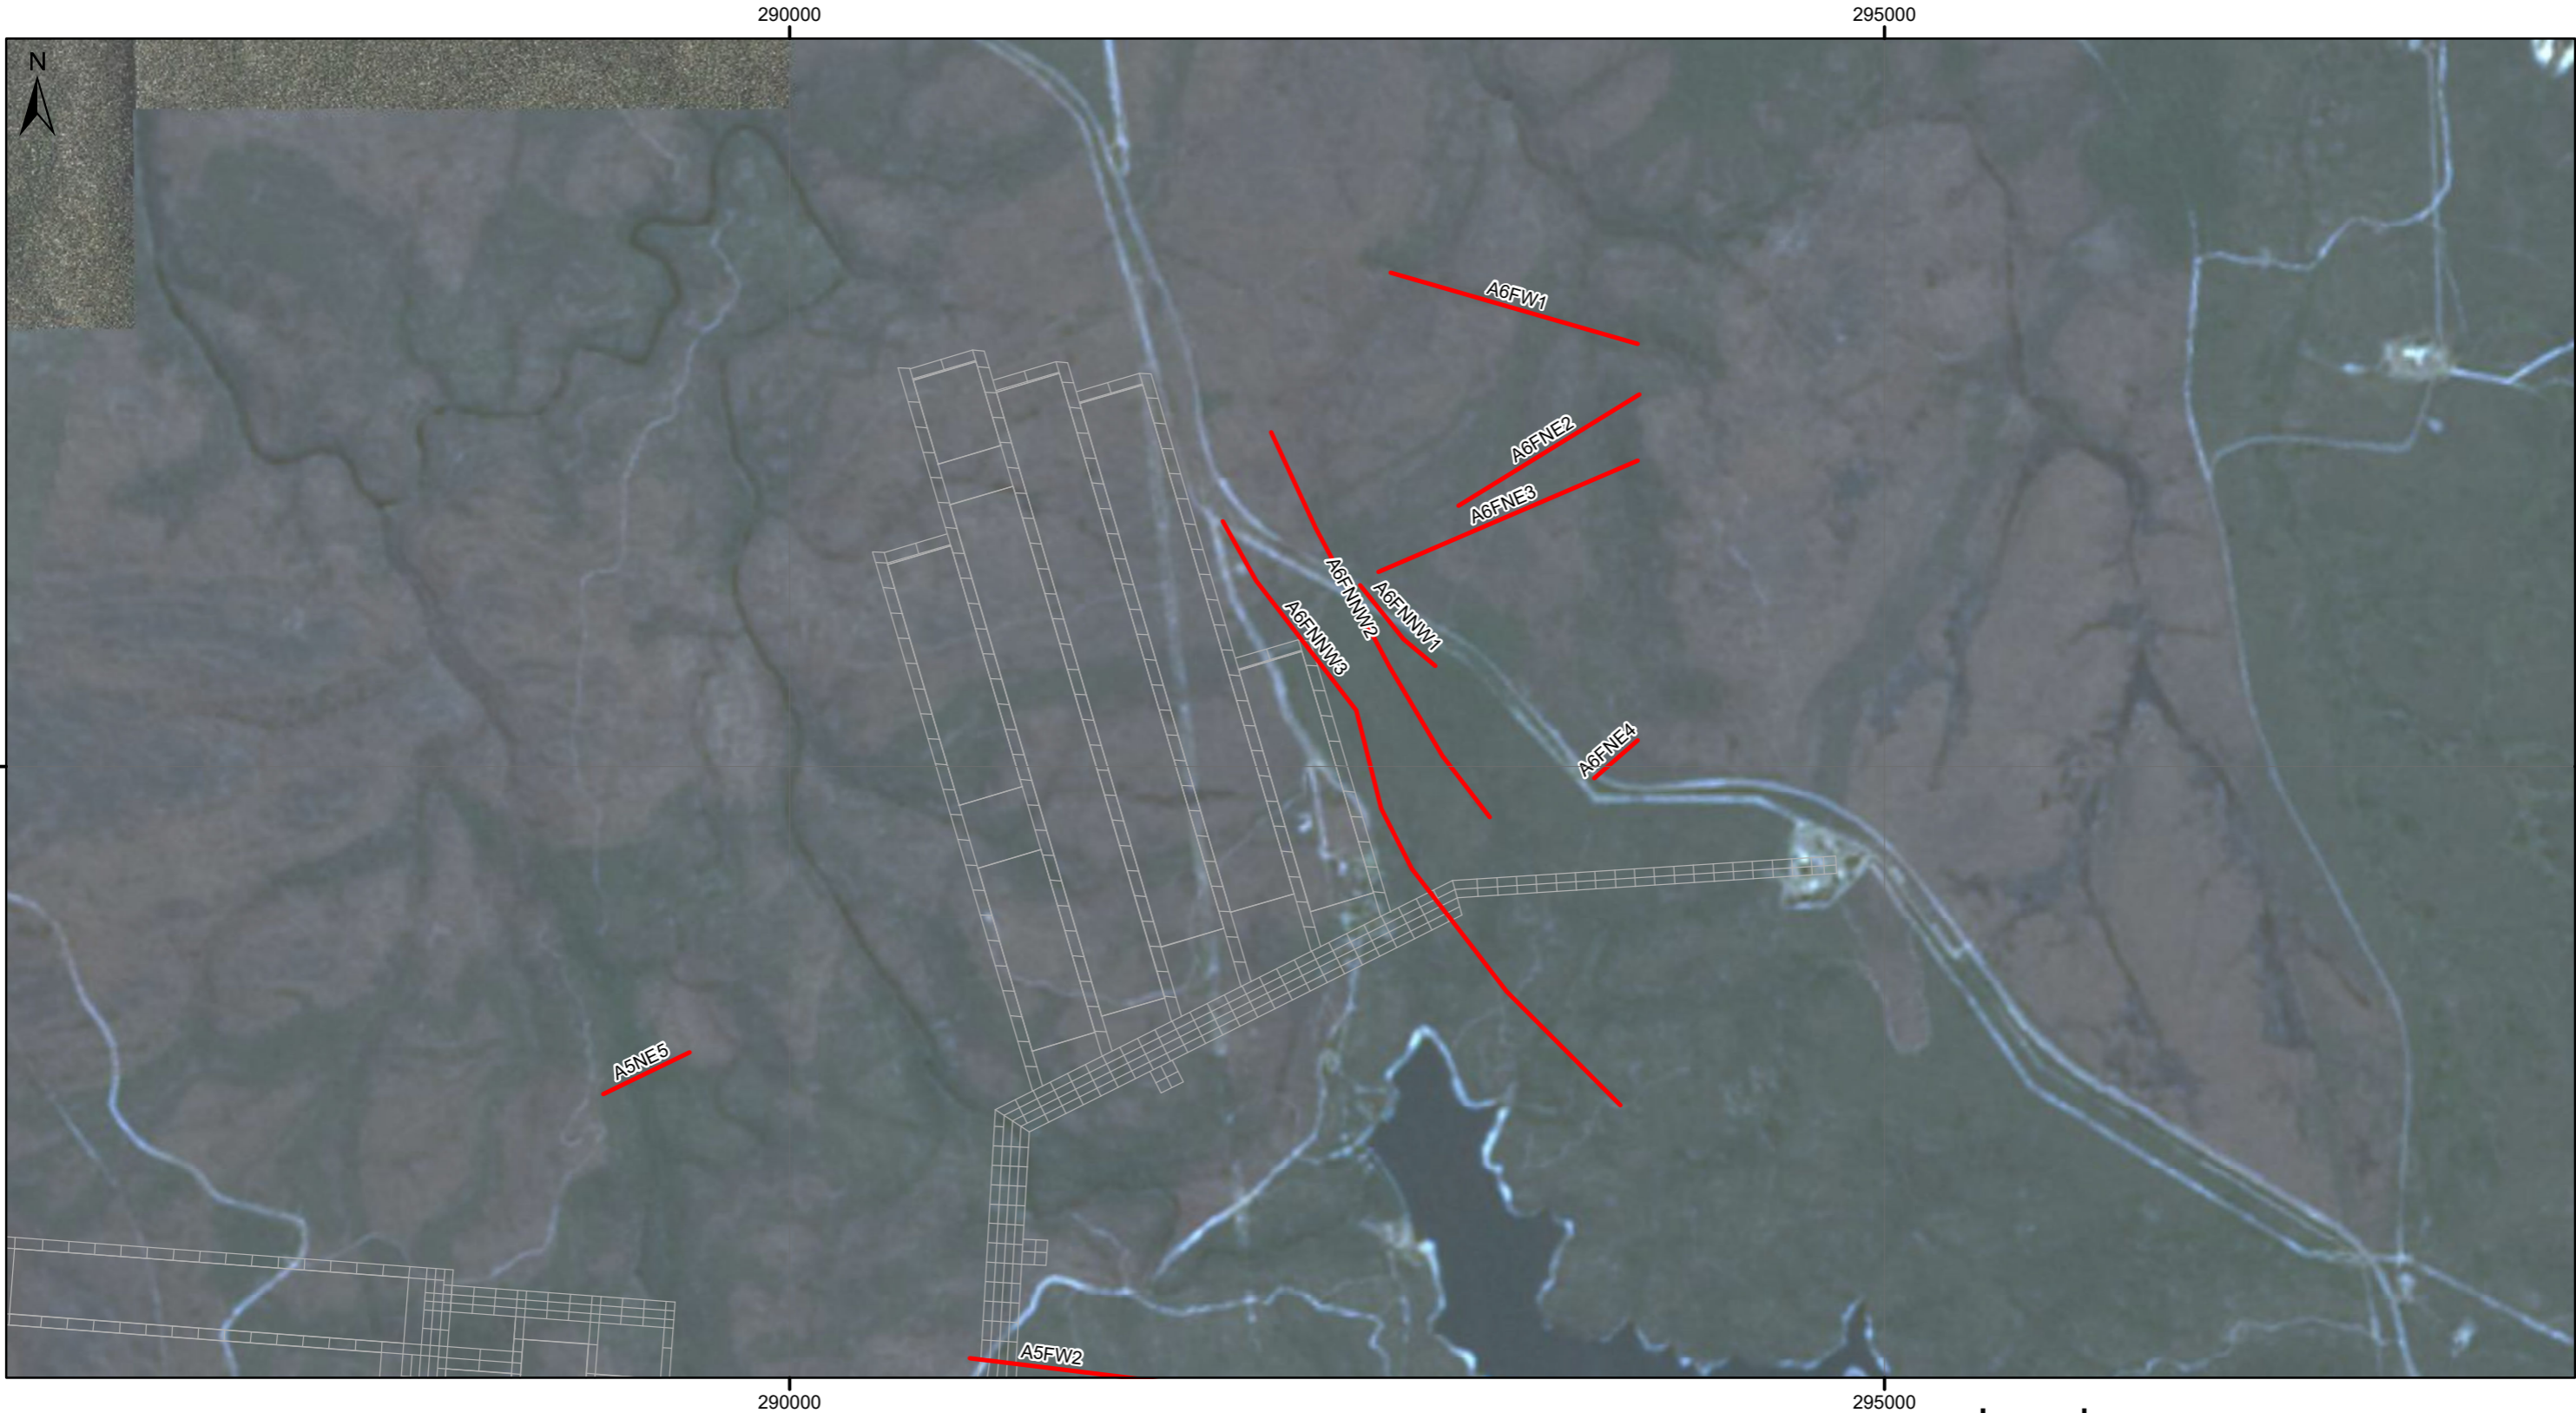
PSM FAULT ID	FAULT TYPE	DISPLACEMENT (m)	PROVENANCE	PERVASIVENESS
A6FW1	Normal	5-8	Cordeaux record tracings and 1994 2D seismic data	Known strike length of 7 km a Bulli Seam level. Existence on surface is unknown
A6FNE2	?	?	Associated with dyke - possible from South Bulli workings mapping	?
A6FNE3	Normal	0.2-1.2	UG Mapping at Cordeaux Workings (Bulli Seam)	Mapped in Bulli Seam; Associated with dyke; presence in Wongawilli Unknown; Not observed at surface
A6FNE4	Normal	0.1-1.1	UG Mapping at Cordeaux Workings (Bulli Seam)	Mapped in Bulli Seam; Associated with dyke; presence in Wongawilli Unknown; Not observed at surface
A6FNNW1	Normal	5 - 30	1990 & 2011 2D Seismic Surveys	Displacement of Bulli and Wongawilli Seams; Not observed on surface
A6FNNW2	Normal	5 - 30	1990 & 2011 2D Seismic Surveys	Displacement of Bulli and Wongawilli Seams; Partially aligns with surficial lineament
A6FNNW3	Normal	8 - 10	1990 & 2011 2D Seismic Surveys	Displacement of Bulli and Wongawilli Seams; Not observed on surface
