# **ARBORICULTURAL IMPACT ASSESSMENT REPORT**

## **LEICHHARDT OVAL REFURBISHMENT**

### **68 MARY STREET, LILYFIELD**

**Report No 25-014**

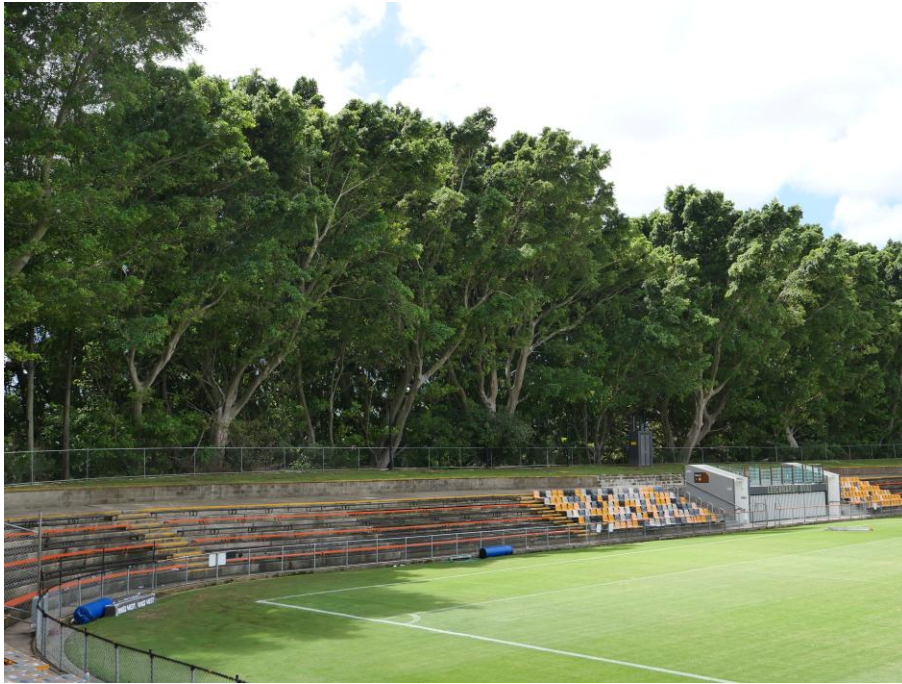
**Plate 1** - showing the subject trees located on the north-east side of the playing field.

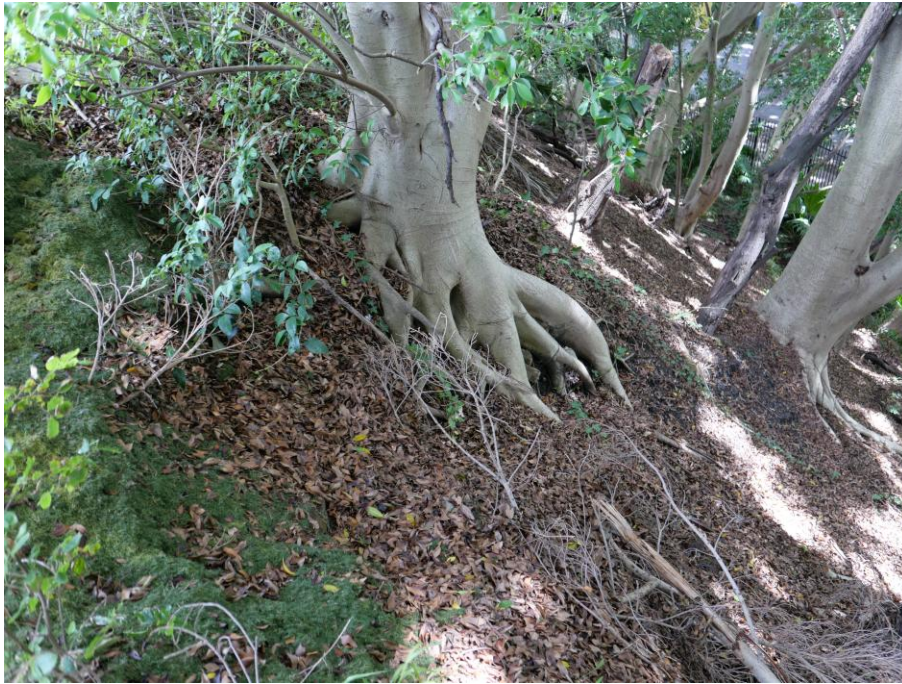
- 2.2.2 The soils within the site have been extensively disturbed and modified during the construction of the level platform for the oval and surrounding embankments. The embankment on which the trees are growing and the adjacent level terrace is likely to be comprised of a mixture of imported and local fill material, capped with up to 300mm sandy loam. The embankment to the north-east (beyond the chain wire fence) is extremely steep (refer **Plate 2**)

**Plate 2** – showing the steep treed embankment on the north-east side of the oval.

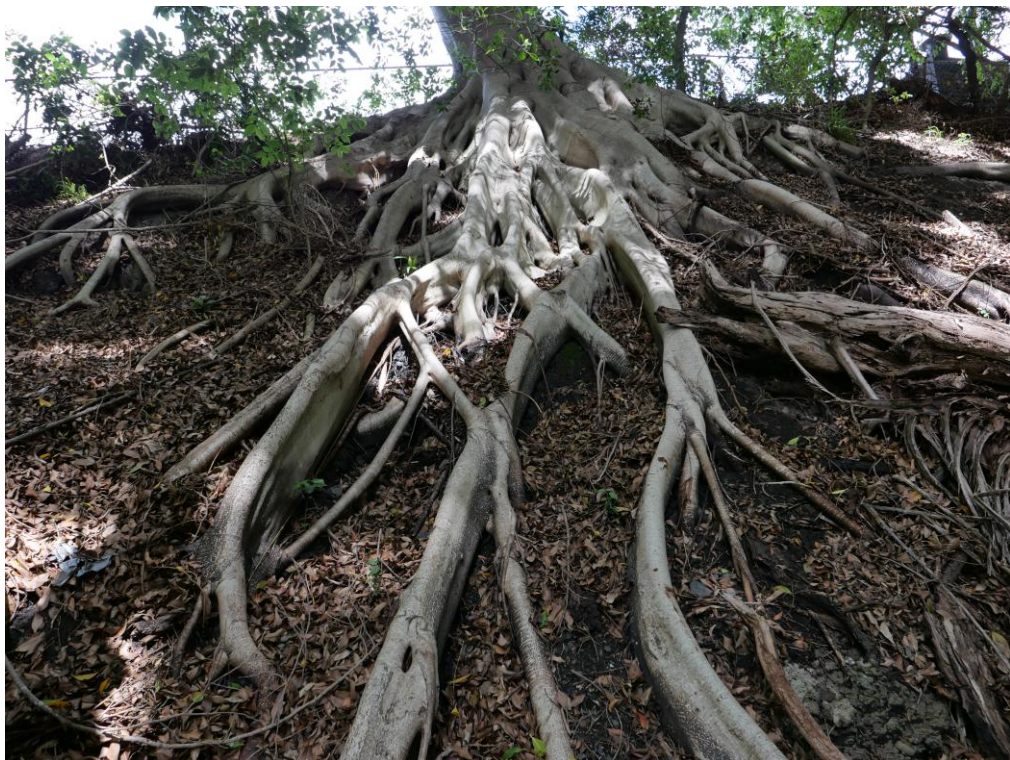
- 4.3.3 The majority of the trees exhibited an extensive network of woody surface roots running down the embankment to the north-east (refer **Plate 3**), although several trees also exhibited large woody roots growing up the embankment and into the lawn terrace area (refer **Plate 4**). Some exposed roots in the lawn terrace exhibited mechanical injuries from recurrent grass-cutting operations, but with no decay evident.

**Plate 3** – showing network of woody surface roots extending down the embankment

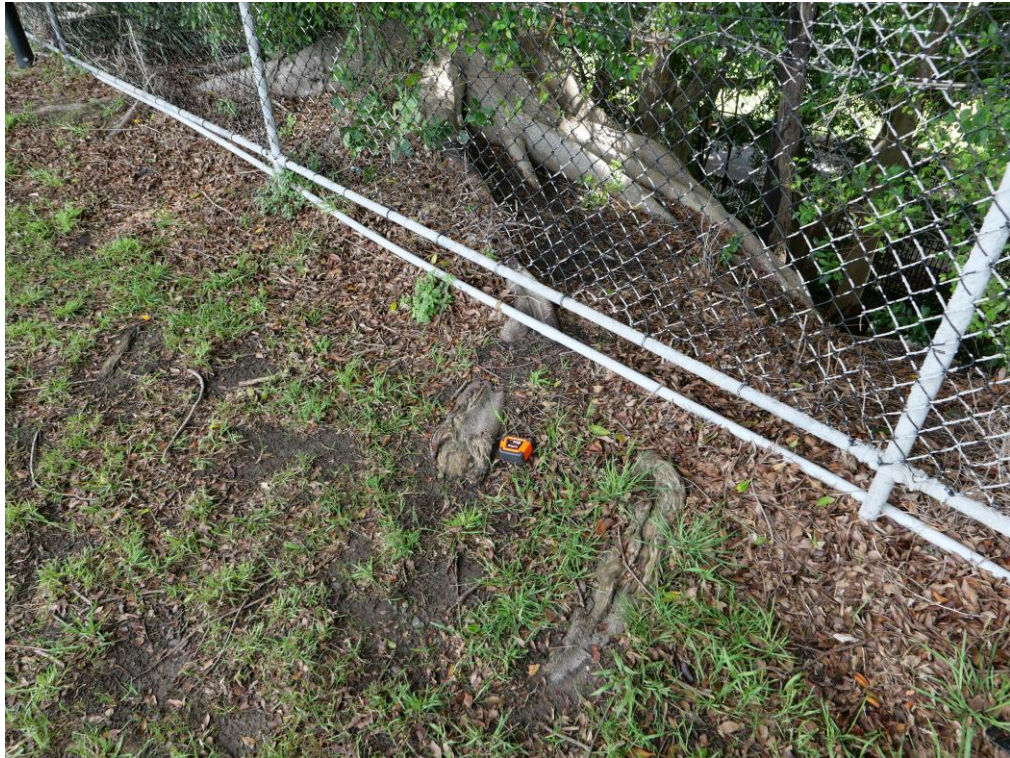
**Plate 4** – showing some roots ascending up into the lawn terrace.

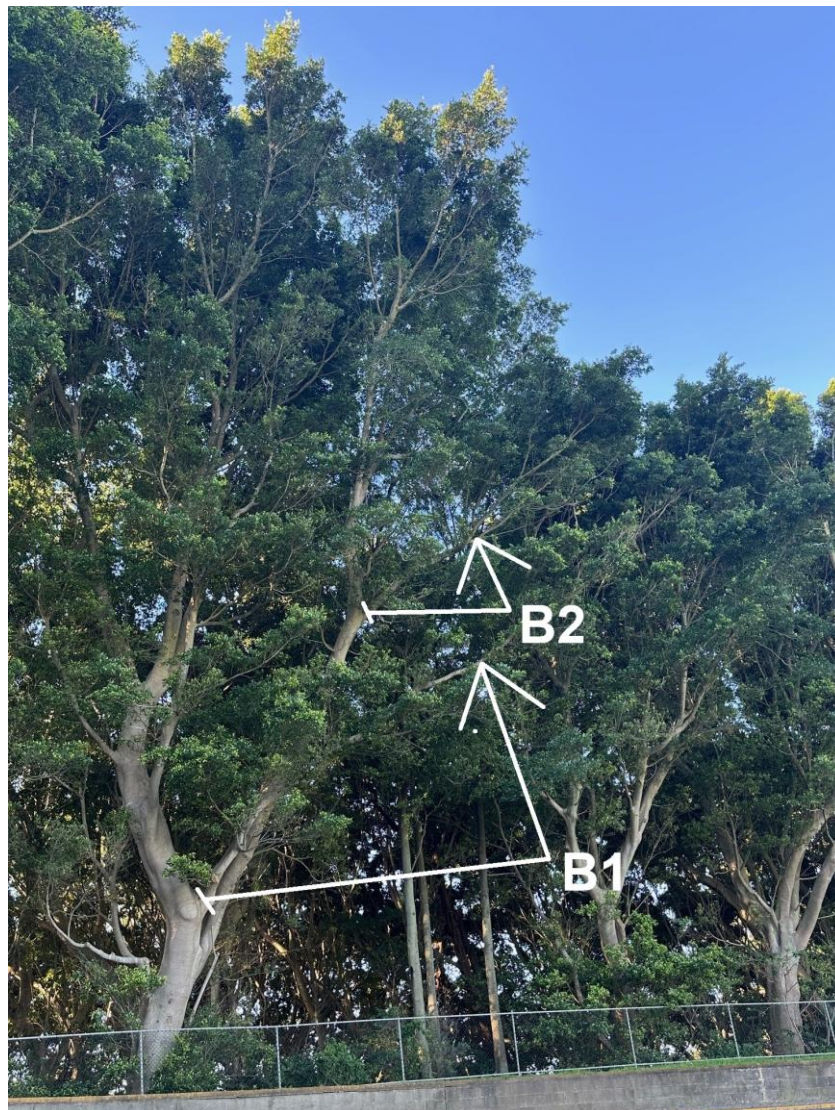
**Figure 7** – Showing required canopy pruning of T23 to clear the building envelope and scaffolding.

| TABLE 6 – PROPOSED CANOPY PRUNING OF T23 | | | | | | |
|---|---|---|---|---|---|---|
| <b>B1</b> | Secondary Limb [SL] | Lateral/ascending – east/south-east | 3 metres | 250mm x 12 metres | Prune at junction with Primary Limb [PL] | 1 |
| <b>B2</b> | Secondary Limb [SL] | Lateral/ascending – east/south-east | 10 metres | 170mm 8 metres | Prune at junction with PL | 1 |
