# AMENDED TREE REMOVAL & PRUNING APPLICATION REPORT

Innovation Plaza - Australian Technology Park,  
Redfern 27.7.2018.

Prepared by Lee Hancock Consulting Arborist AQF Level 5  
[lee@leehancockarborist.com.au](mailto:lee@leehancockarborist.com.au)

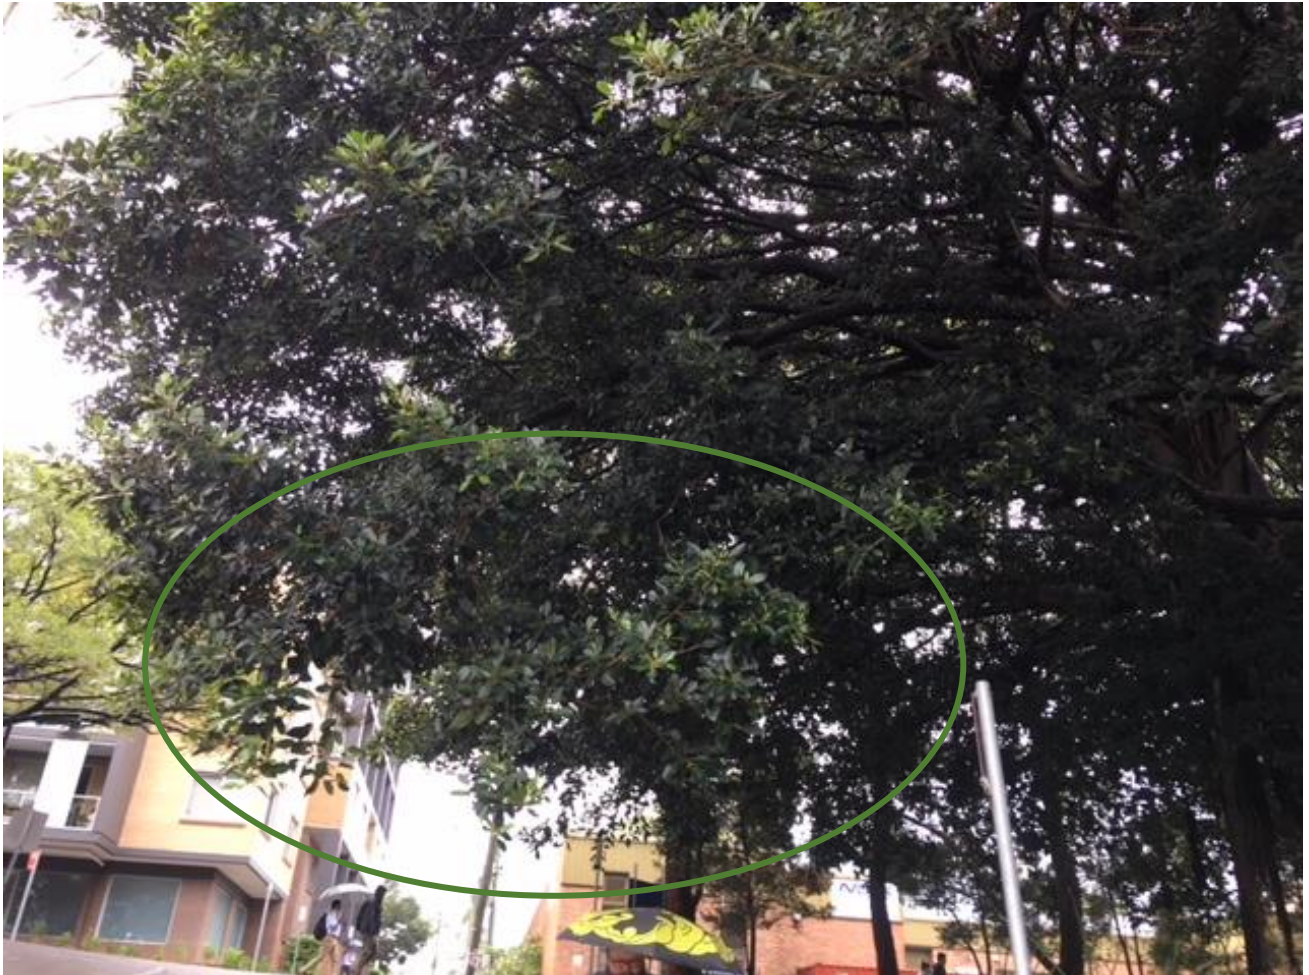
Tree appears structurally stable, in good form and vigour. Tree canopy facing north shall be impacted upon by delivery trucks entering, crown lifting the canopy should minimise any damage to the long-term health and vigour of the existing trees.

*Ficus rubiginosa* (Port Jackson Fig) Crown lifting to accommodate vehicles.

For Tree 43, crown lifting the lower branches to a height of 4.5m clearance without disfiguring the natural growth habit of the tree is recommended. The maximum diameter of branches that are to be removed should not exceed 100mm.

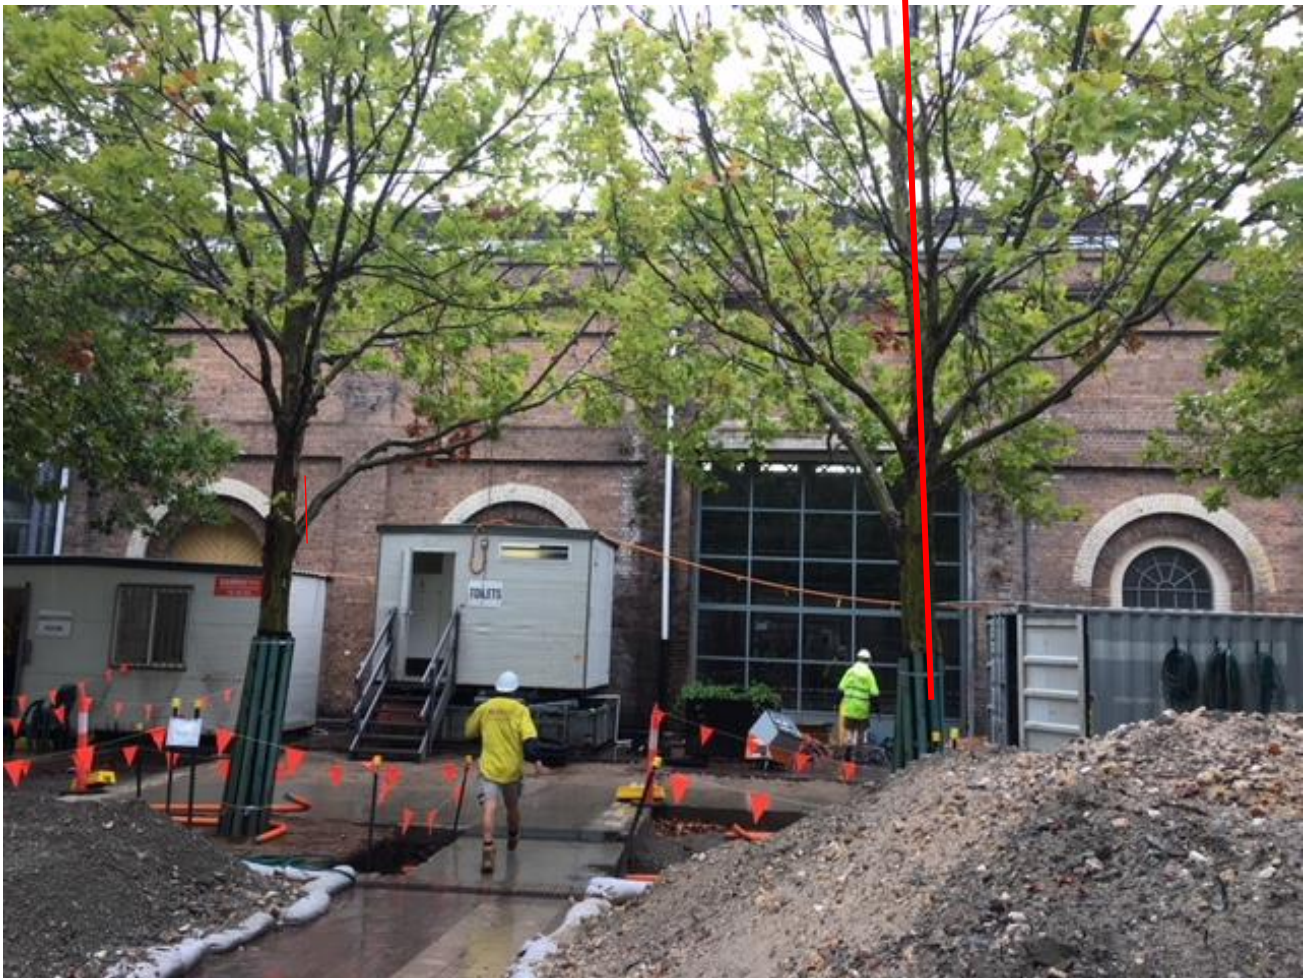
Tree 67 is a semi mature tree in good health and vigour, with sound branch attachments and 14m in height. The supplied swept path assessment plan reveals that there is no feasible alternative for the retention of the tree. The height and maturity of the tree indicates, it is not considered to be a good specimen to be transplanted. Therefore, whilst the tree is considered to be of a moderate retention value, removal is recommended.

Tree 66 . Red line indicates selective pruning of one branch.

Tree 67 to be removed

The proposed access route to the Loading Dock planned within the Locomotion Workshop necessitates the removal of Tree 67 *Platanus x Hybrida*. (London Plane Tree). It does not seem feasible to retain the tree. There are no other alternatives such as transplanting as previously considered, given the size and maturity of the tree, and the economic outlay. Approved tree removal shall be undertaken by an experienced Certified AQF Level 3 Arborist in accordance with Safe Work Australia Code of Practice 'Guide to Managing Risks of Tree Trimming and Removal Work'.

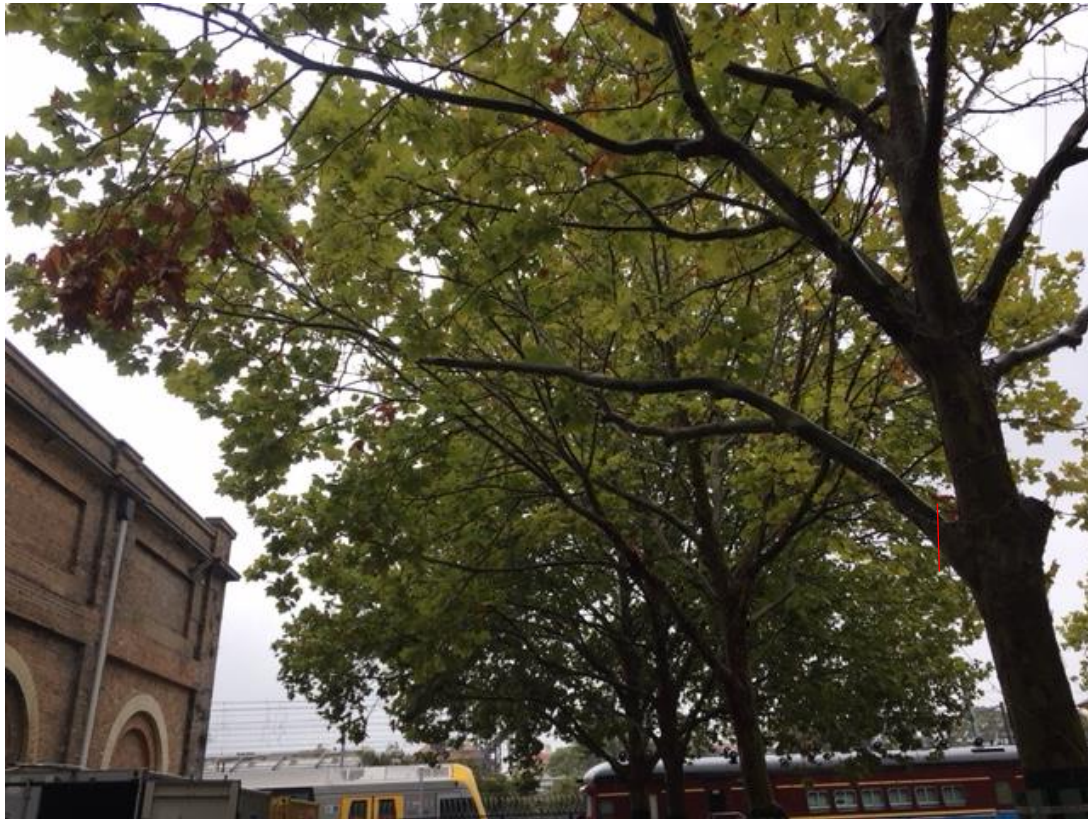
The subject trees 66 and 68 *Platanus x Hybrida*. (London Plane Tree) were assessed to be semi-mature specimens which are in good health and vigour, with sound structural branch attachments. The proposed delivery truck route to access the loading dock will impact upon the lower structural branches of trees 66 and 68. Selectively pruning the lower branches of trees 66 and 68 will minimise any mitigating issues relating to trunk and branch damage. Damage to trunk and branches leaving open wounds can predispose the tree to fungal infections or wood decay fungi.

Tree 68 Lower branch removal indicated by red dash

The remaining London Plane trees 66 and 68 shall be selectively pruned by the project arborist. To attain clearance for vehicles. It is recommended that pruning lower branches to a height of 4.5m clearance. The maximum diameter of branches removed should not exceed 100mm in diameter.

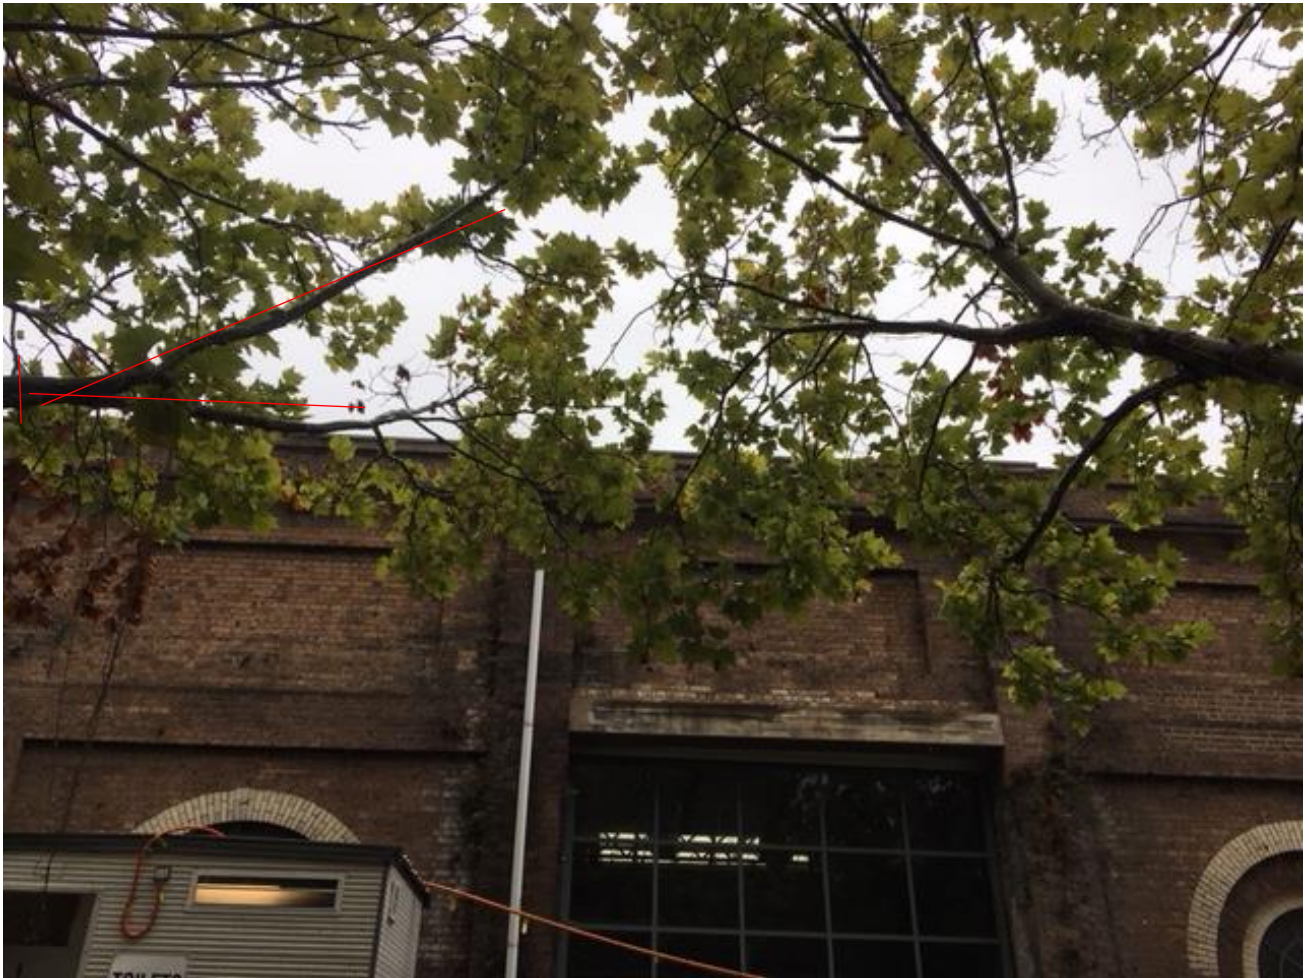
Tree 66 Small diameter branches selectively pruned.
