**Report on Geotechnical Desktop Study**

**Proposed Mixed-Use Development**

**5 Blue Street, North Sydney NSW**

**Project 237286.00**

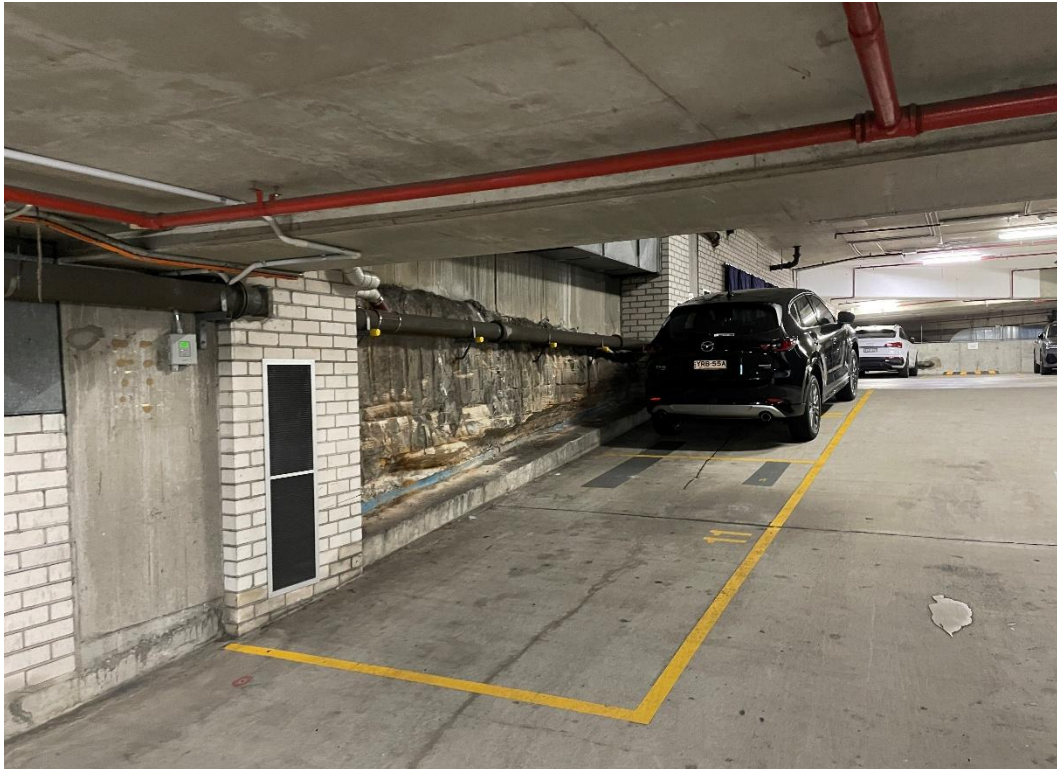
- In the upper basement level of the existing building, the following observations were made:
  - o The entry level of the upper basement does not contain any exposed rock, but as the basement slab ramps down to the west there is rock observed in the northern boundary wall. The rock was considered to be low to medium and medium strength (refer Photo 5).

Photo 5: Photograph of the rock outcrop along the northern wall of the upper basement level

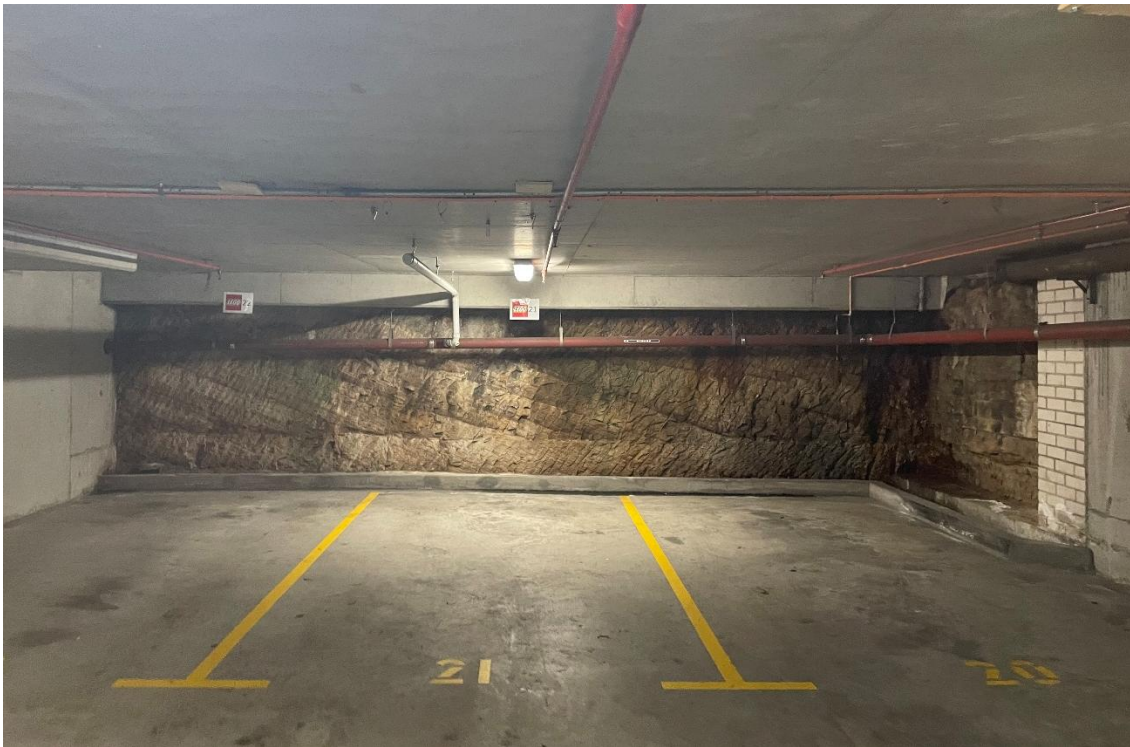
- o Along the western boundary of the upper basement level, medium strength rock was observed (refer Photos 6 and 7). This extended across most of the western boundary but dipping in the last 10 m from the southern boundary. Rock strata with cross-bedding dipping at approximately 20° to 30° was observed within the exposed rock face (refer Photo 8).

Photo 6: Photograph of the rock outcrop along the western wall (northern end) of the upper basement level

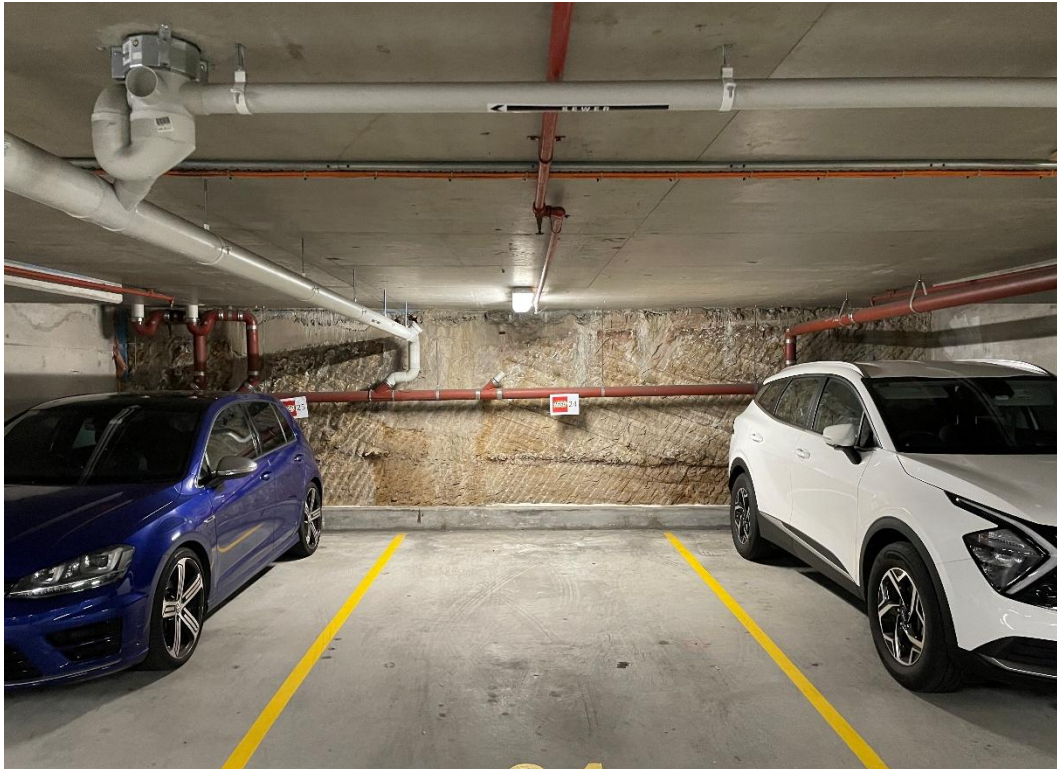
Photo 7: Photograph of the rock outcrop along the western wall (middle) of the upper basement level

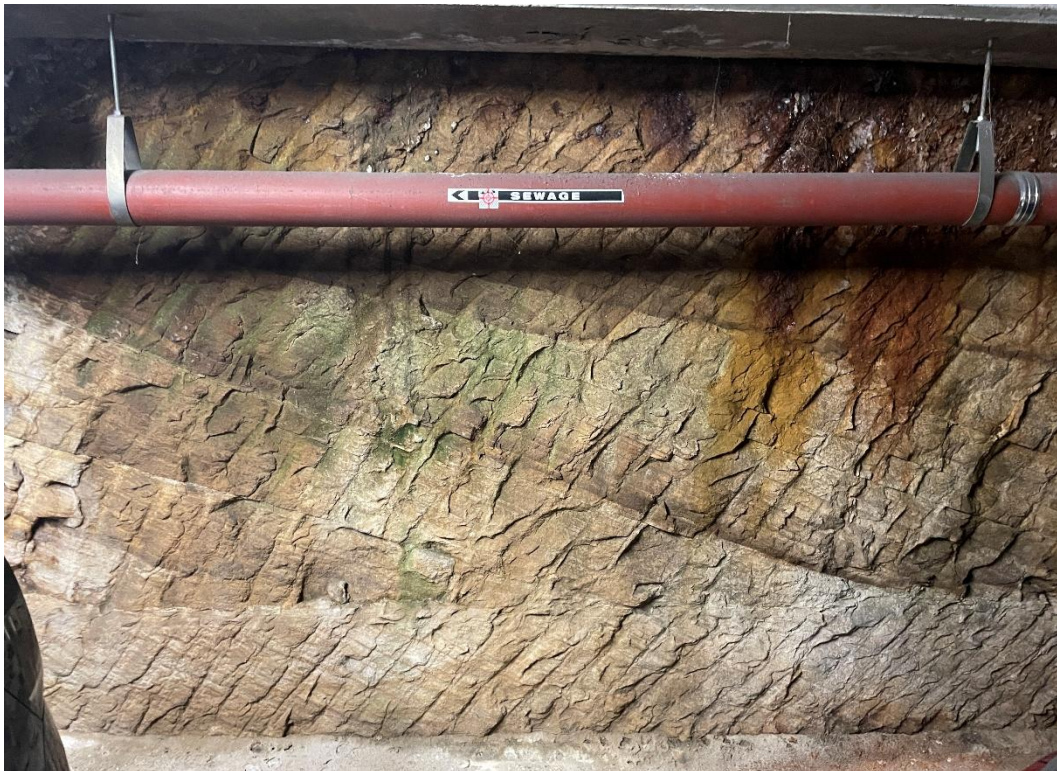
Photo 8: Photograph of the rock outcrop along the western wall of the upper basement level showing cross-bedding

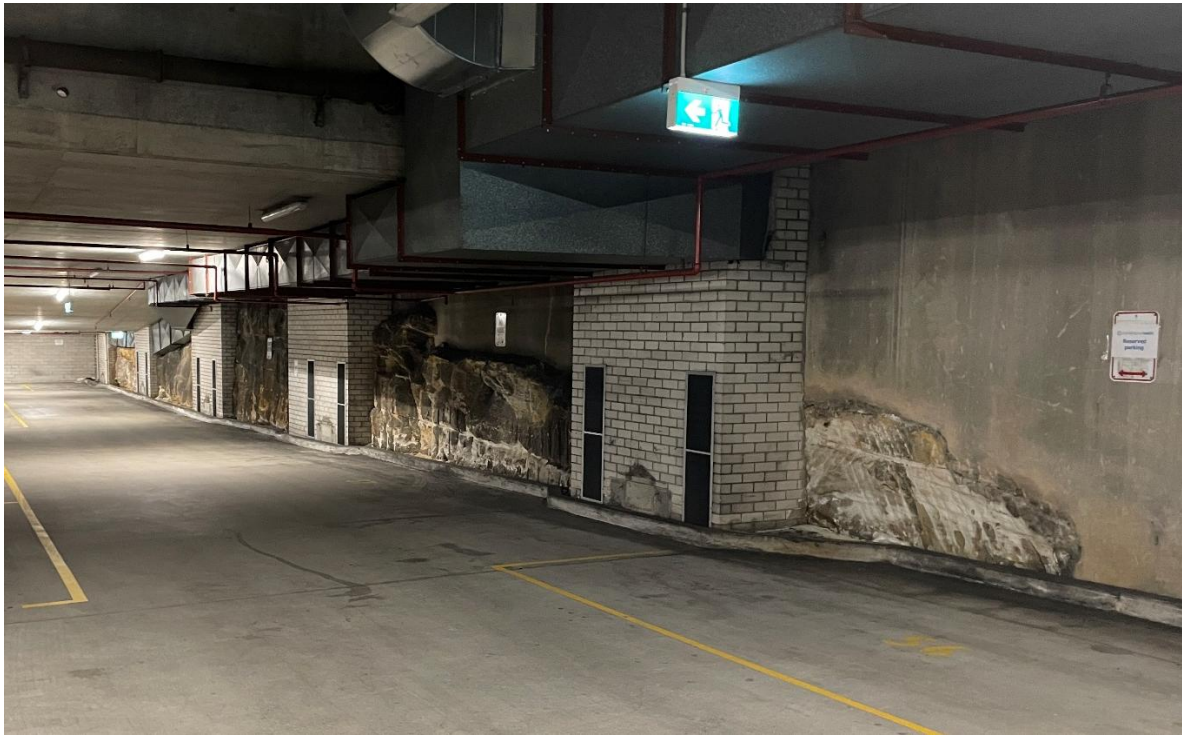
- In the lower basement level of the existing building, the following observations were made:
  - o The entry level of the lower basement has a small amount of rock exposed along the northern boundary (refer Photo 9). The top of rock rises to the west in steps, roughly following the slope of Blue Street until it is the full height of the basement in the western third of the northern boundary. The rock consisted predominantly of medium strength sandstone, with some low to medium strength bands (refer Photo 10). Both NNE and ESE striking joints were observed in the rock face as described in Section 3.1. Additional 40° to 45° dipping discontinuous joints, striking at between 80° and 100° were observed.

Photo 9: Photograph of the rock outcrop along the northern wall of the lower basement level

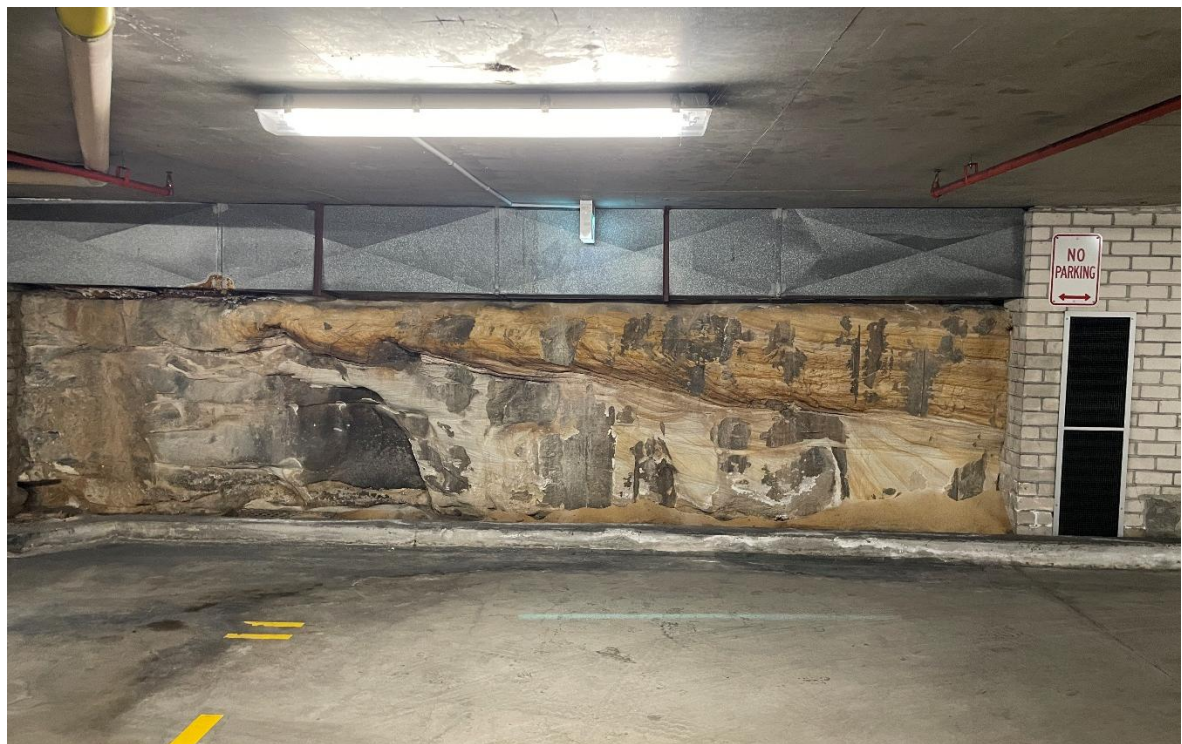
Photo 10: Photograph of the rock outcrop at the western end along the northern wall of the lower basement level

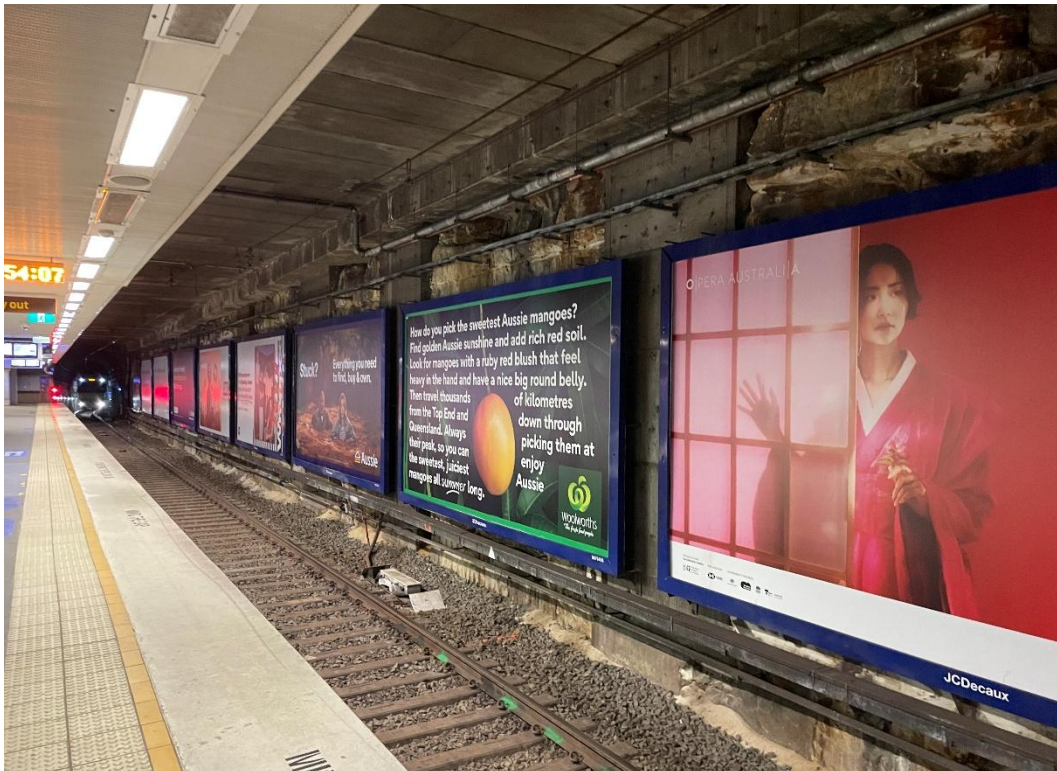
- In the station, medium to high strength rock was observed in the excavation face (refer Photo 11) along the northern boundary (across from Platform 1) for the full height from the track level up to the podium level (station roof). The northern most tunnel at the western end of the station was observed to be concrete lined (refer Photo 12).

Photo 11: Photograph of the rock exposed along the northern boundary from Platform 1

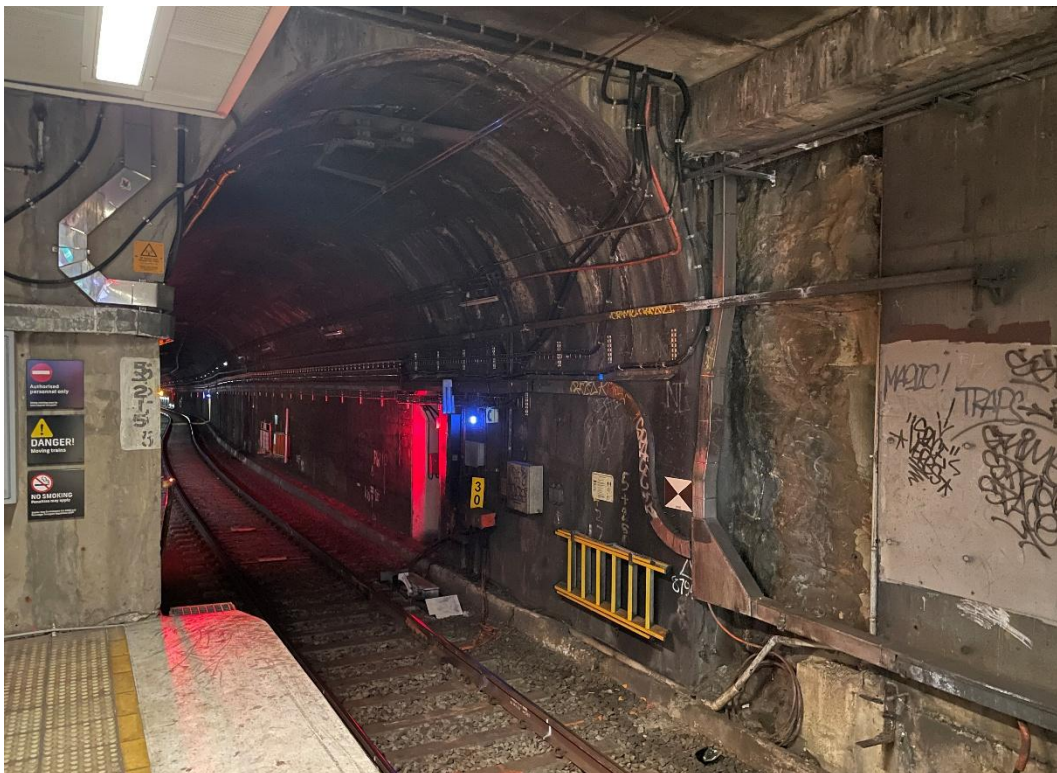
Photo 12: Photograph of the northern tunnel portal at the western end of Platform 1

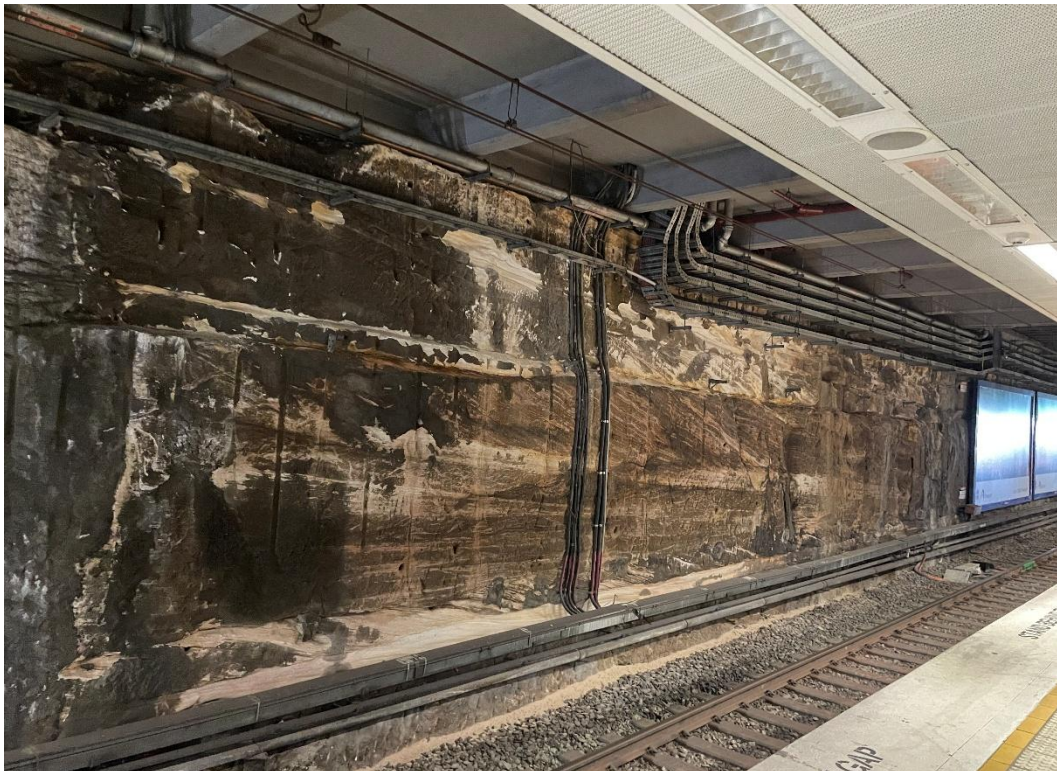
Photo 13: Photograph of the rock outcrop along the northern wall to the east of the site in the station area

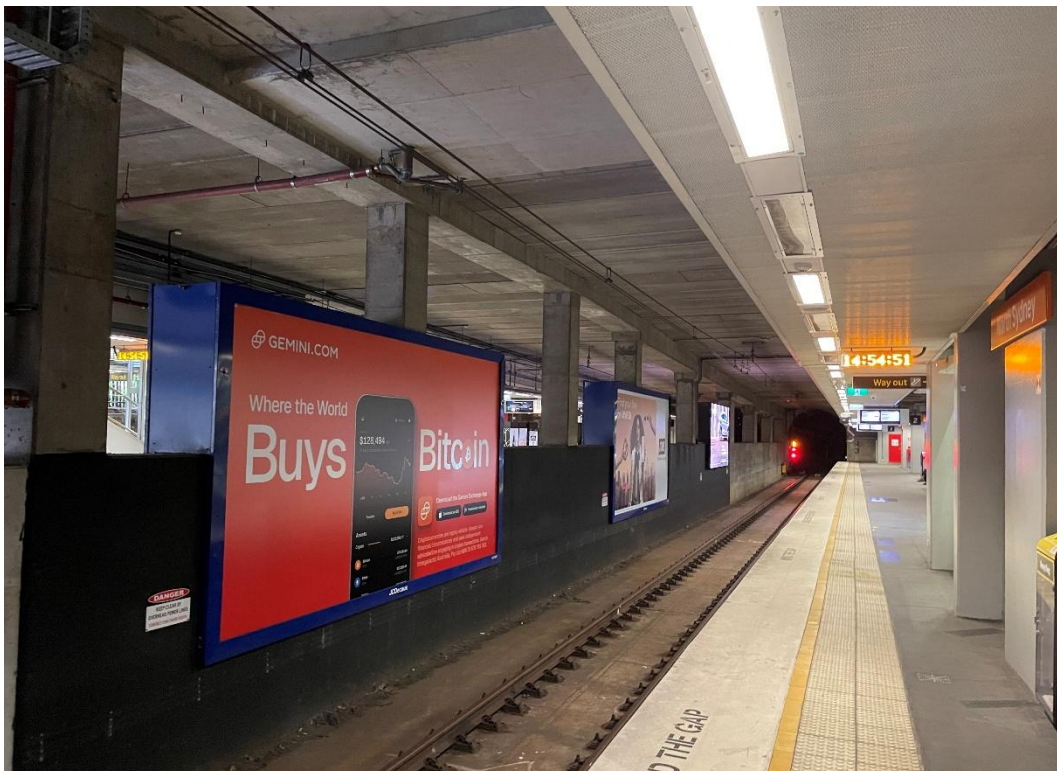
- Columns supporting the podium level and building above are spread throughout the station along the boundaries, platforms and between the two middle tracks (refer Photo 14). Many of the perimeter columns were observed to have widened foundations beneath the columns (refer Photo 18).

Photo 14: Photograph of the columns located between the platforms from Platform 2

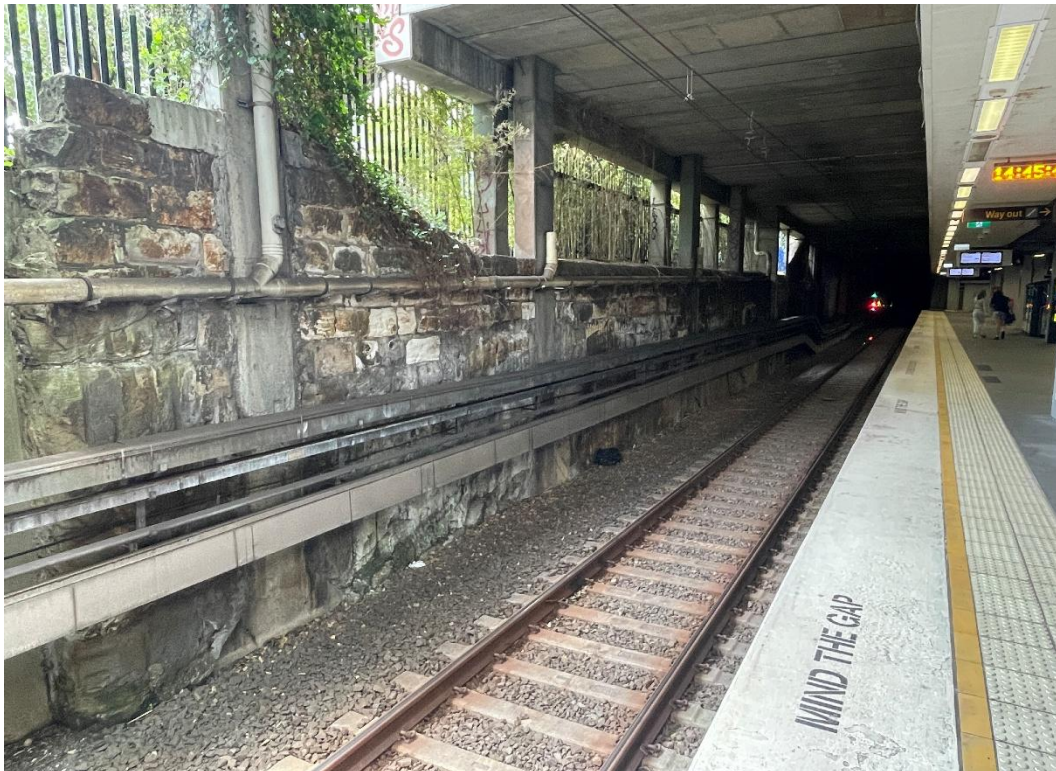
Photo 15: Photograph of the rock along the southern boundary from Platform 4 at approximately the eastern end of the site looking west

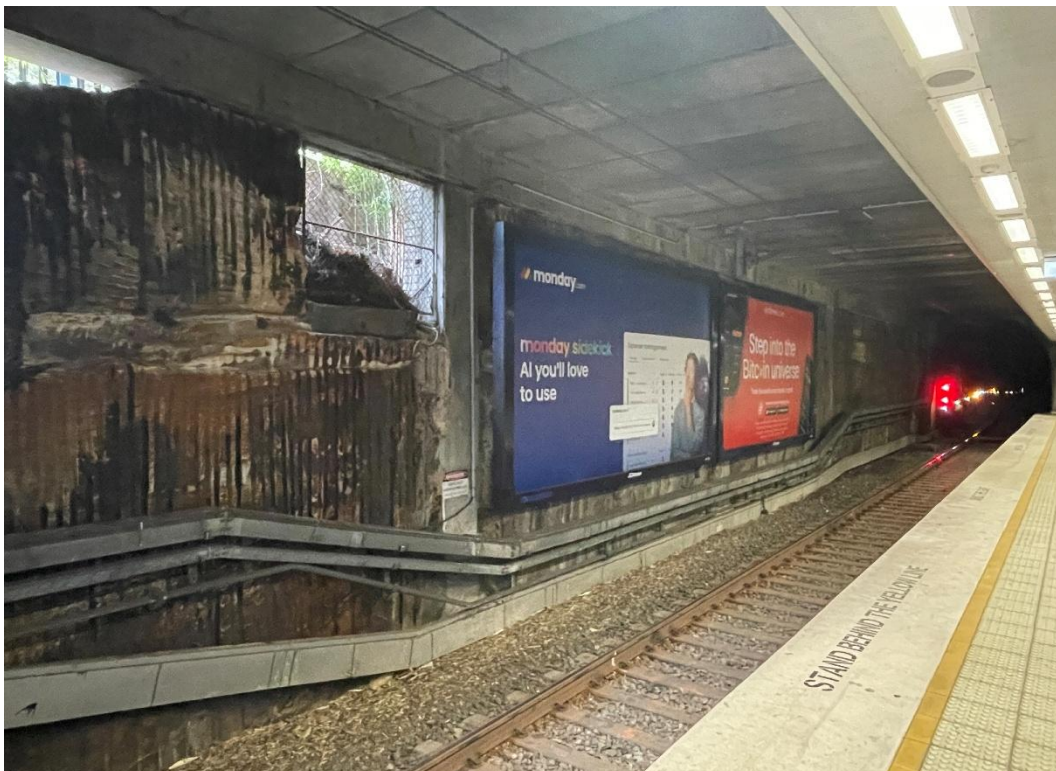
- In the station, medium to high strength rock was observed in the excavation face along the southern boundary (across from Platform 4), however it was only full height in the western third of the site (refer Photo 16), with the station area open to the outside where the rock dipped below the podium level in the eastern end of the southern boundary (refer Photo 15). The southern most tunnel at the western end of the station was observed to be concrete lined like the other tunnels (refer Photo 17).

Photo 16: Photograph of the rock along the southern boundary from Platform 4 at approximately midway along the site boundary looking west

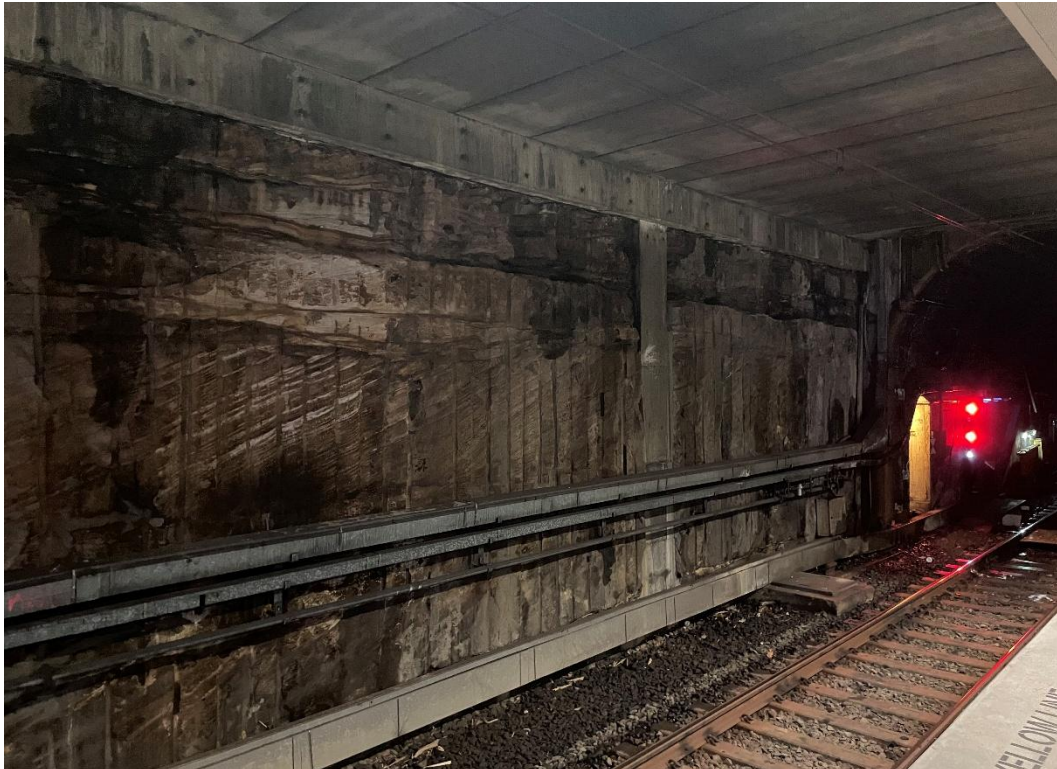
Photo 17: Photograph of the rock along the southern boundary and southern tunnel portal at the western end of Platform 4

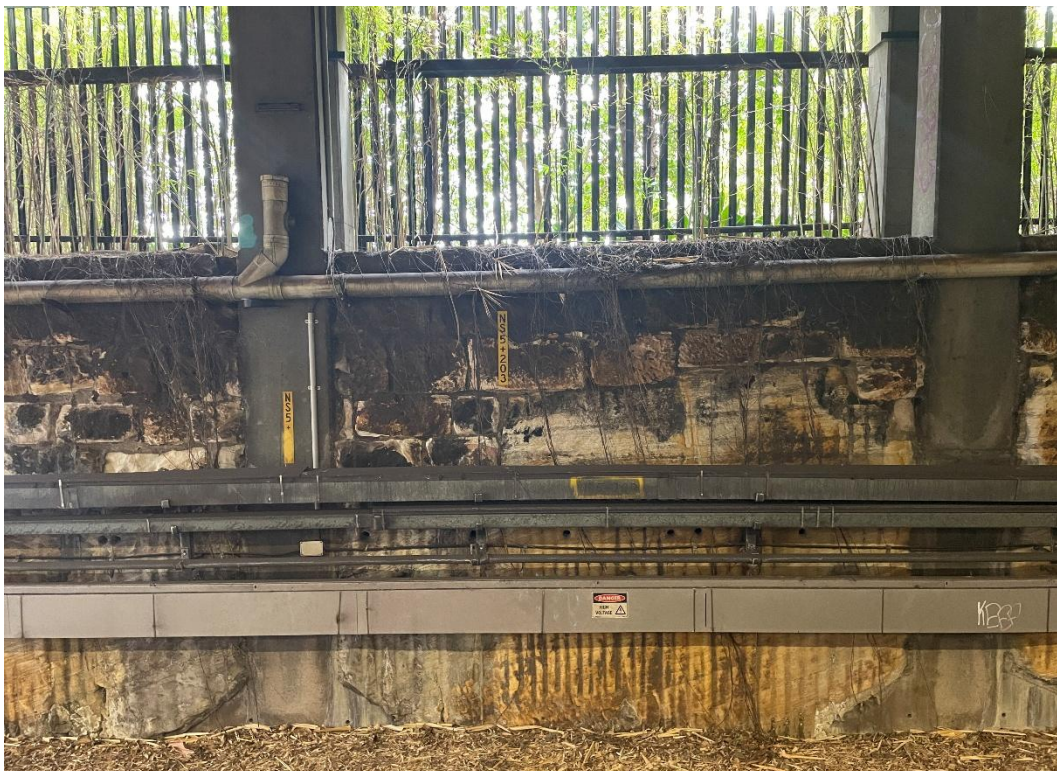
Photo 18: Photograph of the rock along the southern boundary from Platform 4 including the existing tapered foundations of the structure above
