Arboricultural Impact Assessment

St Aloysius' College – Middle School Upper Pitt Street Milsons Point Sydney, NSW

Ref: C91109

RE: Arboricultural Impact Assessment for five (5) trees located in the vicinity of a proposed garden upgrade at St Aloysius' College – Middle School, Milsons Point

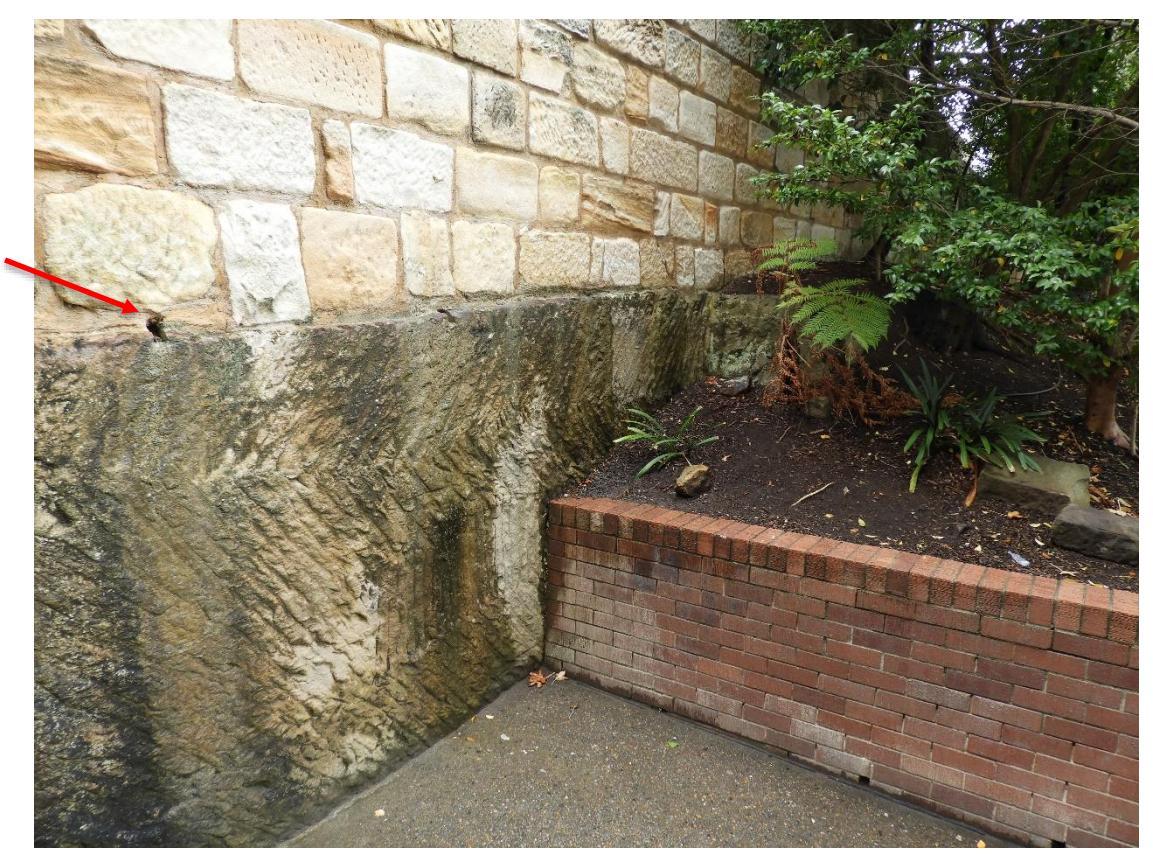
- 5.2.4 A photo of the raised brick garden bed, the sandstone boundary wall and the foundation bedrock are all visible in Figure 2. Note the small drainage hole situated at the base of the stone boundary wall, which is assumed to be replicated at intervals along the interface between the bedrock and stone wall. The exact height and disposition of the interface is unknown as the soil within the raised brick garden bed has been raised above the interface for most of the length of the garden bed. The construction of the stone wall does not appear recent and shows no signs of cracking, misalignment or movement. Such signs would indicate the interface and foundation, between the bedrock and wall, has not been compromised or degraded by root infiltration.

Figure 2: View of the sandstone bedrock, stone boundary wall and the raised brick garden bed. The red arrow highlights what is assumed to be a drainage hole under the wall. Source: Tom Axford 2018

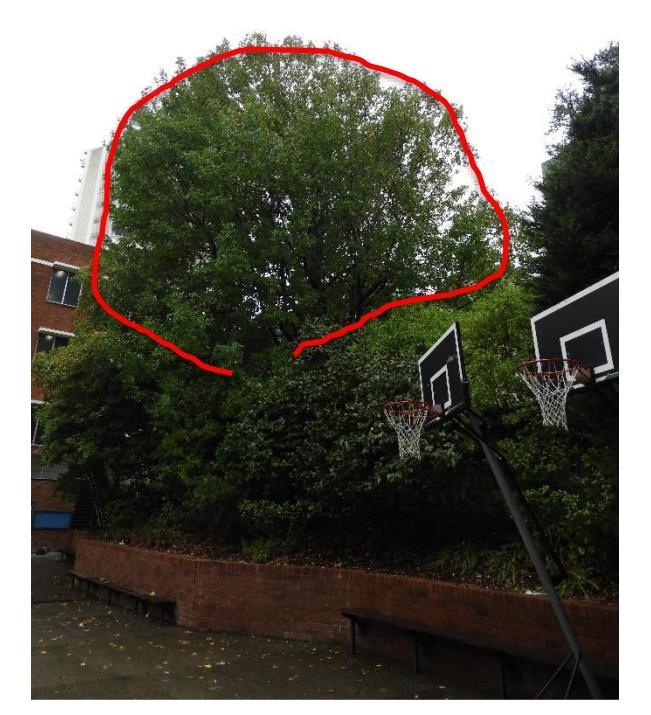
Figure 5: Image is showing Tree 60 Liquidambar. Red line indicates canopy outline. Source: Tom Axford, 2018

- 6.3.3 Tree 60 is a *Liquidambar styraciflua* (Liquidambar). The tree is of moderate size and was considered to be in good health with fair structure.
- 6.3.4 The tree is situated in the adjacent property, but the proposed development would be within its calculated TPZ and also has lateral branches which extend over the school property line. It provides amenity value and shading to the area which will be subject to the proposed landscape upgrade.

6.3.5 The TPZ for Tree 60 is 7.8m measured at a radial distance from the centre trunk taken from the estimated DBH. The TPZ of Tree 60 will be expanded on further in the discussion section (7.1.1) of this report.

- 7.1.2 Using the above criteria, the proposed development would constitute a major encroachment into the TPZ of Tree 60, identified as the only tree on site which is relevant to the definition of a prescribed tree within the North Sydney DCP as outlined in 5.5.3 of this report. Trees generally require removal if they are located within the development footprint or have major encroachment into their TPZs.

- 7.1.3 The general criteria for TPZ calculation, in the instance of Tree 60, should be considered void as the solid stone bedrock and the rock boundary wall appears to have formed an effective barrier for any significant structural roots. This assumption, in the absence of any root mapping or root friendly exploratory excavation, is based on the size, weight, components, age, construction and general appearance of excellent stability of the stone boundary wall.

- 8.2.1 Tree 60 was recommended for retention and requires specific protection measures during construction to ensure it remains viable following the completion of works.

- 8.2.2 Excavation adjacent Tree 60 is to be carried out only under arborist supervision. It was recommended that the proposed excavation commence at the outer extent of the TPZ and move inwards to minimise existing root damage if any significant incursion through the stone boundary wall was discovered.

- 8.3.1 Pruning may be required within the lower western lateral branches, of Tree 60, which are overhanging the College quadrangle. All pruning is to be undertaken in accordance with the Australian Standard AS 4373–2007: Pruning of Amenity Trees and undertaken by a suitably qualified arborist (minimum AQF 3 arborist). Obtaining consent from the tree owner and relevant Consent Authority prior to any pruning is recommended.
- 8.3.2 Reduction pruning should focus on smaller diameter branches overhanging the property boundary and remove no greater than 10% of the total crown. Branches no greater than 50mm diameter are to be removed unless approved by the relevant Consent Authority and specified by the project arborist.

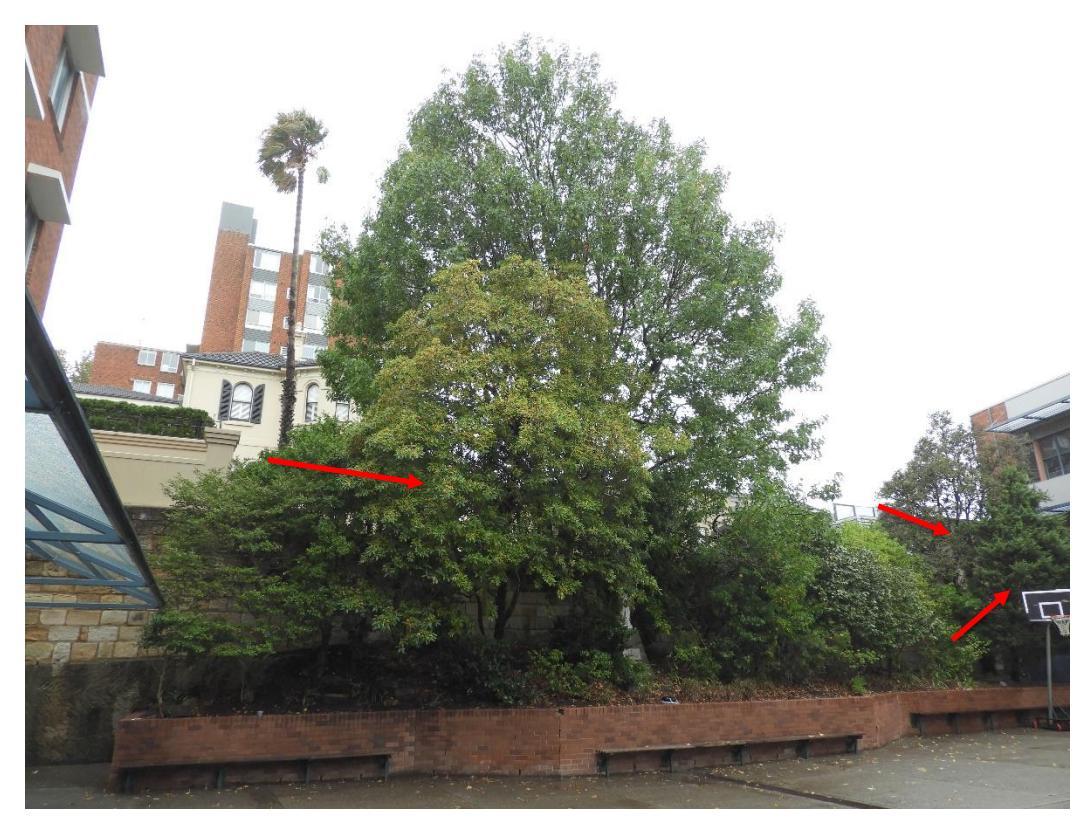
6.4.2 Category C trees are: Trees 1, 2, 3 and 61.

Figure 6: Image is showing the location of the exempt trees listed as category C trees. Complete tree attributes are to be obtained from Appendix C – Tree Assessment Data. Source: Tom Axford 2018

- 6.4.3 The trees are a mixed planting including *Pittosporum undulatum* (Sweet Pittosporum), *x Cupressocyparis leylandii* (Leyland Cypress), *Murraya paniculata* (Orange Jessamine). The trees are growing in the garden bed which is subject to the development proposal.
- 6.4.4 The trees provide minimal additional screening between the College and neighbouring residential properties over and above the existing stone wall and are of an age, species or size which are easily replaceable in a short space of time.

8.1.1 Four (4) trees would require removal to facilitate this development. These are the North Sydney Council DCP exempt, Category C trees numbered 1, 2, 3 and 61.
