ARMIDALE SECONDARY COLLEGE, Butler Street Armidale**Introduction**

Appendix A – McArdle and Sons Tree Report.

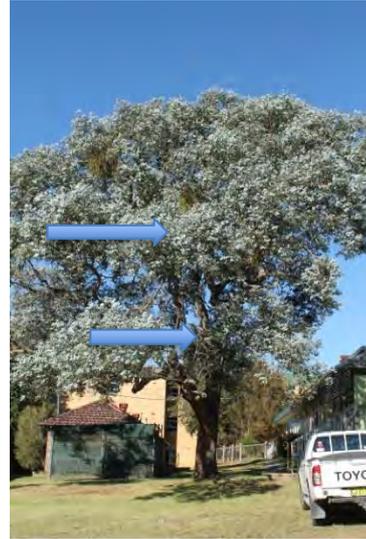
TREE 47 Significant Tree Several Fail sites

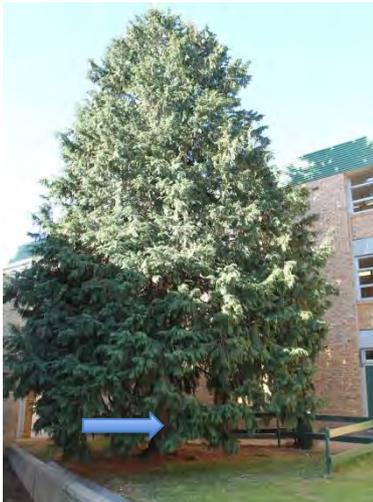
TREE 49 Split base

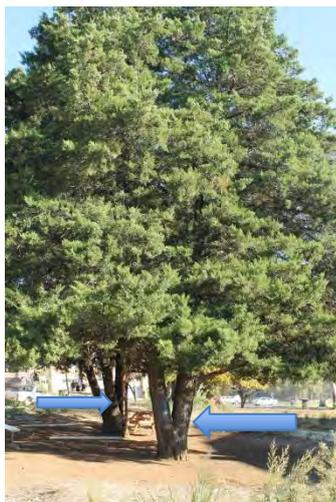
101	Not affected	Cuspressus spp	10	12	40/40	Mature, Physical Damage at Base	90			D3 C4 Low	Tree Indicated for Removal Tree Removal / Retain Plan. Structural defect at base
102	In car access, Path	Cuspressus spp	160	13	50	Mature, Heavily Pruned	6			D3 Low	Structural defect, Cavity at base. Tree Indicated for Removal Tree Removal / Retain Plan
103	Not affected	Quercus robur, English Oak	6	9	25	Mature, Good Condition	30			A2 Medium	Retain
104	Not affected	Liquidambar	3	9	28	Mature, Good Condition	35			A2 High	NOTE: Memorial Tree Retain

TREE 100 & 101 Union separation

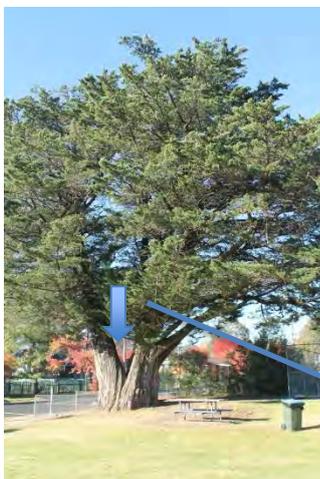
105	Other – Path	Cuspressus spp	19	16	280	Mature, 3x main leader fracture at base east	306			D2 High	Fractured at base monitor @ 6 month intervals Retain
106	Path	Pinus radiata Montereu pine	14	14	90	Mature, Good Condition	110			D2 High	Significant tree Retain
107	Path	Cuspressus sempervirens	3	12	Multi	Mature, Good Condition	65			A2 Medium	Retain
108	Path	Cuspressus spp	10	12	40/10	Mature, Good Condition but Poor Development/Habit	100			D2 Medium	Poor structural form Retain & inspect annual
109	Path	Cuspressus sempervirens	5	12	60	Mature, Good Condition	80			A2 Medium	Retain
110	Path	Populus alba	10	10	50/50	Mature, Moderate Condition, Lean, Cavity at base	80			C4 Low	Removal for safety reasons
111	Path	Cuspressus spp	12	9	60	Mature, Good Condition	90			A2 Medium	Retain
112	Path	Pinus radiata Montereu pine	8	12	50	Mature, Poor Condition, Declining	60			D3 Low	Retain
113	Path	Cuspressus spp	8	12	80	Mature, Good Condition	90			A2 High	Retain

Tree 105 fracture at union
