STATEMENT OF HERITAGE IMPACT

4-18 Doncaster Avenue, Kensington

December 2018

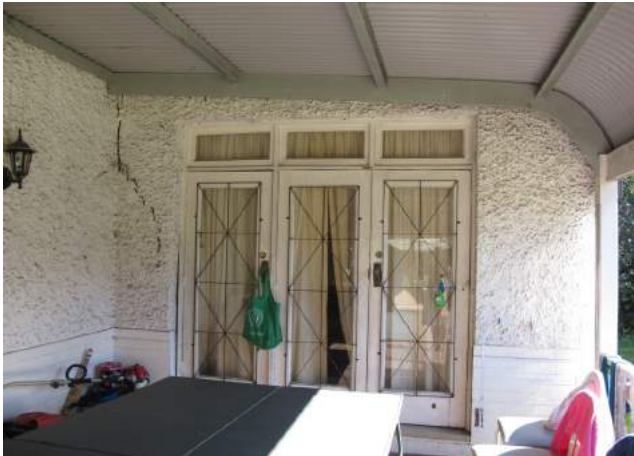
Figure 3.11
Detail showing as example of the cracking to the exterior of 4 Doncaster Avenue.

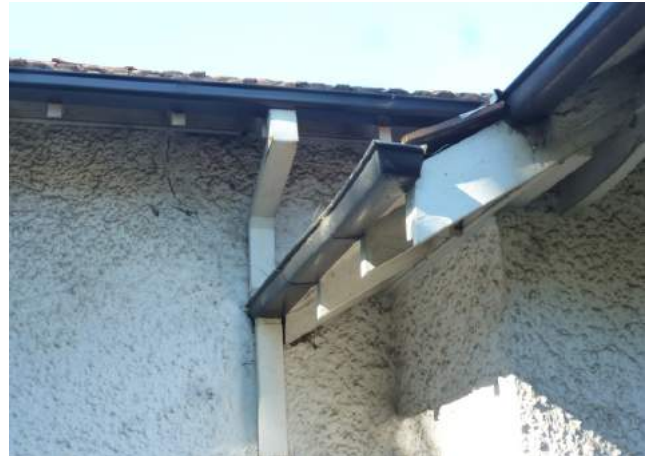
Figure 3.12
Detail of exterior showing cracking.

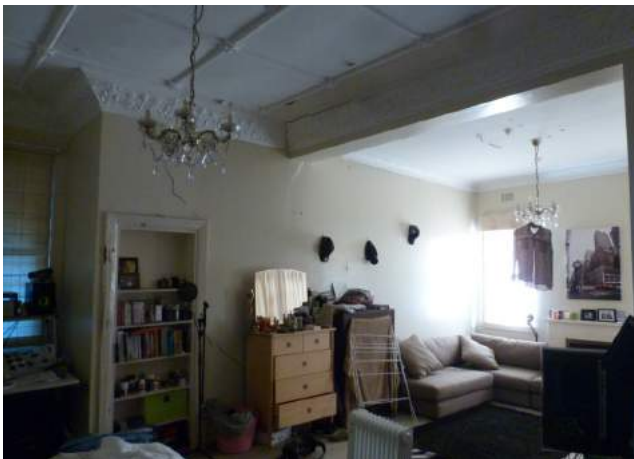
Figure 3.13
The living area within 4-8 Doncaster Avenue. Decorative plaster ceilings and cornices are visible in the foreground. A large structural beam illustrates where the dwelling was extended and associated cracking.

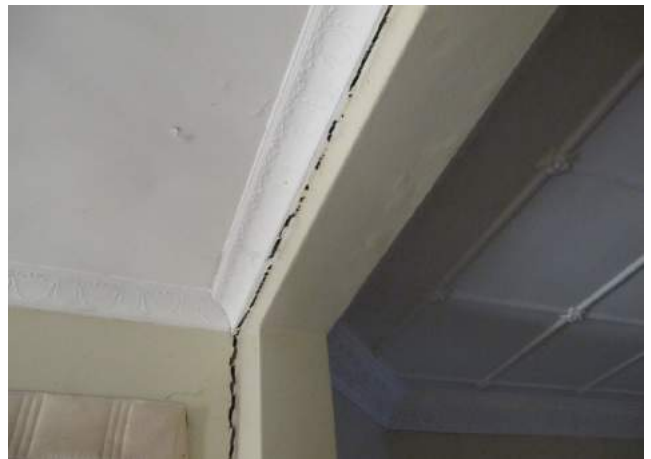
Figure 3.14
Detail of interior showing cracking and ceiling separation at beam.

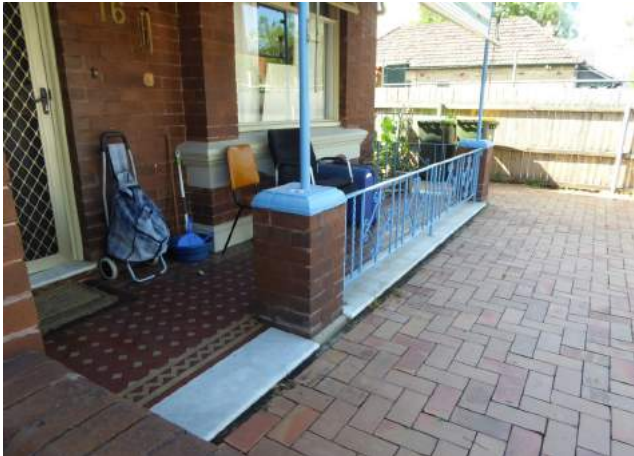
Figure 3.28
16 Doncaster Avenue, showing unsympathetic metal verandah posts and railing, non-original tiles and garden paving.

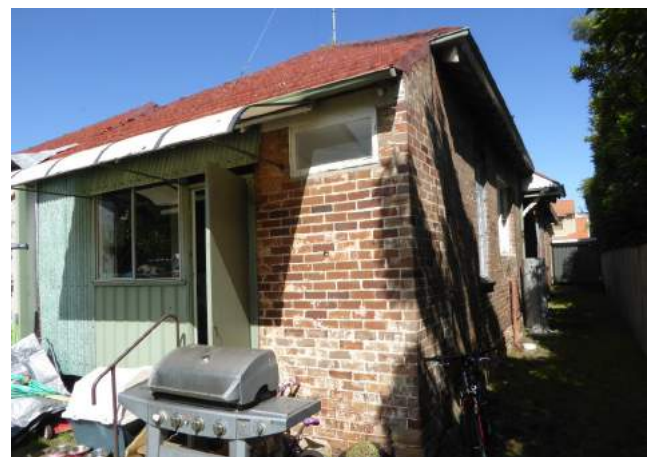
Figure 3.33
Rear of 14 Doncaster Avenue, showing changes to the brickwork and window opening, with unsympathetic cladding and aluminium framed window, showing rear details.

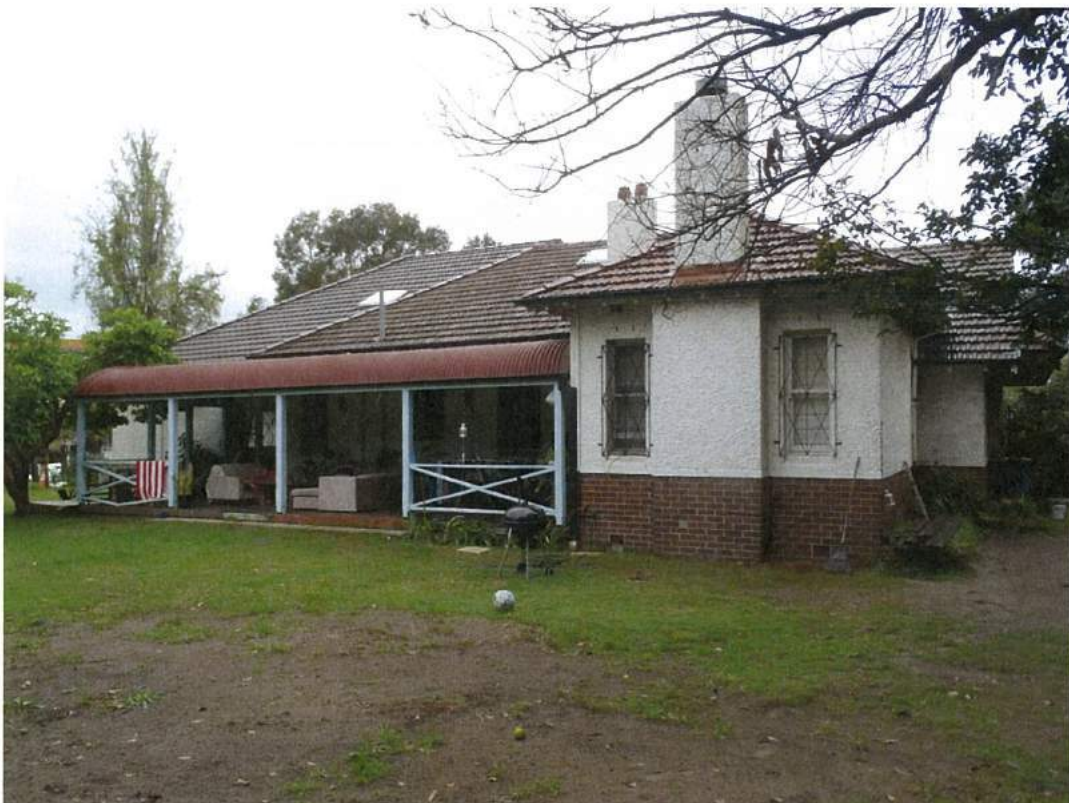
View of the building from the north. The north wing, which has rotated is on the right of the picture.

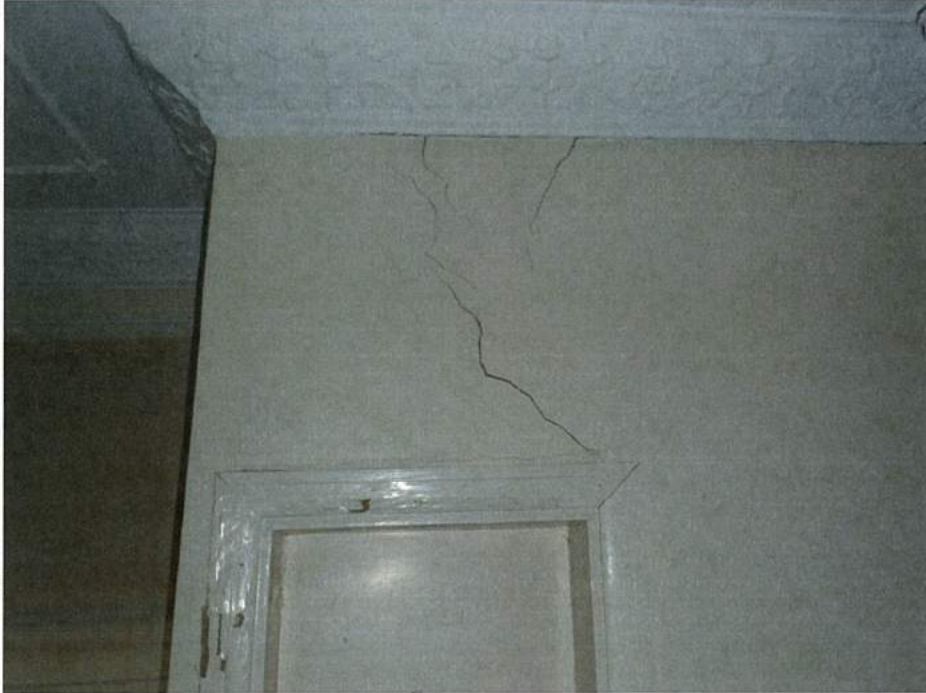
Cracking in west wall of north wing. Note also termite damage in joinery

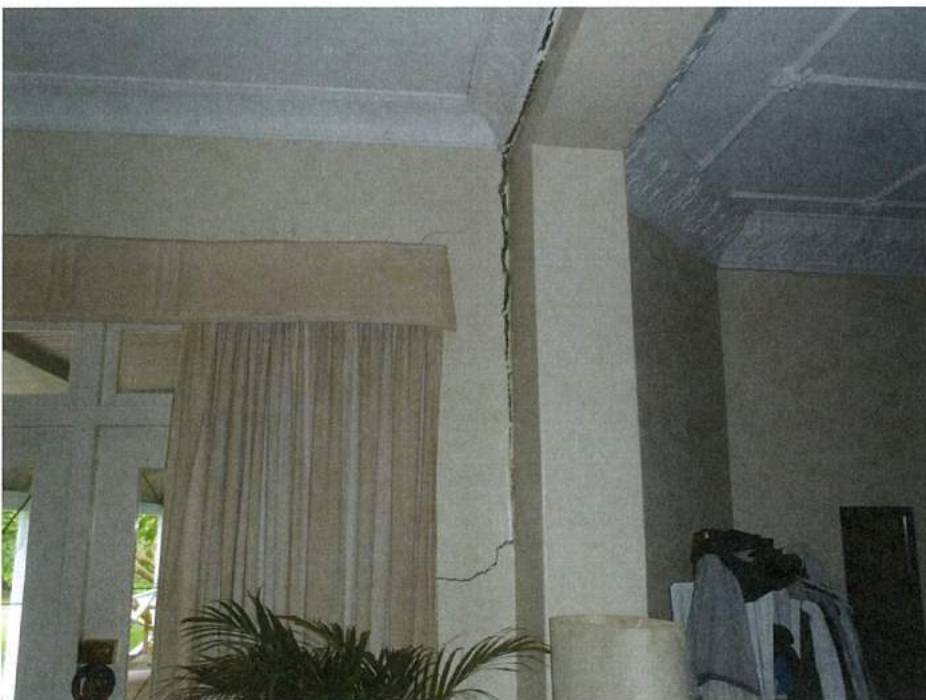
East wall of north wing showing ceiling separation at beam and severe cracking in wall

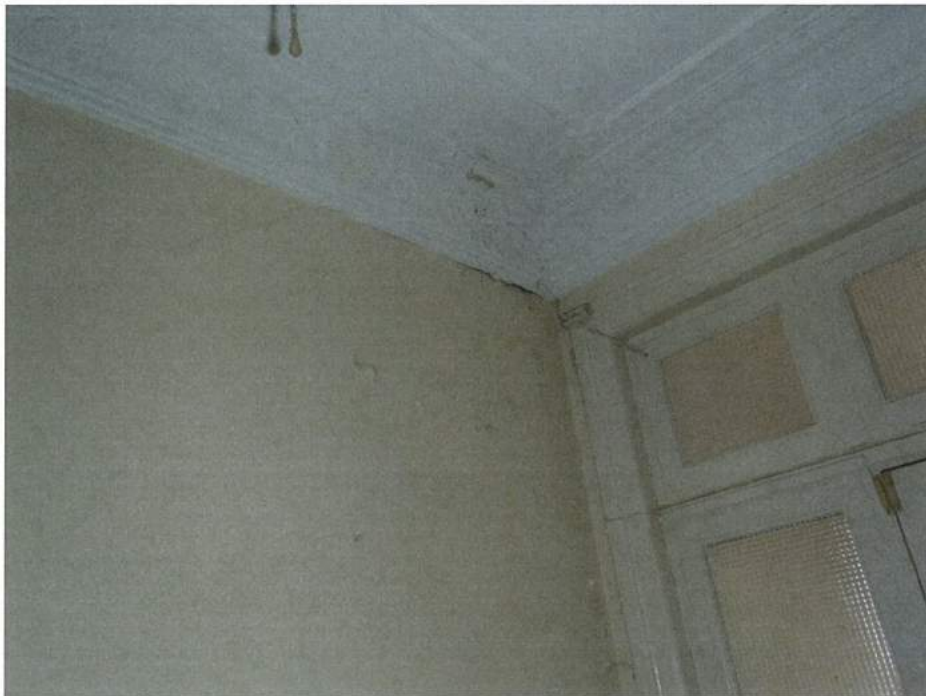
Damp penetration near entry

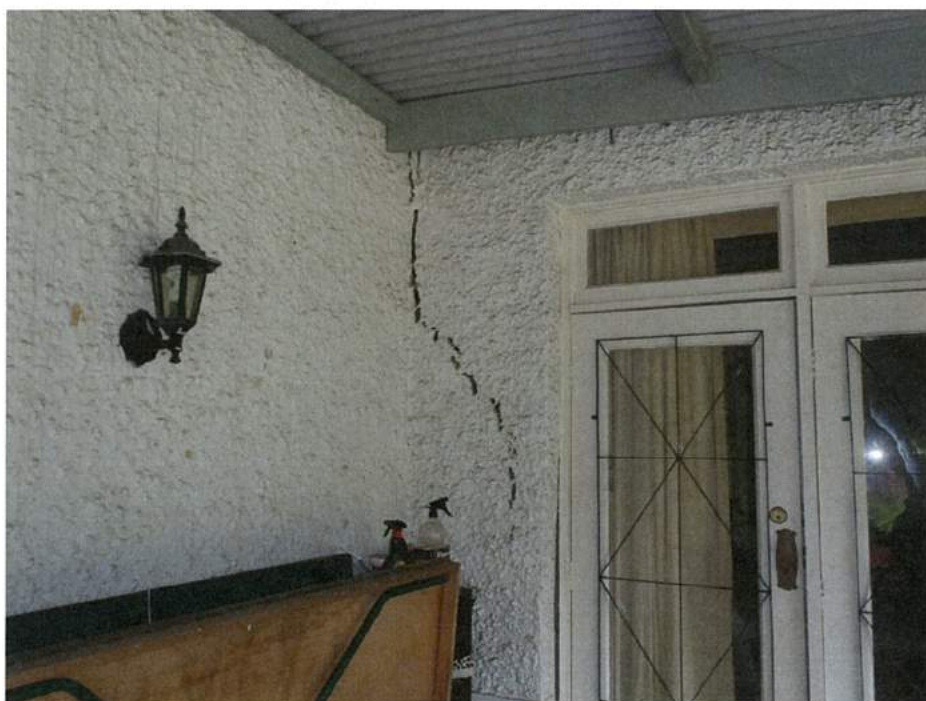
East wall of north wing – external view

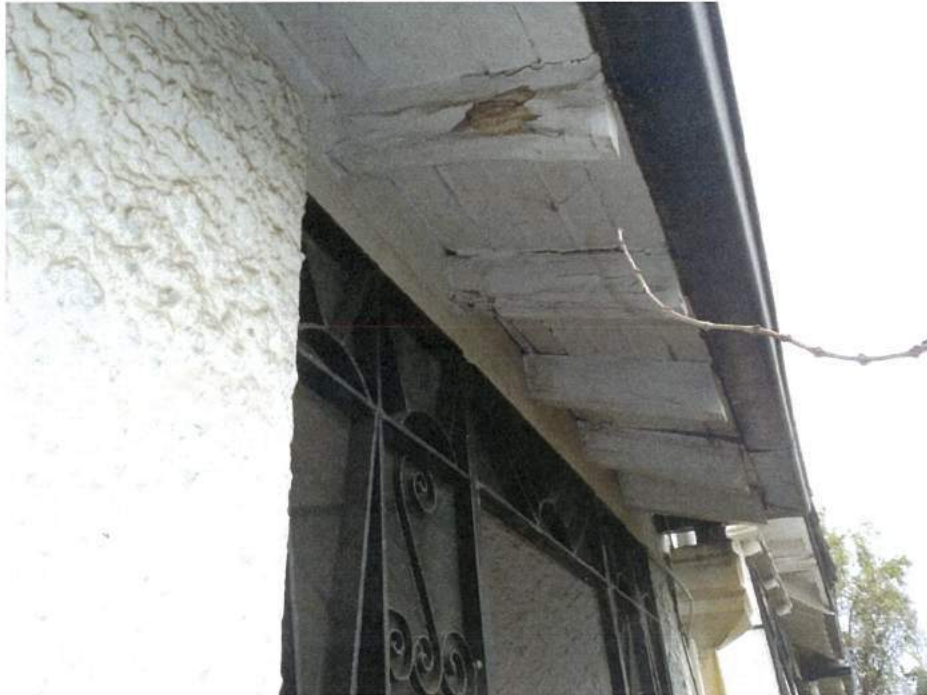
Eaves decay near entry

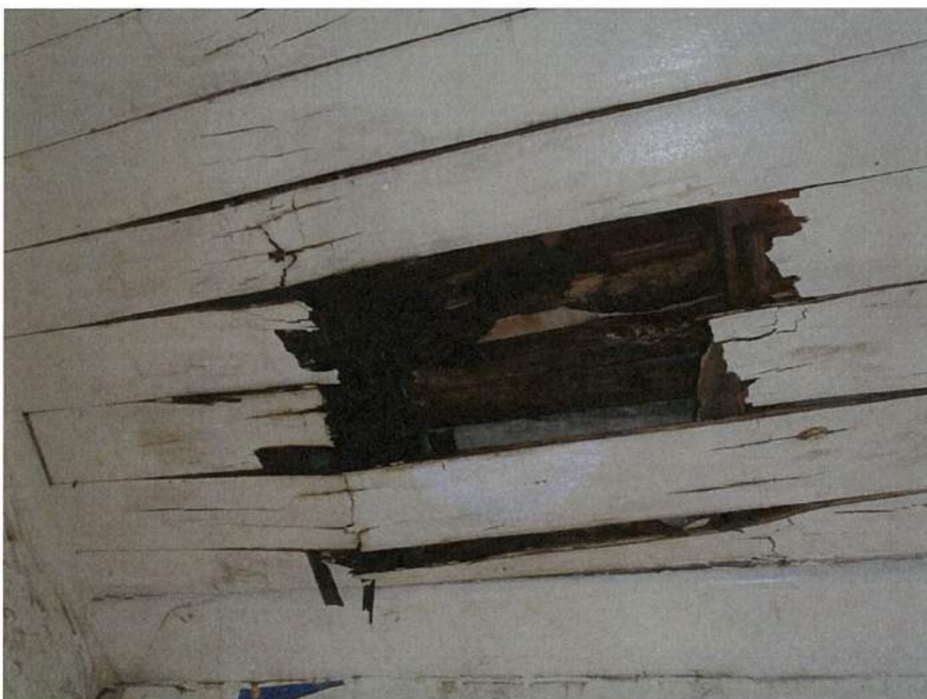
Roof and ceiling decay over entry

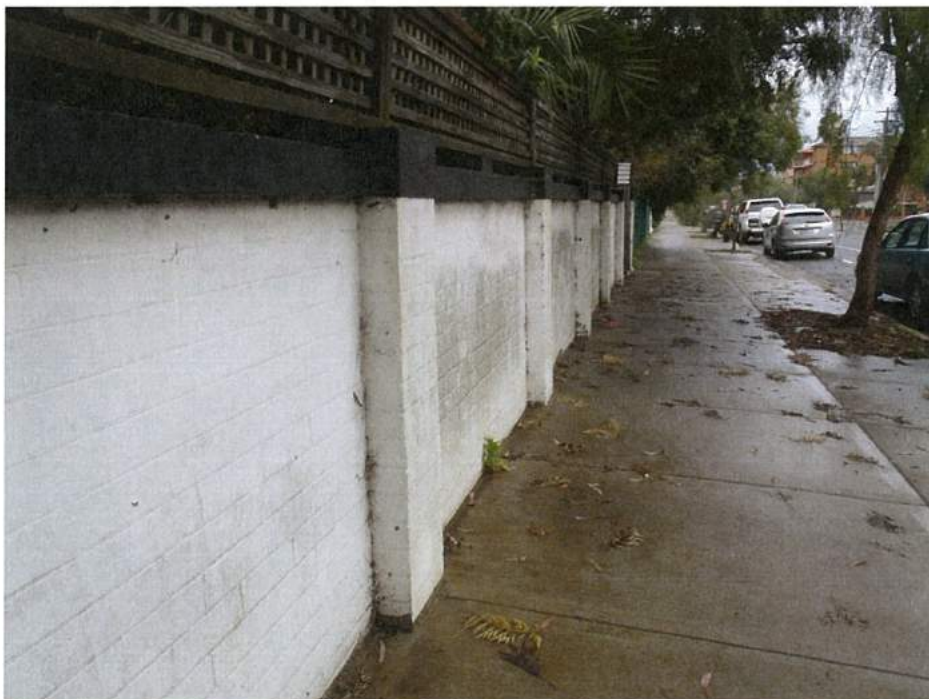
Rotating boundary wall
