Long-term Environmental Management Plan

Nihon University
9 Church Street, Newcastle

Project 91667.03
September 2021

Project No.	91667.03	Document No.	R003.Rev1.LTEMP
Document title	Long-term Environmental Management Plan		
	Nihon University		
Site address	9 Church Street, Newcastle		
Report prepared for	Nihon Daigaku Australia Newcastle		
File name	91667.03.R003.Rev1.LTEMP.docx

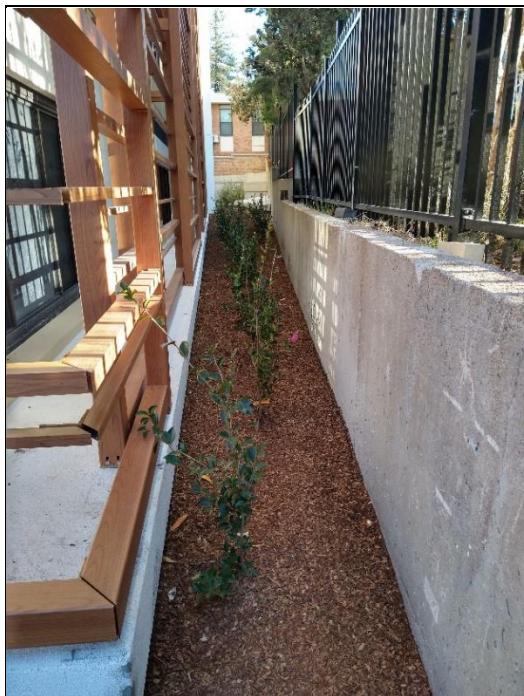
Figure 2 – Looking south at garden bed and mulch along western investigation boundary adjacent Education Building (20 August 2021)

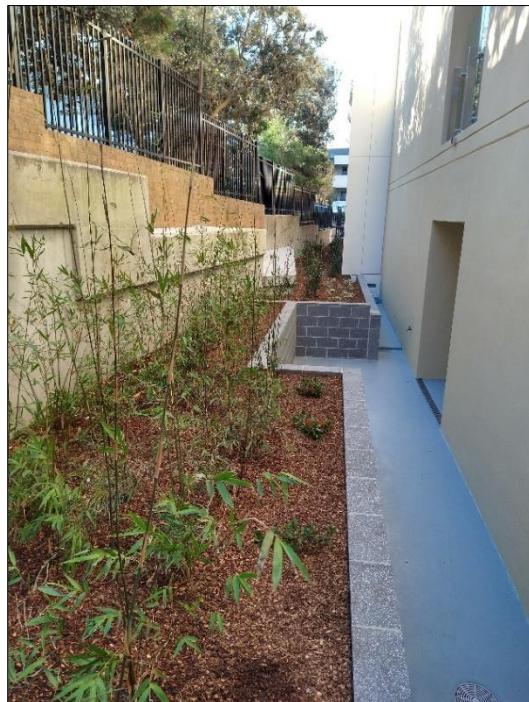
Figure 3 – Looking north at garden bed along western investigation boundary adjacent Education Building. (20 August 2021)

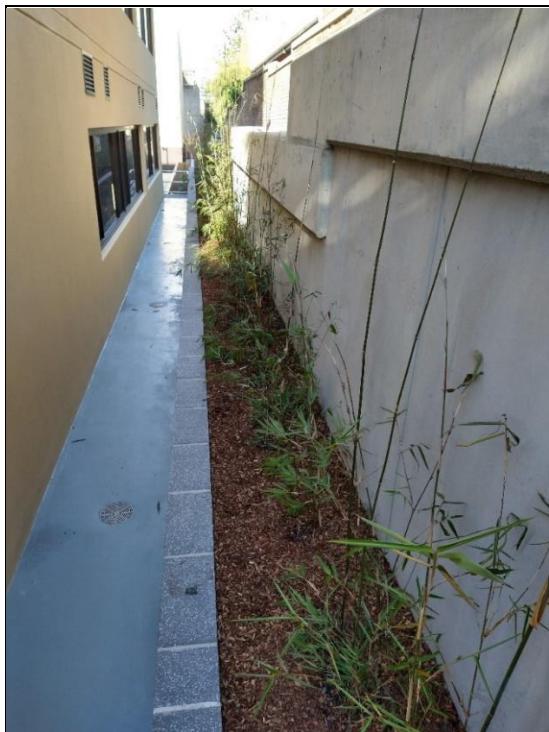
Figure 4 – Looking east at garden bed along southern site boundary adjacent Education Building.

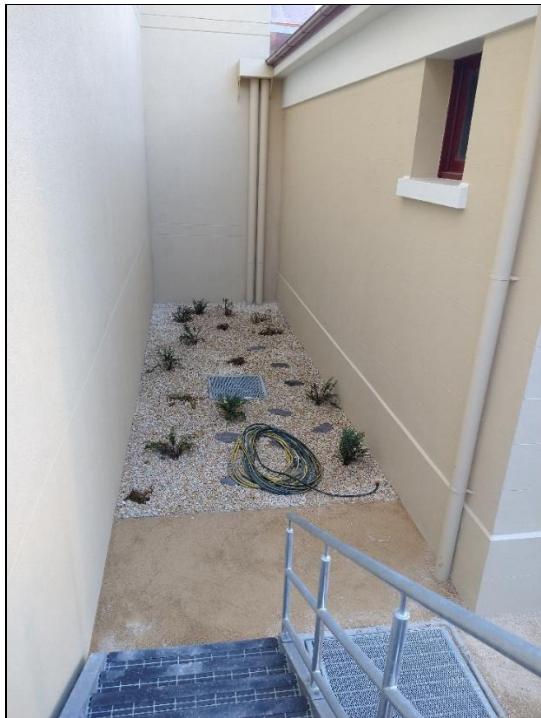
Figure 5 – Looking north at garden bed and walkway along southern side of Education Building. (20 August 2021)

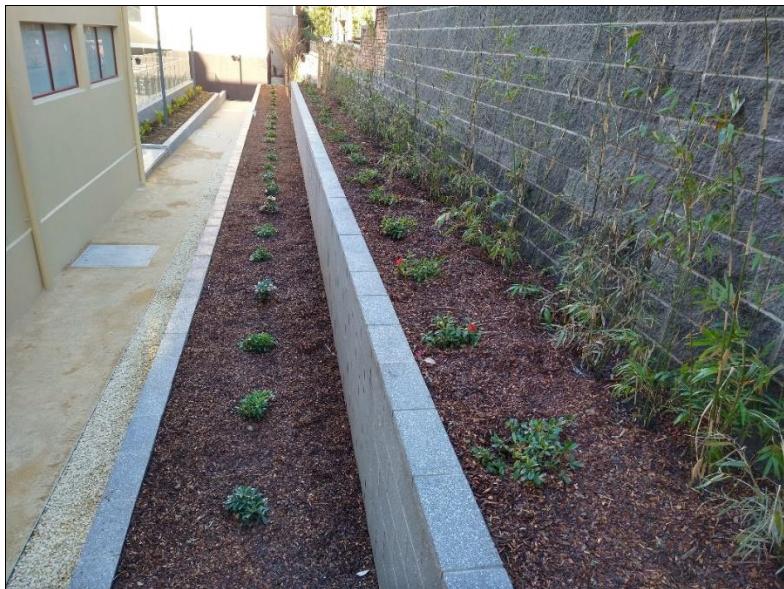
Figure 6 – Looking east at garden bed and walkway along southern side (rear) of central building (20 August 2021)

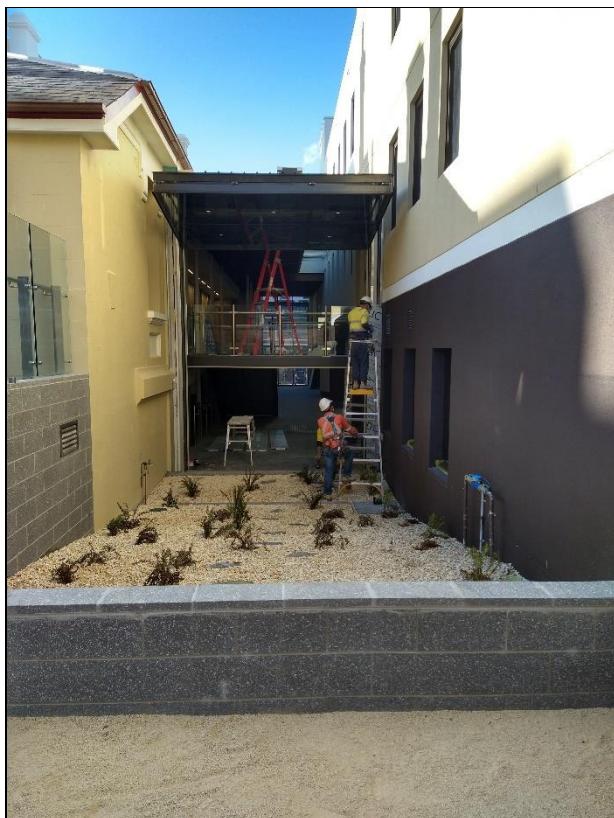
Figure 7 – Looking north at garden bed and walkway along southern side of Atrium (20 August 2021)

The minimum thickness of capping as presented in the RAP has generally been achieved across the site with the minor exception of the two landscape areas to the north and south of the Atrium (min 191mm as shown on Geosurv Asbuilt Plan in Appendix C). The survey plan provides accurate levels indicating the depth to the geofabric marker layer. This depth should be considered during any future disturbance/maintenance of soils within the site on Geosurv Asbuilt Remediation Layers survey plan in Appendix C. Any changes to depth (eg. as a result of landscaping requirements) should be documented as part of LTEMP review and maintenance.

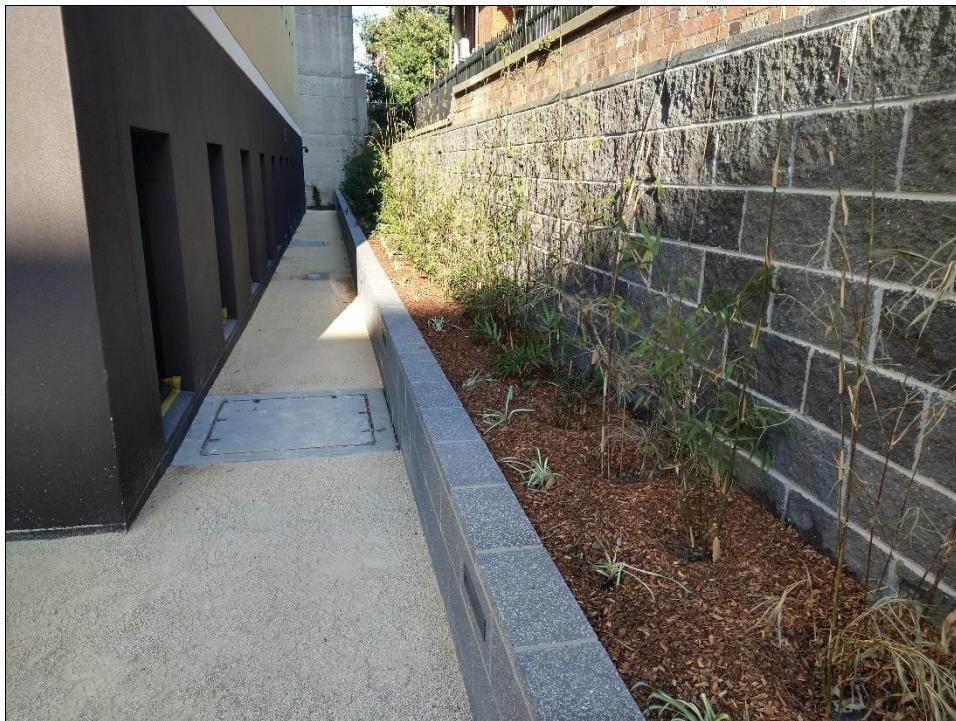
Figure 8 – Looking east at garden bed and walkway along southern side of Student Accommodation Building (20 August 2021)

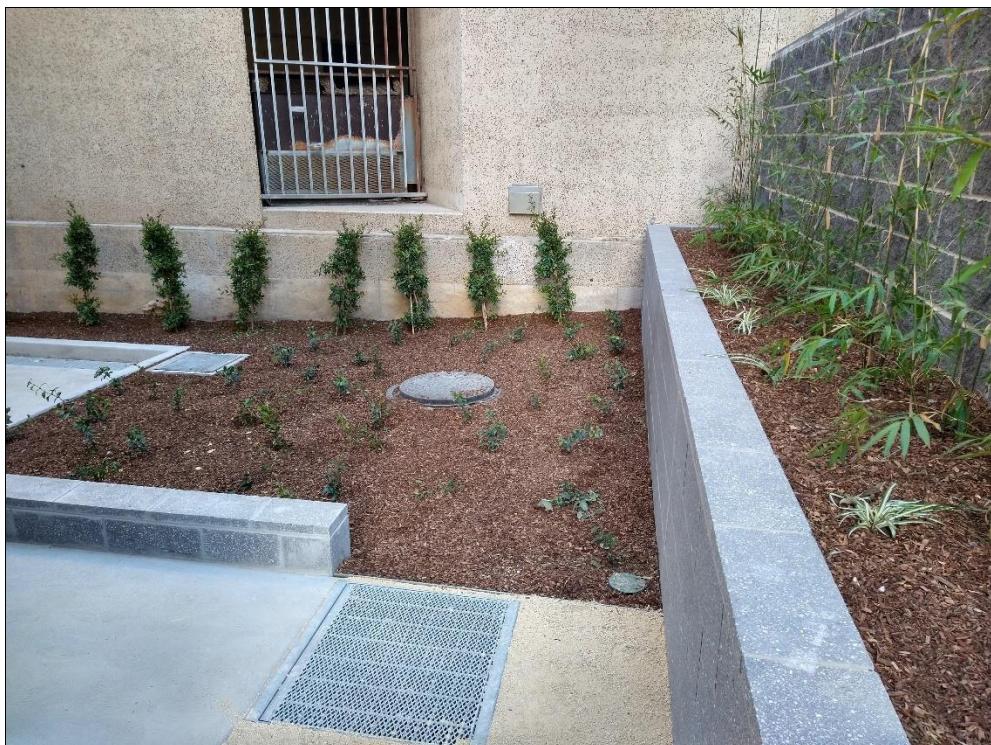
Figure 9 – Looking east at garden bed and walkway in south eastern corner of site (20 August 2021)

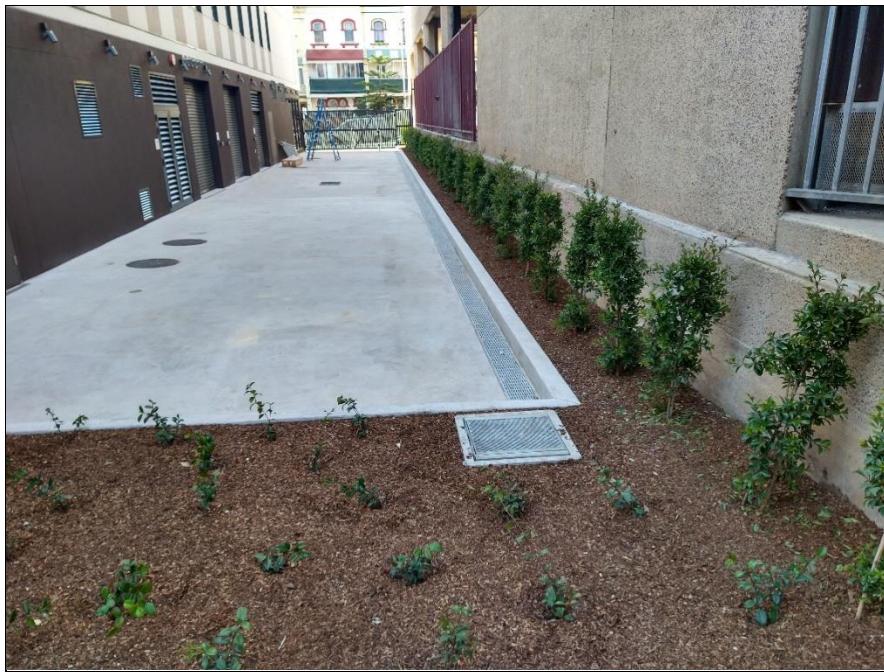
Figure 10 – Looking north at concrete driveway and adjacent garden bed along the eastern site boundary (20 August 2021). Student Accommodation Building to the left and the Newcastle Police Station to the right.

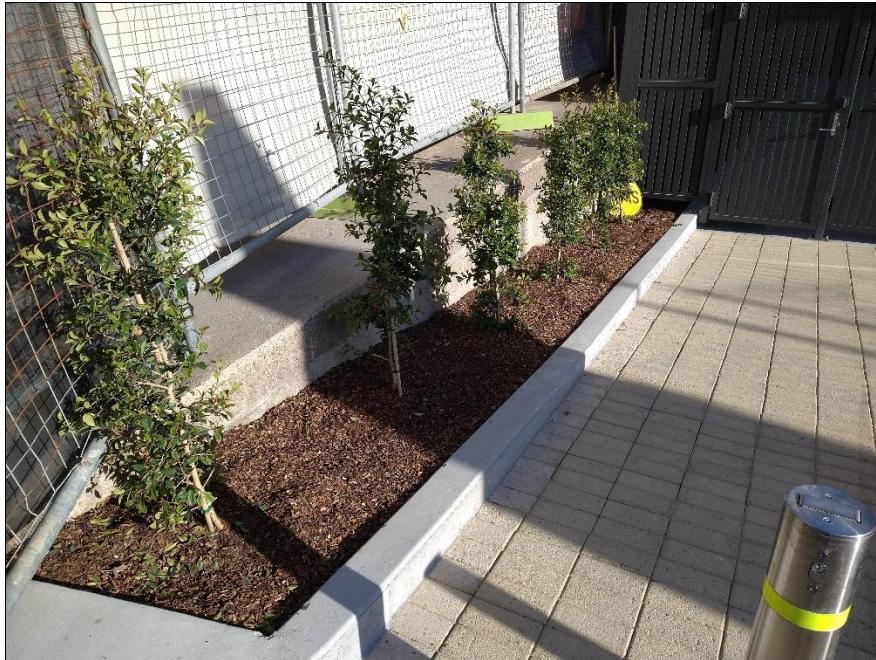
Figure 11 – Looking southeast at concrete paved driveway and adjacent garden bed along the eastern site boundary (20 August 2021)

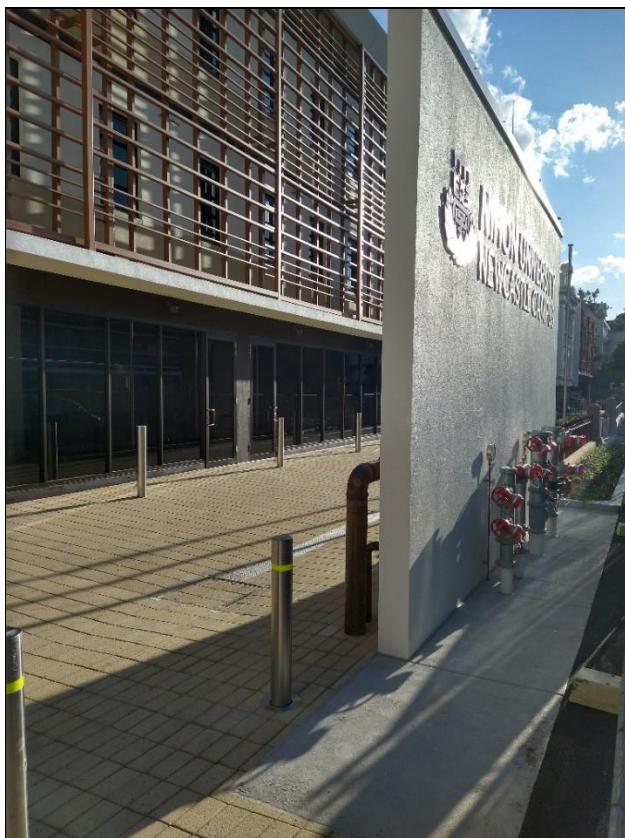
Figure 12 – Looking west at concrete paved driveway/footpath along the north side (front) of the Student Accommodation Building (20 August 2021)

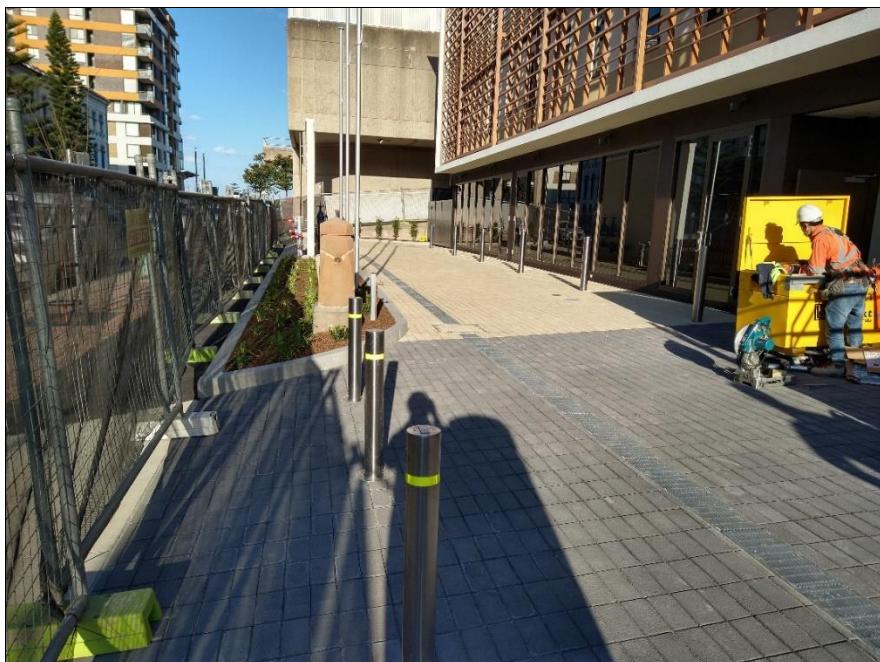
Figure 13 – Looking east at concrete paved driveway/footpath and adjacent garden bed along the northern side (front) of the Student Accommodation Building (20 August 2021)

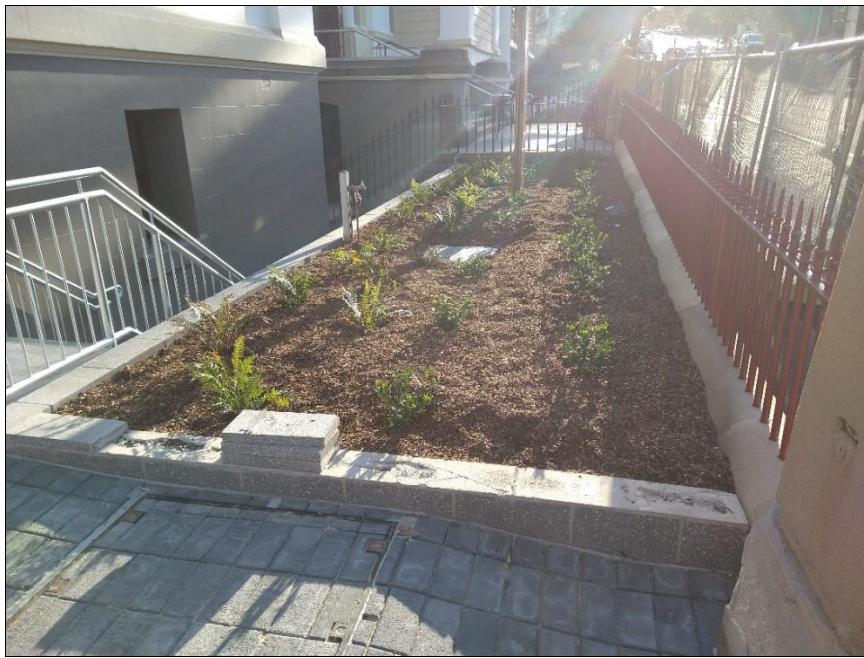
Figure 14 – Looking west at concrete paving and adjacent garden bed along the northern side (front) of the central building (20 August 2021)

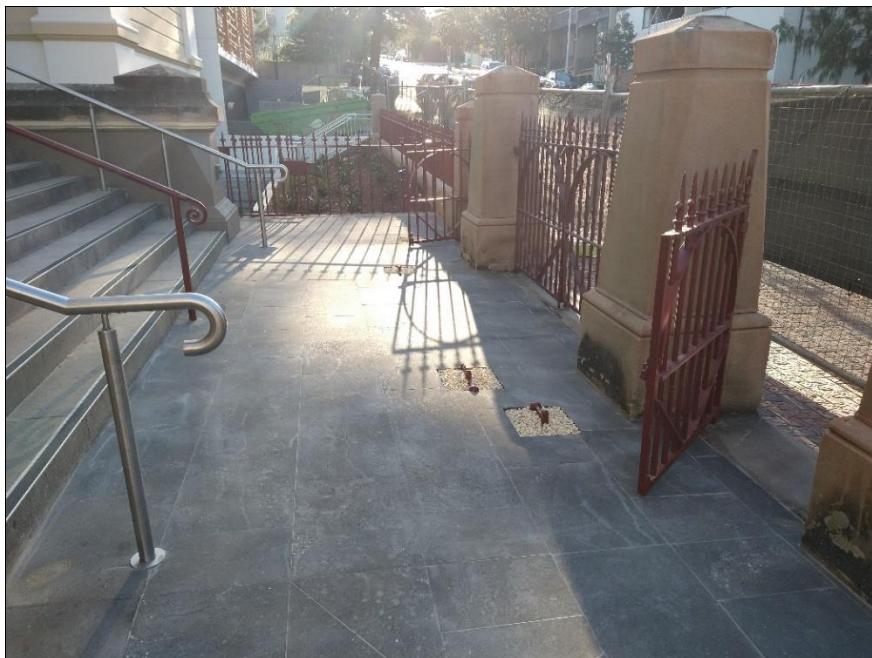
Figure 15 – Looking west at Bluestone paving and adjacent garden bed along the northern side (front) of the central building (20 August 2021)

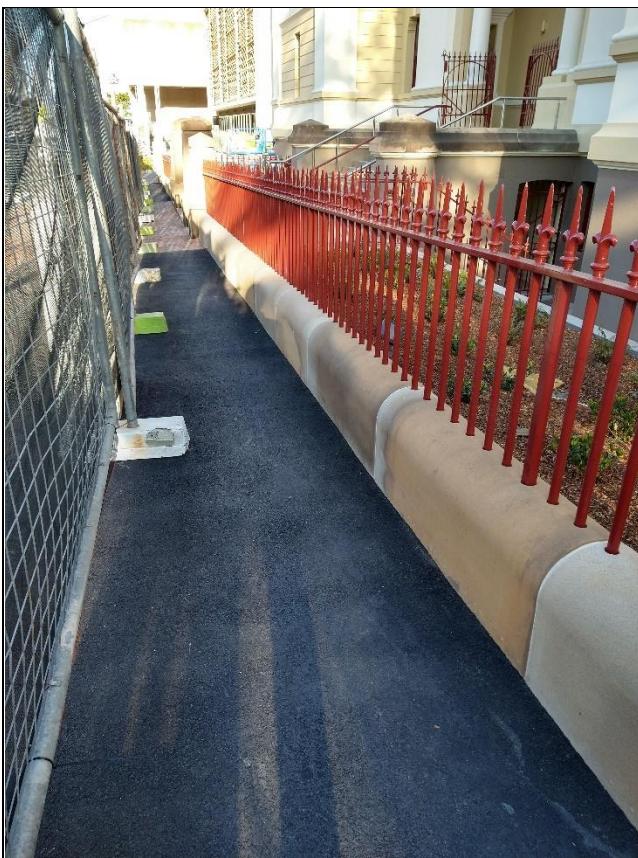
Figure 16 – Looking east at asphalt paving and adjacent garden bed along the northern side (front) of the central building (20 August 2021)

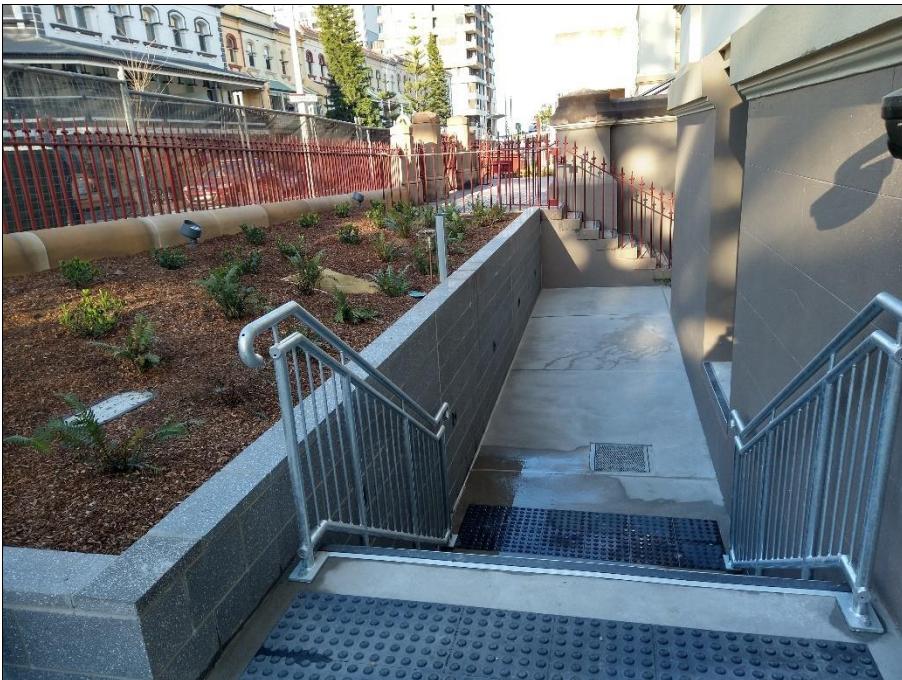
Figure 17 – Looking east at garden bed and concrete footpath pavements along the northern side (front) of the central building (20 August 2021)

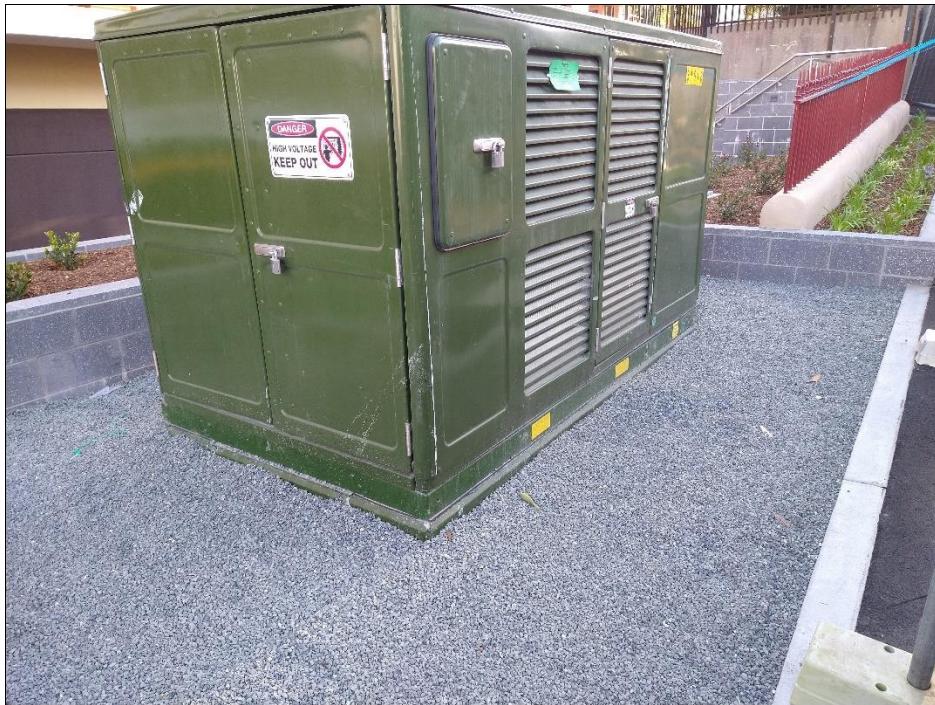
Figure 18 – Looking west at electrical kiosk along the northern side (front) of the Education Building (20 August 2021)

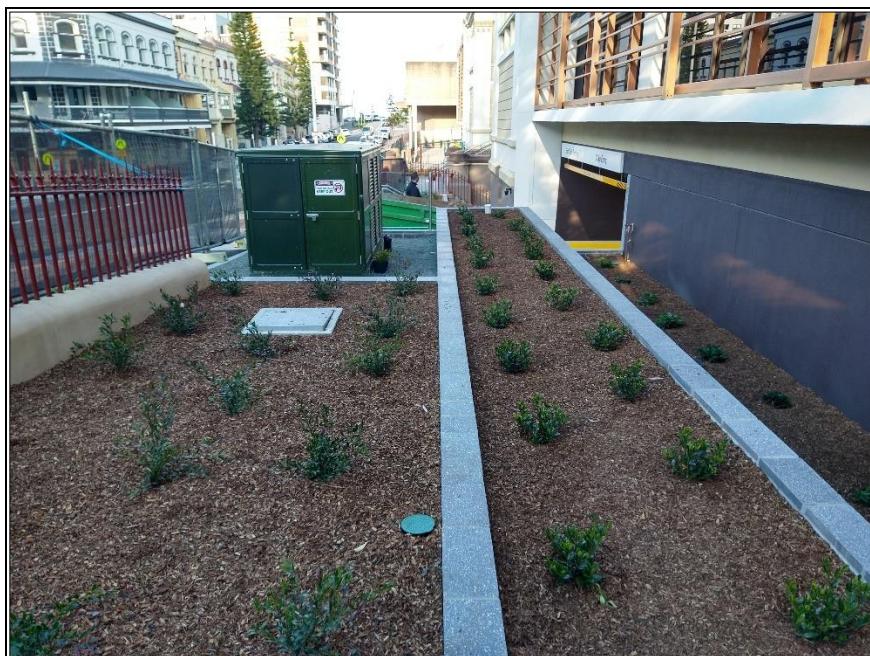
Figure 19 – Looking east at garden beds along the northern side (front) of the Education Building (20 August 2021)

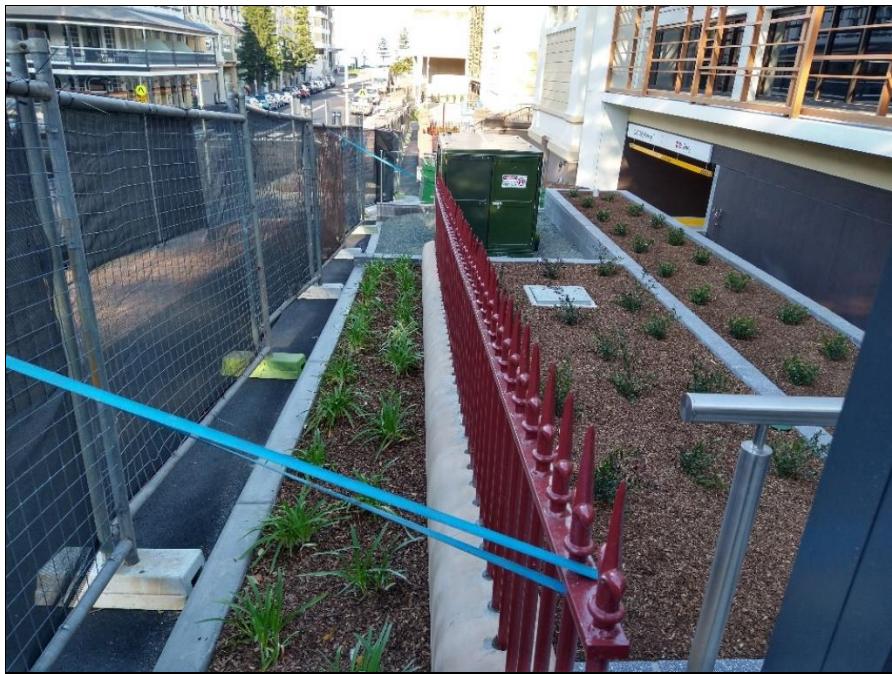
Figure 20 – Looking east at asphalt pavement and garden beds along the northern (front) boundary and northern side of the Education Building (20 August 2021)

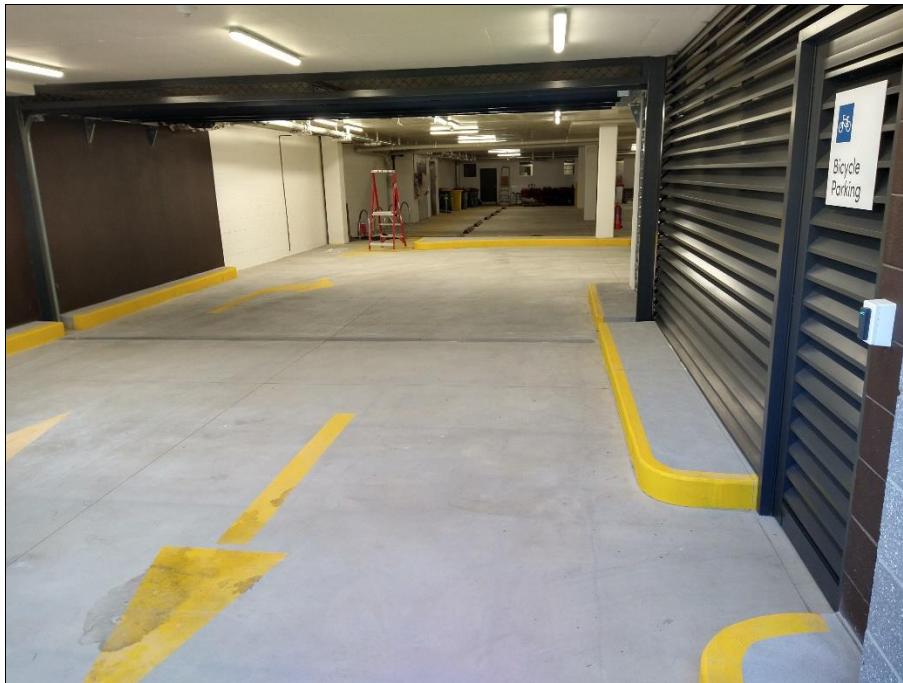
Figure 21 – Looking south at concrete pavements within the underground carpark of the Education Building (20 August 2021)

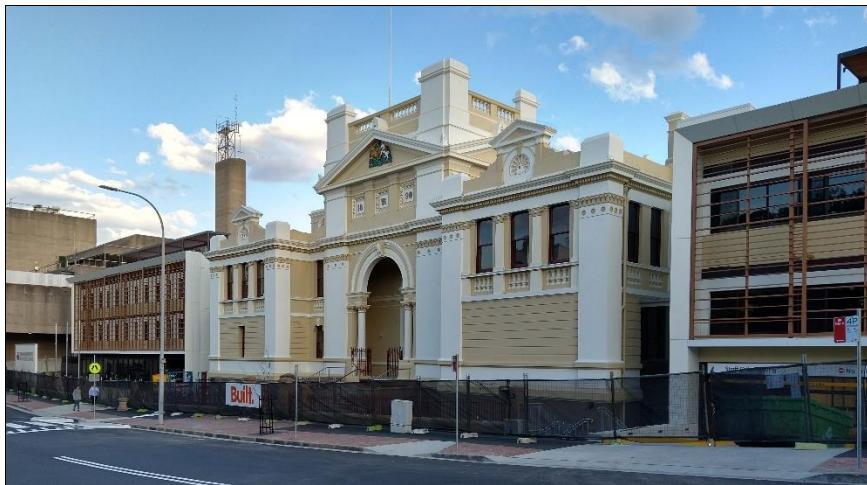
Figure 22 – Looking south east at Church Street and the Nihon University development site (20 August 2021). Newcastle Police Station to the left.

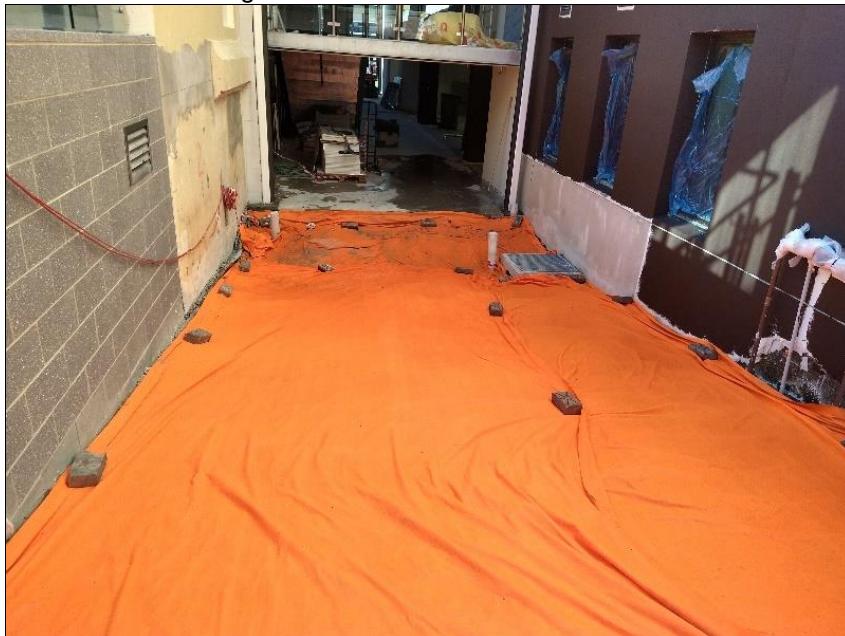
Figure 23 – Orange geofabric marker layer in garden bed at the rear of the Atrium (16 July 2021)

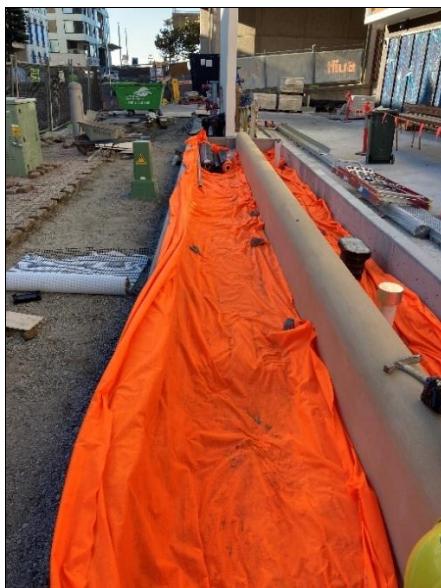
Figure 24 – Orange geofabric marker layer within garden bed on northern (front) side of the Student Accommodation Building (22 July 2021 – supplied by Built)

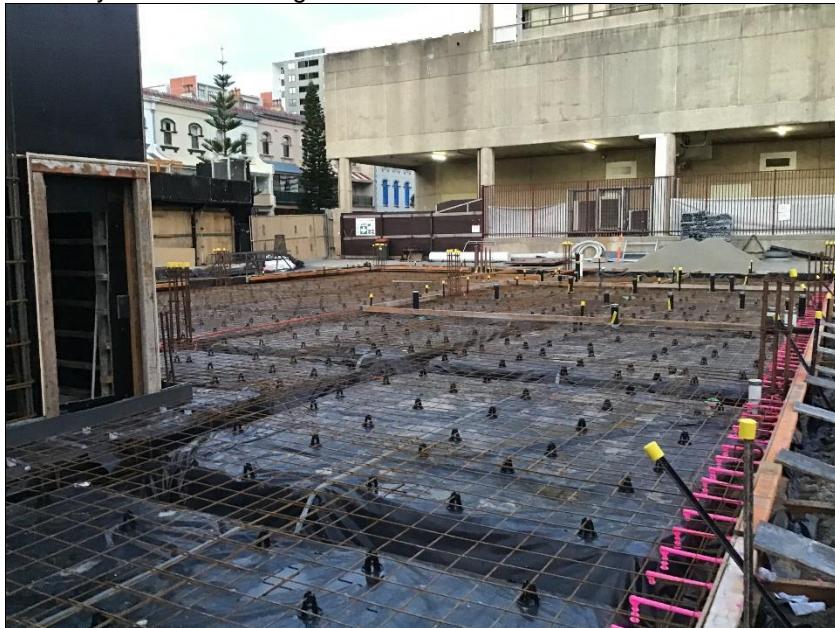
Figure 25 - Black plastic marker layer beneath Student Accommodation Building concrete slab (30 July 2020 - supplied by Built)

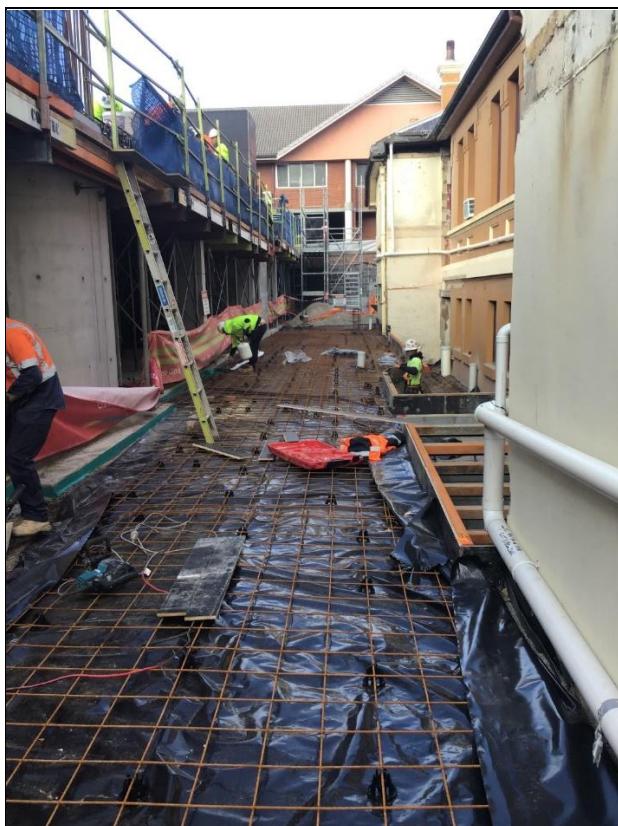
Figure 26 - Black plastic marker layer beneath Atrium concrete slab (25 August 2020 - supplied by Built)

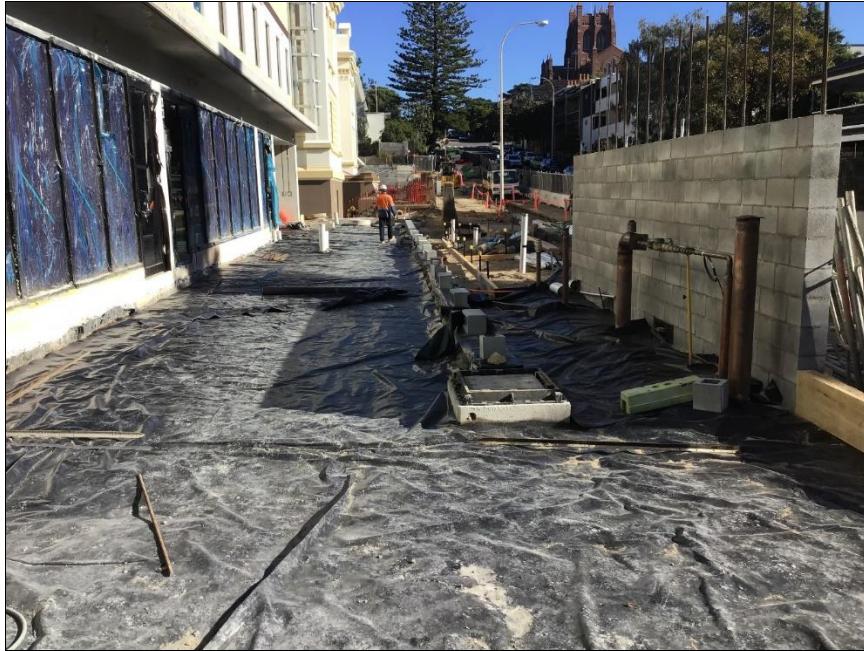
Figure 27 – Black plastic marker layer beneath concrete pavement on northern (front) side of Student Accommodation Building (26 June 2021 – supplied by Built)
