## **SEASONED TREE CONSULTING**

### **ARBORICULTURAL IMPACT ASSESSMENT REPORT** For Early Works SSDA (Amending DA To DA-2023/156)

Prepared for  
**Wollongong Developments No.5 Pty Ltd**

Site address  
**357-363 Crown Street & 2-4 Gladstone  
Avenue, Wollongong**

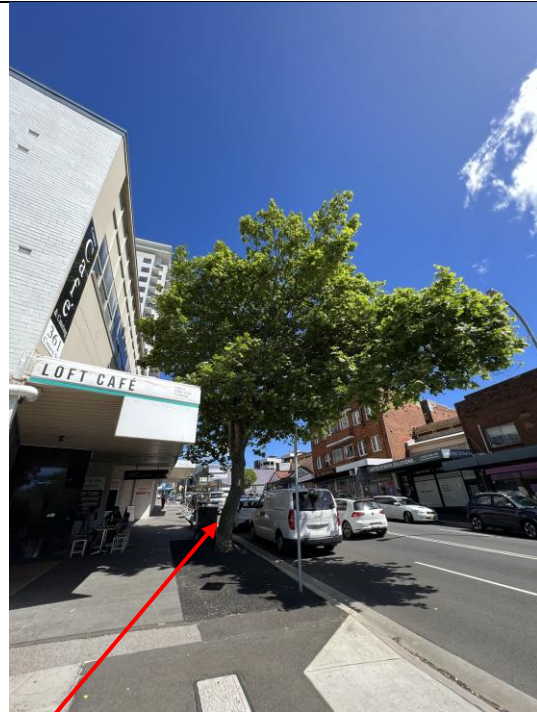
T3,

| Tree ID | Species | Retention value | NRZ radius (m) | SRZ Radius (m) | TPZ Area (sqM) | TPZ encroachment | Discussion/ Conclusion | Recommendation |
|---|---|---|---|---|---|---|---|---|
| 3 | <i>Platanus × acerifolia</i> , London plane | A1 | 5.52 | 2.6 | 95.7 | Major | <p>A large street tree located along Crown street. The tree is in good condition and this species is known to be tolerant of construction impact.</p> <p>Works proposed for the site include the demolition of all existing structures within the site with deep excavation of the site for below ground carparks. Construction is then proposed for a multi-level building.</p> <p>Section 3.3.4 of AS4970-2009 (Protection of Trees on Development Sites) discusses that the presence of existing or past structures or obstacles affecting root growth should be considered when assessing the impact of TPZ encroachments. The existing structure will likely have restricted root growth, therefore any development works within the subject property will not impact the tree's root system and the tree will not be significantly affected. Strict project arborist supervision will be required for all works including demolition of the existing building and then the deep excavation. Canopy pruning will be required to be carried out. The pruning is estimated at less than 10% of the canopy. Any pruning works must be carried out by an AQF Level 3 Arborist, in line with the AS4373-2009- Pruning of Amenity trees. If scaffolding must be installed within close proximity to the tree, it is recommended that the tree branches be tied back and then scaffolding working around and through the canopy of the tree, with branch protection required where the tree may rub against the scaffolding.</p> | Retain and protect. |

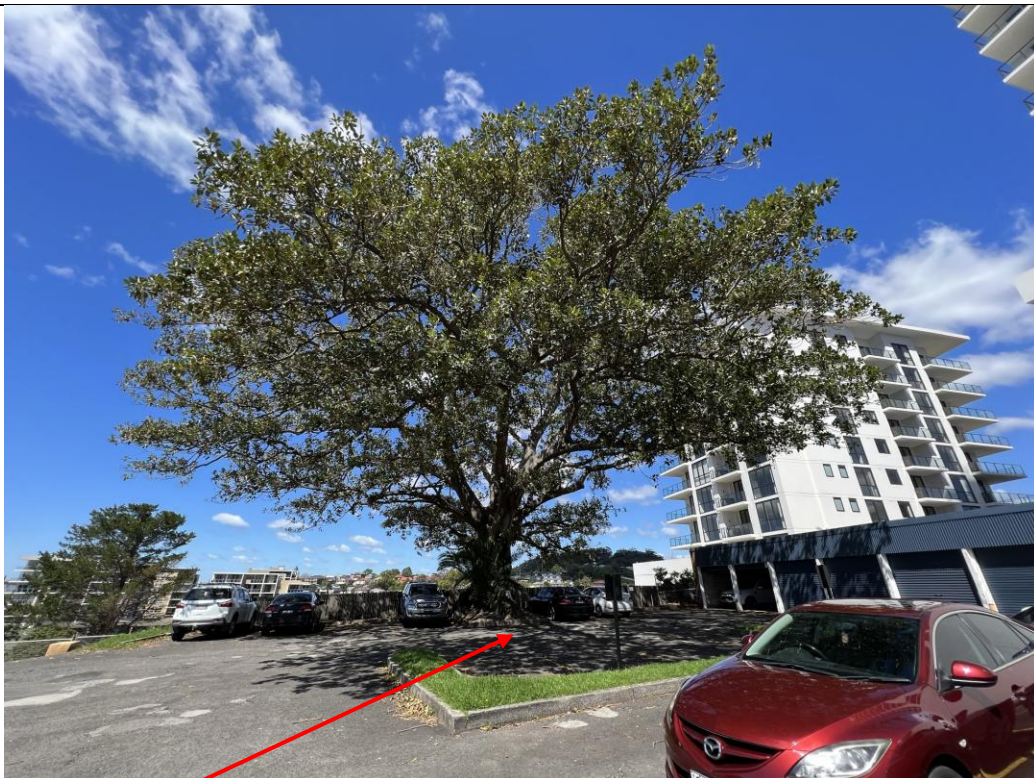
| Tree ID | Species | Retention value | NRZ radius (m) | SRZ Radius (m) | TPZ Area (sqM) | TPZ encroachment | Discussion/ Conclusion | Recommendation |
|---|---|---|---|---|---|---|---|---|
| 6 | <i>Ficus macrophylla</i> , Moreton Bay Fig | AA/ A4 | 15 | 4.4 | 706.9 | Major | <p>The subject tree is very large and is listed as the Local heritage item 6290 in Schedule 5. The tree has some minor crown and tip dieback but is of generally good health and condition.</p> <p>There are large portions of the TPZ covered in bitumen and concrete guttering/ edging. Concrete edging appears to have restrained structural roots within 5m of the tree and some roots have grown over this concrete edging. There is a Phoenix palm growing beside/ within the trunk of the tree, which should be removed extremely carefully.</p> <p>Works proposed for the TPZ include the demolition of all existing hard surfacing within the site with re-landscaping of the area which includes stepping stones, turfing, planting, sandstone seating, granite paving path and a timber deck. These works calculate for a major encroachment. Markups have been shown in Appendix 1A on the landscape plan as that is the plan with the most significant direct impact to the tree.</p> <p>Associated works proposed that may indirectly impact the tree are the construction of the 2 tall towers to the north and northeast of the tree that will have an effect on and likely reduce the amount of sunlight the tree will receive throughout the year.</p> <p>Fig trees are known to be tolerant of change including being tolerant of reduced light levels and less sunlight, and the fig will still receive reflective light as well as partial light through the newly proposed tall buildings (Shadow diagrams have been shown and assessed that show the tree still receives light for the majority of the year). The tree will also receive east/west sun and reflected light. Ultimately it is only possible to give an indication or estimate to assess the impact the tall buildings and less sunlight that will have on the tree, but the proposal is unlikely to significantly impact the health or condition of the tree long term. Mitigation strategies should be put in place which should include a drip irrigation system and mulched gardens beds/ turf areas under the drip line of the tree to improve growing conditions.</p> <p>All proposed ground works are to be sympathetic with existing ground levels (that is no land filling over 200mm in grade change or excavation of more than 100mm).</p> <p>Ultimately, all ground works as proposed will improve the growing conditions through the removal of hard surfacing and installation of (permeable) garden</p> | Retain and protect. |

- 8.4 **Project Arborist supervision and management of all works (including demolition) within the TPZ and SRZ of T3 and T6 is highly recommended.** All proposed ground works within the TPZ and SRZ of T6 are to be sympathetic with existing ground levels (that is no land filling over 200mm in grade change or excavation of more than 100mm). Strict project arborist supervision will be required for all works including demolition of the existing surfacing, and removal of the concrete edging. There are sections of the concrete edging that the tree roots are growing over that should be retained insitu rather than be removed. This should be decided by the Project Arborist whilst supervision is occurring. If sections of the concrete edging are removed, they must be done by hand (jackhammer), with no excavator to be used that could damage structural roots.

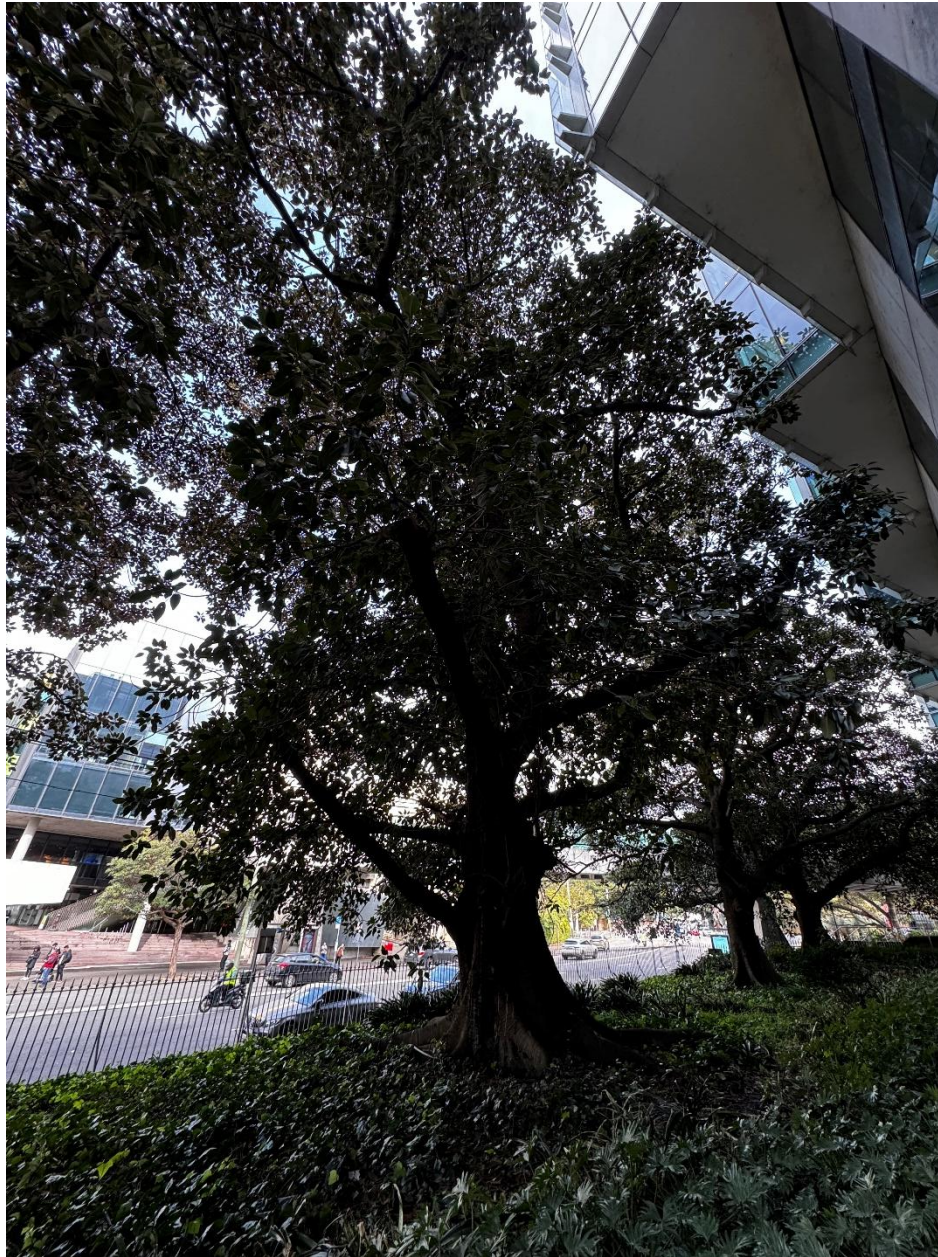
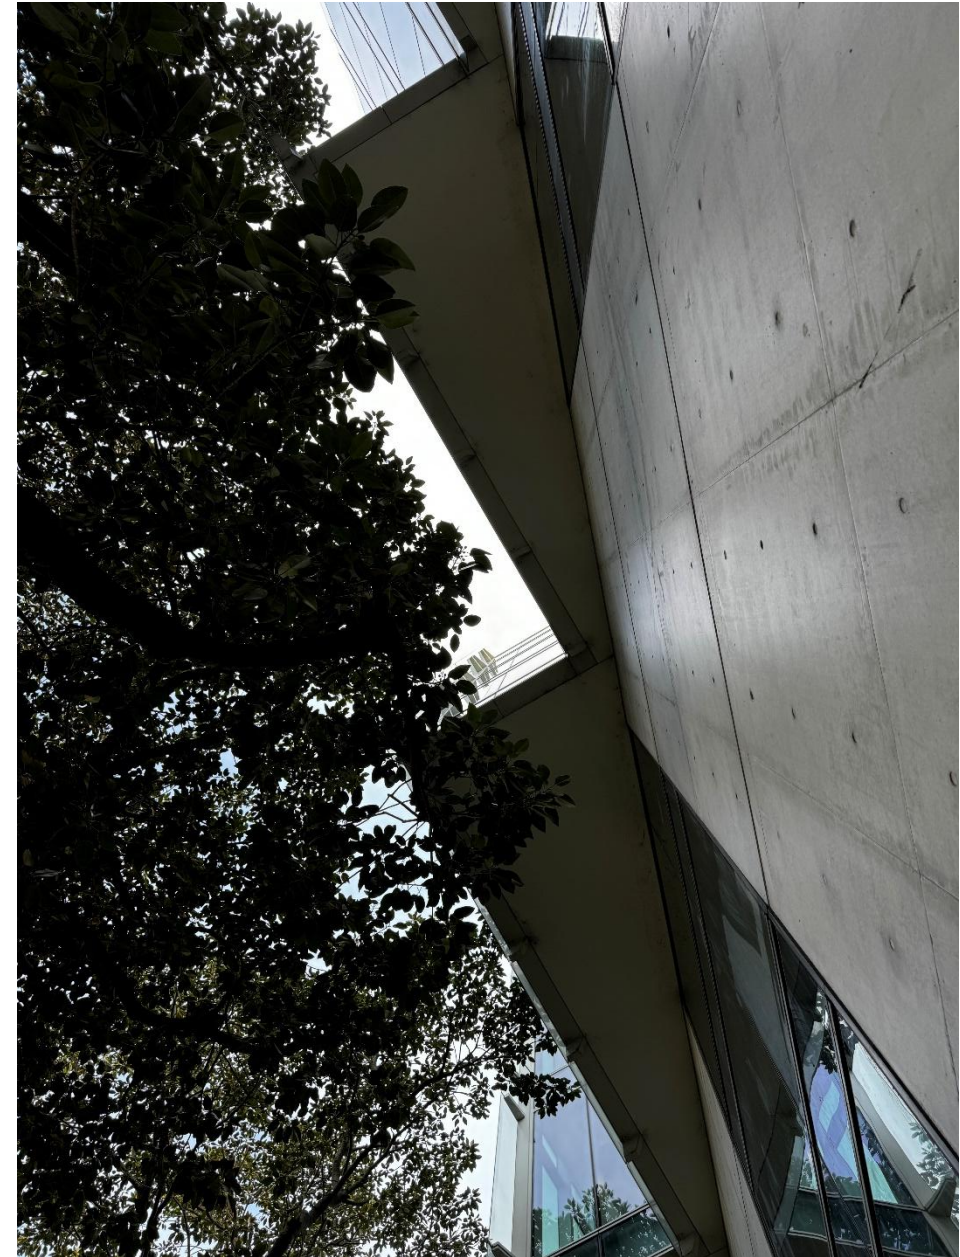
Significant canopy pruning of F1, F2, F3 and F4 has occurred to accommodate the development

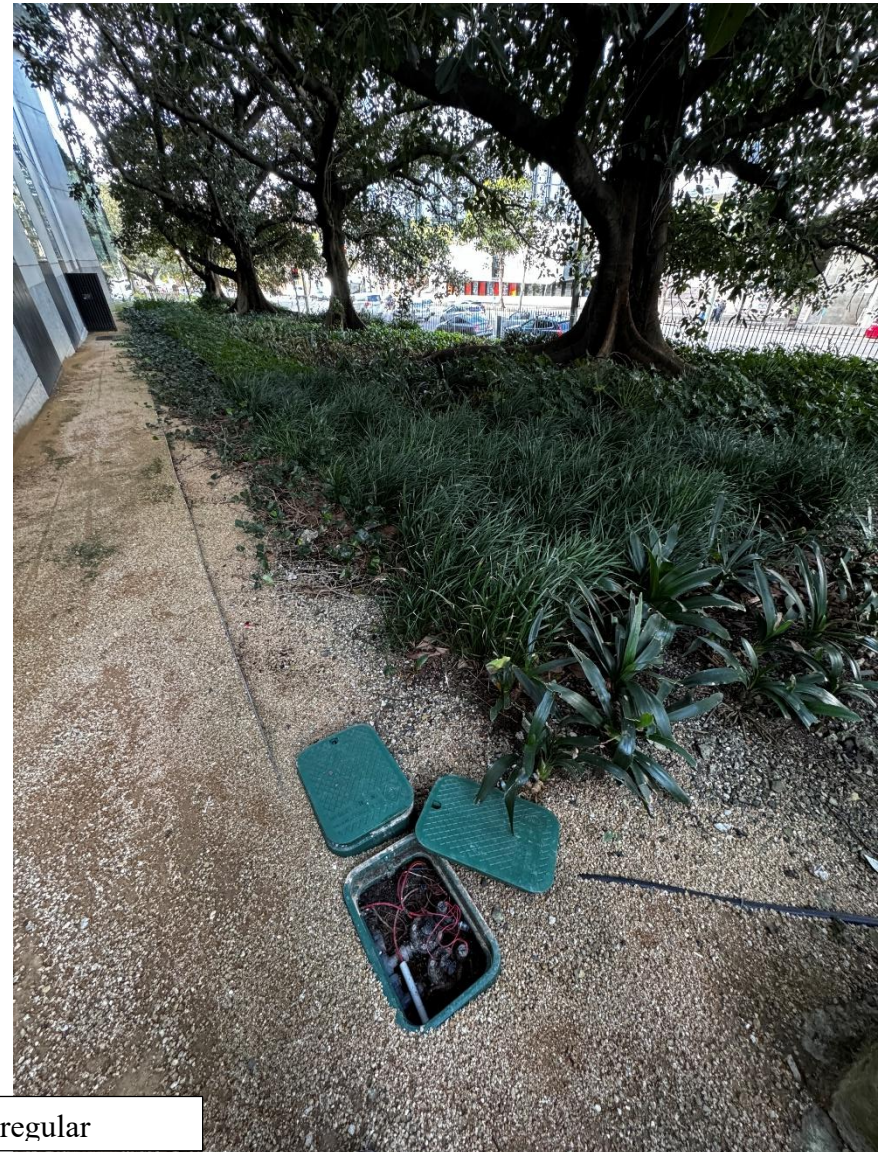
Drip irrigation solenoids for regular

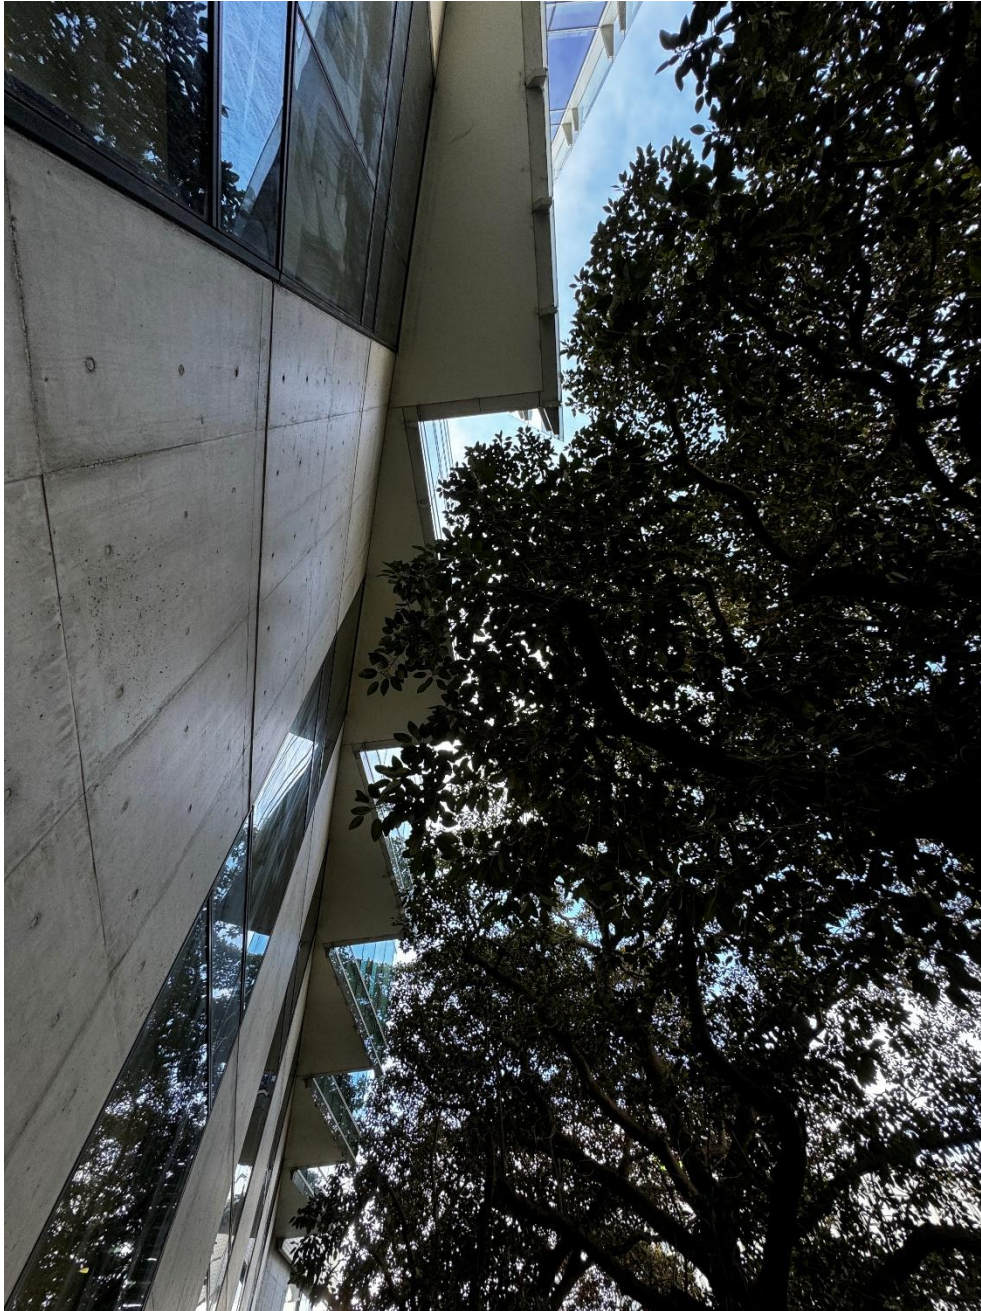
The amount of overshadowing is massive here.

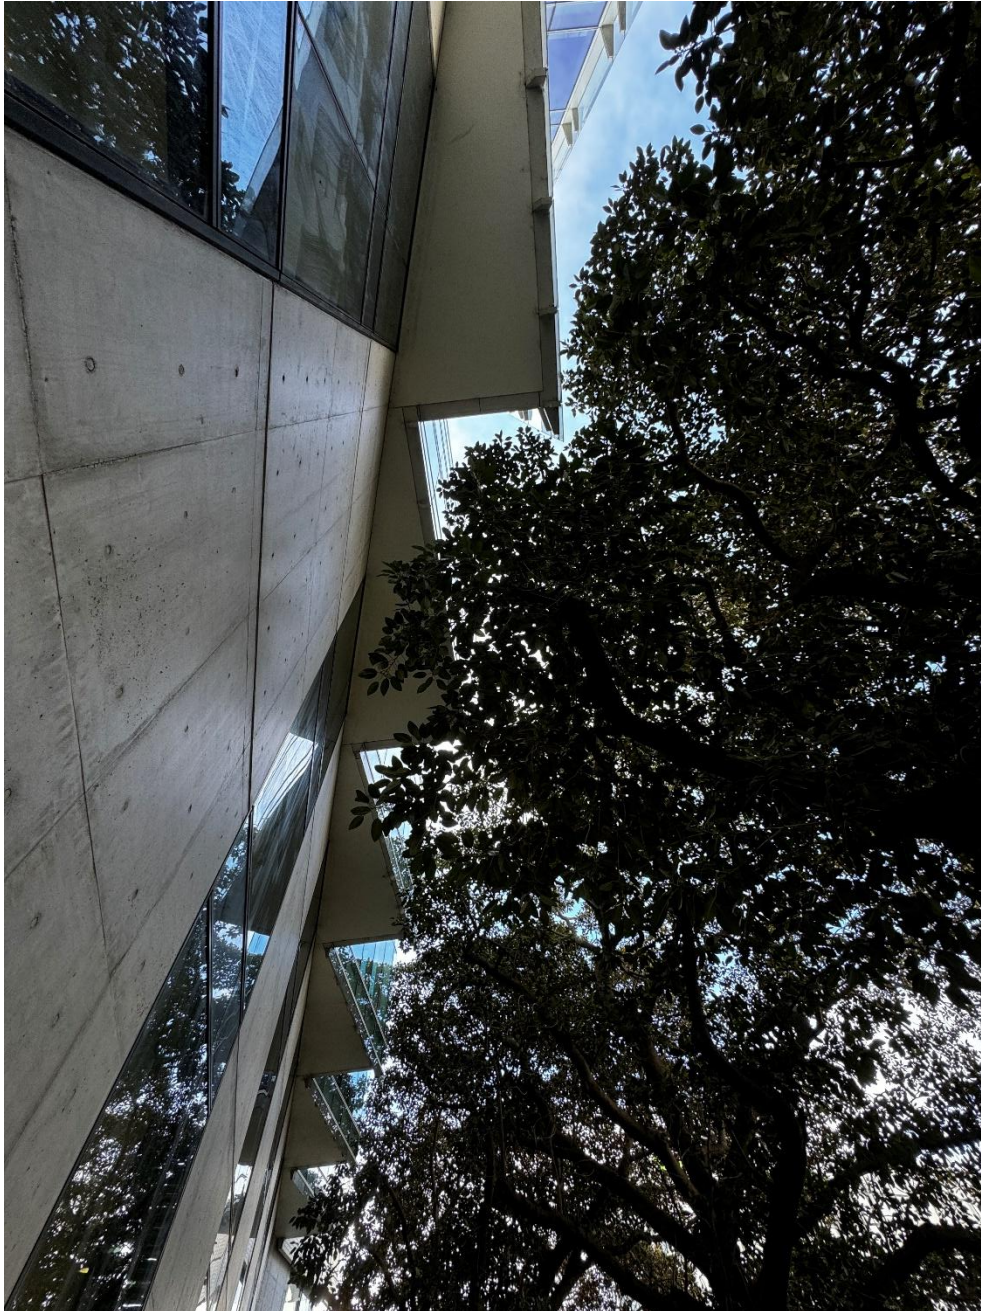
The amount of overshadowing is massive from the northern development.
