**Lederer Group - Gosford Development Site B**

Geotechnical Desktop Study Assessment

1 December 2015

Coffey Geotechnics Pty Ltd  
Level 19, Tower B, 799 Pacific Highway  
Chatswood NSW 2067 Australia  
t: +61 2 9406 1039 f: +61 2 9406 1002  
ABN: 93 056 929 483

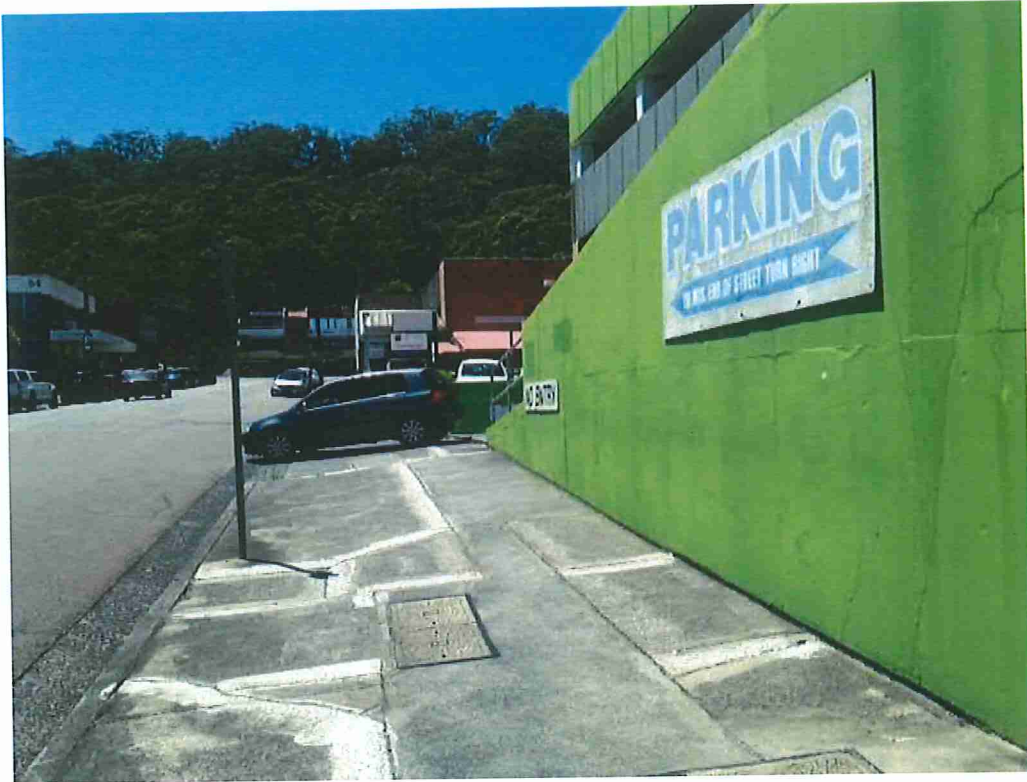
PHOTO 1: View of car park entrance ramp on William Street (view to east)

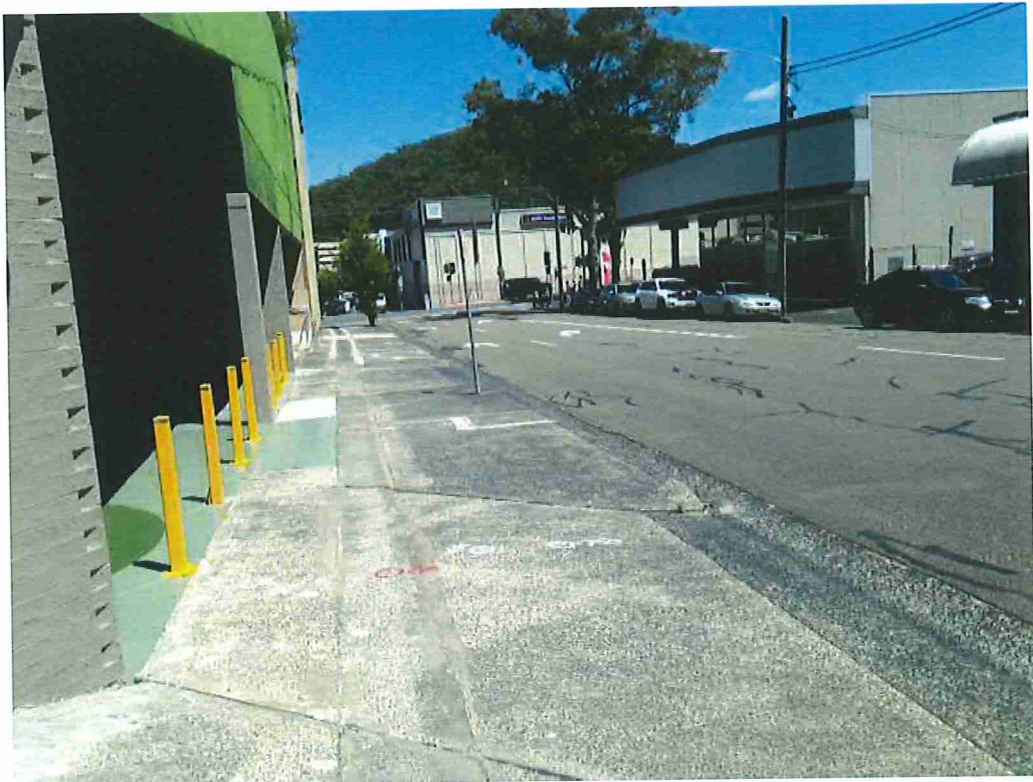
PHOTO 2: Ground level entrance on William Street (view to west)
