DARLINGTON PUBLIC SCHOOL REDEVELOPMENT Appendix CC — Arborist Report

SSD-9914

Arboricultural Report

Darlington Public School Chippendale NSW 2008 May 2020

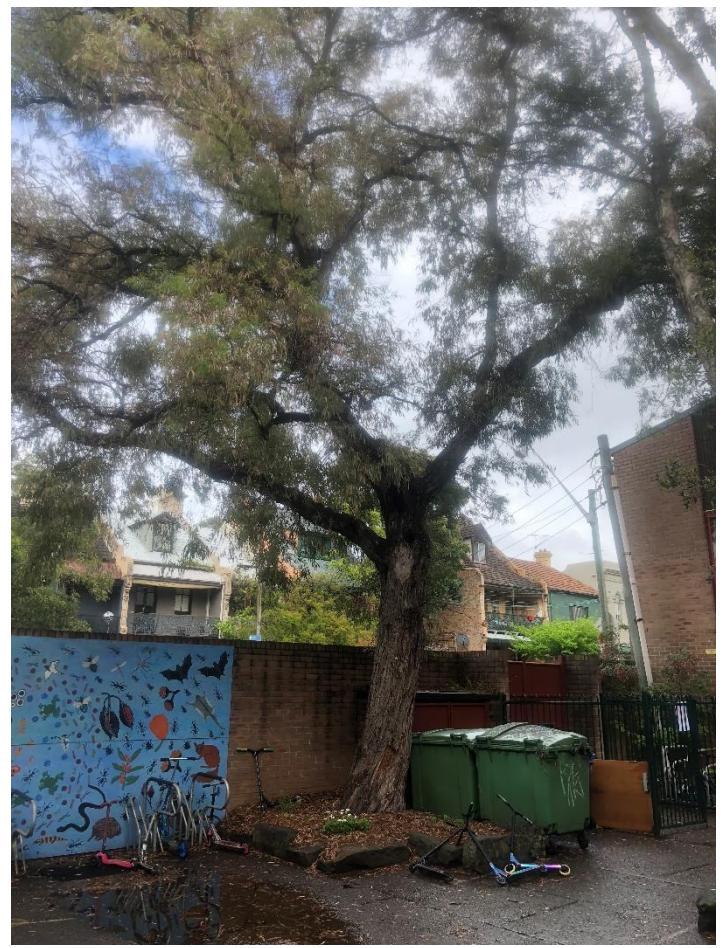
- 3.4 The Site Trees: The site was inspected on 15th October 2018. Each tree has been given a unique number for this site and can be viewed on the Tree Location Plan (Appendix 1). All site trees have been tagged to correspond with the Tree Location Plan.
- **3.5** The site consists of several buildings connected by covered walkways. Playground areas are located throughout the site with specimen trees located in some protected courtyard areas (Plate 1). Some of these courtyard specimens are large mature specimens and potentially are nearing over-maturity such as Tree 3.

Plate 1: Image showing Tree 3. This tree has signs of drought stress however recent rainfall may extend its life expectancy. Working around a mature tree such as this will be difficult in terms of canopy impacts and root disturbance. P. Vezgoff

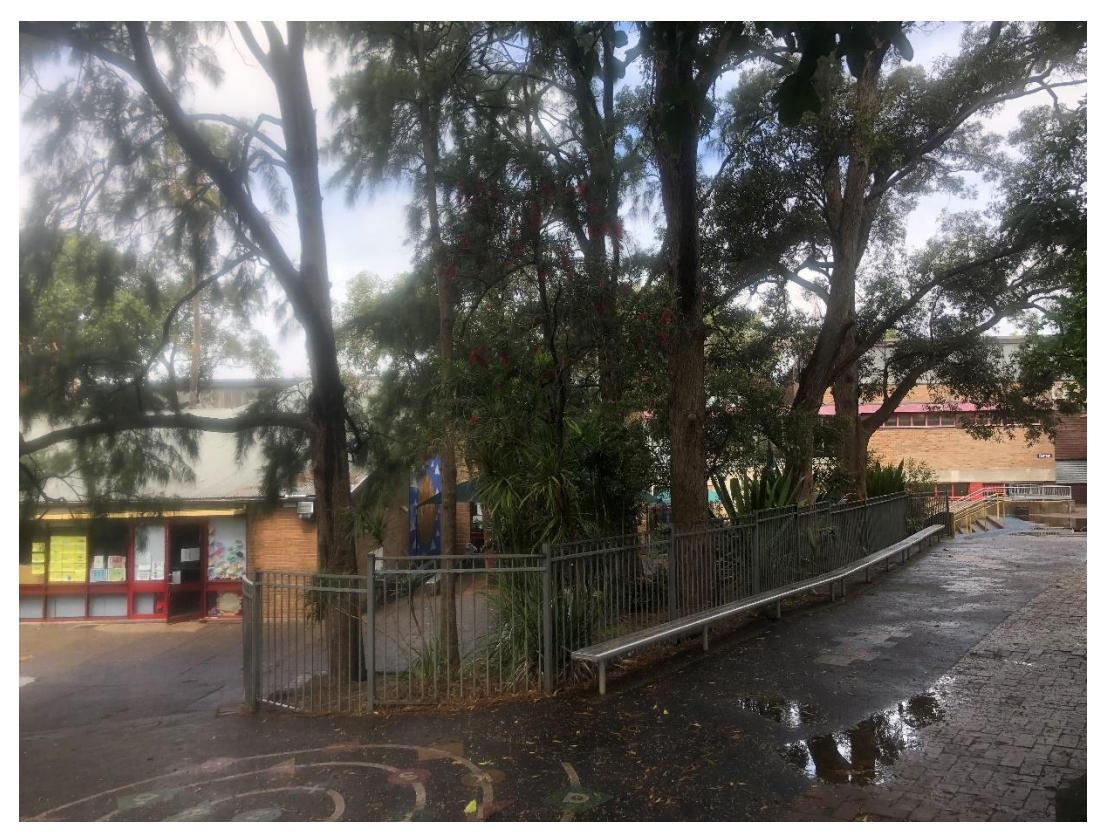
3.6 Trees 7-15 are within the central playground area (Plate 2). Although not great specimens individually, they do work well as a group providing canopy cover and good aesthetic value to the rear area.

Plate 2: Image showing Trees 7-15 central to the playground area. The area not facing the camera consists of a low retaining wall. P. Vezgoff

- **3.14** The design levels around Tree 12 are very tight as it is surrounded by an existing brick wall and sandstone steps (Plate 2). Any new wall around these trees is likely to require additional excavation to allow for drainage. The landscape design is working to retain existing levels and allowing for the construction of new accessible footpath however further consultation may be required in relation Trees 12-15 to achieve this.

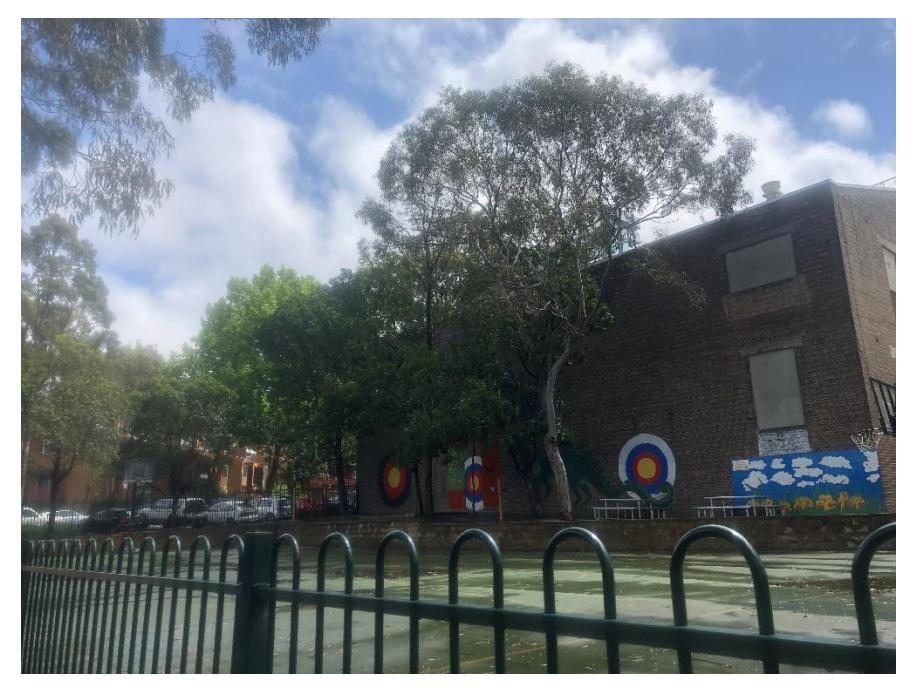
3.7 Trees 26-31 (Plate 3) are tightly grouped specimens that have a restricted root space and are covered with asphalt and playground rubberised matting up to the trunks. These trees are mostly in good health but could be replaced with better specimens. They would not be considered long term specimens.

Plate 3: Image showing Trees 26-31. P. Vezgoff

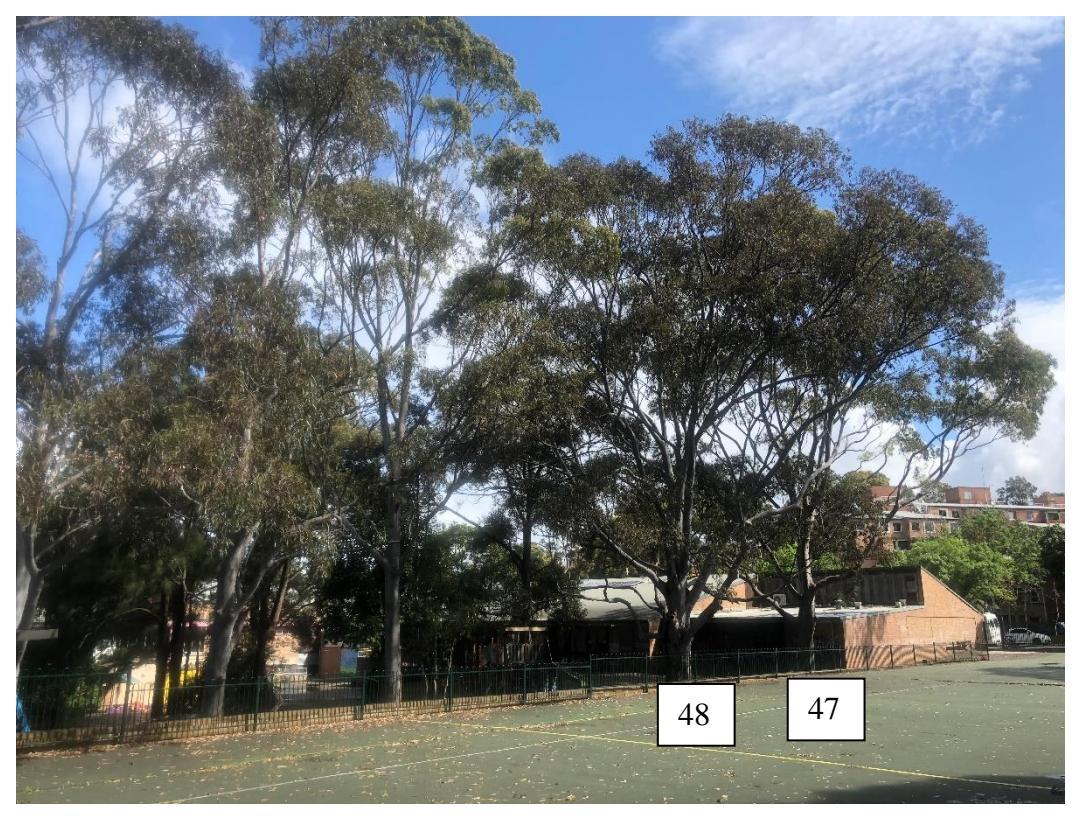
Plate 4: Image showing Trees 48 and 47. P. Vezgoff Moore Trees Arboricultural Report for Darlington Public School

- **3.8** Trees 47 and 48 (Plate 4) are some of the larger trees on site being some twenty (20) meters in height. Again, the majority of the root zone of these trees is covered with hard surface. These trees have some previous failures which is to be expected from trees of this size and age. These trees were assessed as being in good health and condition. The main trunks, first and second order branches are free of any cracks, splits or fruiting bodies. New extension growth was noted. The basal area and woody root zone were free of any ground heaving, or lifting. Ideally an aerial inspection should occur to fully determine the condition of the main branch unions.

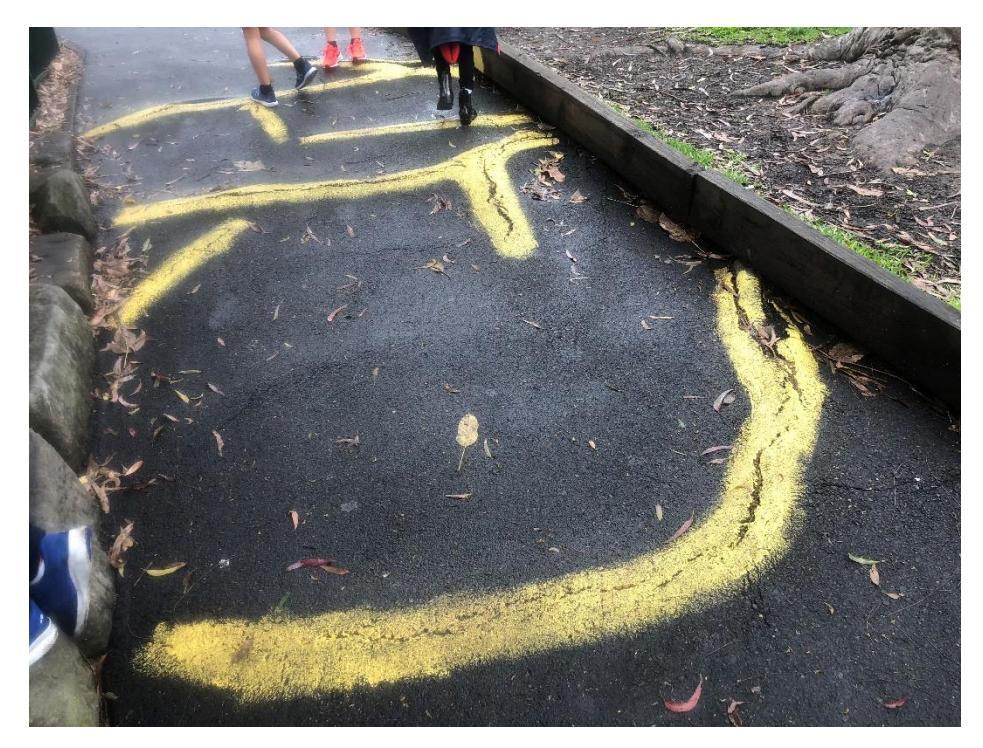
- **3.9** Although this part of Sydney may be high in sand content that would normally encourage deeper root systems, the site has an uncertain history. Based on Diagram 2, it appears that prior to the school being built there were rows of terrace houses and warehouse structures, so subsoil conditions will be far from natural and would be highly disturbed. This will mean that old footings or foundations that may be subsurface will deflect woody roots keeping them close to the surface such as near Tree 20 (Plate 5).

Plate 5: Image showing surface roots from Tree 20. P. Vezgoff

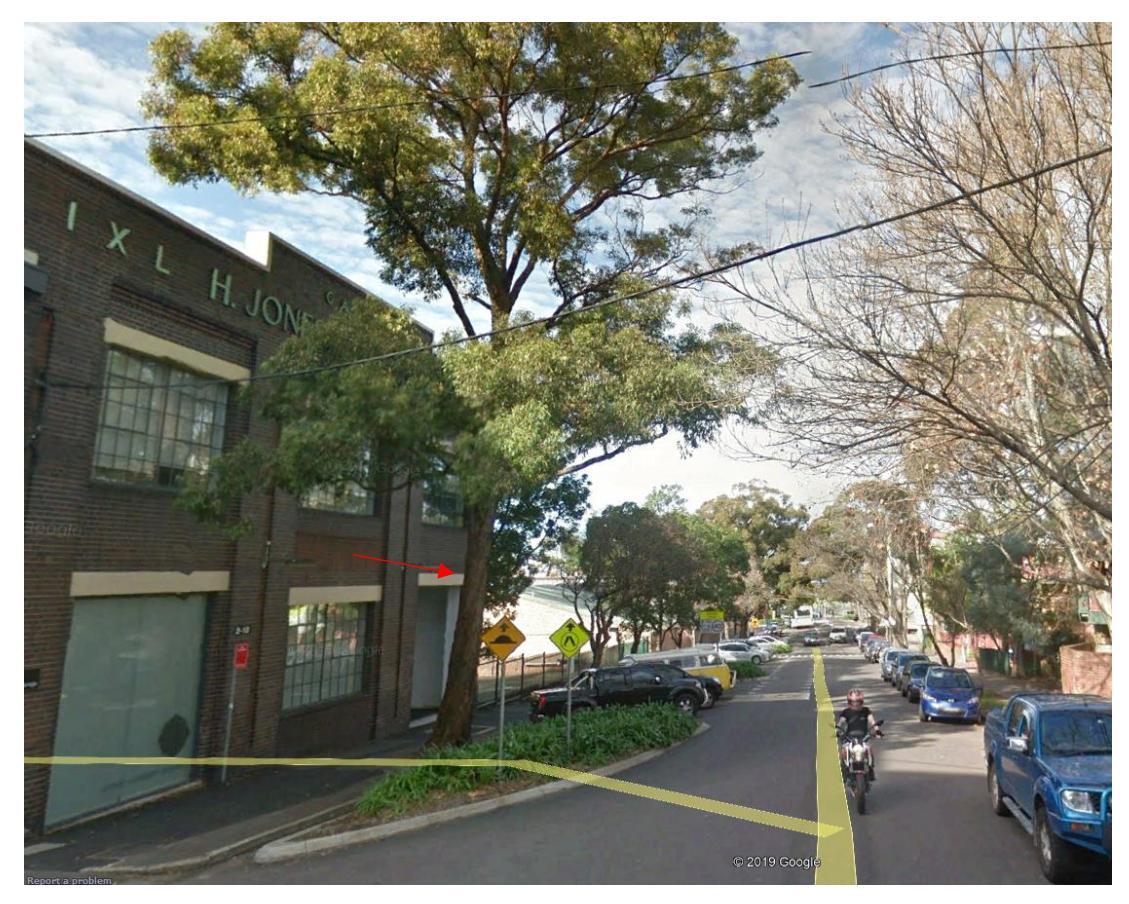
- **3.15** The proposed substation on Golden Grove Street may impact on the large Tree 68 (Plate 6). This tree is a large mature Tallowwood (*Eucalyptus microcorys*). This tree is in excellent health and condition. The main trunk, first and second order branches are free of any cracks, splits or fruiting bodies. Old pruning wounds are showing good occlusion, a sign that the tree is photosynthesizing effectively. New extension growth was noted with leaf colour showing good vitality. The tree would be considered to have a 95% live canopy. The basal area and woody root zone were free of any ground heaving, or lifting. Any trenching below this tree will need to be under bored using directional drilling.

Plate 6: Image showing Tree 68 (Red arrow). P. Vezgoff
