Darlington Public School – SSDA Condition C21

Darlington Public School

SSDA Condition C2I Satisfaction Report

A W EDWARDS PTY LIMITED

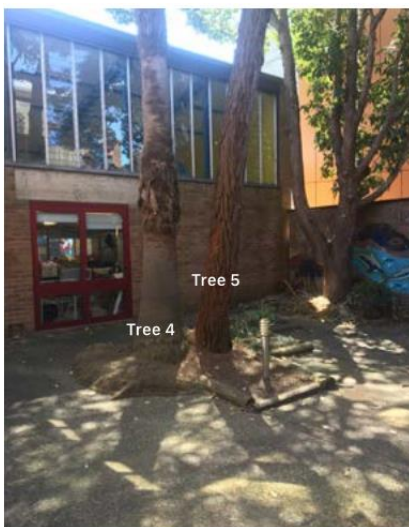
(Photo 1) Image showing Tree 4 and 5.

The recommendation is to remove the existing *Livistona Australis* and *Eucalyptus Robusta* numbered Tree 4 and Tree 5 respectively as a result of advice received from the project arborist.

A combination of existing growing conditions, building and concrete pavement demolition, and EFSG m2 provision for active play space per child have contributed to the necessity to remove trees 4 and 5.

- Encumbered existing root system due to growing conditions within courtyard concrete hardstand.
- Demolition of existing buildings and hardstand areas likely to impact greatly on existing trees and root system during demolition phase of the project.

It's recommended to remove the existing *Livistona Australis* and *Eucalyptus Robusta* due to the encumbered existing root system and the highly likely impacts on the existing root system during the demolition of the surrounding courtyard buildings and concrete hardstand area. Demolition will greatly impact the potential short term survival of Trees 4 and 5.

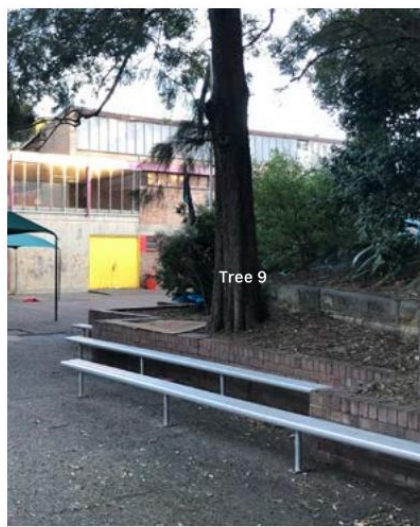
(Photo 2) Image showing Tree 9

In the previous design the proposed path and boardwalk alignment from the COLA into the outdoor play spaces collides with the existing Tree 9 location. Trees 10, 11, 12, 13, 14 and 15 are highlighted to be retained and are located with the existing garden terrace within close proximity the proposed boardwalk.

Further design investigations have shown that Tree 9 can also be retained with a slight adjustment to the proposed boardwalk alignment.

Its recommended to retain the existing *Casuarina Cunninghamiana* Tree 9, 10 and 11.

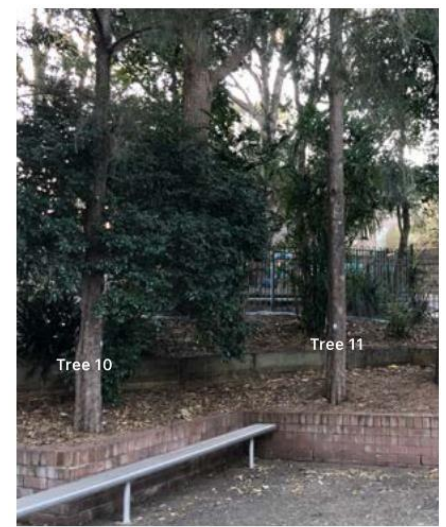
(Photo 3) Image showing Trees 10 and 11.

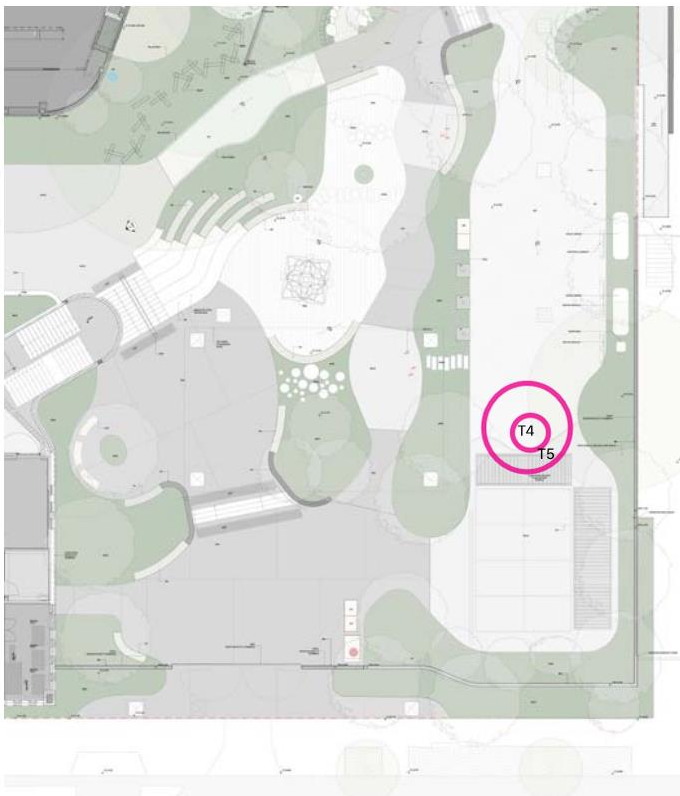
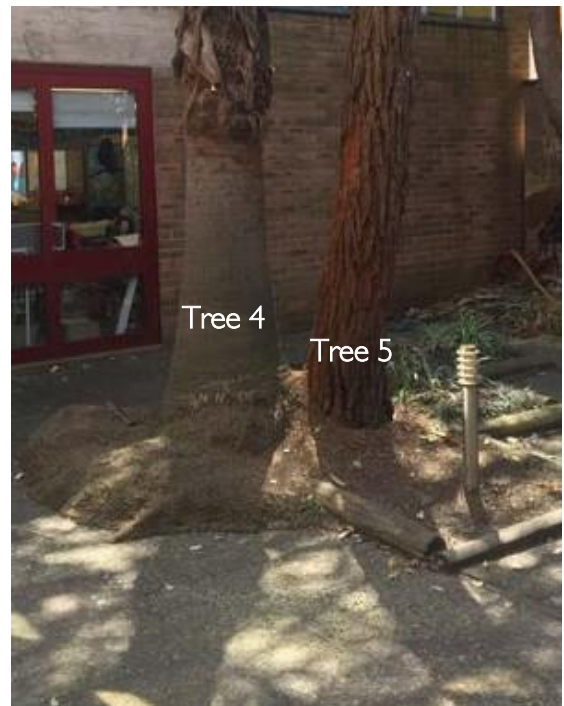
The consulting arborist report highlights unknown condition of the root system under the existing courtyard concrete slabs to be demolished. Demolition of the existing buildings surrounding the two trees have a very high likely-hood damaging the existing root system having grown into the underside of the existing concrete pavement. At present, the existing concrete pavement covers the entire Structural Root Zone area of the two trees.

The extensive and raised root systems sitting above the existing concrete can be seen in photo 4 below. The Arborist recommends Trees 4 and 5 are to be removed to achieve contamination capping/marker layer which can't be installed without destabilizing the trees.

(Photo 4) Image showing exposed tree 4 and 5 roots above the pavement.

In summary the demolition of existing built fabric around existing trees will impact heavily on short term survival of trees. The arborist report confirms that the Tree Protection Plan has been updated to show the removal of Trees 4 and 5.

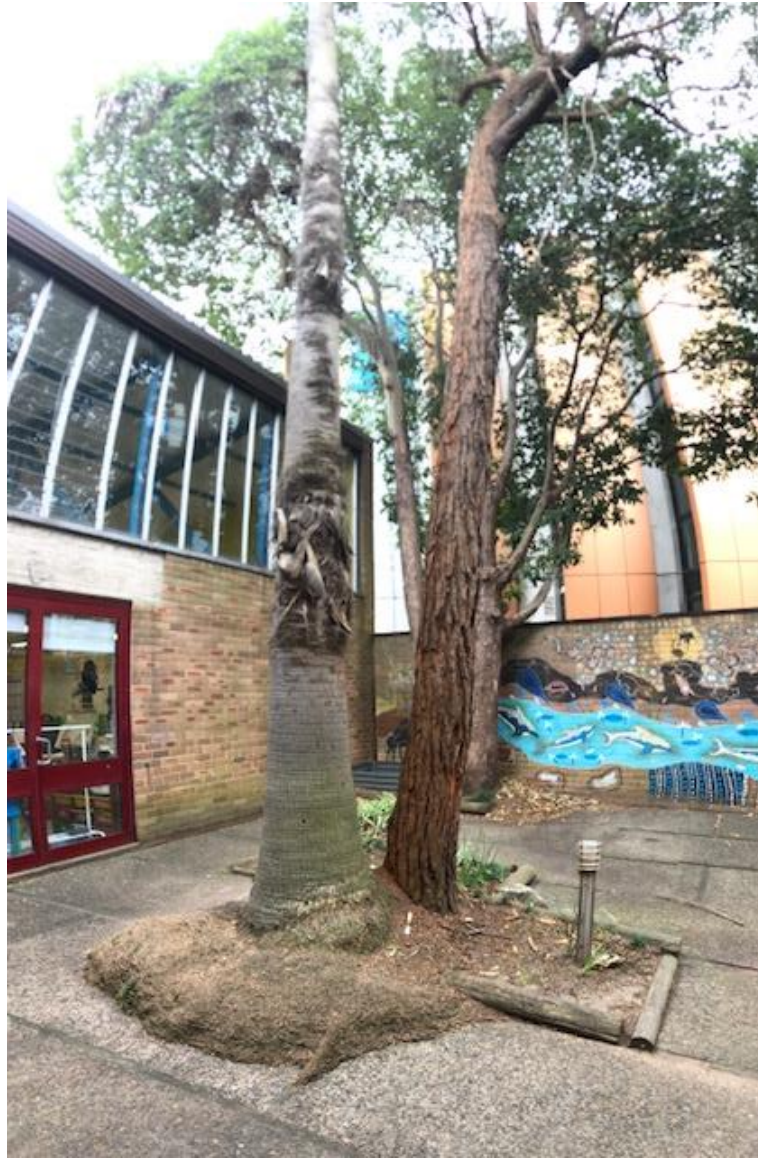
Item	Response	Recommendation
21a	<p>Trees 4 and 5: Unknown condition of roots under the concrete slabs that surround these two trees. It is more than likely that roots will be damaged during demolition having grown into the underside of the concrete. At present, the concrete covers the entire TPZ area for these two trees. The extensive root systems can be seen in Plate 1.</p> <p>Trees 9, 10 and 11: Trees 9-11 are located within the center of a pedestrian path and as such cannot be retained without major design changes. To retain these trees impacts on the accessibility & functionality of the play spaces and path network.</p> <p>Accessible pathways are required site wide. The design has maintained smooth even grades at a max 1:20 grade in the current design to ensure access and accessibility to the heart of the play area from the main arrival / COLA.</p> <p>The length and positioning of pathway gradients in the proposed pathways and play spaces are critical to deliver compliant grades for EFSG and DAA equitable access. A number of design options were tested to re-locate and rearrange the accessible paths around the play elements.</p>	<p>Trees 4 and 5 to be removed to achieve capping layer. (Plate 1)</p> <p>Root mapping not possible. Trees 9-11 to be removed. (Plate 2)</p>

Plate 1: Image showing Tree 4 and 5. Tree 6 at the rear growing against the wall. P. Vezgoff

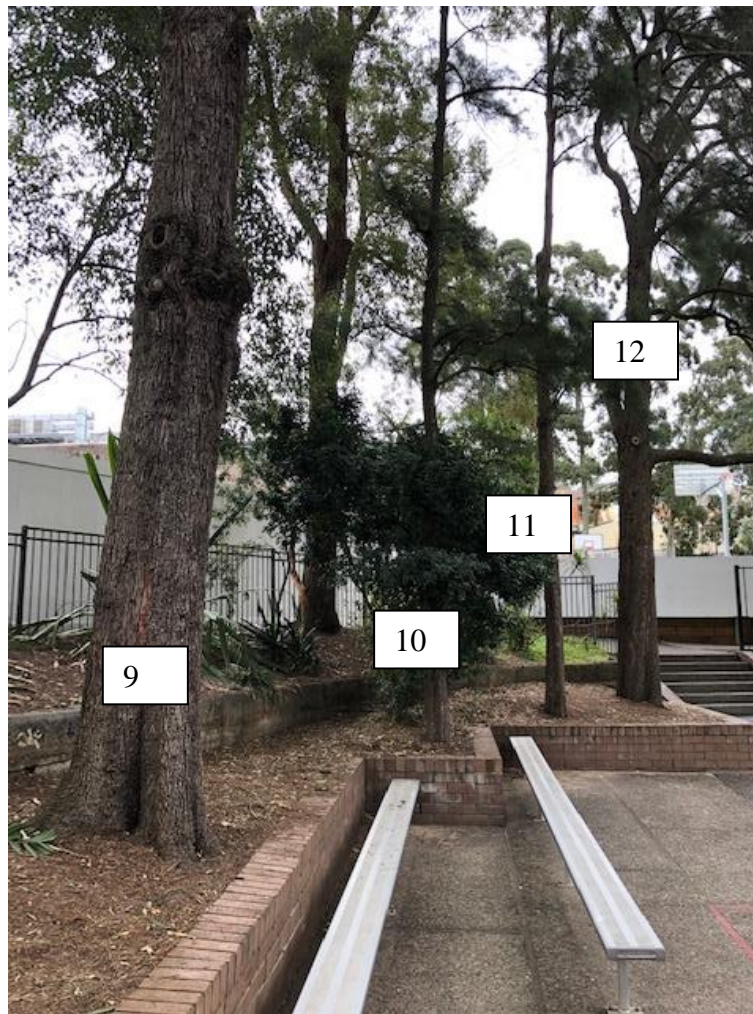
Plate 2: Image showing Trees 9, 10, 11 and 12. P. Vezgoff
