Dendrobium Mine Extension Project

Geological Structures Review

PSM3021-012R 24 March 2022

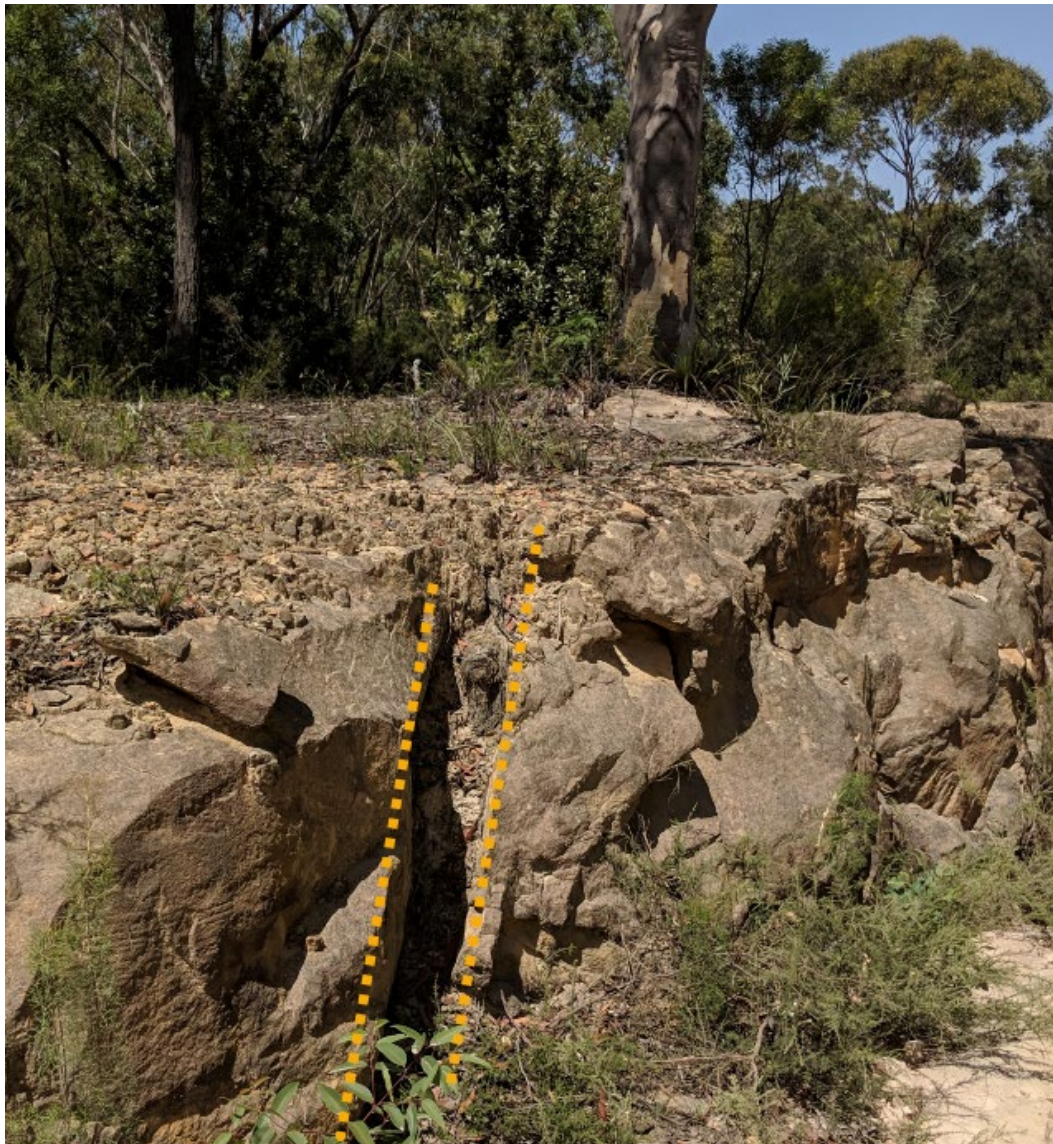
Photo 1 shows a 200 mm wide dyke, located 380 m east of DD33 of which the minor dyke parallels. These are strong indicators the dyke shown in Photo 1 extends from seam to surface.

Photo 1: Dyke, approximately 200 mm wide, observed by PSM during site visit.

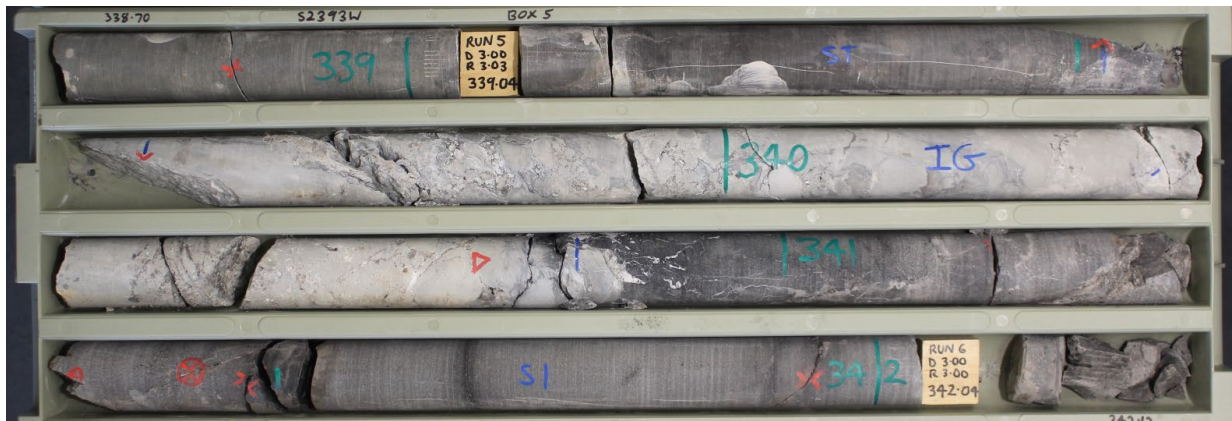
Photo 2 presents a typical dolerite dyke intersected in a vertical borehole. The dolerite appears fresh with a sharp contact with the surrounding sandstone. Basaltic lavas are generally under pressure when being emplaced, which, if sufficiently high, can generate its own fracture network within the host rock (Reference 16). More commonly, magma exploits existing fractures such as faults and joints, which is likely in the case of the Bulli Fault.

Photo 2: Example of a dolerite dyke intersected in borehole S2393 at approximately 340 m depth.

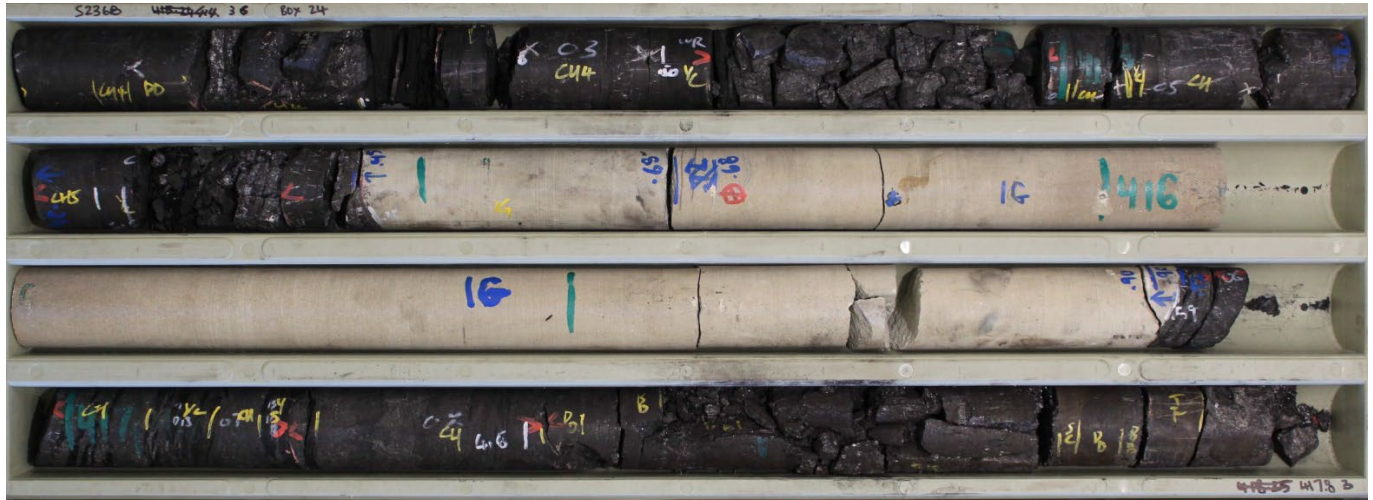
Intersected sills present with variably levels of alteration, generally, thinner sills (less than 3 m thick) are completely altered to clay, and thicker sills (greater than 3 and up to 40 m thick) are fresh (Reference 7). Photo 3 presents an example of the “Bulli Sill” (less than 3 m thick at this location) as intersected in borehole S2368.

Photo 3: Example fresh dolerite sill in borehole S2368 at approximately 416 m.

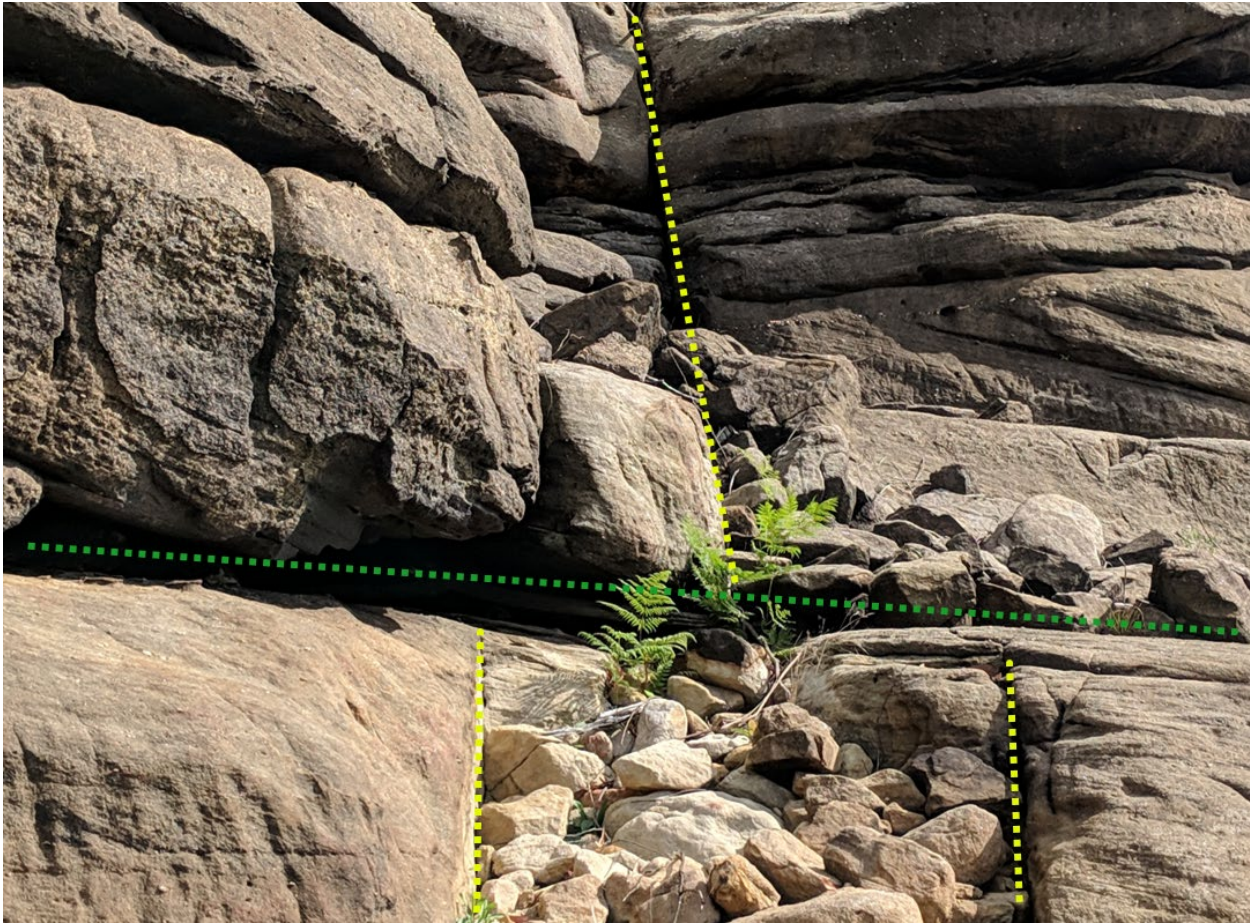
The joints observed within the study area were typically planar and often terminated against bedding partings, see Photo 4. Generally, the persistence of joints was no greater than 10 m (Photo 5).

Photo 4: Example of typical sub-vertical joints (yellow) terminating against a horizontal bedding parting (green) near northeast shore of Cordeaux Reservoir.

PSM consider it is unlikely that the joints observed at the surface persist to seam level.

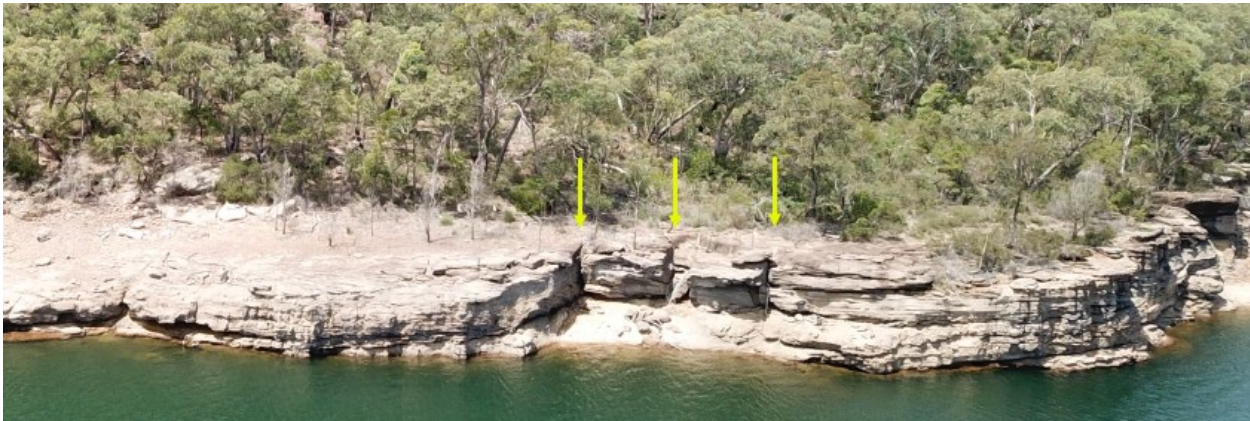
Photo 5: Joints (indicated by yellow arrows) striking northwest spaced approximately 3 m on northwest shore of Avon Reservoir.
