Pacific Highway Upgrade: Woolgoolga to Ballina, Sections 1 and 2

Microbat and Nest box Monitoring –
Operational Phase, (2020-2021)

Sandpiper Ecological

8 November 2021

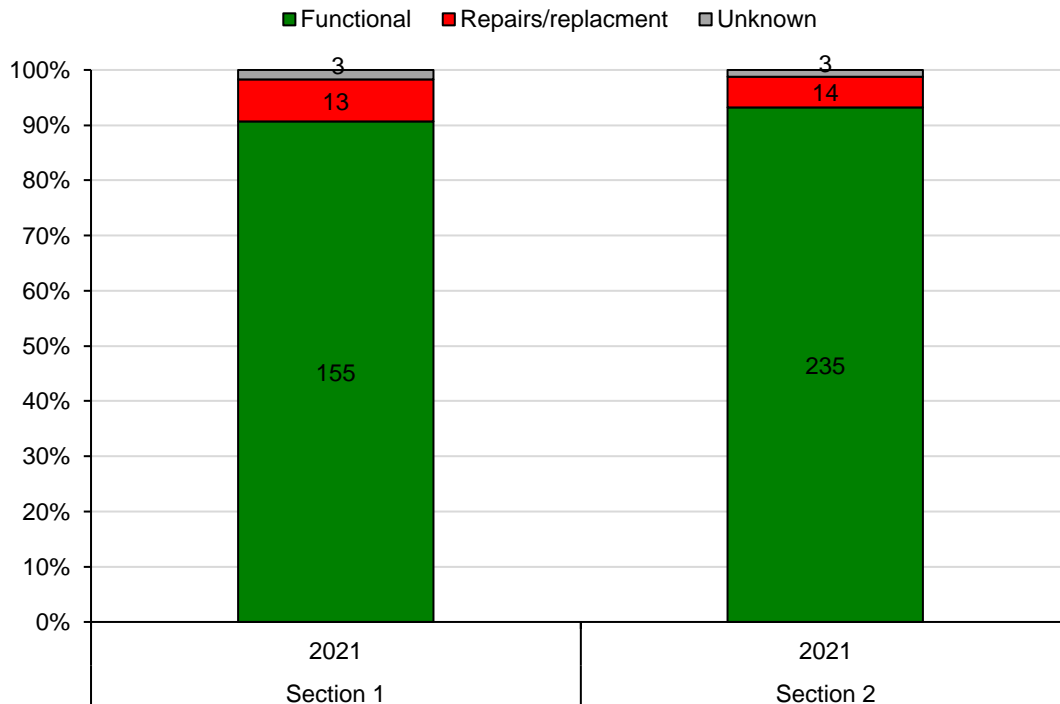
A total of 13 (7.6%) boxes in section 1 and 14 (5.5%) in section 2 required maintenance or replacement during the 2020-21 operational monitoring (Figure 10). The “unknown” nest boxes in Figure 10 include three boxes on inaccessible private property in Section 1, and three boxes unable to be found due to co-ordinate error or burnt in section 2. Causes for repair included burnt (S1 = seven boxes, S2=nine boxes), wire/spring failure (S1 = three boxes, S2 = one box), lid/hinge reattachment (S1=two boxes, S2=four boxes) and wire growing into tree (S1 = one box) (see Appendix A, Table A1 and Appendix B, Table B1). A total of 21 repairs were undertaken in July 2021 including replacement of burnt boxes (n=16) with Cyplas designs, box reinstallation at section 1 (n=2), lid reattachment at section 1 (n=2) and wire repaired on hanging scansorial mammal box at section 1 (n=1) (see Appendix A, Table A1, and Appendix B, Table B1). A further six boxes had deteriorated (i.e. missing one hinge with lid still attached, or partial lid deterioration) yet were deemed functional.

Figure 11: Nest boxes requiring repair or replacement during operational phase monitoring at W2HC (Section 1) and HC2G/WC2G (Section 2), 2020-2021.

Nest boxes that had moderate or severe deterioration were assessed to determine the best ameliorative approach. Maintenance was undertaken on 5 and 6 July 2021 with several boxes replaced in section 1 and 2 due to bush fires and damage from wire/spring failure. Replacement Cyplas boxes were reinstalled via ladder with an ecologist present. Other repairs accessible via ladder were also undertaken such as wire replacement, lid reattachment and box reinstallation.

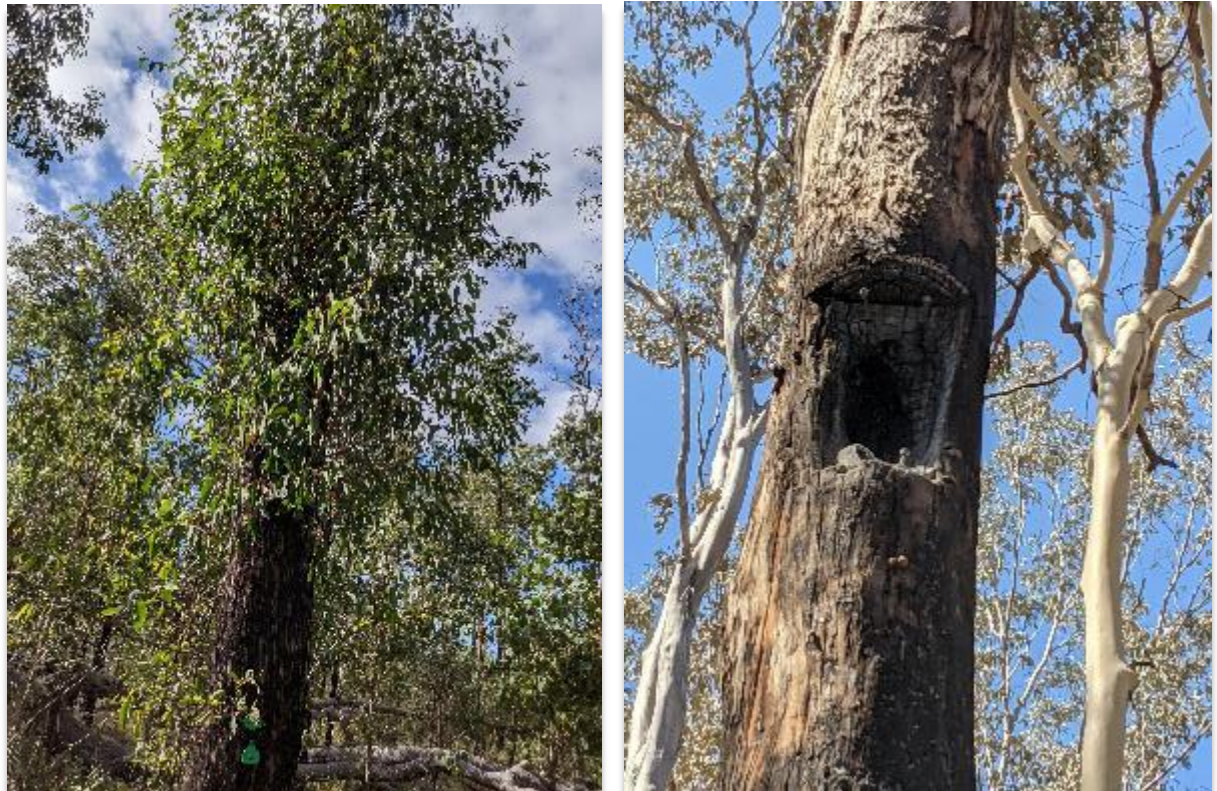
During inspections, epicormic growth was removed around several hollows (five during spring 2020 and three during autumn 2021) to facilitate passage for fauna (plate 2, see Appendix D). Arboreal ants were also present in relatively high abundance occupying five hollows during spring and eight during autumn (Figure 12).

Plate 2: Epicormic growth surrounding entry of chainsaw hollows (left). One of several chainsaw hollows destroyed by fire (right).

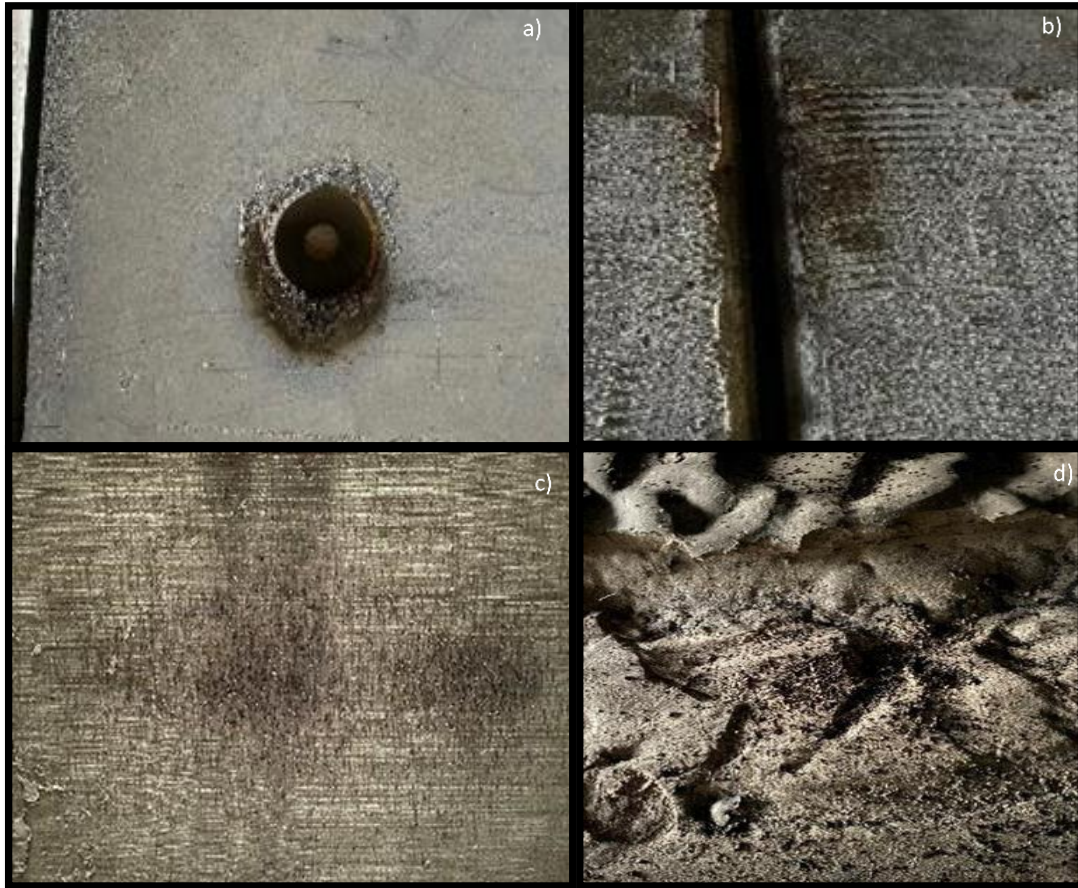
The inspection identified a large area of suitable roosting habitat in addition to bat boxes. Potential roost sites included joins greater than 20 mm wide between box sections, roughened culvert ceiling, uneven box sections and lift points (Plate 2). The Halfway Creek and Boneys Creek culverts had the largest area of roosting habitat with over 40 suitable joins and artificially roughened ceiling recorded at each site (Table 7). The subject culverts could support several thousand non-breeding bent-winged bats during late autumn/winter. The number of bats recorded is not indicative of the total number that are likely to utilise the sites.

Plate 3: Microbat scuff marks around lift point (a) and culvert joints surrounded by roughened concrete (b). Microbat scat below bat boxes (c) and culvert joints (d).
