Woolgoolga to Ballina Pacific Highway upgrade

**Sections 3-11 Microbat Monitoring
Annual Report 2018**

W2B Sections 3 – 11 Microbat Management Plan 2018 Annual Monitoring Report

Pacific Complete

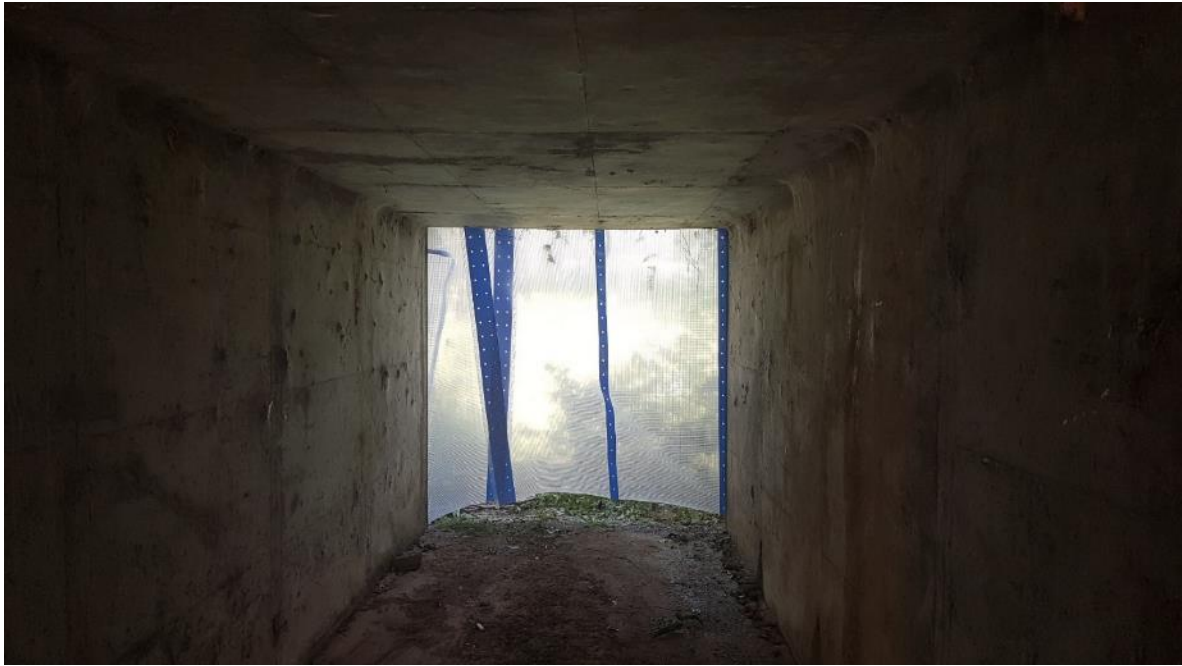
Figure 15: Internal view of exclusion device for microbats using heavy duty plastic sheeting across a culvert outlet, Devil's Pulpit tie in, Woolgoolga to Ballina Pacific Highway upgrade, April 2018.

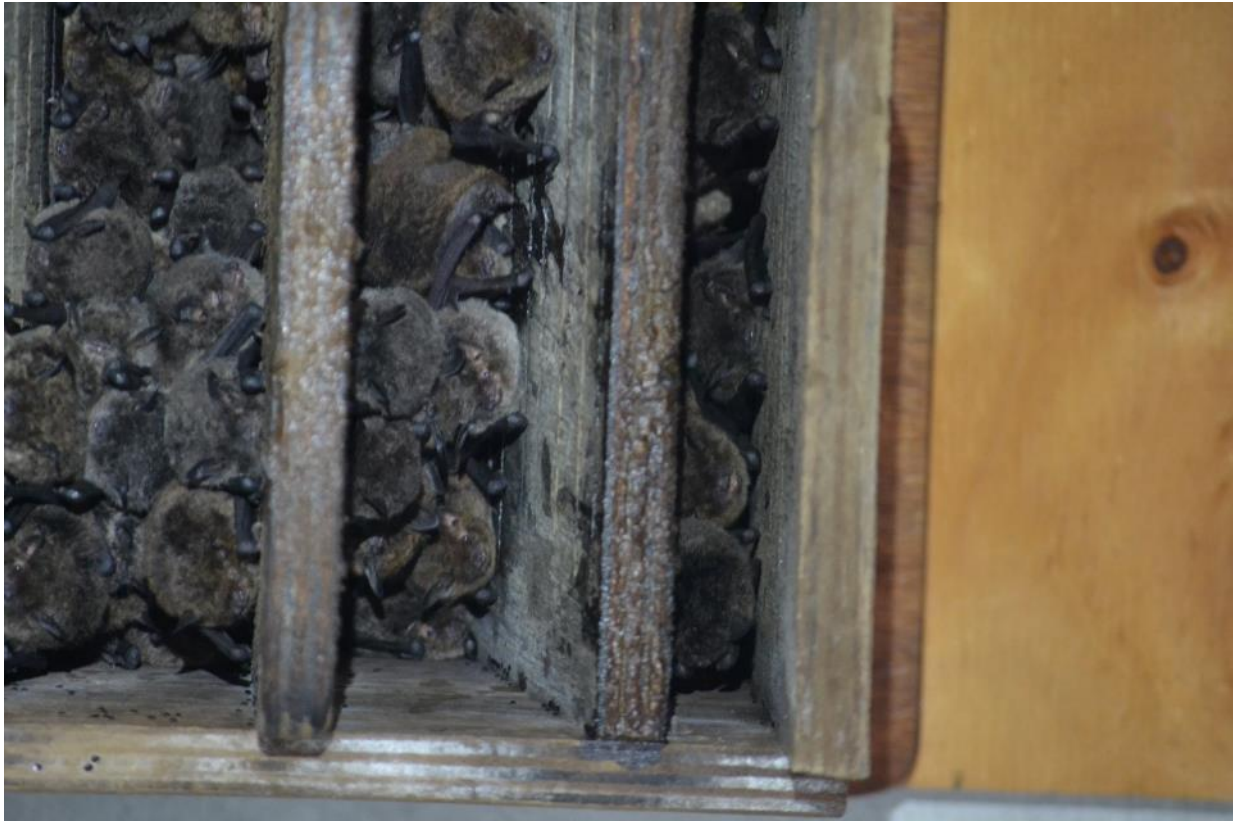
Figure 17: One of the four bat boxes installed beneath Mororo Bridge full of Southern Myotis.

The four boxes underneath Mororo Bridge (south) were also not installed as part of the W2B project. Mororo Bridge is a control site and any existing boxes attached to the bridge whether used or unused should remain where they were originally placed. Significant degradation of these boxes has been noted during monitoring inspections, with the timber permanently coated with excretions (guano and urine) from the bats. The boxes are often at capacity and the local population of Southern Myotis would benefit from installation of at least 6 new boxes of similar size or with a capacity to accommodate up to 500 Southern Myotis at this location.

It is recommended, although not required as part of the W2B project, that the additional boxes be constructed from a mixture of marine grade ply manufactured in a lattice style (proven to be successful for Southern Myotis at numerous sites throughout NSW) and from Cyplas as this material is not likely to react with guano and urine and create an unhealthy environment in the bat boxes. A mixture of materials is recommended because long term usage of Cyplas boxes by Southern Myotis (or any microbat species) has not been documented as this material is new to the market.

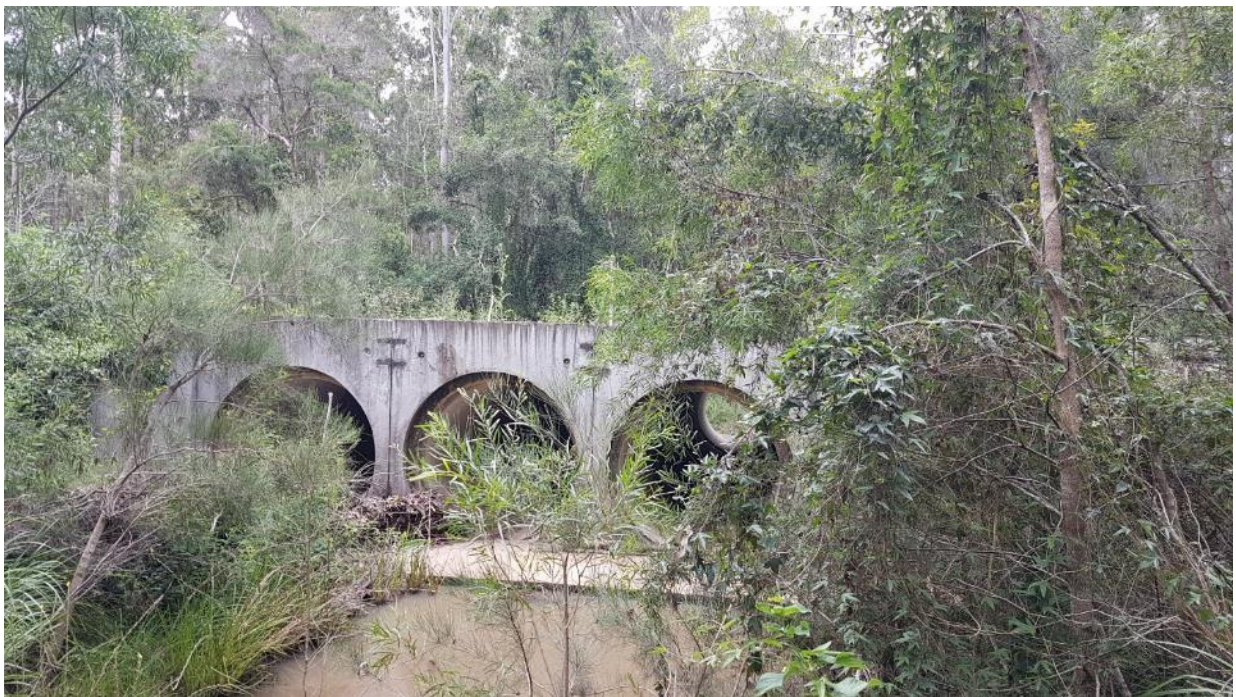
Similarly, the culvert at Pheasants Creek CH 35900 (Figure 20) was only partially excluded to microbats, with the internal holes and gaps sealed using expanding foam. This was due to the need to maintain a flyway for Southern Myotis along the creek line at this location whilst removing the chances of large breeding aggregations inhabiting the culvert prior to demolition. There was a small amount of guano recorded in the culvert during Sept 2018 inspections, but no further evidence of microbat usage recorded in Dec 2018.

Figure 20: Glenugie Link Section 3A Pheasants Creek culvert, January 2018.
