Woolgoolga to Ballina Pacific Highway upgrade

Threatened Rainforest Communities and Rainforest Plants Monitoring Program Annual Report 2019

Construction Phase Report

Woolgoolga to Ballina Pacific Highway Upgrade, Sections 10 & 11, Threatened Rainforest Communities and Rainforest Plants, Annual Monitoring Report # 3 (2019)

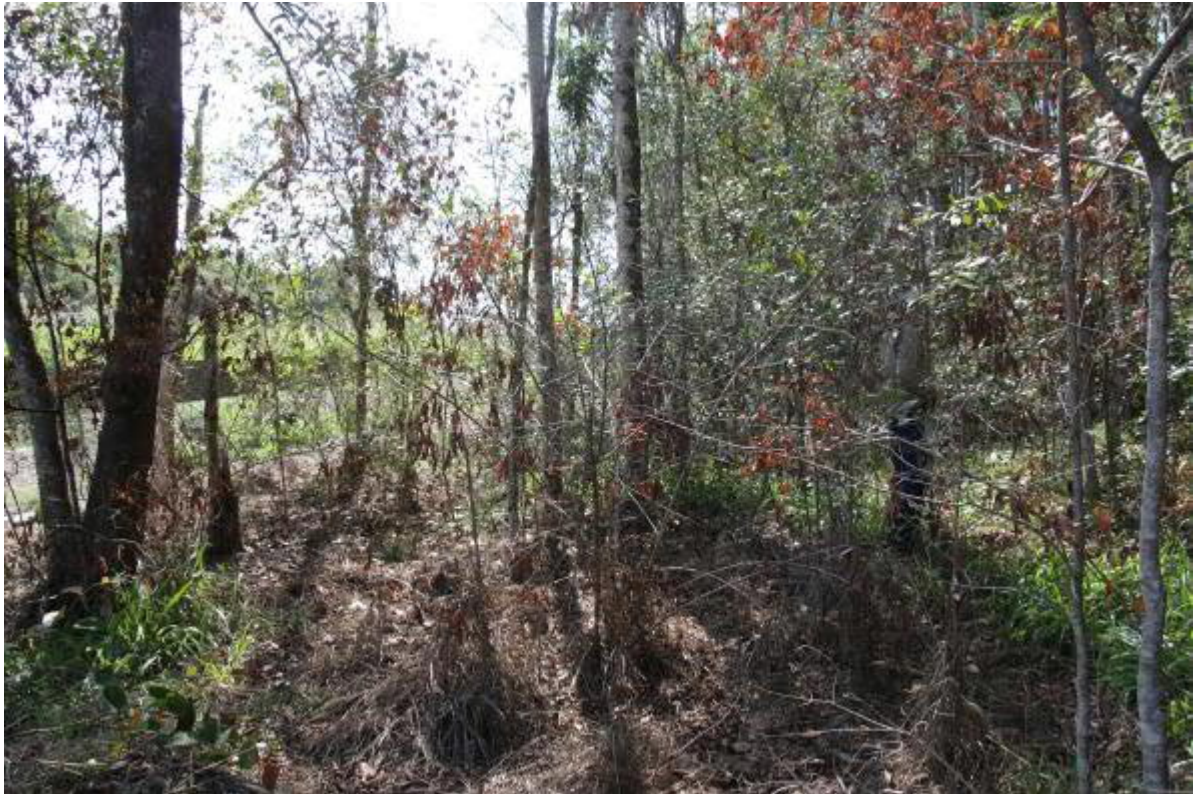
There was evidence of roadside herbicide spraying having affected the threatened species Native Guava (*Rhodomyrtus psidioides*). This species has recently been listed as Critically Endangered due to a dramatic decline in populations caused by the introduced disease Myrtle Rust.

Plate 1: Roadside bush near rainforest community Plot 11 showing ground layer die-off from herbicide spraying.

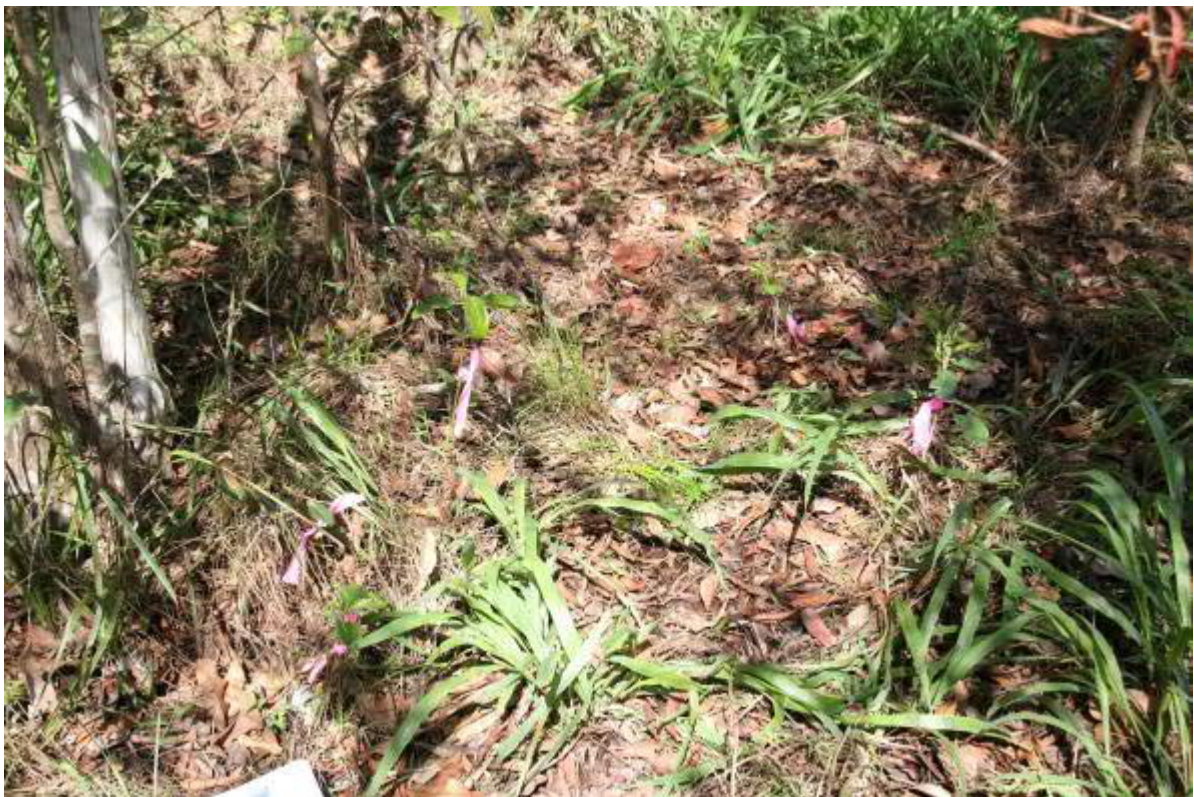
Plate 2: Regrowth in the ground layer at the site in Plate 1, two shoots of Native Guava (*Rhodomyrtus psidiodes*) with pink tape. The grass is Broad-leaved Paspalum an environmental weed that reshot after being sprayed.

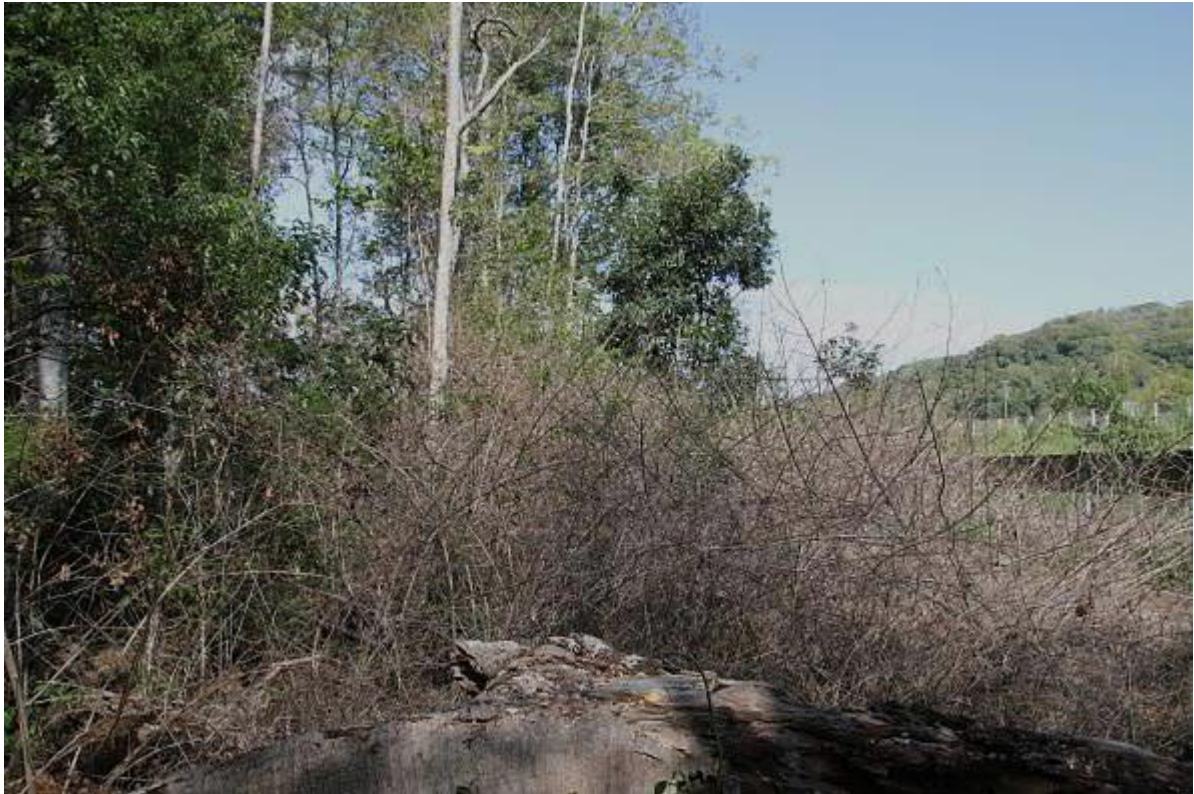
Plate 3: Dead Lantana in the same area, which has been over-sprayed probably with a spray gun. Spray drift has affected the adjoining littoral rainforest edge containing the Critically Endangered species Native Guava (*Rhodomyrtus psidiodes*), see Plates 1 and 2.

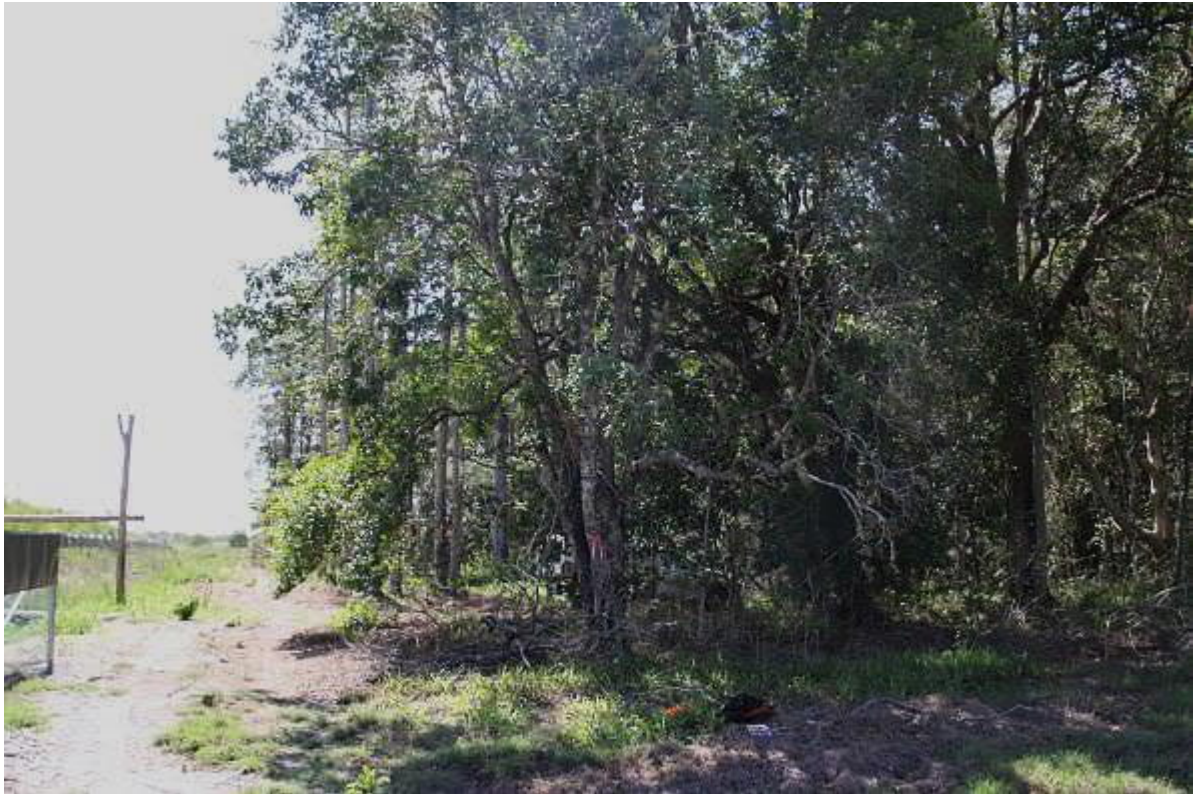
A mature White Laceflower (*Archidendron hendersonii*) tree next to the highway just north of Lumleys Lane has produced several large root sucker shoots on a sandy track that appears to be used as an access for maintenance and monitoring work. We marked the plants on the track with stakes and pink tape with threatened species written on it, but an alternative access needs to be worked out so they are not damaged by accident in future (see Plates 4-5).

Plate 4: White Laceflower (*Archidendron hendersonii*) tree previously unmarked north of Lumleys Lane.

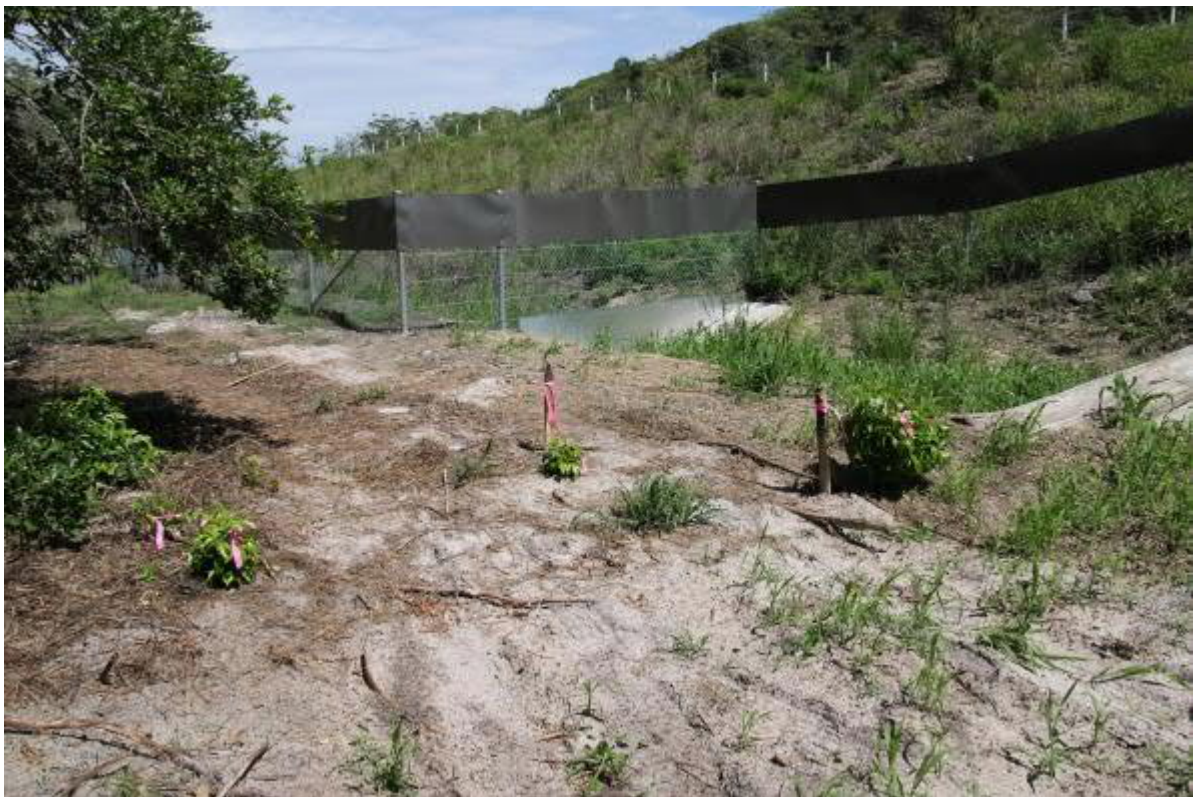
Plate 5: White Laceflower (*Archidendron hendersonii*) root sucker shoots on a sandy access track next to a fauna underpass tunnel just north of Lumleys Lane. The shoots are coming from the tree in Plate 4 above.

Recommendation Number	Recommendation	TfNSW response
3	Make the eradication of Giant Devils Fig a high priority (include removal of any fruits)	Adopted – Weed management contractor will be provided with this report and to carry out removal of Giant Devils Fig.
4	Identify and clearly mark occurrences of the Critically Endangered Species Native Guava (<i>Rhodomyrtus psidiodes</i>) within the project boundary and on adjacent RMS property.	Adopted – Native Guava within project boundary as identified in this report have been flagged. Where individuals are known on adjacent RMS property they will also be flagged
5	Fence off and protect White Laceflower (<i>Archidendron hendersonii</i>) vegetative recruitment on sandy track (see Plates 5 & 6).	Adopted – Contractor responsible for weed management will investigate the feasibility of fencing off White Laceflower on access track. If fencing is not feasible, individuals will be flagged.

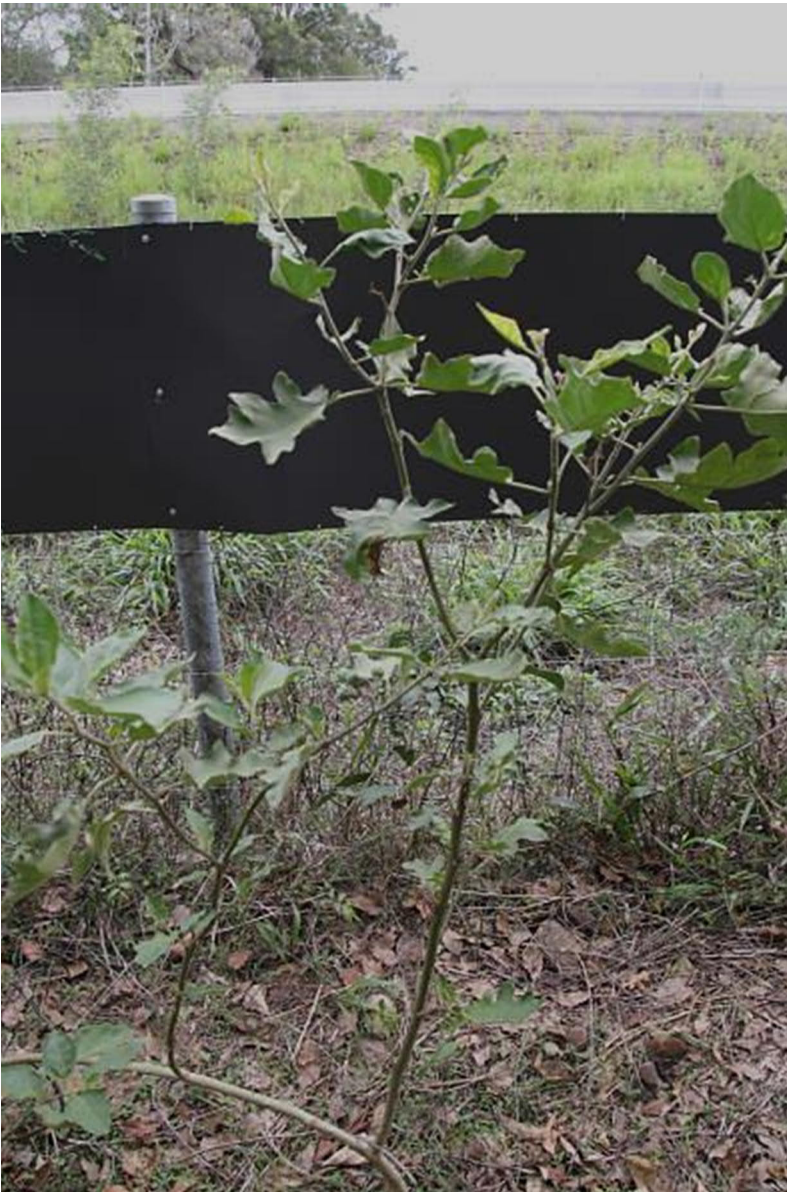
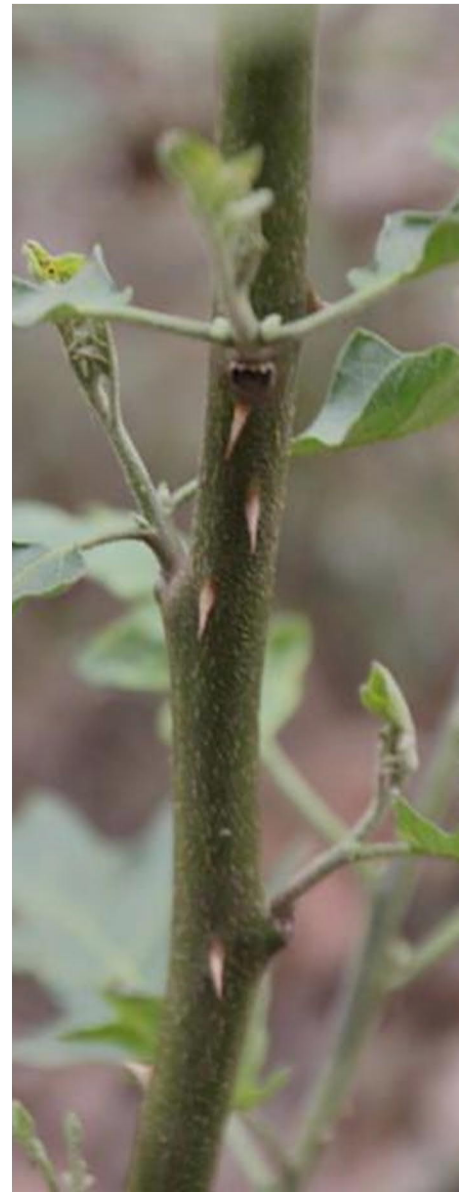
Also, a founder population of the environmental weed Giant Devils Fig (*Solanum chrysotrichum*), a vigorous invader of native bush, was observed next to the fauna fence in the Lumleys Lane area. This should be eradicated as soon as possible and any fruit on the plants collected and destroyed (see Plate 6).

Plate 6: Giant Devils Fig (*Solanum chrysotrichum*). This tall solanum with sharp thorns on its stems is an environmental weed in NSW and Qld. It invades most types of native forest and forms dense stands impossible to walk through because of the thorny stems. It is expanding its range in NSW and is presently not common south of the Tweed valley.

A few plants were seen on the edge of the highway in the Lumleys Lane area on the northern side of the alignment about 50 m west of rainforest plot 8. These plants should be killed as soon as possible to prevent them spreading into subtropical rainforest regrowth on the Blackwall Range next to the highway.

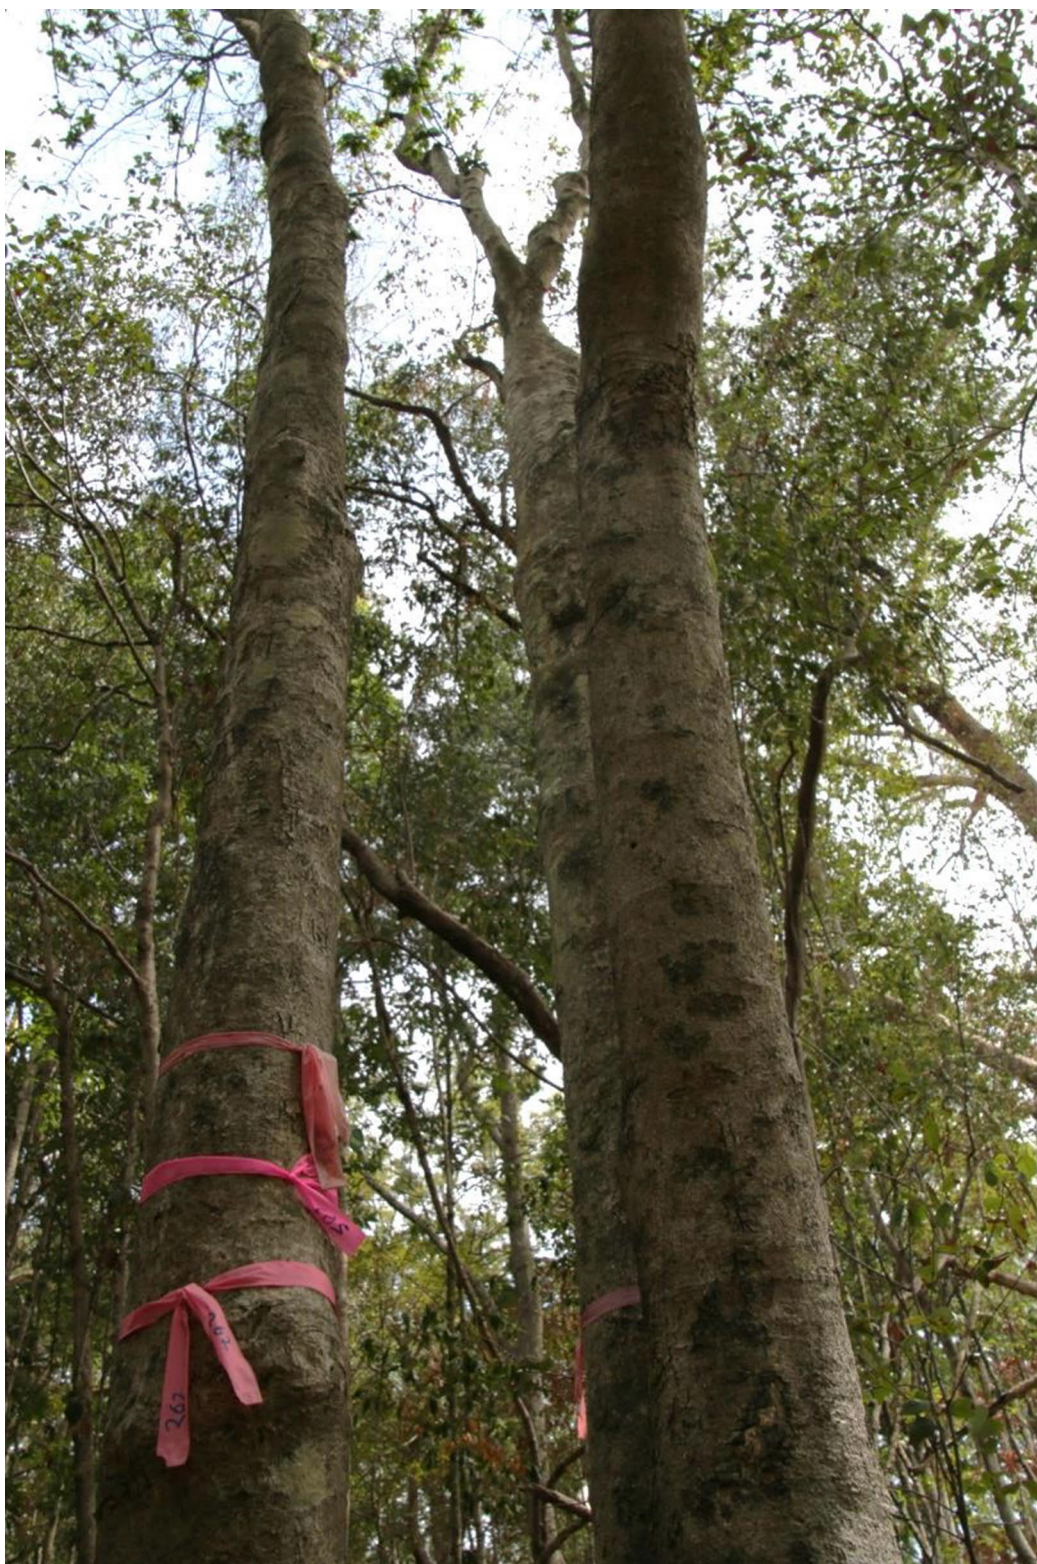
Plate 2: White Laceflower (*Archidendron hendersonii*) no. 73 near Plot 6. Foliage crown a bit sparse due to the drought.

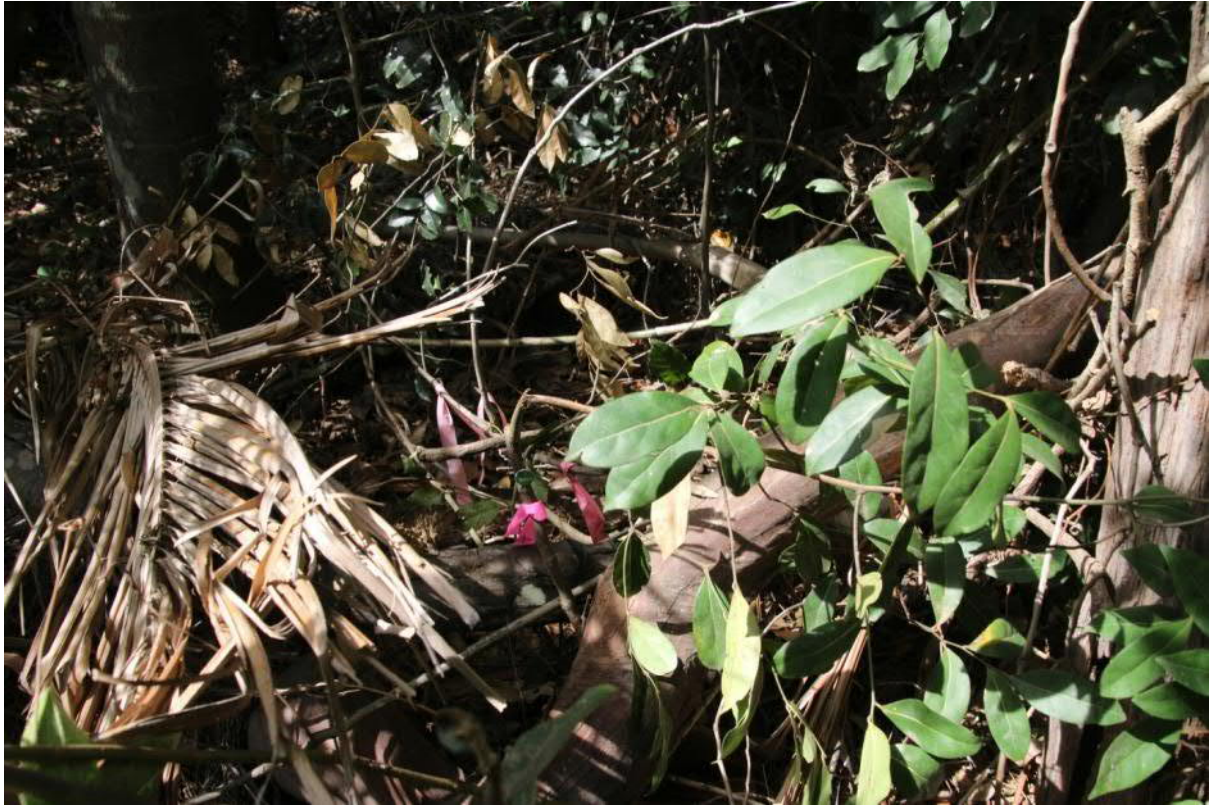
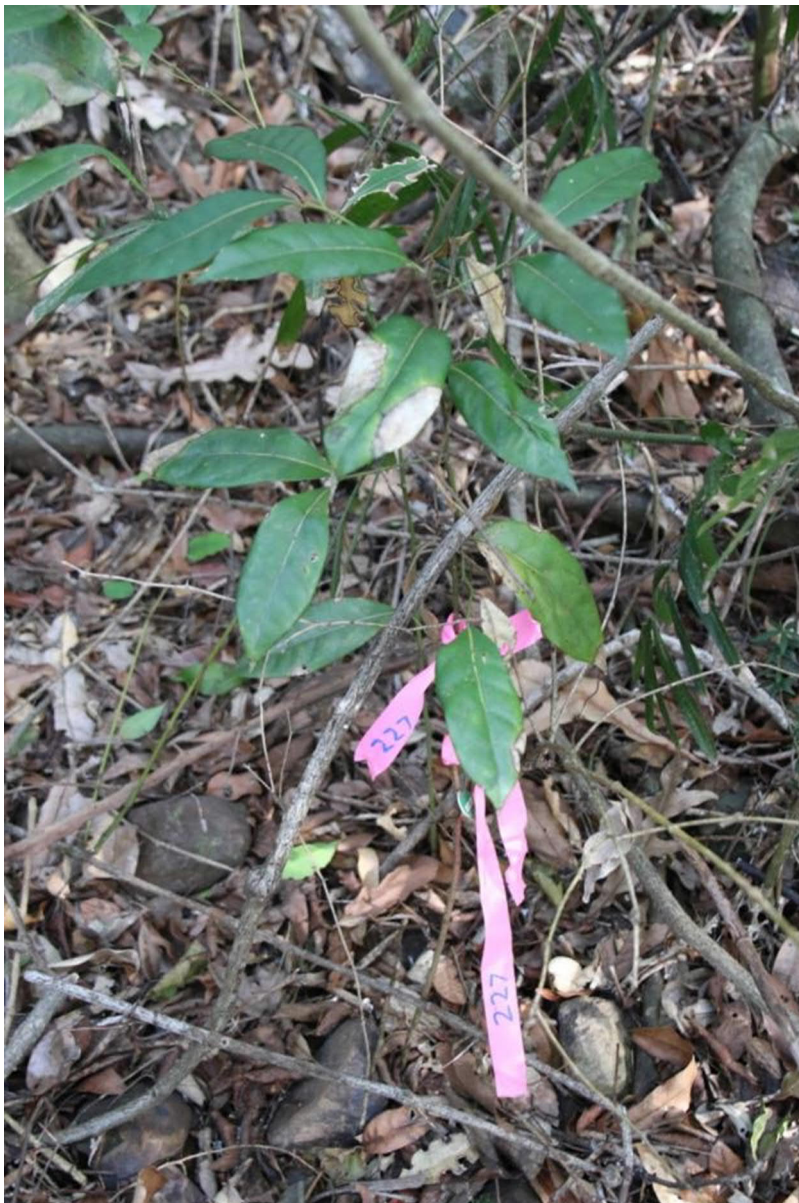
Survival/condition: 1 individual broken off by fallen limb. (Note – number less than originally recorded as several individuals appear to be *Cryptocarya microneura*.)

Plate 4 & 5: Stinking
Cryptocarya
(*Cryptocarya foetida*) no.
5 broken off by a fallen
tree (above) and no 227.
Both showing no
obvious ill effects of the
drought.

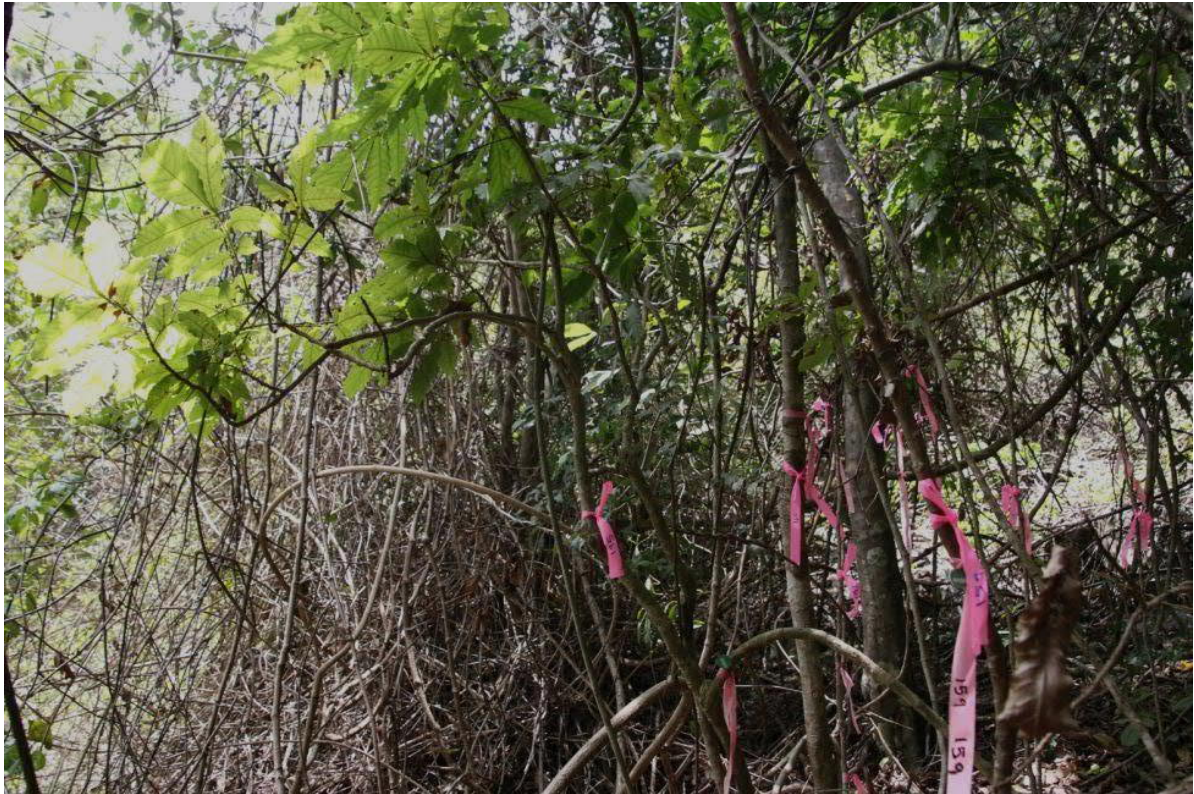
Survival/condition: 38% of stems dead in January 2020

Plate 6: -Smooth-leaved Davidsonia (*Davidsonia johnsonii*) no. 159. Part of a copse of more than 30 stems, some showing effects of drought dieback.

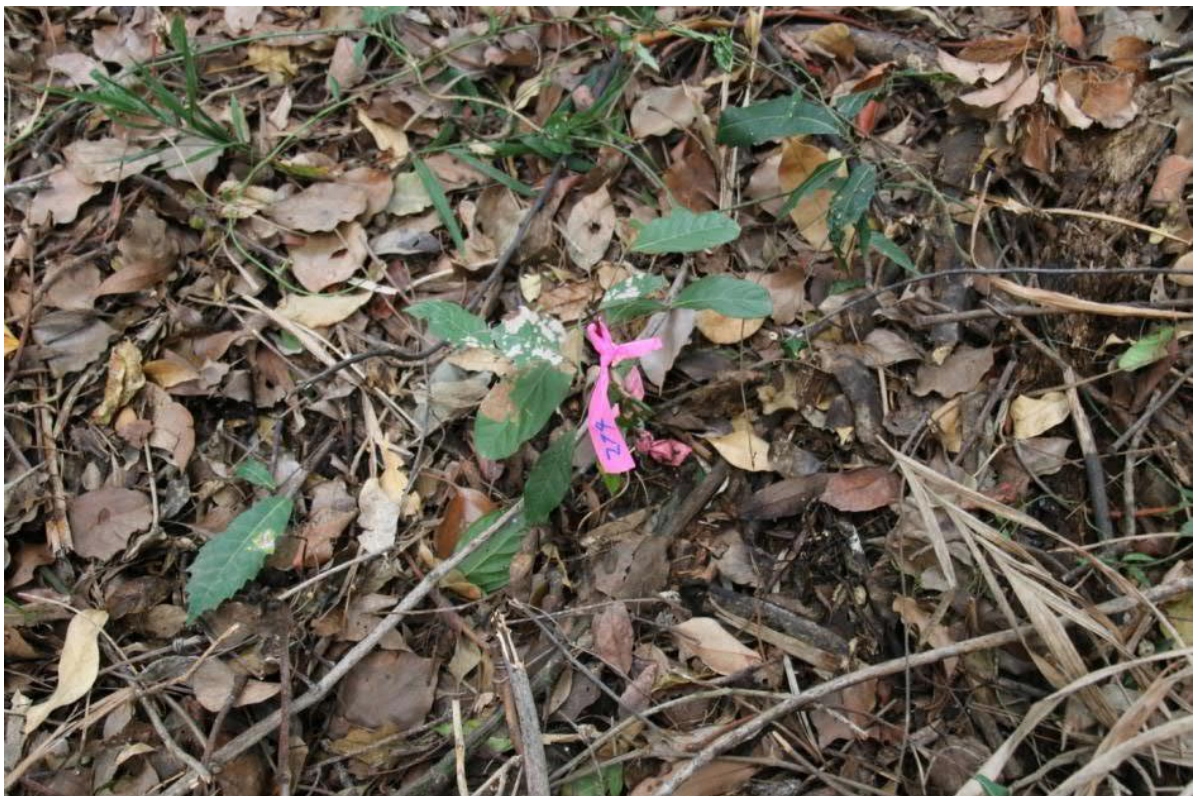
Plate 10: Rusty Green-leaved Rose Walnut (*Endiandra muelleri* subsp. *bracteata*) no.274 near Plot 2. A small juvenile plant showing leaf browning and leaf fall due to the drought.

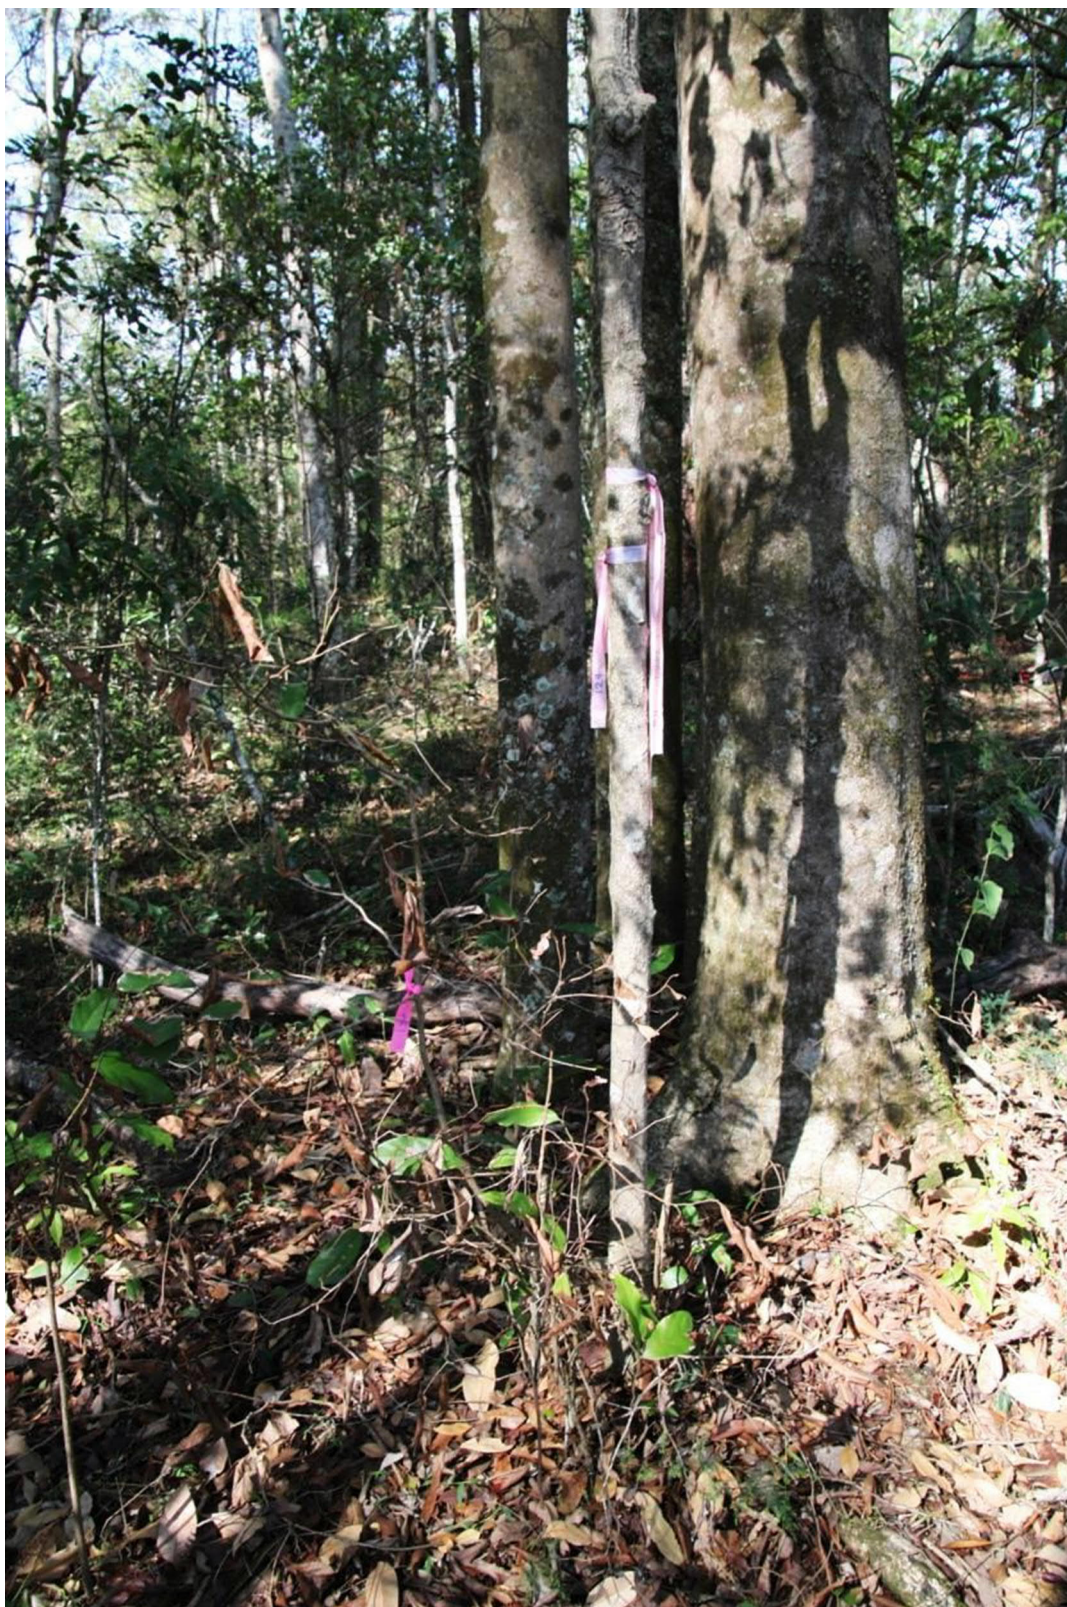
Plate 12: Rusty Green-leaved Rose Walnut (*Endiandra muelleri* subsp. *bracteata*) no.124 near Plot 11. The main stem has died and it has live coppice shoot around the base.

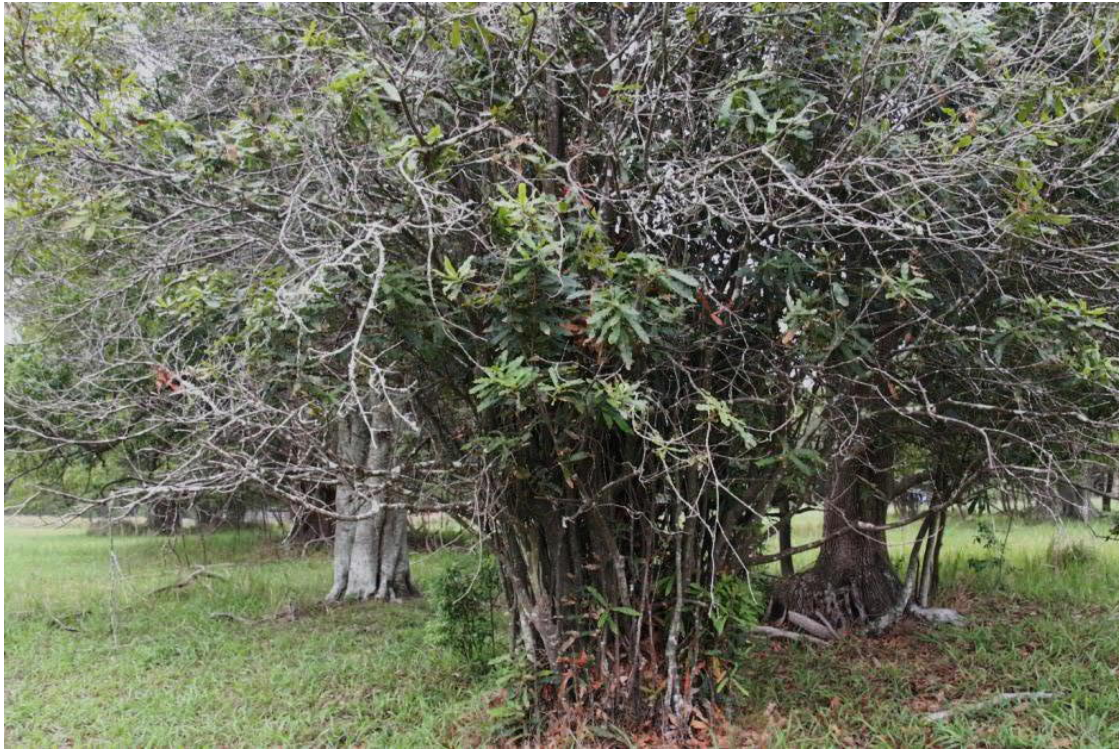
Plate 16: Rough-shelled Bush Nut (*Macadamia tetraphylla*) no. 170 near Plot 10. This mature individual made up of 50 or more coppice stems is showing canopy dieback from several years of below average rainfall.
