Woolgoolga to Ballina Pacific Highway upgrade

**Construction Monitoring of In-situ
Threatened Flora (non-rainforest flora)**

Annual Report 2017-18

In-situ Threatened Flora (non-rainforest flora) Annual Monitoring Report 2017

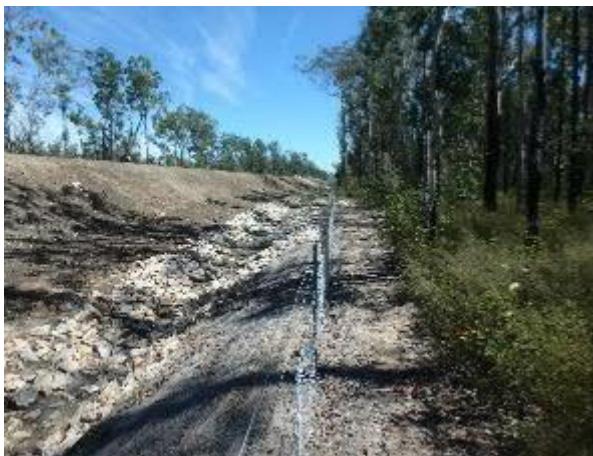
Majority of sites with *E. tetrapleura* are in good condition with low or no weed cover/abundance and intact structure and native species diversity. Two sites (Et-2.1 and Et-2.2) have been burnt in last 1-2 years but younger saplings have regenerated. Site Et-2.1 had two trees removed by clearing activities where the project boundary penetrated the plot (refer to Photograph 1).

Photograph 1: Project boundary edge within Site Et-2.1 (loss of two trees) showing plot on right side during summer surveys (summer 2017).

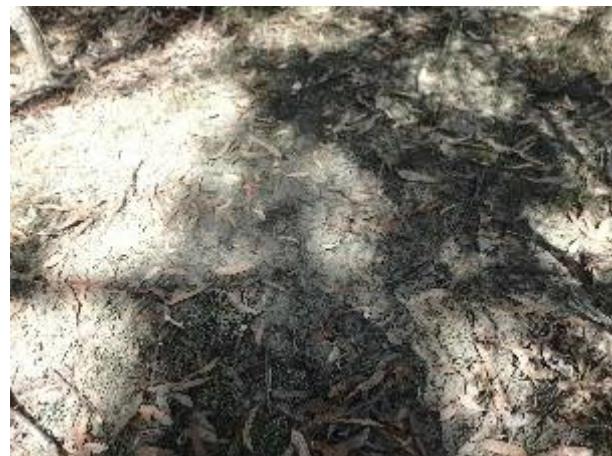
Evidence of project related erosion and fast flowing surface water run-off was observed at Site Et-2.3. Run-off was sourced to a nearby overflow pipe from a sedimentation basin, this has washed away top soil within the plot. No decline of tree health was observed but any potential loss of top soil may in affect the establishment of seedlings (refer to Photograph 2). A summary of results is shown in Table 3-2.

Photograph 2: In-situ Site Et-2.3 with bare ground caused by surface water runoff that has washed away top soil (summer 2017).

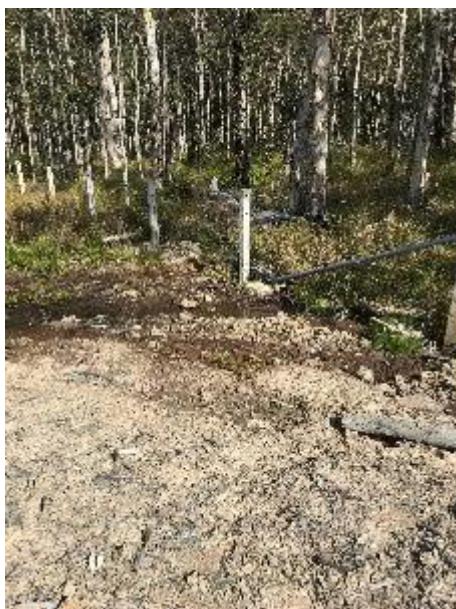
Construction related clearing has affected two sites with complete removal of Site La-1.1 and partial clearing of Site La-1.2. Changes to hydrology and potential water quality of surface water run-off was observed at sites La-1.2 and La-1.3, however there is lack of evidence to support indirect impacts to habitat or species decline. Refer to photographs 3 and 4. Results are summarised in Table 3-3.

Photograph 3: Edge of Site La-1.3 showing project related run-off flowing into site (winter 2017)

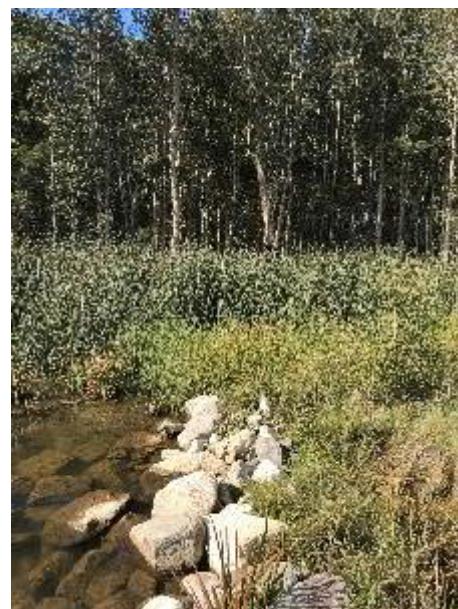
Photograph 4: Edge of Site La-1.2 shows modified hydrology with installation of rocky basin (winter 2017)

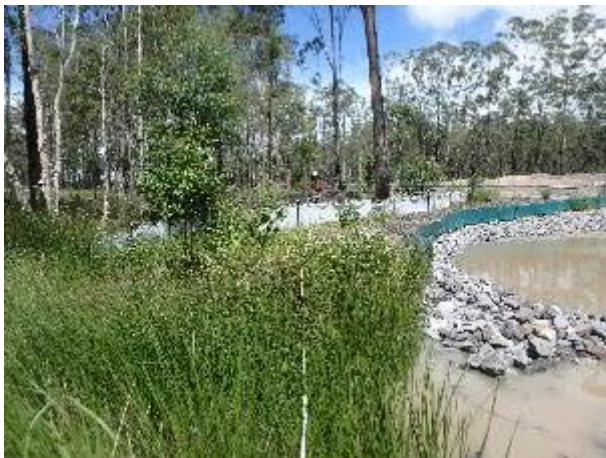
Photograph 5: Project boundary edge within new Site Mt-1.2a established in summer 2017 scour rock design beyond culvert apron in place of original monitoring plots (Mt-1.2 and Elt-1.1).

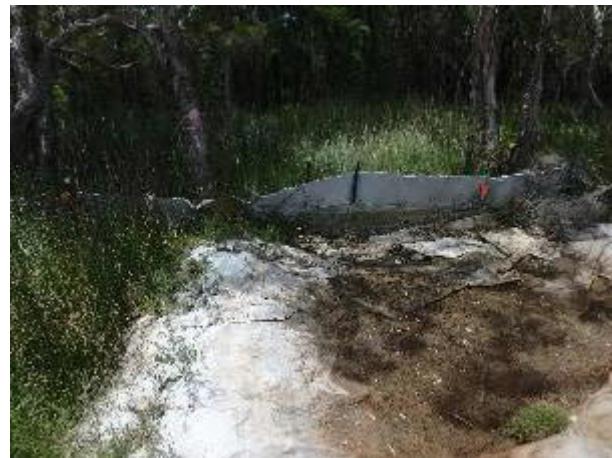
Photograph 6: Sediment and erosion control geo-fabric smothering some *M. triglochinoides* individuals next to Mt-2.1 (summer 2017)

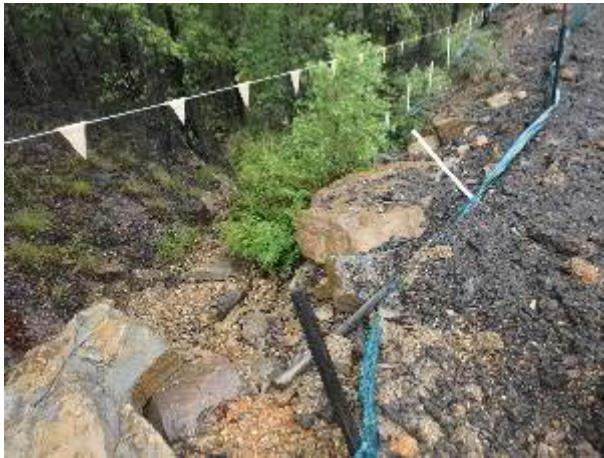
Photograph 7: Overtopping erosion control leading into a drainage line associated with in-situ Site QM-1.1 (summer 2017)

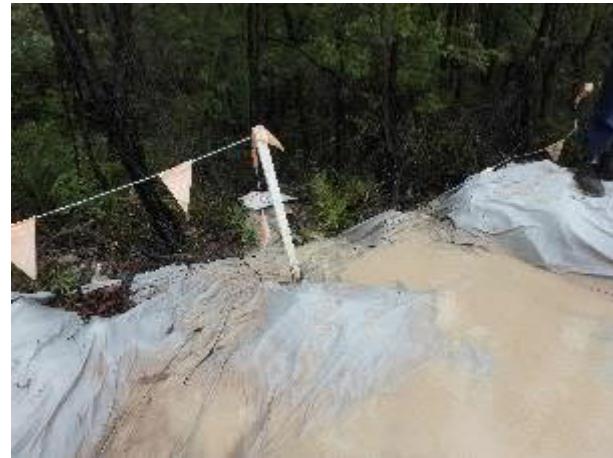
laden runoff flowing into associated habitat drainage line outside of in-situ Site QM-1.2 (chainage: 8400) (refer to Photographs 7 and 8).

Photograph 8: Sediment-laden runoff during a high rainfall event flowing into nearby habitat linked to in-situ Site QM-1.2 (summer 2017)

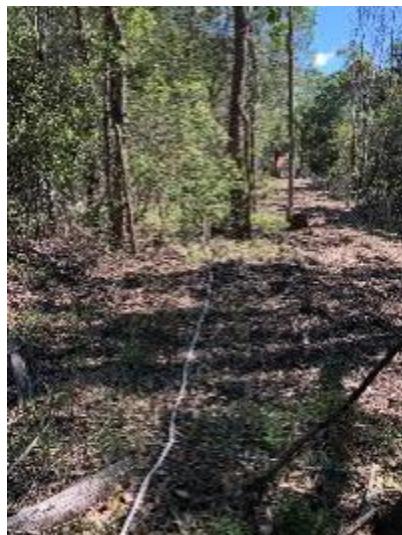
Photograph 9: Clearing and under scrubbing of Site 3.10a for fence construction

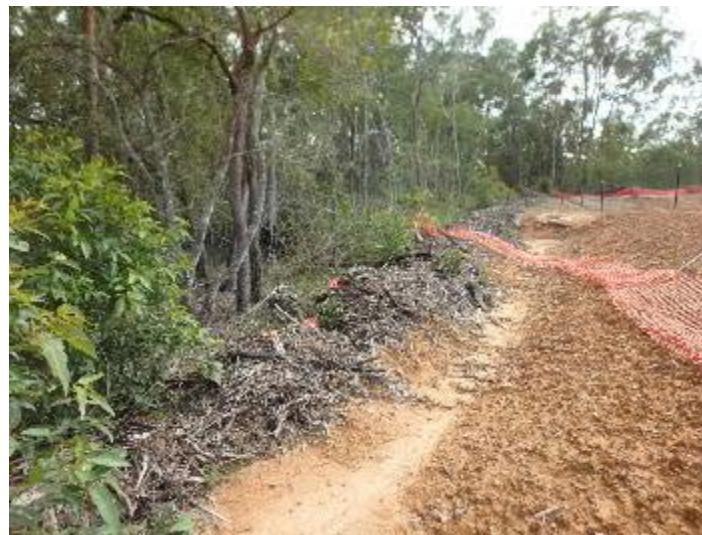
Photograph 10: Project boundary edge next to Site Ar-3.10a showing damaged exclusion fence, *A. robur* trees and seedlings in mulch on edge during autumn surveys.

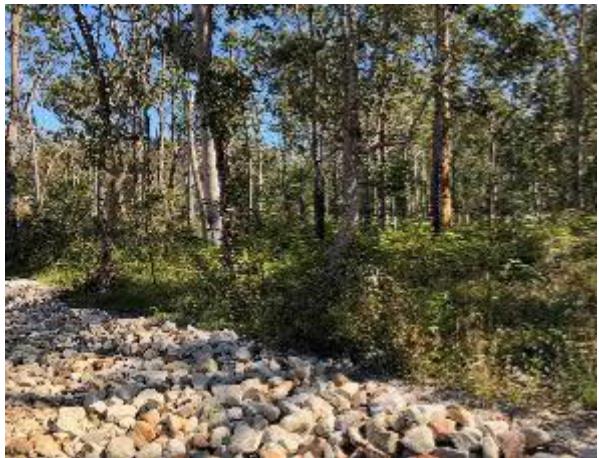
Photograph 11: Direct impacts to Site Ar-3.2 showing introduced rock inside plot next to A. robur trees and lack of exclusion fencing (spring 2017)

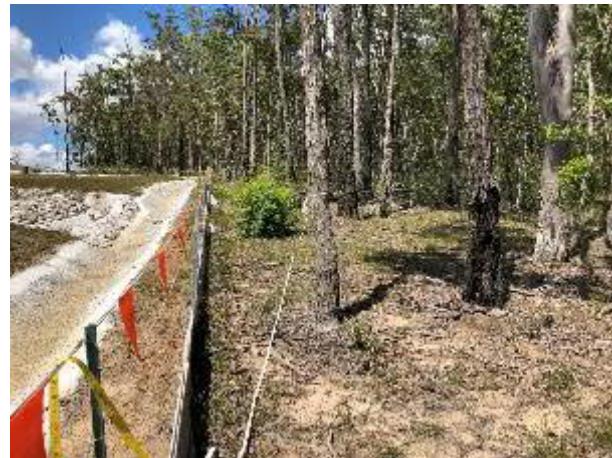
Photograph 12: Direct impacts to Site Ar-3.5 showing constructed fence and drain inside plot next to flagged A. robur tree (spring 2017)

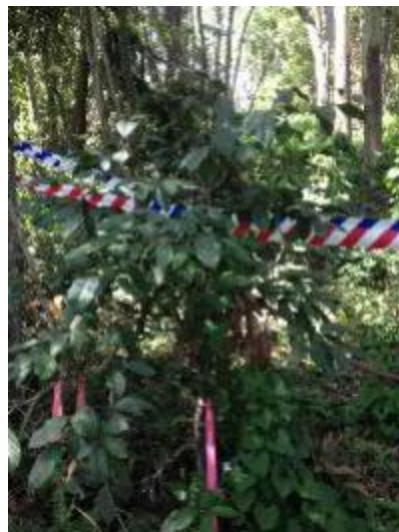
Photograph 14: *E. muelleri* subsp. *bracteata* at in-situ site Emb-4.1 with weed *Aristolochia elegans* and new flagging in November 2017

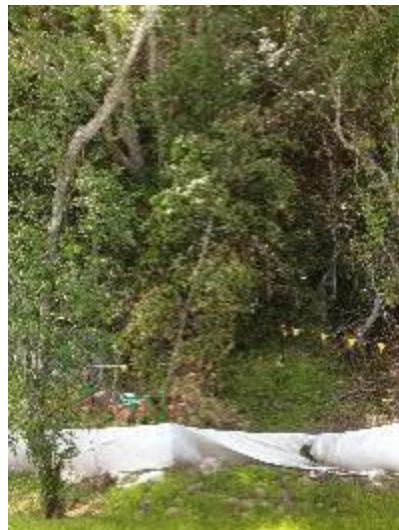
The small tree at Site Emb-4.2 (chainage: 80700) has had continuous new shoot growth on lower and upper branches but has not grown in height with visual crown dieback and moderate dieback of upper branches in spring 2017 (refer to Photograph 15 and 16). Site Emb-4.2 has had no increase in weed cover, but weed species numbers have increased inside the plot, particularly at the lower end around the individual *E. muelleri* subsp. *bracteata* where the site had been cleared to allow for the new embankment. There is potential for future weed invasion and spread.

Photograph 16: *E. muelleri* subsp. *bracteata* at in-situ site Emb-4.2 with new fencing and showing new growth (in red) and dieback of upper branches in November 2017

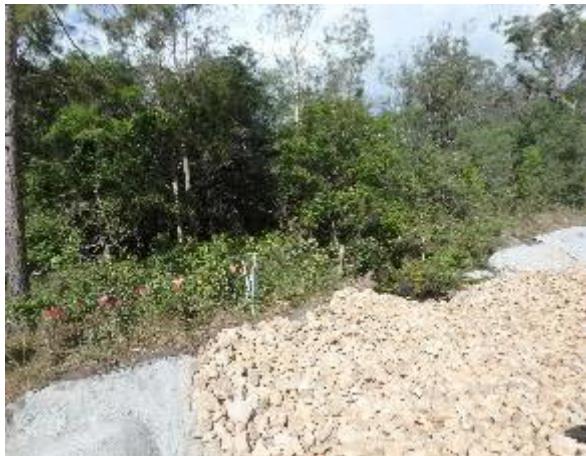
Photograph 17: Edge of Site Gq-3.1 showing loss of habitat, introduced rock and concrete drain. (autumn 2017)

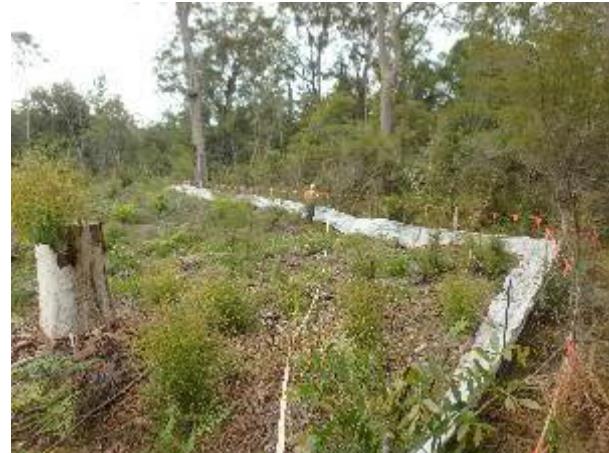
Photograph 20: Construction in-situ Site Li-3.1 showing cleared habitat and geofabirc on exclusion fence smothering some *L. incisa* (May 2017)

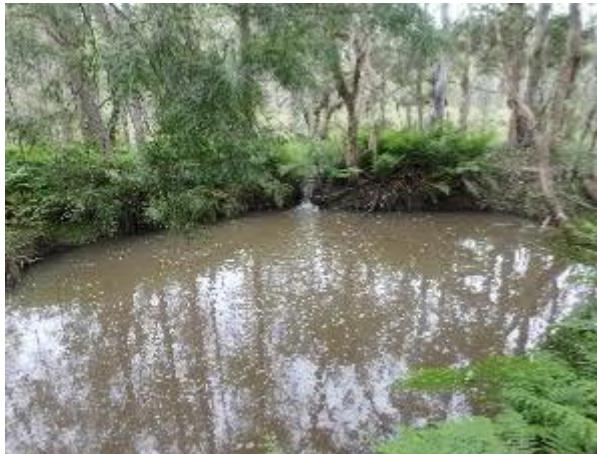
Photograph 21: Sediment-laden water flowing into *M. triglochinoides* habitat of in-situ Site Mt-3.2 (May 2017)

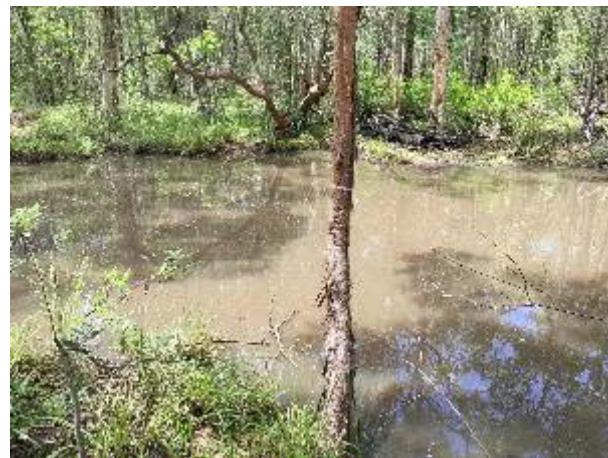
Photograph 24: Construction phase at in-situ Site Mt-7.2 showing major decline of *M. triglochinoides* population (Nov 2017)

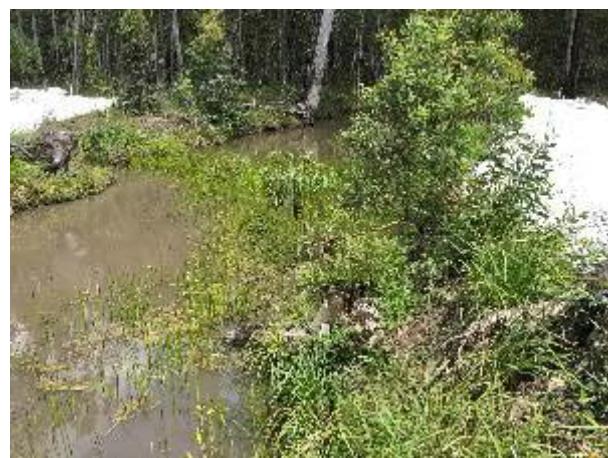
Photograph 26: Construction phase at in-situ Site Mt-7.3 showing change in habitat of *M. triglochinoides* population (Nov 2017)
