Appendix H – Mine Subsidence Assessment

Drought Response Desalination Plant Mine Subsidence Desktop Assessment - Desalination Plant Site, Seawater Pump Station and Direct Ocean Intake

Hunter Water Corporation
 Belmont Drought Response Desalination Plant
 Mine Subsidence Desktop Assessment

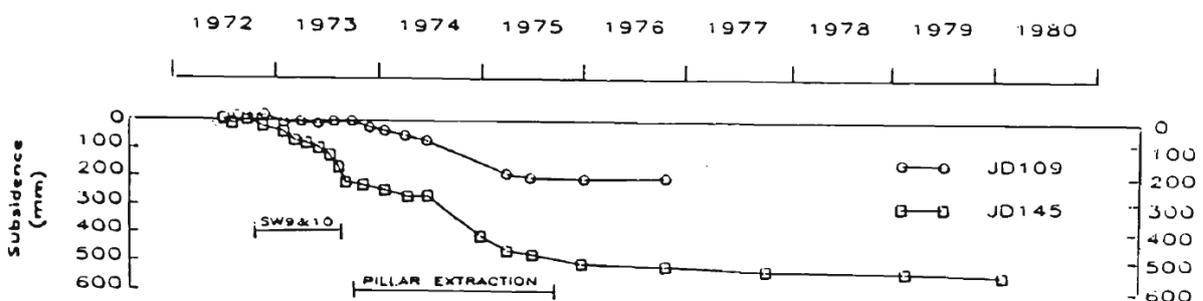
Figure 3 Subsidence monitoring (Kapp, 1984)

Fortunately the ground surface above the area of second workings noted in Table 2 was monitored and subsidence recorded in the PhD thesis (Kapp, 1984). A surface survey line was monitored between 1972 and 1975 to record subsidence due to extraction of a number of mini wall panels as well as the area of pillar extraction in the VT Seam. Maximum subsidence (S_{max}) of 600 mm was recorded (compared to a predicted S_{max} of 690 mm). Subsidence monitoring continued until 1980 and showed no further notable movement. After 1980, longwall mining in the Victoria Tunnel Seam and underlying Borehole Seam was undertaken and additional subsidence would have occurred.

Note: JD109 located above short wall, JD145 located near southern edge of pillar extraction

Kapp (1984) noted the subsidence profile was smooth with no unaccounted irregularities, indicating full roof convergence (collapse) occurred over the area of secondary workings. Calculation of the geometric relationship (size, depth and height) of the pillars indicated that surrounding smaller pillars would have been crushed and larger pillars would not have remained stable (Kapp, 1983, pp B-86). Based on the above, we anticipate that goafing of the second workings did occur and further roof convergence (crushing of pillars due to abutment loading) surrounding the area of secondary workings also occurred.

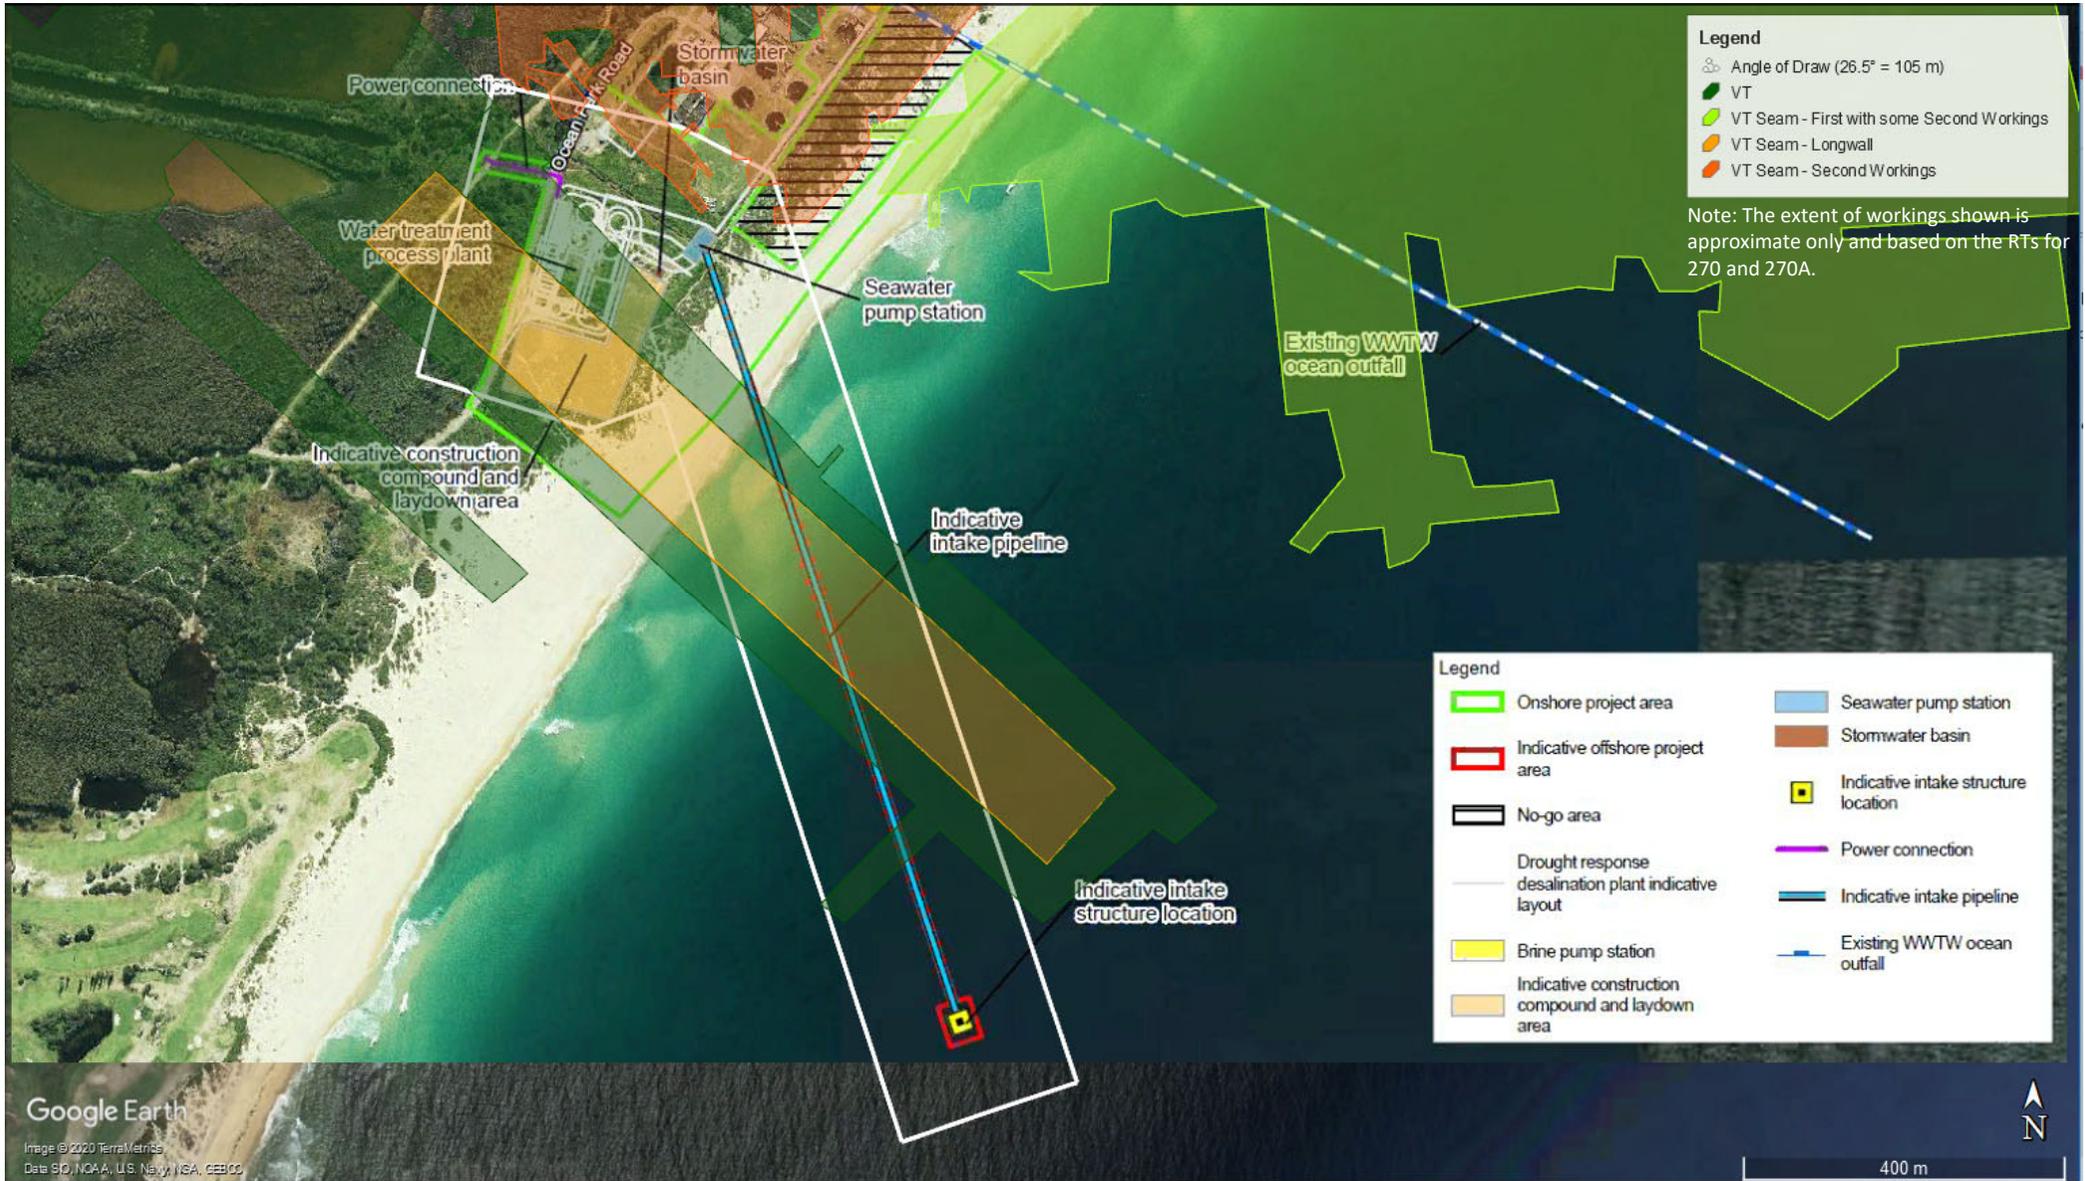
The Victoria Tunnel longwall panel shown on Figure A (Appendix A) overlies two Borehole Seam longwall panels, all of which underlie and are within the angle of draw of the plant, seawater pump station and intake alignment.

Historic Underground Mining – Victoria Tunnel Seam workings (approx.)

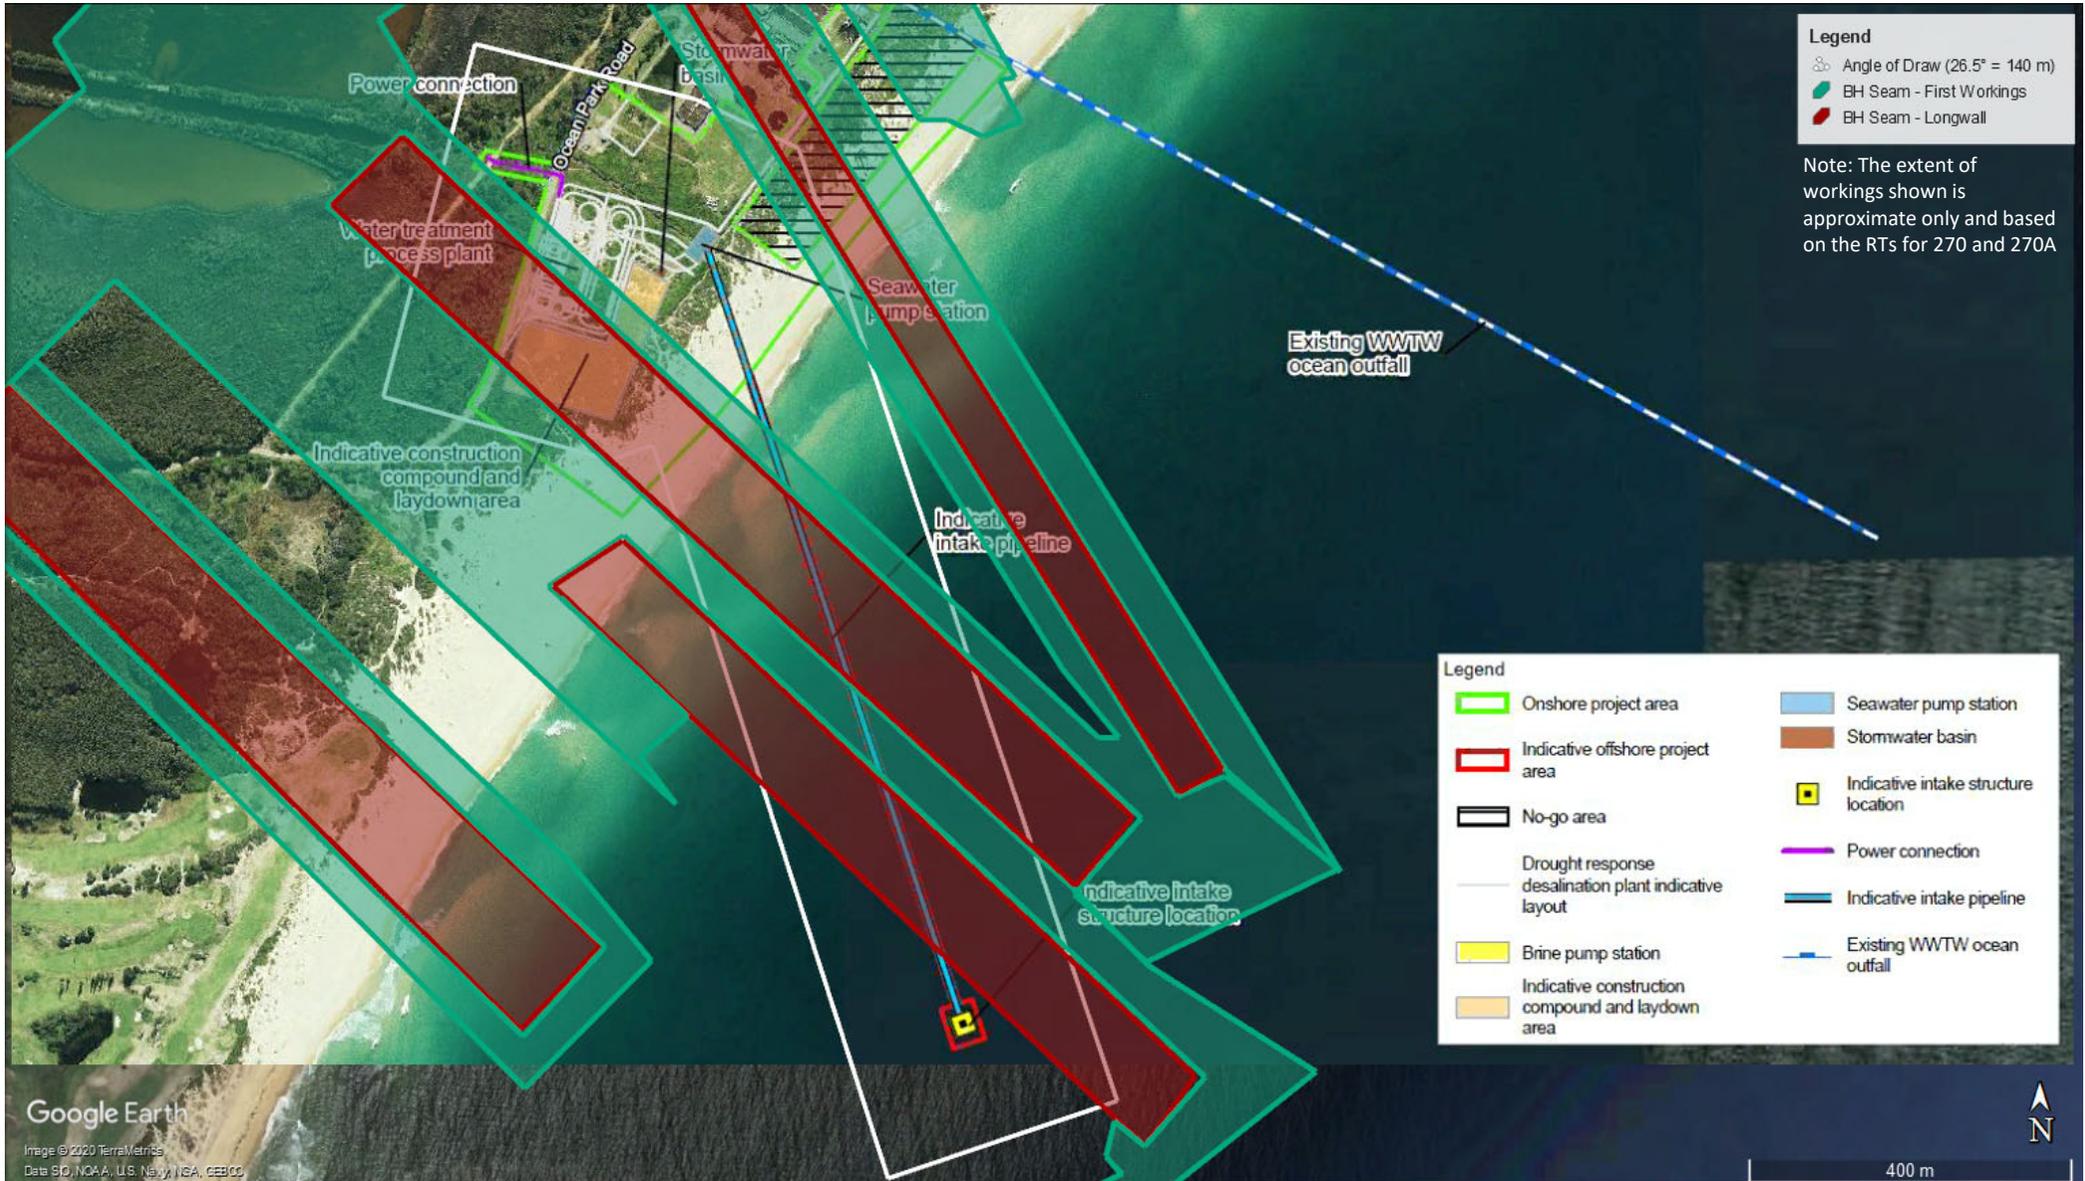
Figure B

Hunter Water Corporation
 Belmont Desalination Plant
 Historic Underground Mining – Borehole Seam workings (approx.)
