Report on  
Detailed Geotechnical Investigation

Proposed New Hospital  
Metford Road, Metford

Prepared for  
Multiplex Constructions Pty Ltd

Project 81719.09  
March 2019

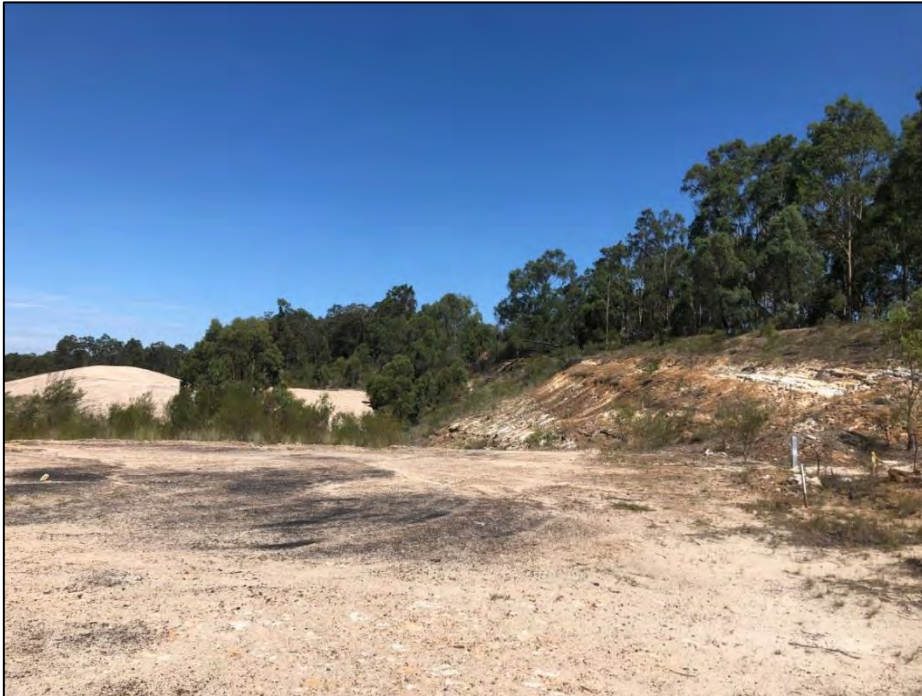
**Figure 7: Looking south-east towards sandstone cutting in southern area of the site**

Sandstone bedrock was observed outcropping in the northern area of the site near Pit 4001 and Bore 3001 as well as the rock cutting at in southern area of the site (refer Figure 7). The sandstone was generally very low strength or stronger.

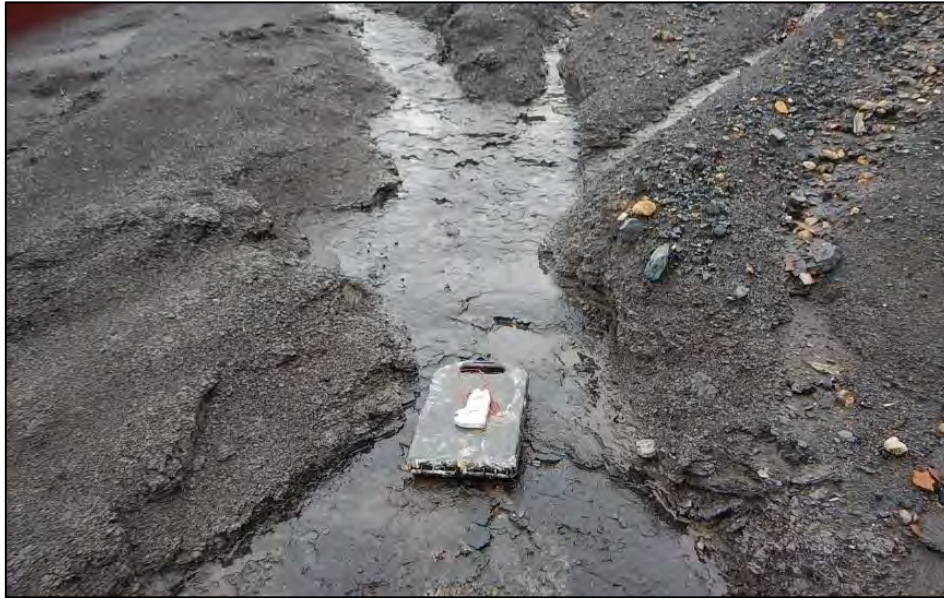
**Figure 9: In-situ coal exposed beneath edge of carbonaceous material stockpile in eastern area of the site (2015)**

- Coal was observed to be outcropping in excavations around the existing stockpile.

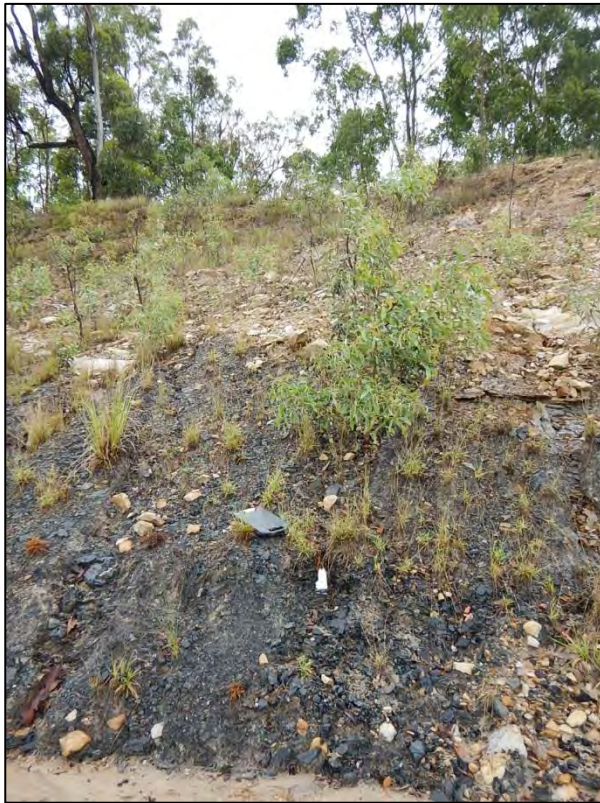
**Figure 13: Coal exposed in lower area of batter**

- The batter was generally formed at a slope ranging from about 20° to 25°;
- Interbedded siltstone and sandstone was exposed within the batter;
- Within the upper portion of the batter, bedding was observed with a dip of 5° to 15° and a dip direction of about 310° to 340° M;
- The dominant jointing in this lower portion of the batter was sub-vertical to 80° with a dip direction of 080° to 090° M and a spacing ranging from about 0.05 m to 0.2 m;
- Within the lower half of the batter, bedding was observed with a dip of 0 to 5° and a dip direction ranging from about 000° to 050° M;
- The dominant joints were dipping at about 65° with a dip direction of around 060° M and a spacing ranging from 200 mm to 1000 mm; and
- Coal was exposed within the lower approximately 1 m towards the eastern visible extent of the batter (refer Figure 13 and Figure 14).

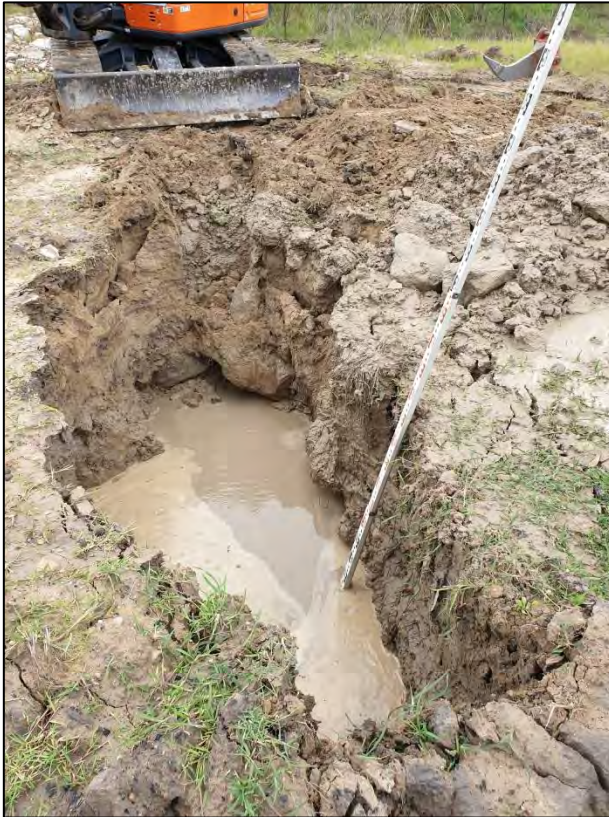
**Figure 21: Conditions encountered in Pit 4002**

The soils present within the eastern, low lying, area of the site are anticipated to have elevated moisture content and are not likely to be suitable for re-use without significant moisture reconditioning. Pit 4002, which was excavated within the edge of the existing pond (refer Drawing 1), encountered loose/soft clayey sand to 1.4 m depth overlying soft sandy clay sediments to 1.6 m depth where collapse of the pit precluded further investigation (refer Figure 21). These water-charged sediments are anticipated to be difficult to work with and would require removal to expose the underlying stiff or stronger natural soils prior to placement of filling.

- The limited investigation carried out to date in this area (Pit 4002 and probing during previous investigations) has not established the depth of the weak sediments. Hence it is recommended that additional investigation is undertaken in this area once the surface water has been removed to further quantify the volume of weak sediments and provide further comments on likely site preparation measures required to allow placement of filling.

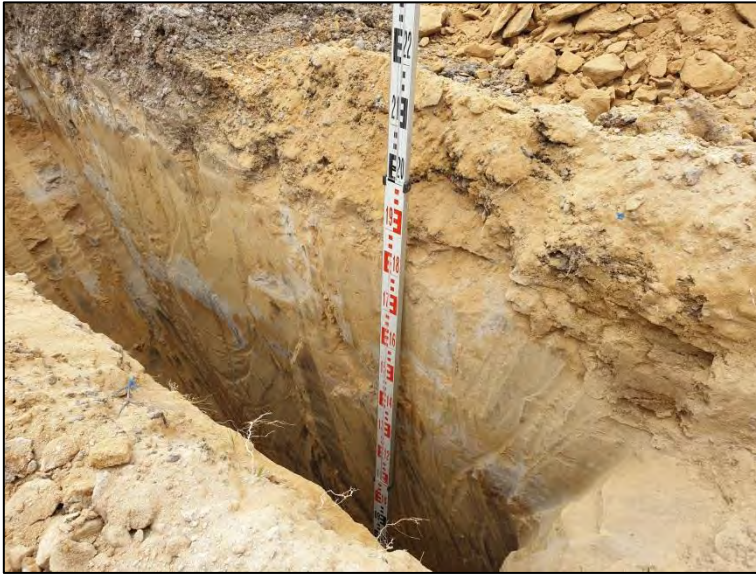
**Figure 22: Weathered rock conditions in Pit 4001**

It is anticipated that very low to medium strength weathered siltstone and sandstone encountered in Pits 301 to 305, and Bores 601 to 606, could be readily excavated / ripped to a particle size of less than about 0.3 m but more likely less than 0.15 m. It is suggested that cross-ripping methods and heavy pad foot rollers could be used to further break down excavated bedrock to material with a maximum particle size of less than 150 mm. Pits 4001 and 4003 were excavated in the areas of proposed pavements. These pits do, however, provide an indication of the excavatability of the weathered siltstone and sandstone. The weathered bedrock was relatively readily excavated using a 6.5 tonne excavator into particles in the order of 50 mm to 300 mm in Pit 4001 (refer Figure 22), and hence with additional preparation (breaking down of particles) this material would be suitable for re-use as engineered filling.

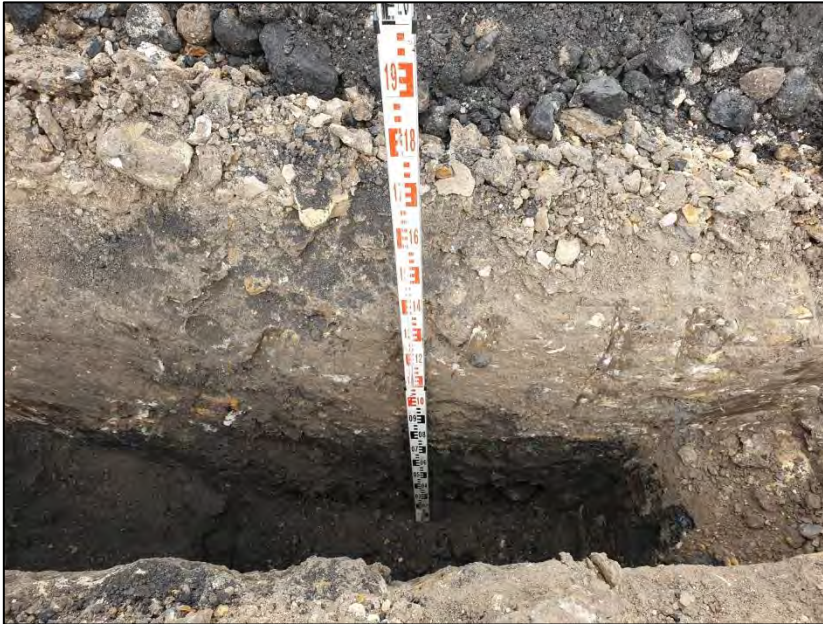
**Figure 23: Photo of Pit 5002, showing existing capping and underlying carbonaceous material**

The carbonaceous material is likely to be high in combustible material. In this regard, previous assessment of samples from the site (Ref 16) indicated that combustible percentages of up to 90% were recorded in the samples of coal testing. The pits undertaken within the stockpile (Pits 5001 to 5004) encountered a blend of coal and carbonaceous material (refer Figure 23).
