# **Proposed Development – 2 to 6 Conway Avenue, 15 & 15A Fernleigh Avenue, & 38 to 40 Carlisle Street, Rose Bay**

## **Preliminary Assessment of Potential Geotechnical Impacts on Neighbouring Properties**

Our ref: JM/C17267\_Rev1

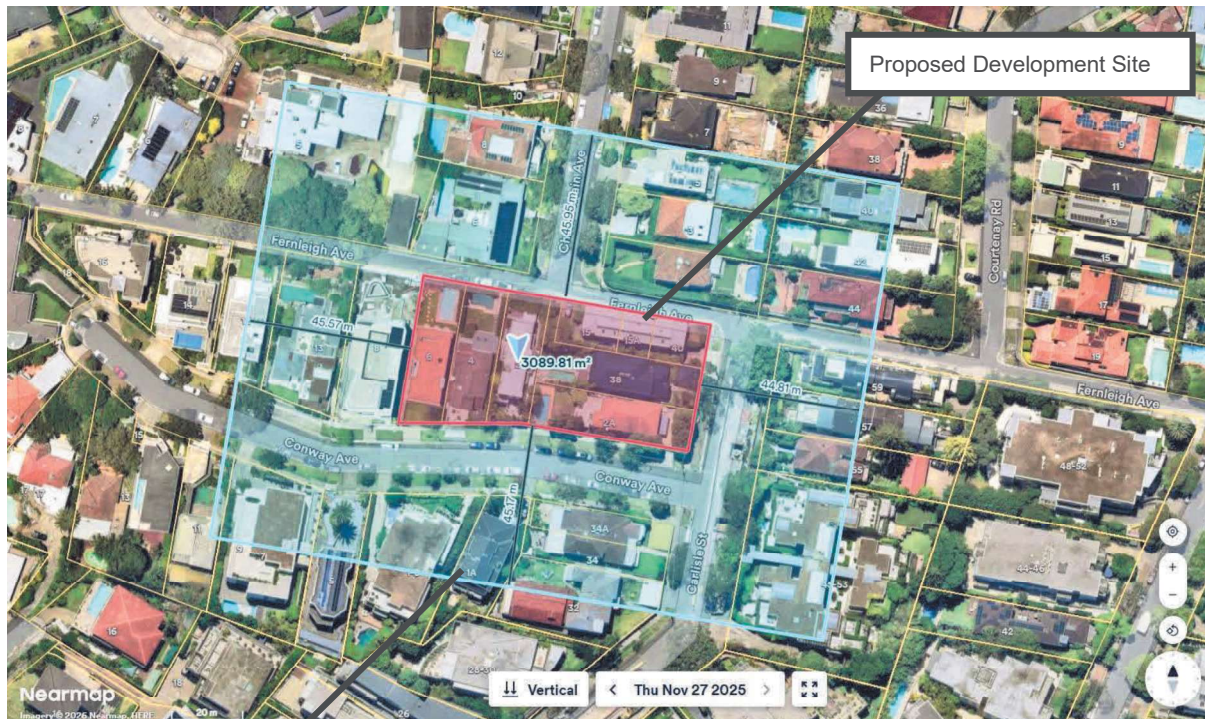
Plate 4-1: Aerial Photo Showing the Approximate Area That will be Impacted by Groundwater Drawdown During Dewatering

- Based on our own assessment of potential groundwater drawdown (no numerical modelling has been provided by the proponent), it is estimated that drawdown of the groundwater table will not just be limited to the site, but exceeds 0.3m of drawdown extending between 15m and 35m away from the excavation boundaries (and therefore exceeding the GHD and Council DCP Amendment 30 recommended value of 0.3m of drawdown up to ~35m away from the site boundaries). Therefore, the area impacted by groundwater drawdown exceeding the GHD recommendation is shown in the aerial photo in Plate 4-1 below, and impacts between 20 and 25 properties.

Approx. Area Impacted by  
Groundwater Drawdown During  
Dewatering (assuming ~45m  
impact radius)

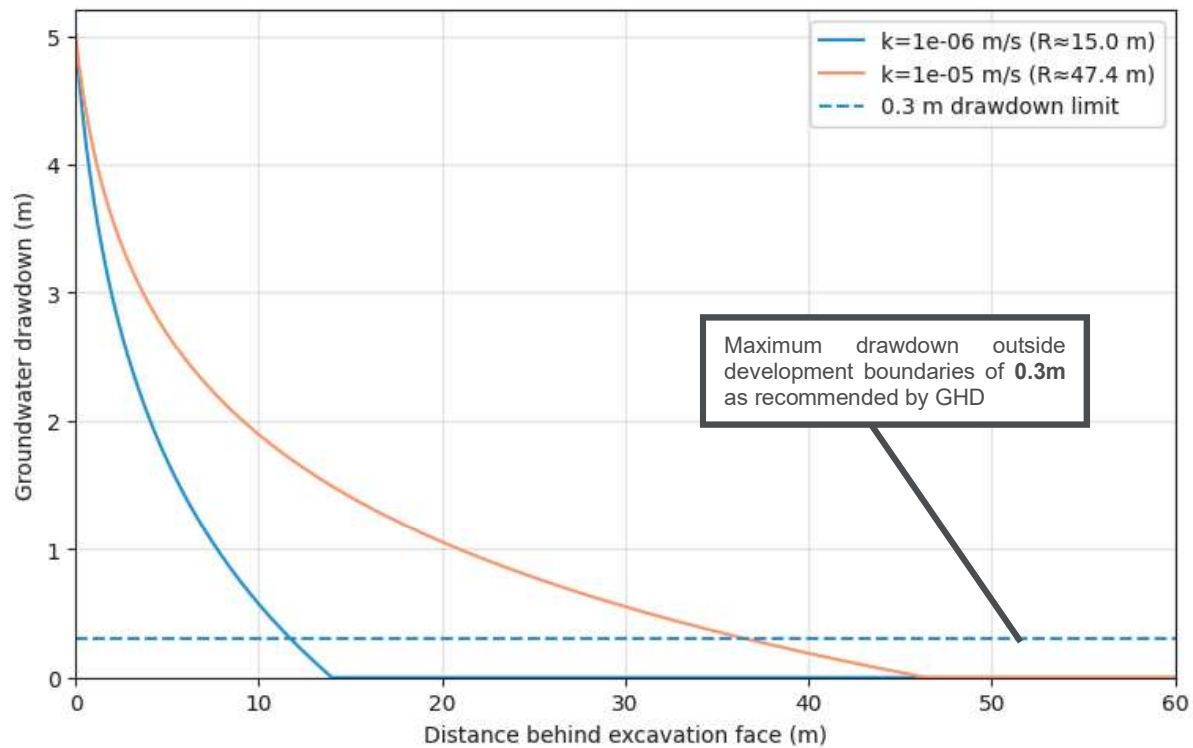
Plate 4-2: Graphical Representation of the Depth of Expected Groundwater Drawdown at Distances Extending From the Excavation Boundary (not based on numerical modelling, as this has not been provided by the proponent)

- There are existing structures within 5m to 10m of the proposed excavation, and our estimate is that drawdown of the water table could be greater than 2m depth at this set back distance. The GHD report commissioned by Woollahra Municipal Council states that such drawdown can cause settlement and damage to properties, and therefore recommended that **a limit of 0.3m of groundwater drawdown outside the development boundary** be permissible. Given that we estimate that groundwater drawdown will be greater than this affecting between 20 and 25 neighbouring properties, it is assessed that the proposed development would not comply with Council advice under these conditions.

- Plate 4-2 below is a graph prepared by us based on our own assessment showing the potential groundwater drawdown at set-back distances behind the excavation shoring wall. It should be noted that this is our preliminary estimate, as no numerical modelling has been provided by the proponent.

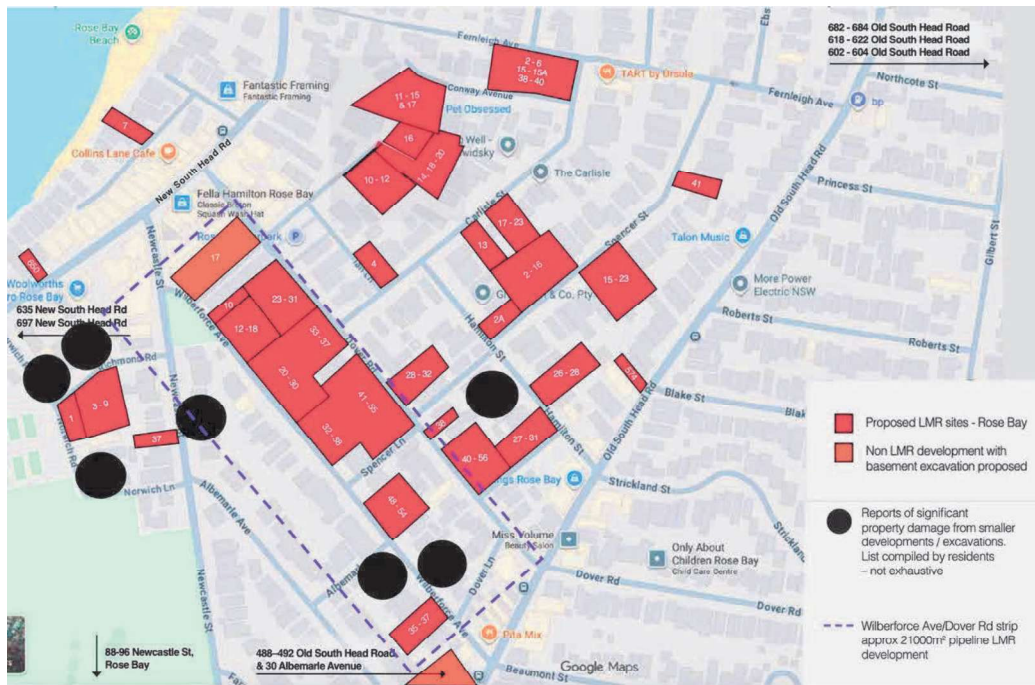
- Numerous instances in Double Bay and Rose Bay of structural cracking and damage to existing houses and apartments which are located near or adjacent to building sites where deep excavations with dewatering are being undertaken. Specific instances where structural damage to neighbouring properties that have been attributed to shoring installation (both from vibrations due to installation of sheet piling and over-flighting for bored piles), excavation and dewatering works in Rose Bay are shown in Plate 5-1 and include:

- o Norwich Lane – back wall came away from the neighbouring house
  - o Richmond Avenue – structural cracks appeared in block of neighbouring units (stop work issued).

- o Wilberforce Avenue – neighbouring house collapsed. The house was deemed unsafe for occupancy and it was subsequently sold and demolished.
  - o Wilberforce Avenue – the same above development caused flooding into the basement of a neighbouring house.

Plate 5-1 – Indicative markup provided by the client showing the development site (yellow), proposed LMR development sites (red), and known properties that have experience structural damage due to adjacent developments.
