Review of Document for SSD-30759158

Dam Dewatering Assessment: 268 & 278 Catherine Fields Road, Catherine Fields, NSW P2108320JR03V01 – April 2022 Prepared by Martens Consulting Engineers

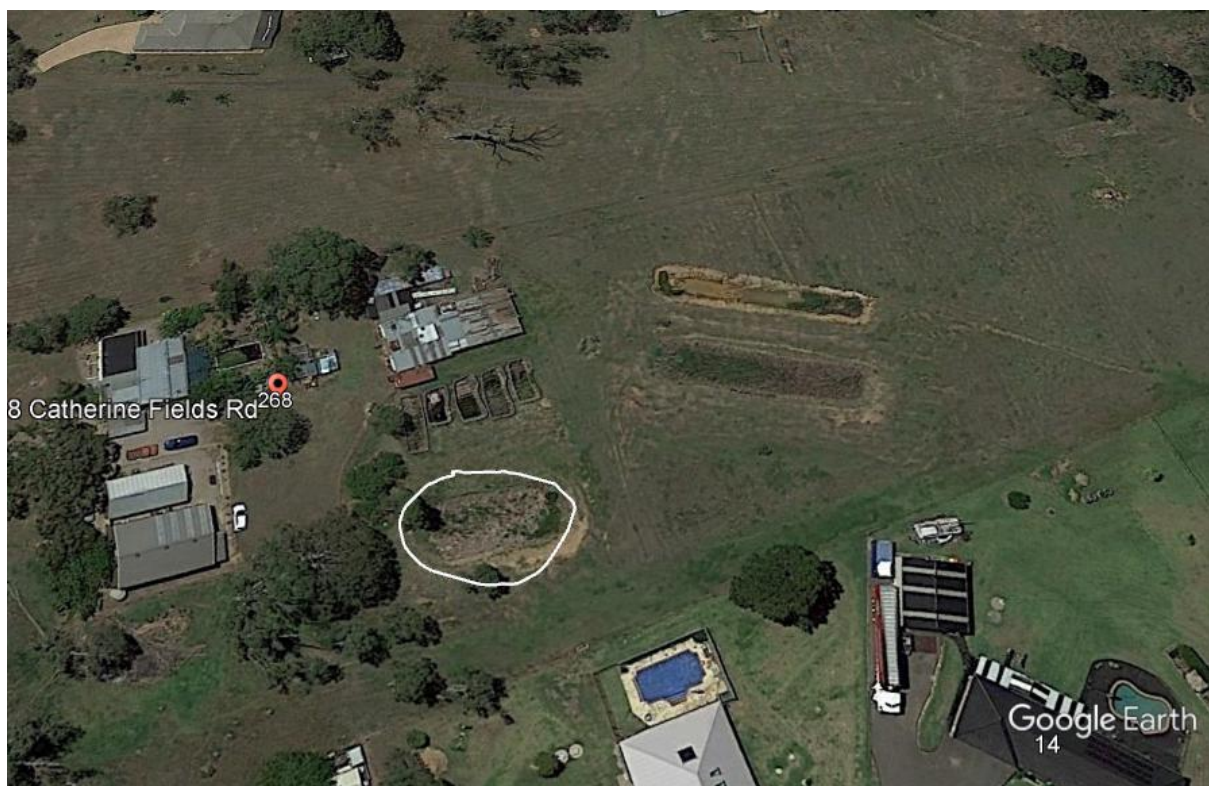
At the time of the alleged walkover there was another large dam on the site that was dewatered and filled in, shortly before the property was taken possession of by the development proponents. If Martens had completed the site walkover and observations on the date claimed, then they should have observed the third dam which was the biggest of the three. This aerial Imagery date is 22/03/2018 The third dam is circled but all 3 dams were dry at the time as it was taken in a drought period.

At the time of removal, the third dam was about 1/3 to half full.
