Errors add to confusion!

App G LVIA Addendum - 7.0 Morrisons Gap Rd Upgrade, Page 30

Protect Morrisons Gap Road

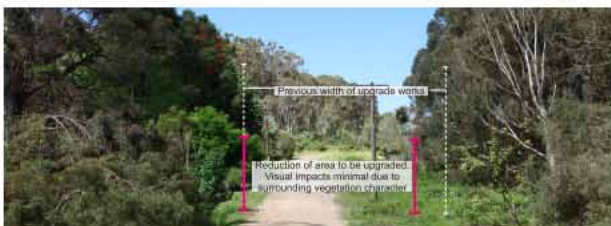
Image 03

This section involves a creek crossing but there is no indication whether a new bridge is required. Also two power poles may need to be relocated. The proposed layover for OSOM vehicles is not shown on Image 04 or Figure 17. Placement of a layover in a section of road passing through a lifestyle property subdivision is not appropriate.

Image 03. View of Morrisons Gap Road near NAD_15 AD_15

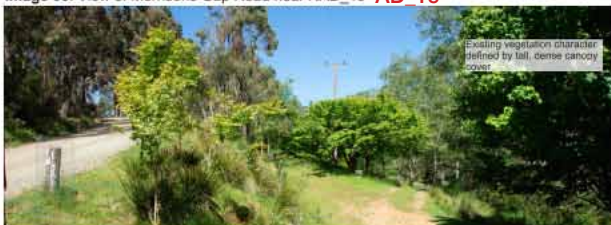
Image 04

Image 04. View of Morrisons Gap Road
HILLS OF GOLD WIND FARM | LANDSCAPE & VISUAL IMPACT ASSESSMENT ADDENDUM

BLIND SPOT: this corner is a serious potential traffic hazard. Widening of the road will be restricted because retaining walls have been eliminated following feedback from Tamworth Regional Council.

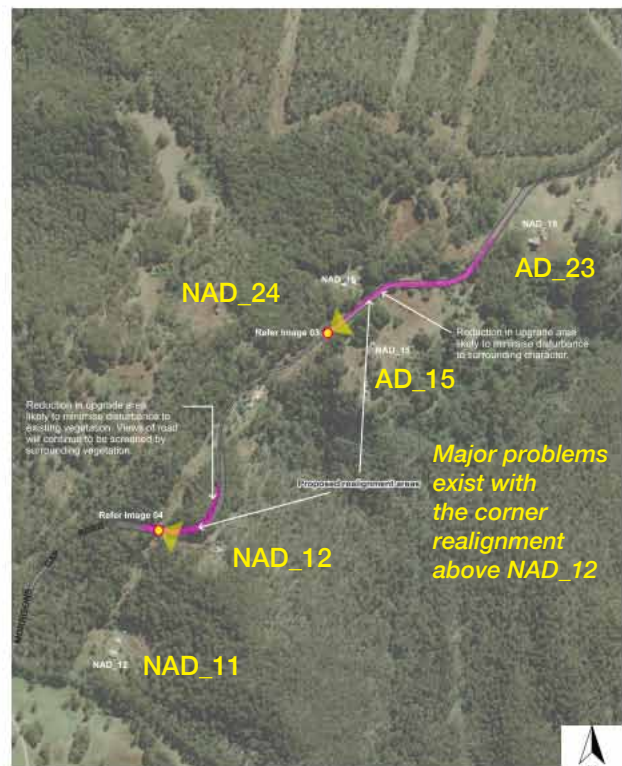
Figure 17. Morrisons Gap Road Upgrade (Not to scale, Map Source: ESRI Imagery 2022)

NAD_18 should be AD_23

NAD_15 should be AD_15

NAD_12 is shown incorrectly at NAD_11 location

NAD_12 & NAD_24 are not marked

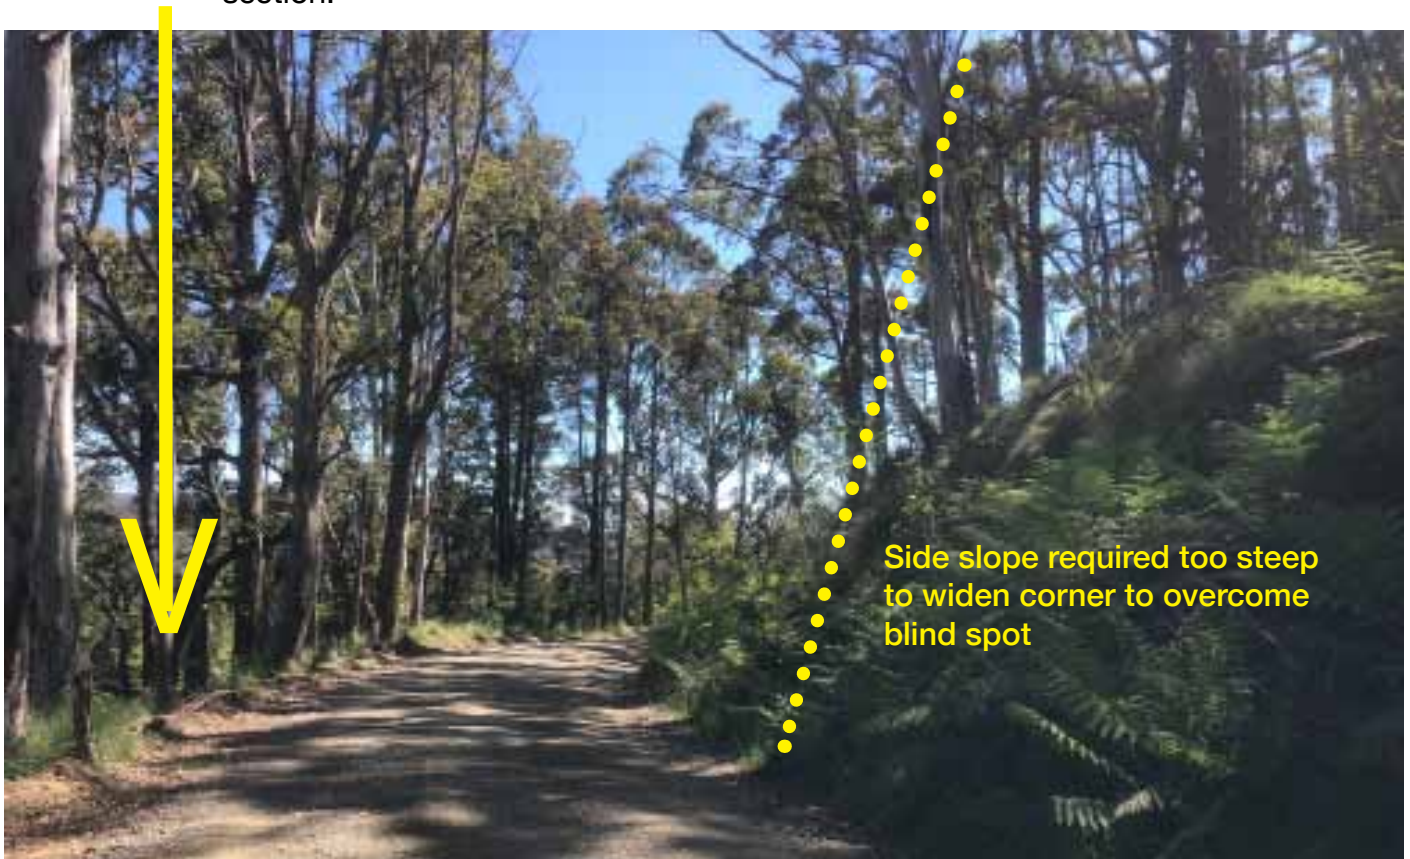
The proposed realignments for Morrisons Gap Rd will transform this quiet rural road into a high traffic work road. Adjustments to the corner above NAD_12 involve cutting into the northern embankment as the slope of the southern side is too steep. This will involve serious disturbance to existing vegetation as well as creating erosion problems.

Road cannot be widened on southern side because of steep slope. Tamowrth Regional Council rejected application for retaining walls in this section.

- Unacceptable impact to cut into this embankment
- Unacceptable loss of native vegetation and habitat

Morrisons Gap Rd - Corner above NAD_12 - view to south

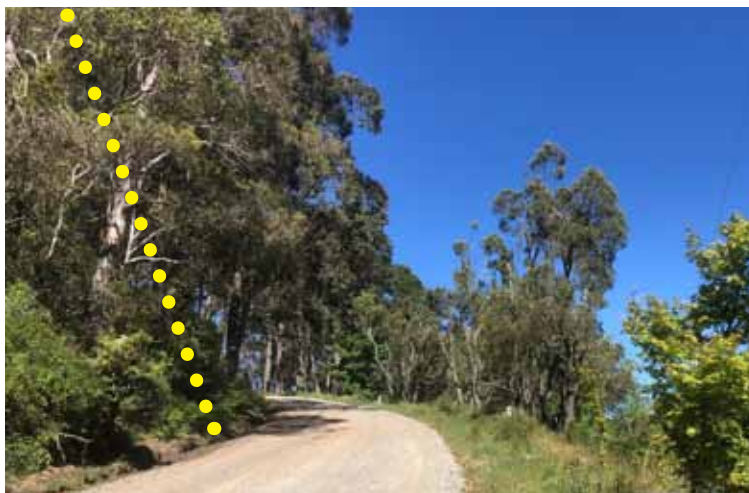
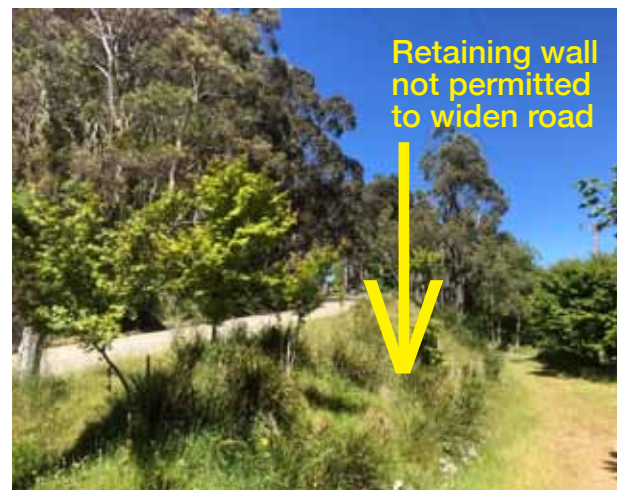
Morrisons Gap Rd - corner above NAD_12 view to north
