LAND

The Land section describes the characteristics of the proposed development site land, their limitations for the proposal and likely impacts.

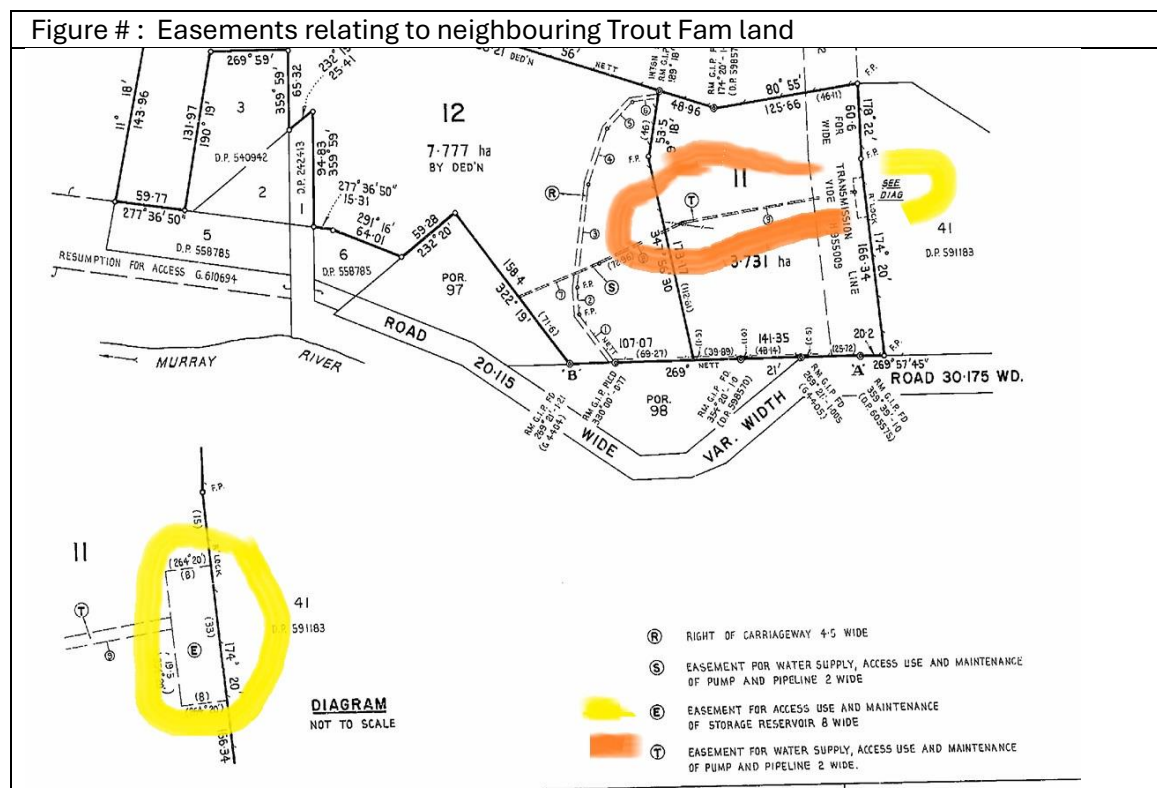
Not listed in the EIS are the associated reciprocal entitlements the Trout Farm land has over water supply access easements located on the proposed development site land (Figure : Easements relating to neighbouring Trout Fam land). The areas marked orange and yellow identify the location of the easements relating to the neighbouring Trout Fam land.

An adjacent neighbour has the right to the easement, and it must retain access. BESS structures can not be located over it. The water related easements are not mentioned in Section 1.6 Restrictions or covenants, p 5) but critically relevant as it may be “subject of a separate approvals process” (SEARs general Requirements. P 1)”.

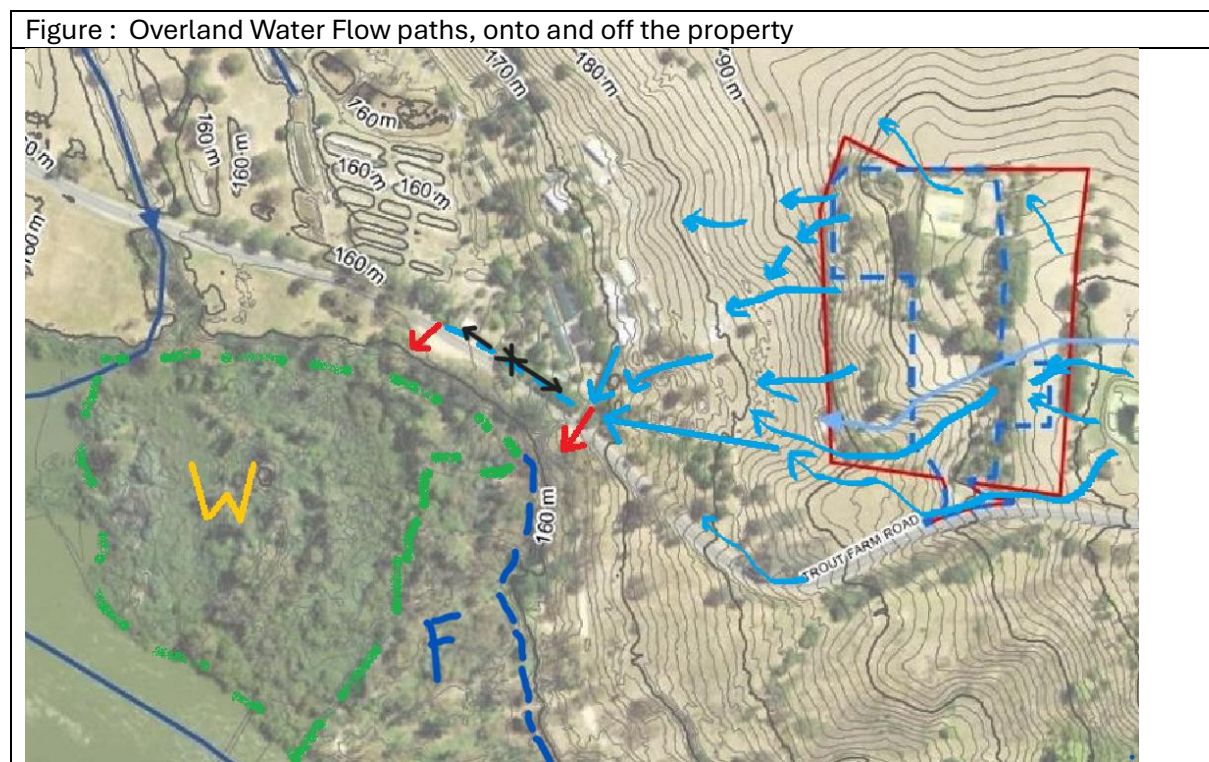
It is far short of the detail assessment required for site runoff, and run-on, for proposed project where almost all of the site is either concreted or hard paved. A more appropriate detailed map is provided in Figure : Overland Water Flow paths, onto and off the property, below.

Runoff is received from the Water Treatment works above (Figure : Overland Water Flow paths, onto and off the property, above). This is significant during large storms (see Flooding, p 8 below).

Almost all runoff from the property flows to the Trout Farm land adjacent to the west. If substantial, that runoff flows to a culvert under the Trout Farm Road (red arrow) to the Murray River ox-bow wetland (marked “W”).

If the culvert reaches its limit, the water flows along the roadside to the next culvert. This has occurred a couple of times in the 2020’s and cut out a ditch along the pavement edge (marked black * on Figure : Overland Water Flow paths, onto and off the property above).

The area adjacent the Murray River marked “blue F” is Floodplain. It inundates at declared “moderated flood” levels. It was inundated for several weeks during the controlled flood induced as a response to Hume Dame wall crack/movements (2012).

- Flow path determination is too coarse and does not adequately consider:
 - run-on from land above, or
 - the end point of runoff onto the Trout Farm land; and the wetland/Murray River known to have occurred.
 - site runoff, for proposed project where almost the whole site is either concreted or hard paved

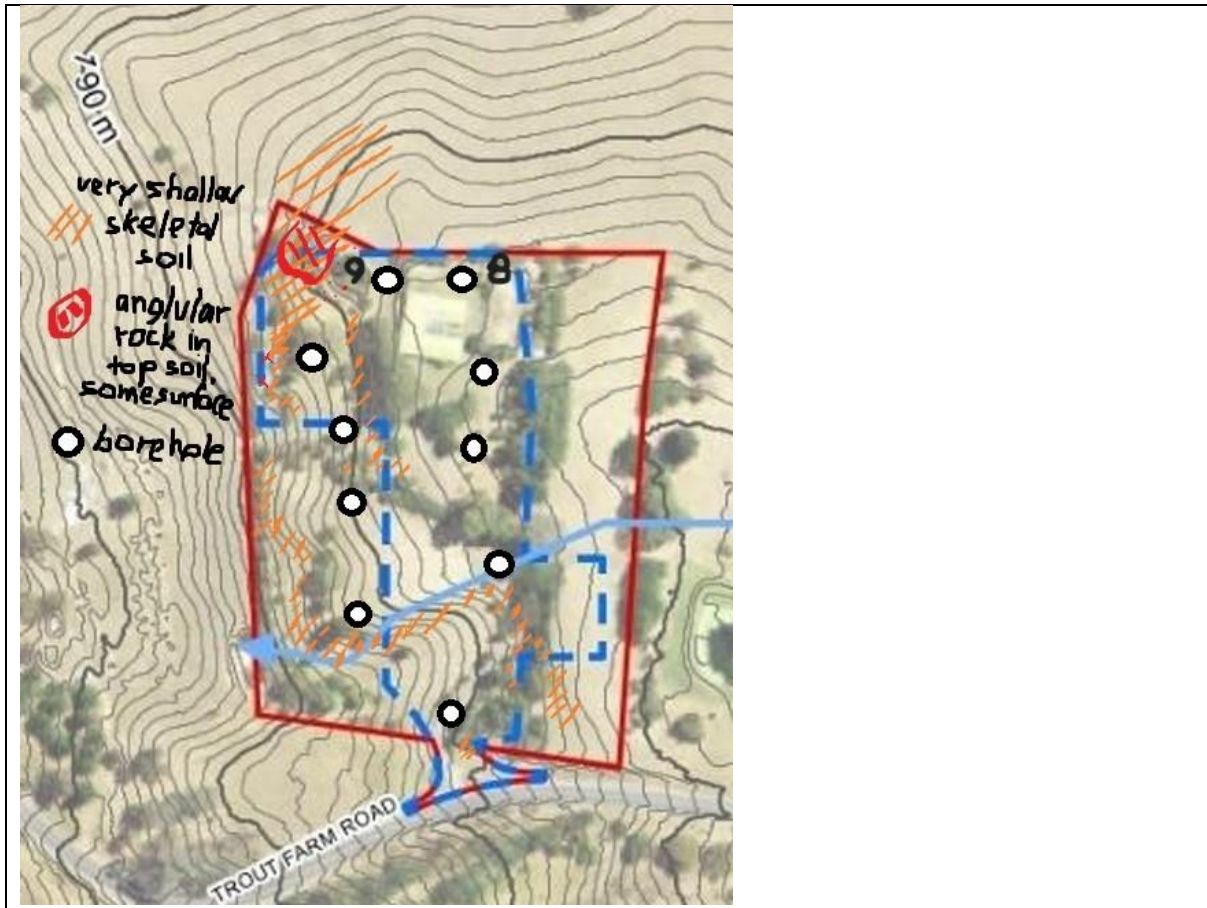
A map showing the location of shallow soil and with “rock/stone“ (large angular pebbles/gobbles, 20 - 200 mm, (ASLS, 1990), close to the surface, some on the surface were produced (see Figure : Lanark - Shallow Soils and “Rock” below).

Sites of the Geo Technical investigations bore holes have been approximately also located on the map to reveal any correlation.

There are rock/stone areas on the property as identified with a red circle in Fig : Shallow soils and rock, above

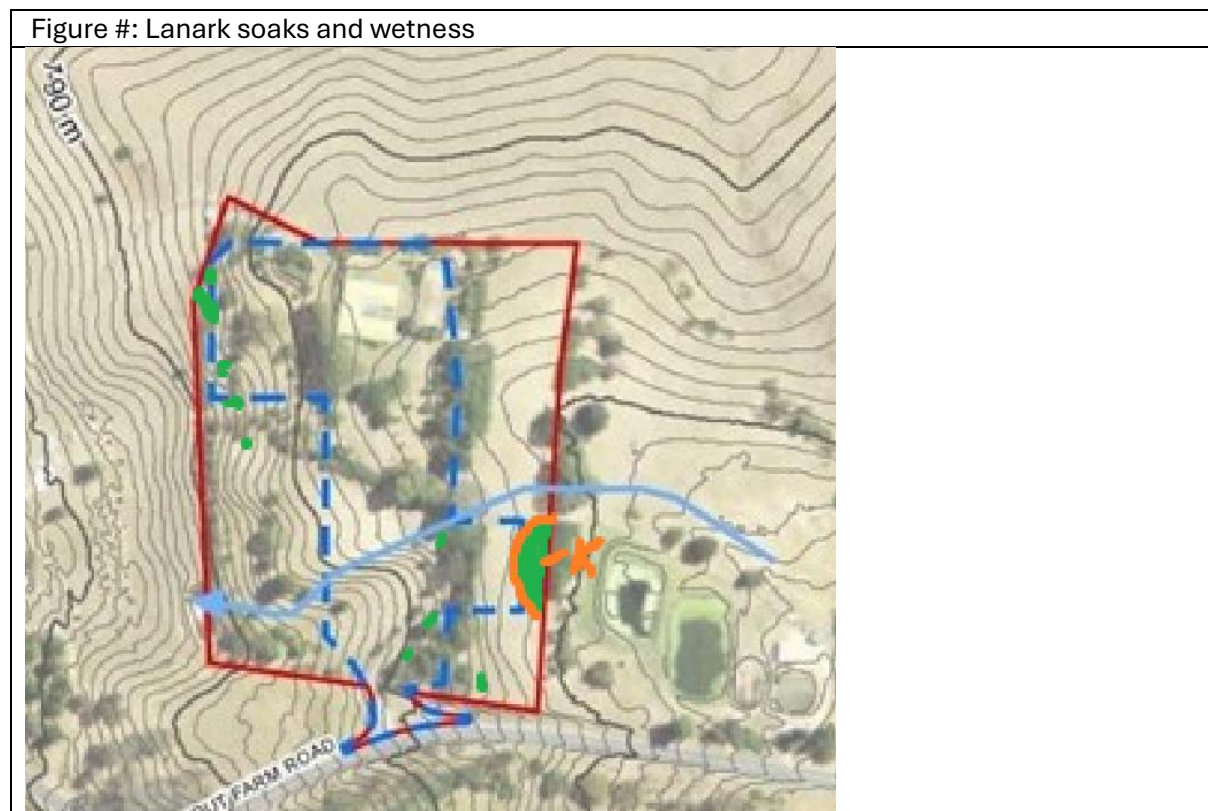
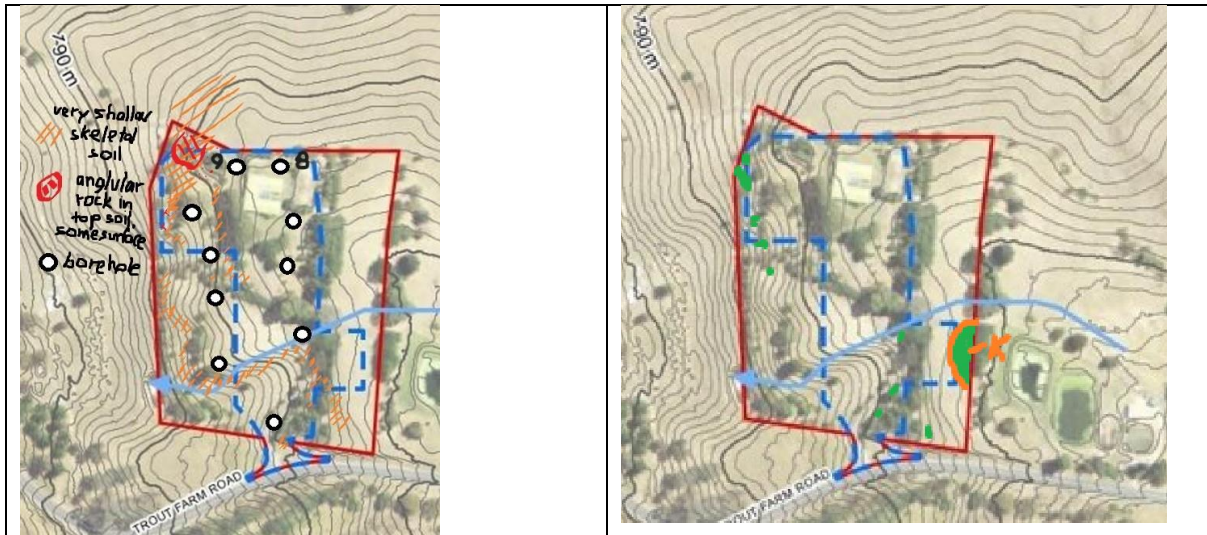
Figure #a: Steeper shallow soil areas

Soaks occur at several locations on Lanark most years and addition areas appear in particularly wet years. These have been identified on Figure # below. The annually wet areas had wet indicator plant species such as rushes, paspalum grass and are untrafficable by foot or 4WD

- a change of slope below the steeper shallow soil areas (see Figure : Lanark soaks and wetness ,overleaf), Subsurface seepage is visible in the uphill side of the entrance road cutting after soaking rains and the soak adjacent the Trout Farm Road is to be avoided with vehicles as a fencing contractor learnt the hard way after driving there.
- shallow rock band

The portion of Lanark immediately below the sewerage treatment ponds is quite wet and boggy for a portion of most winters. The extent reflected by an area of Kikuyu Grass (marked “K” on Figure # Soaks and wetness) and stays green well into Summer; and required gumboots to be worn in winter.

A likely explanation is regular seepage during winter or minor off site flows from the Treatment Works site (pond).

- **ACHAR consultants need to be advised of the presence of these soaks and assessed SAL status if they are significant as the soak identified on Crown Land Lot 98.**
- **Proponent of the development needs to be aware of this land characteristic risk and the effect it will have on the cut/fill presently designed**

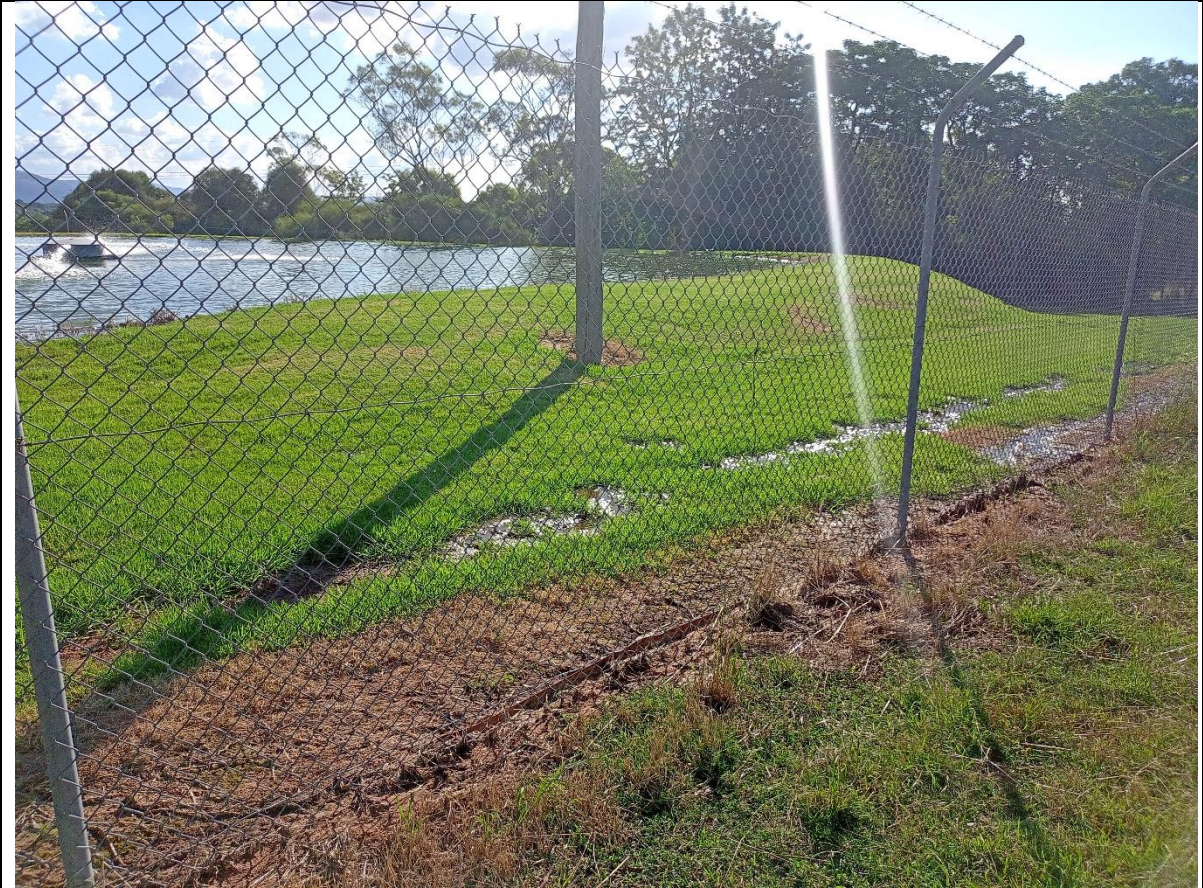
Following heavy rain, the bottom pond of the adjacent Wastewater Treatment pond overflowed and maybe overtopped (see Photo x.1 below).

Photo x .1: Sewerage Treatment Pond overflowed

Water spilled into Lanark spreading across the “Lemon Tree Paddock” then down through the “Driveway Tree lot” and stock yards toward the property entrance road. Some water crossed the bitumen access road but most flowed down the road towards the front gate.

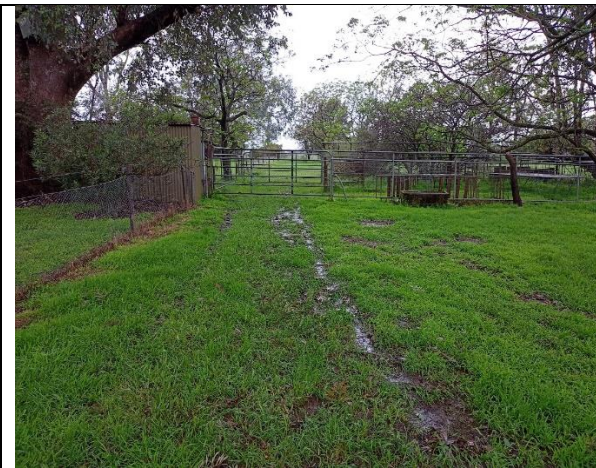
The water flow was substantial and removed all the gravel from the bitumen surface pushing it into the fence to the west of the road in several points (photos x.2 – x.5 below).

Photo x .2: Stockyard gates

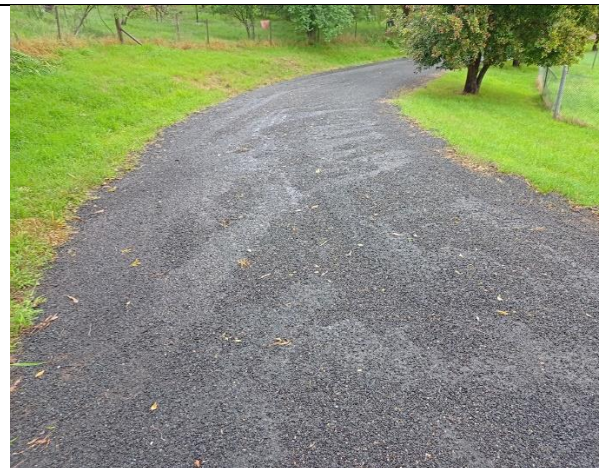
Photo x .3: Road bitumen wash 1

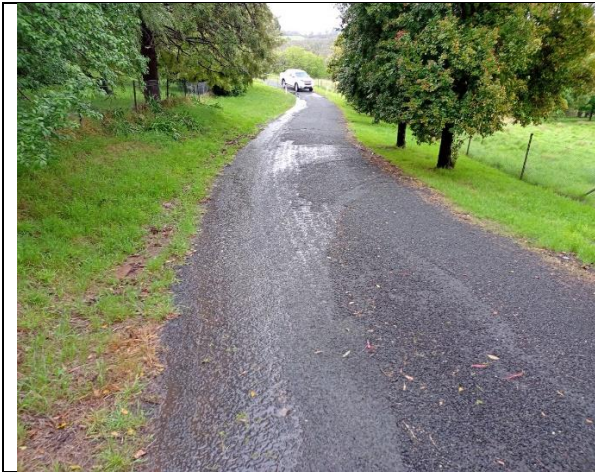
Photo x .4: Road bitumen wash 2

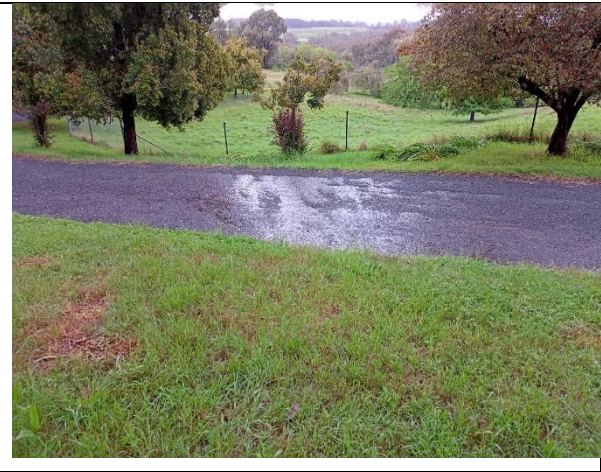
Photo x .5: Road bitumen wash 3
