24 November 2020

Our ref: 20SYD - 17804

Harbourside Redevelopment Microbat Survey

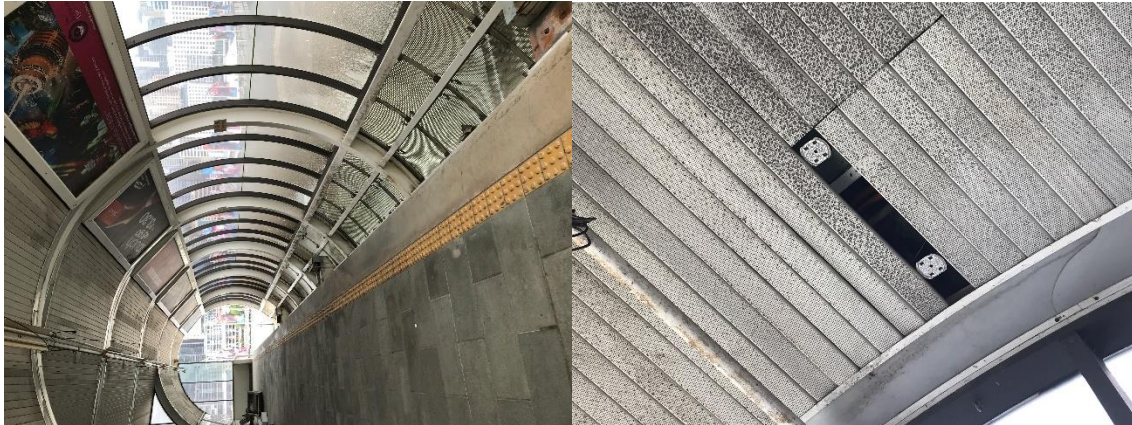
Monorail	Exterior	Holes throughout old monorail roof, with insulation visible in roof. No signs of bats or calls heard. Likely very windy, but some coverage to wind (depending on direction). Low noise and light exposure compared to surrounding area. Old building (closed shop at station) doesn't look suitable with an open vent roof with no covered cracks	Unlikely
Overpass to Car Park (Over Darling Drive)	Exterior	Superficial expansion joints provide potential habitat, though it is very exposed. High light, wind and noise disturbance. No signs of bats	Unlikely
Plant Room Second Floor	Interior	Very dark and lots of cracks and holes in roof. High noise disturbance from machinery. Holes in roof accessing roof cavity (small). Whole room unable to be surveyed due to safety reasons and we were unable to determine whether entry/exit points to the outside were present.	Unlikely
Plant Room Second Floor (no 2)	Interior	Lots of cracks and hidden areas (e.g. behind large pipes or panels). Low light disturbance but high noise disturbance from machinery. Whole room unable to be surveyed due to safety reasons	Unlikely

APPENDIX 2 EXAMPLES OF CRACKS AND CREVICES OBSERVED DURING THE SURVEY – DISUSED MONORAIL

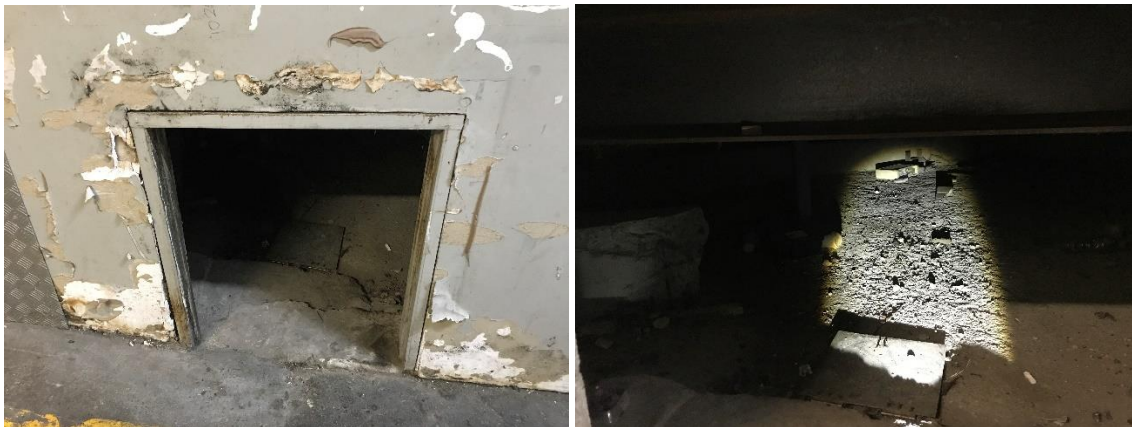
Region	Interior / Exterior	Microbat habitat features	Likelihood of occurrence
Dock Region (including security office)	Exterior	Lots of cracks were observed near the docks but this area experiences very high noise and light disturbance. The space underneath the security office was accessible by an open manhole and may provide potential habitat. This was not able to be visually inspected completely underneath	Unlikely
Gas Valve Room	Interior	Small gaps where roof meets bricks. No signs of stains or bats, but no cobwebs over gaps	Unlikely
Grease Arrestor Room (near Docks)	Interior	Couldn't see back of roof cavity and electrical cavity on roof has some gaps, though no signs of bats. Low noise disturbance, medium light disturbance.	Unlikely
Meter Room No 4	Interior	Cracks between roof and wall. Low light, no noise disturbance. No signs of bats. Water pit in room. Large hole on outside of building near room	Unlikely

APPENDIX 3 EXAMPLES OF CRACKS AND CREVICES OBSERVED DURING THE SURVEY – UNDERNEATH OF SECURITY BUILDING

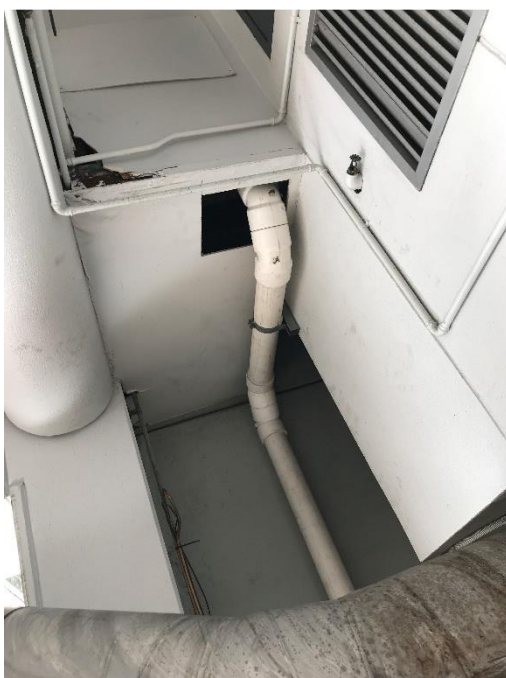
APPENDIX 4 EXAMPLES OF CRACKS AND CREVICES OBSERVED DURING THE SURVEY – HOLE NEAR METER ROOM NO 4

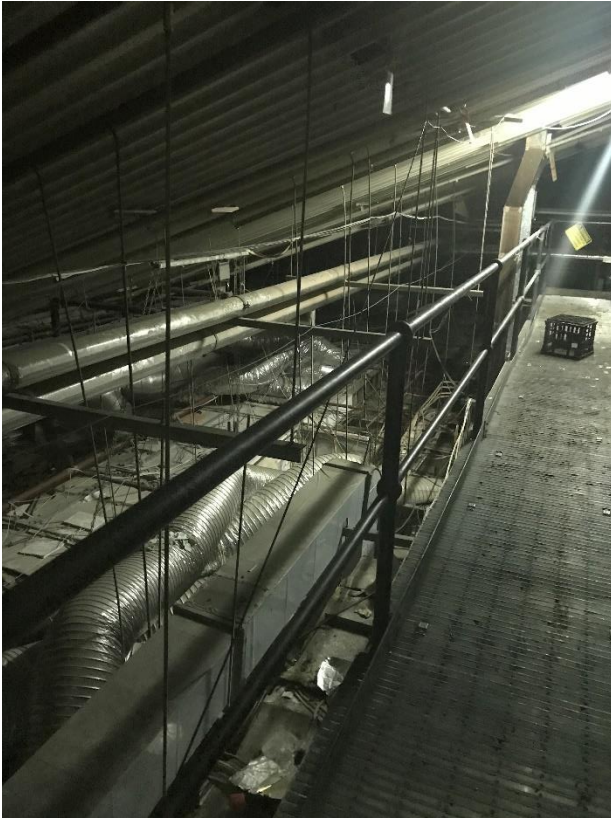
Plant Room Second Floor (Cooling Tower)	Interior	Very dark and lots of cracks and holes in roof. High noise disturbance from machinery. Holes in roof accessing roof cavity (small). Whole room unable to be surveyed due to safety reasons	Unlikely
Water Meter Room	Interior	Dark with little noise disturbance. Lots of cracks. Cobwebs over most cracks. Small hole in wall. Lots of areas for bats, but lots of cobwebs suggestion little movements/disturbance	Unlikely
Workshop (near Docks)	Interior	Moderate light and noise disturbance. Cracks in roof (concrete). No signs of bats. Some staining of roof (not bats). No cobwebs	Unlikely
Transgrid Workspace	Interior	Not accessible by Harbourside staff	Unlikely
Control Room (near Docks)	Interior	Control room with pipes and electronics. Very noisy. High disturbance. Machinery in operation. No bat signs. No obvious gaps suitable for microbats	No

APPENDIX 5 EXAMPLES OF CRACKS AND CREVICES OBSERVED DURING THE SURVEY – PLANT ROOM ON SECOND FLOOR

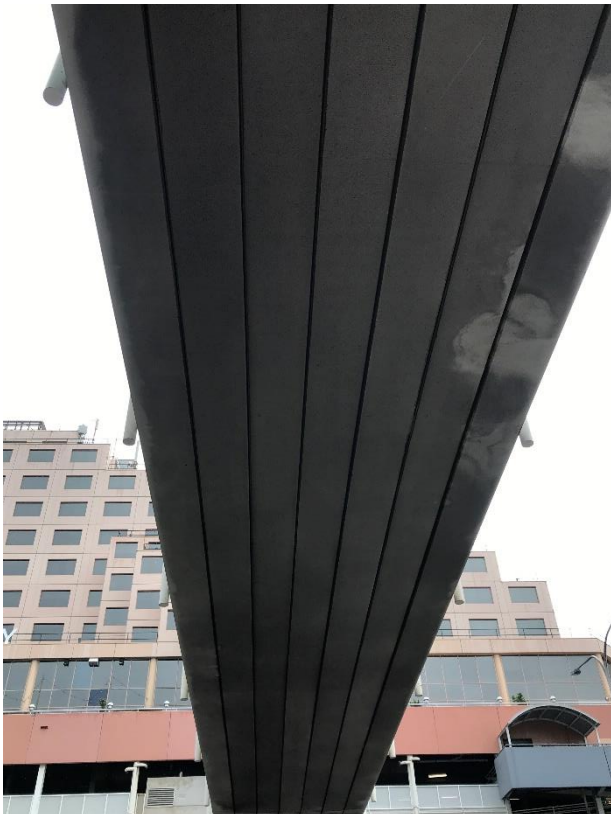
Two overpass pedestrian walkways and one disused monorail platform were also inspected. Both overpass walkways (above Darling Avenue) were highly exposed to light, noise, vehicular and wind disturbance. The expansion joints between concrete slabs comprising the deck of the walkways and between the headstocks and walkway deck appeared to be mostly superficial on both walkway structures, extending only a short way into the concrete (~ 20 mm). The disused monorail station contained potential microbat roosting habitat, with gaps in the roofing panels which may provide shelter for microbats; although no guano was observed beneath these panels. The area underneath the security office in the loading dock had an open hatch which may provide an entrance point to potential microbat roosting habitat below. A full inspection underneath this building was not possible. The Transgrid work space near the dock area was not accessible to Harbourside staff, and was therefore not inspected.

APPENDIX 3 EXAMPLES OF CRACKS AND CREVICES OBSERVED DURING THE SURVEY – OVERPASS TO CARPARK
