RE: Submission to Proposed Cable Manufacturing facility Application # 10\_0039

#### ACCESS ROAD CONDITONS

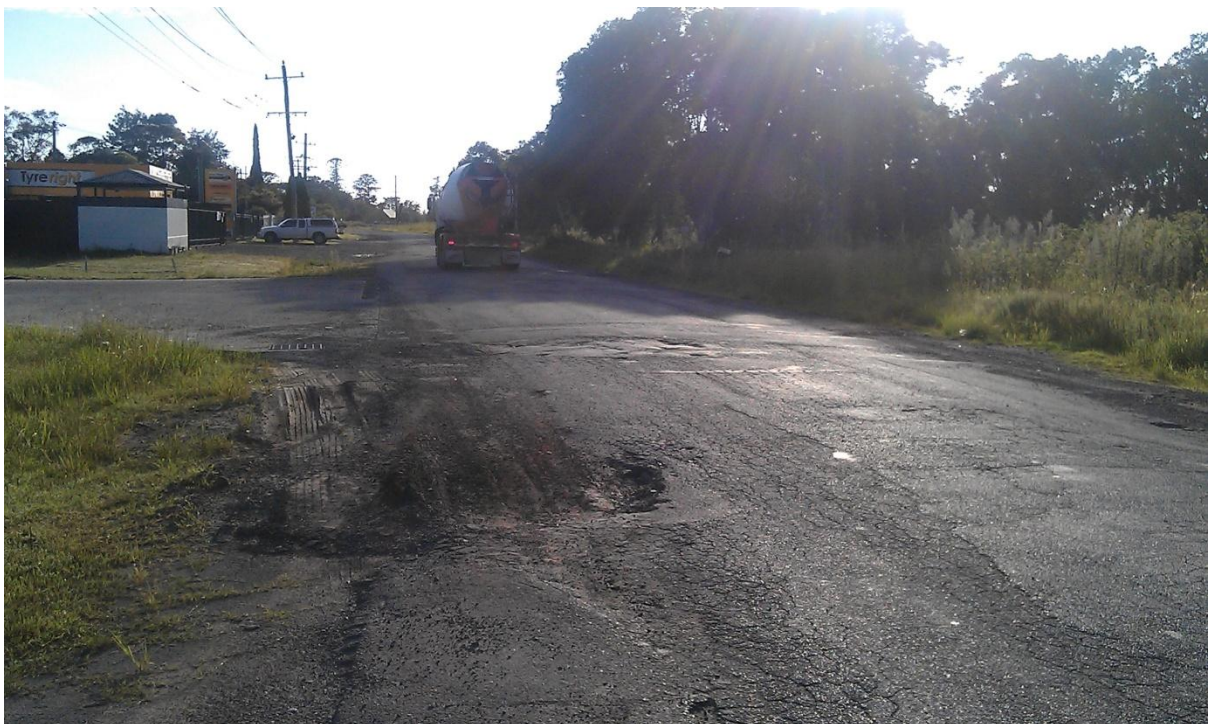
The western 500m is mostly two lanes but in its current state it has lengths that are only 4m wide of sealed surface. See Photo below.

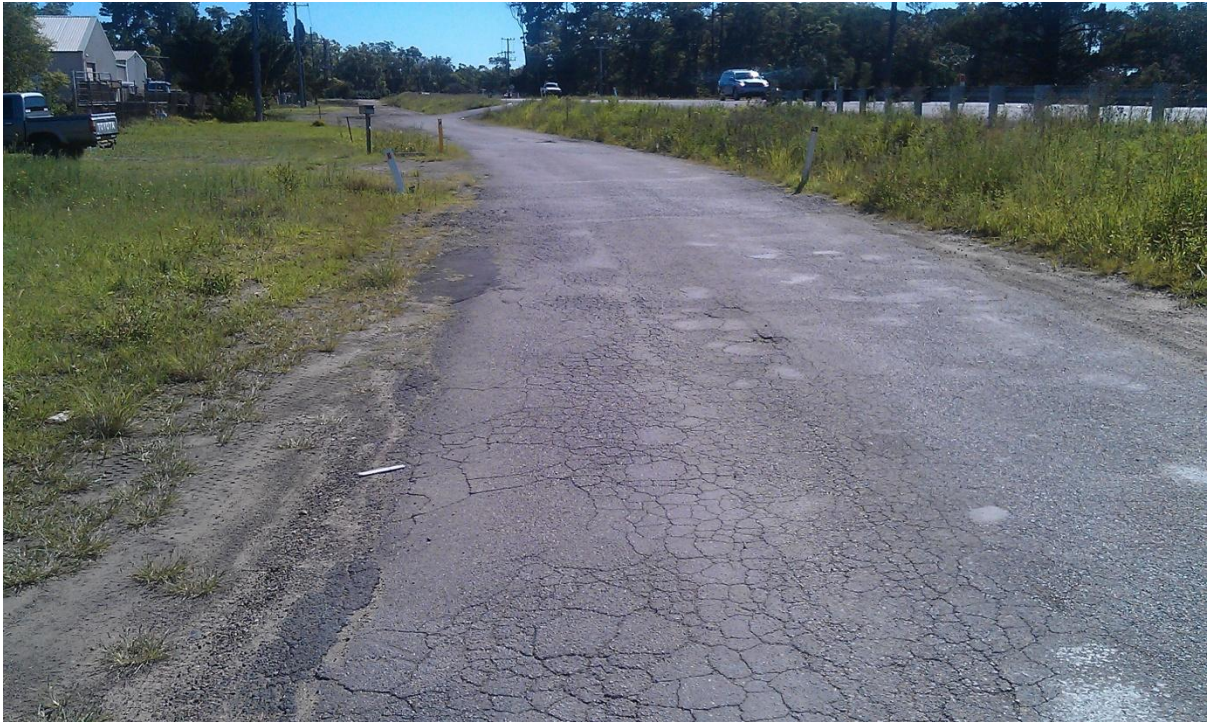
The eastern 500m of School Dve is only 1 lane wide and in many parts only semi sealed surface.

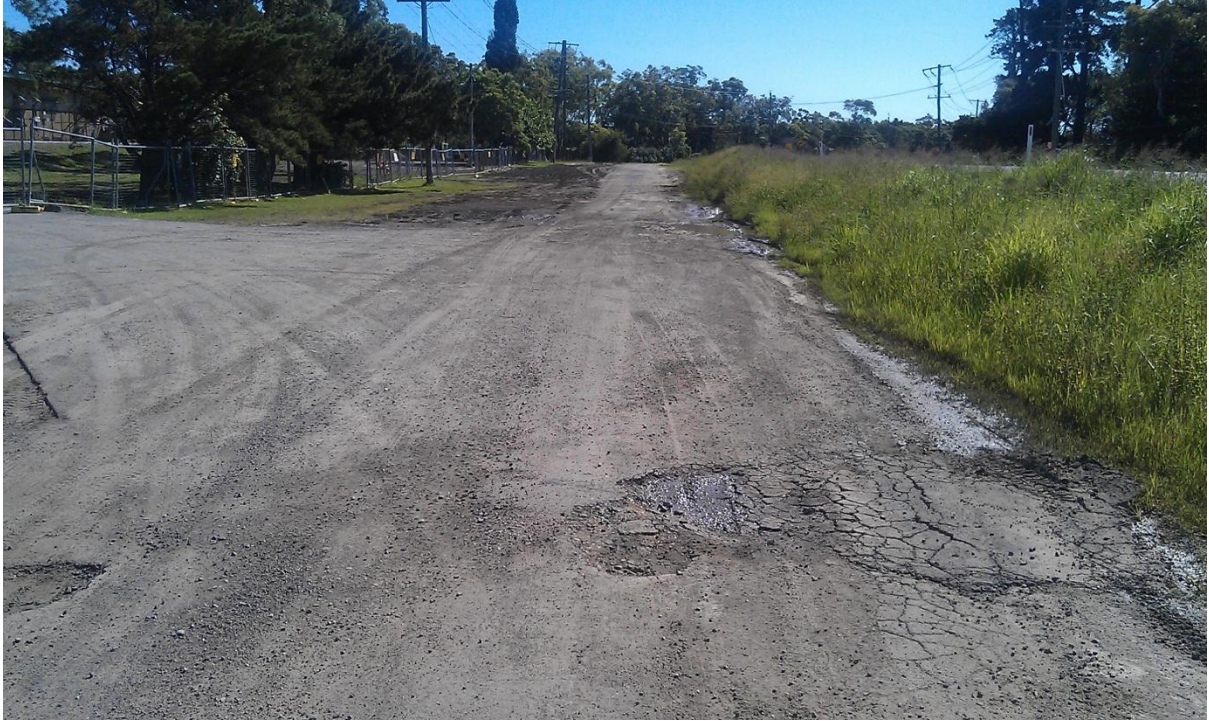
- \* Construction of a new substation @ 37 School Dve and associated works destroyed much of the Northern shoulder of School Dve due to underground cabling and the road in front of 37 39 41 School Dve.

The Complete failure of School Dve in front of the new Aus Grid Sub Station @ 37 School Dve due to construction works.

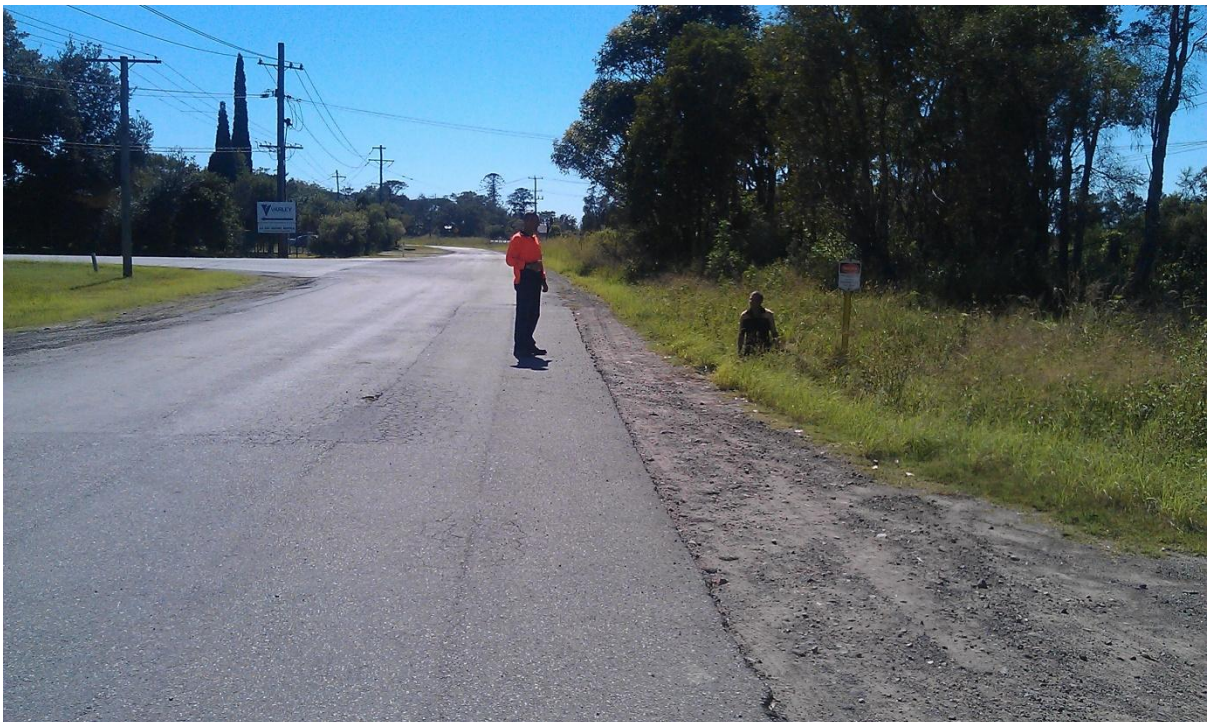
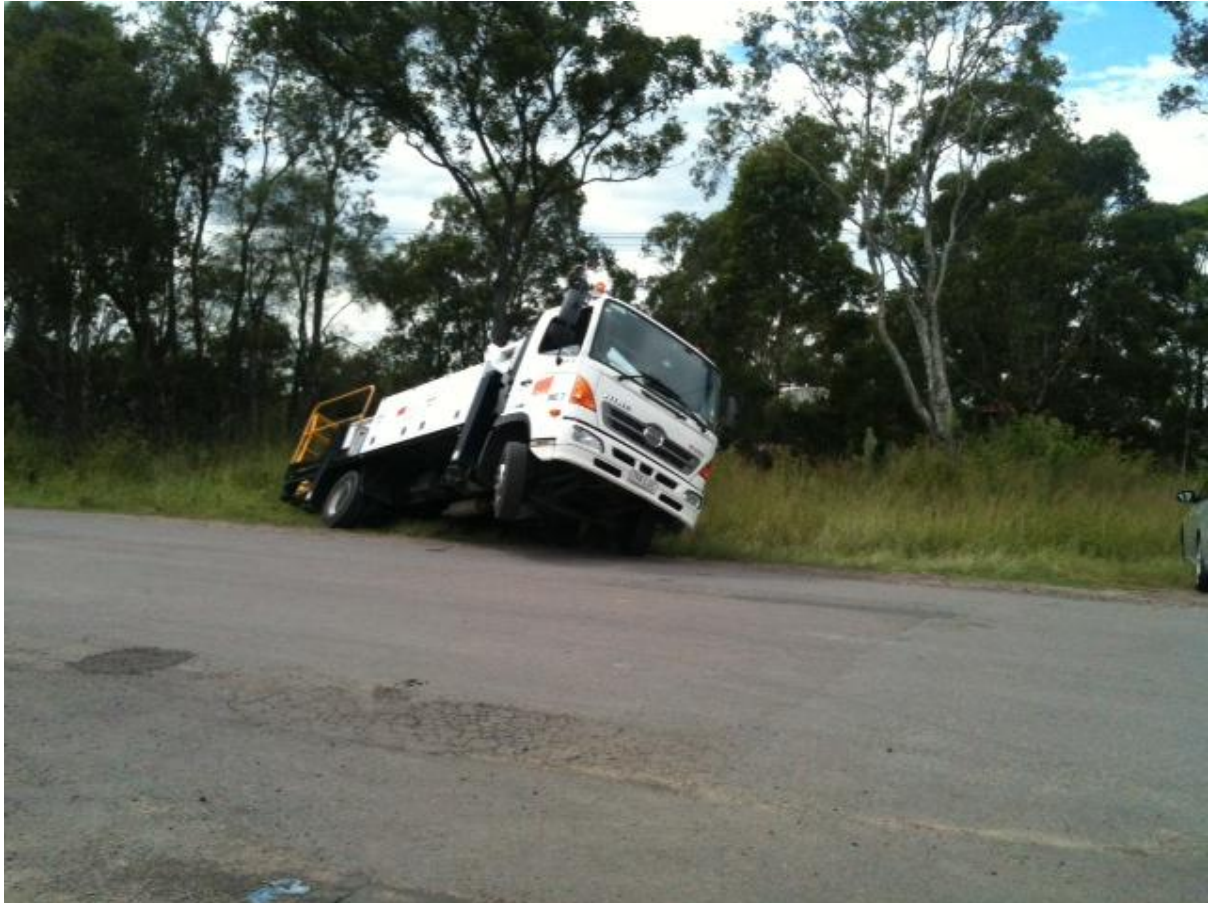
- \* Concealed drainage that is a hazard to vehicles parking on the shoulder on the road.

Lack of adequate drainage on the shoulders of the road. And also concealed drains in the shoulder
